NO. 1 SLOPE FIRE RECLAMATION
Abandoned Mine Reclamation Project
Contract No. OSM 49(2065)106.1 EMER

**NO. 1 SLOPE FIRE RECLAMATION
ABANDONED MINE RECLAMATION PROJECT
CONTRACT NO. OSM 49(2065)106.1 EMER**

FACT SHEET

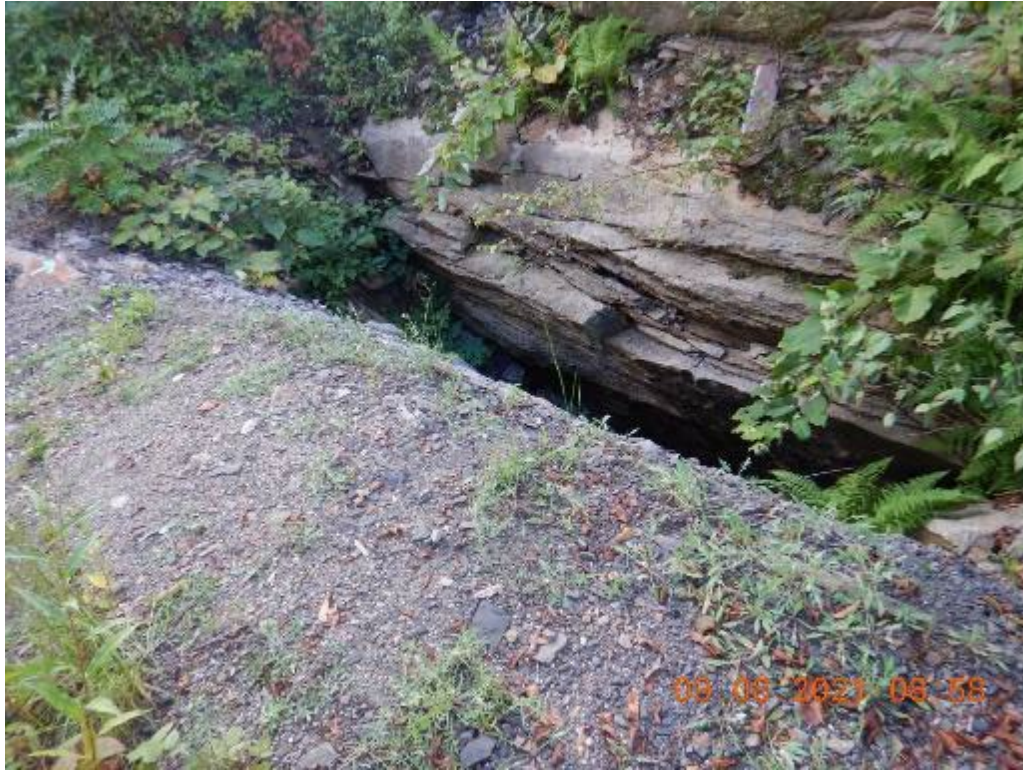
AML Feature 2065-05, the No. 1 Slope opening, looking Southeast

The final project, Construction Emergency (Phase 3), involved excavating, loading, hauling and grading the on-site, borrow material to backfill the No. 1 Slope and five additional adjacent vertical openings following a mined coal seam. A total of 16,952 cubic yards of borrow material was utilized to backfill and reclaim all the vertical openings, AML features 2065-05 (VO), 2065-06 (VO), 2065-07 (VO), 2065-08 (VO), 2065-09 (VO) and 2065-10 (VO). Of that total, approximately 2,914 cubic yards was used to backfill the No. 1 Slope opening. Each dangerous abandoned mine land feature met the Office of Surface Mining Reclamation and Enforcement’s (OSMRE) Priority 2 safety criteria. Upon completion, the site was revegetated with a seed mixture of various grasses and legumes.

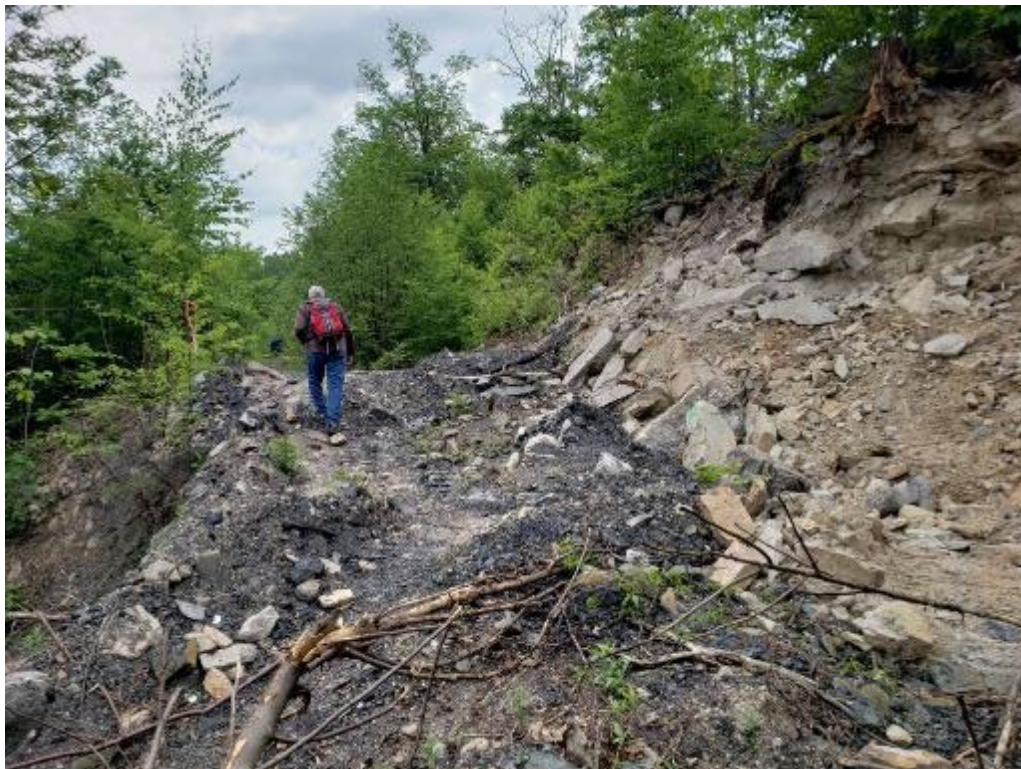
Looking East, the series of six vertical openings reclaimed in this project follow the coal seam at the foot of the rock face in the right of the photo.

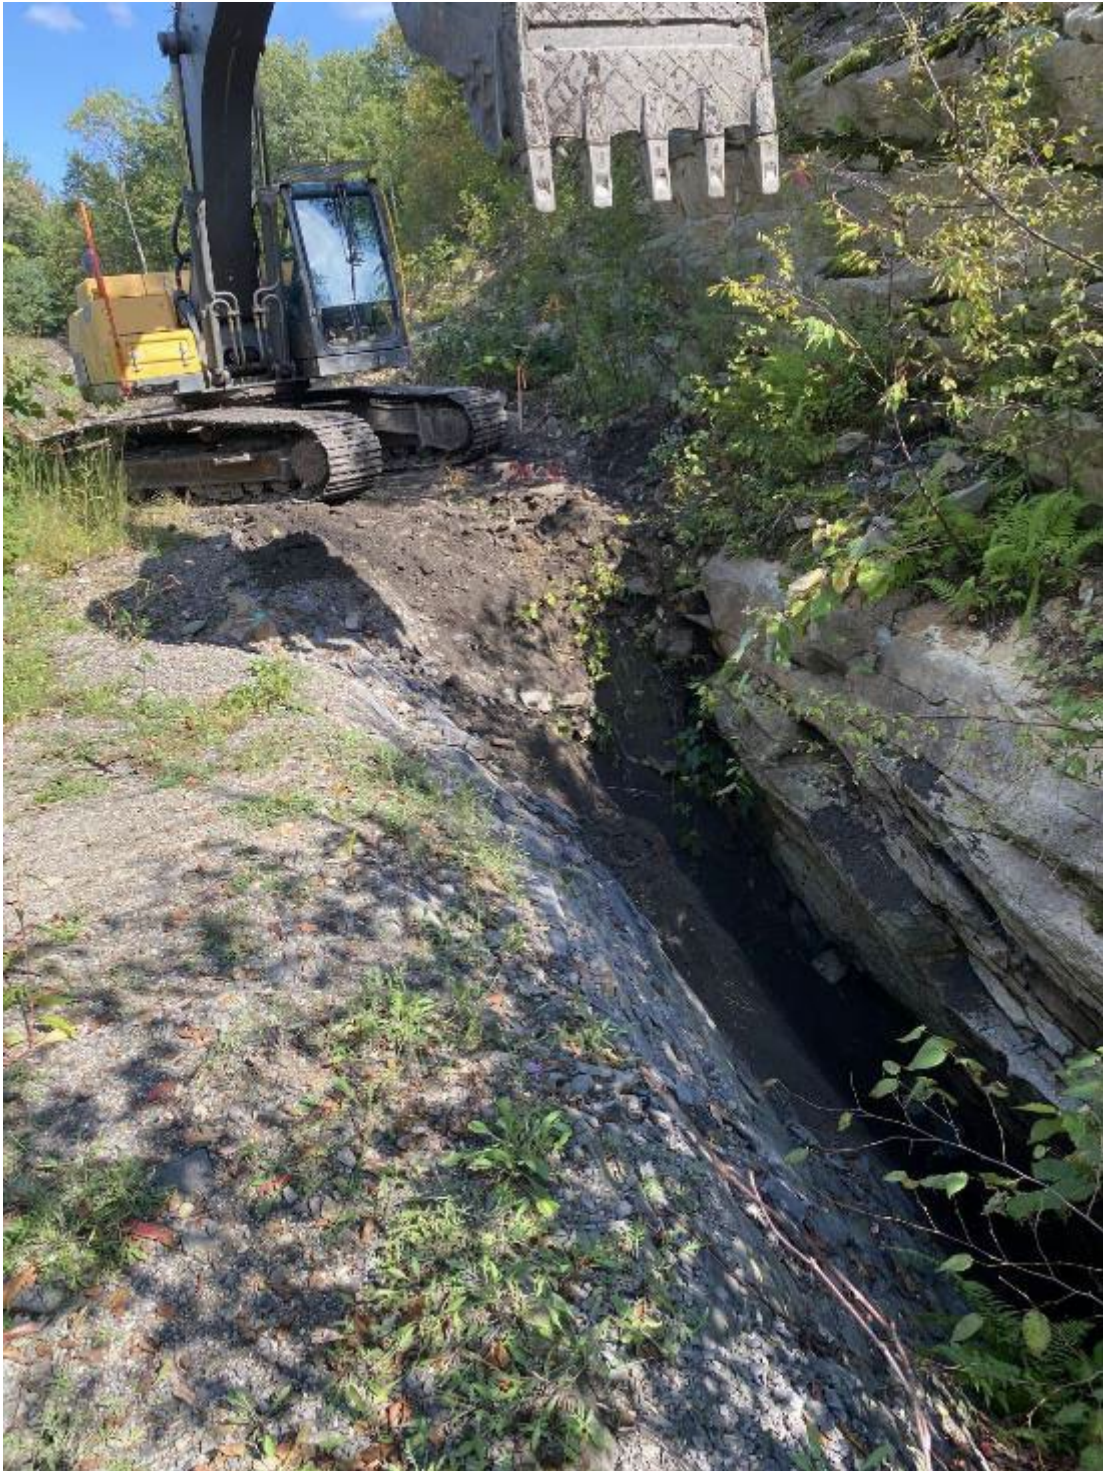
Backfilling the No. 1 Slope

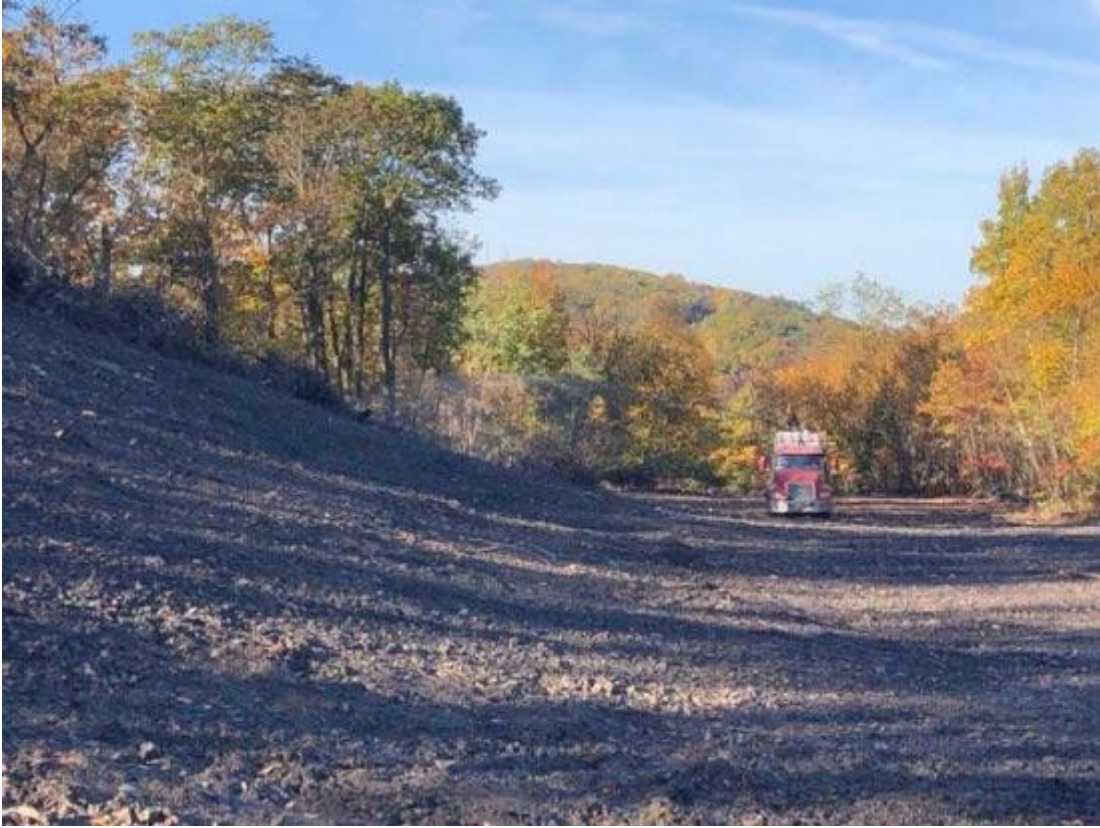
Mulching of Grading Area

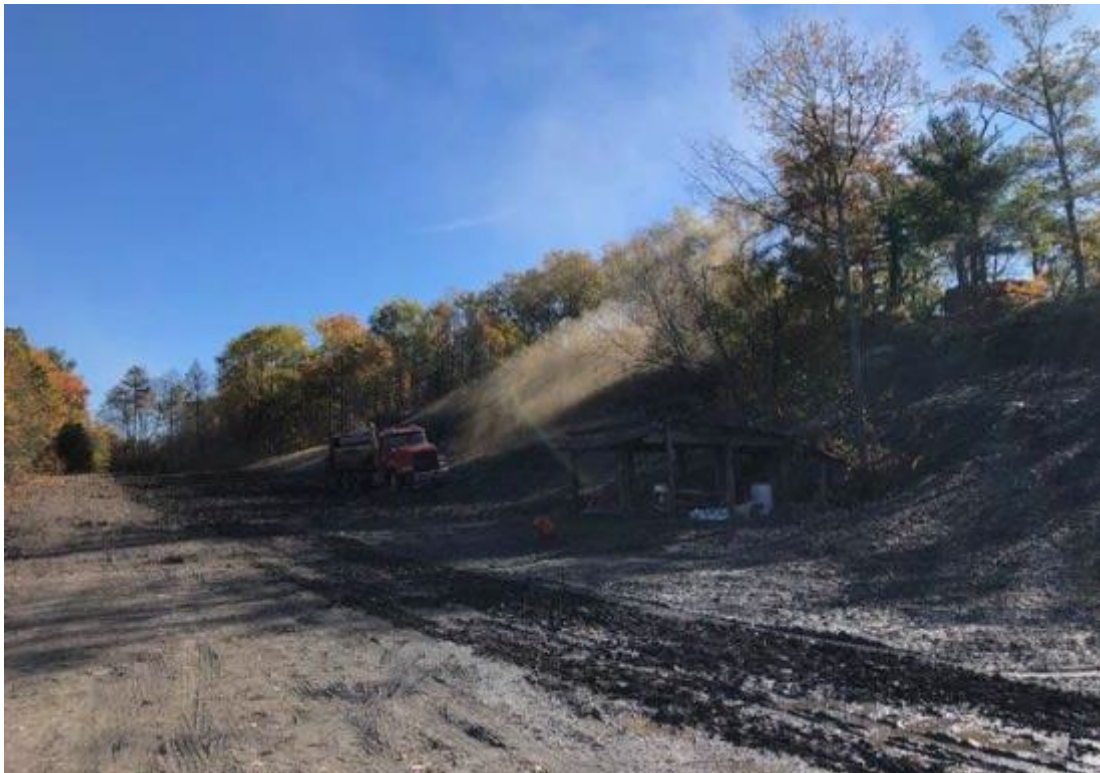
Mulching of Grading Area and No. 1 Slope
