RAUSCH CREEK POWERSPORTS SUBSIDENCES 2 Abandoned Mine Reclamation Project Contract No. OSM 54(0435)104.1 EMER

#### DEPARTMENT OF ENVIRONMENTAL PROTECTION OFFICE OF ACTIVE AND ABANDONED MINE OPERATIONS BUREAU OF ABANDONED MINE RECLAMATION

#### FACT SHEET

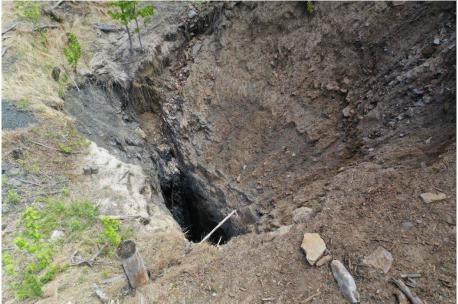
AMLF 0435-18 (VO): Looking Southeast at the vertical opening and subsidence with underground mine workings visible, depth to mining is approximately 189 feet.

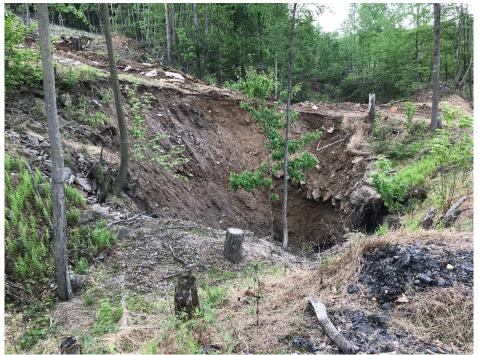
AMLF 0435-18 (VO): Looking East, this vertical opening is 40 feet in diameter at the surface, 10 feet in diameter at the bottom, and 40 feet deep.

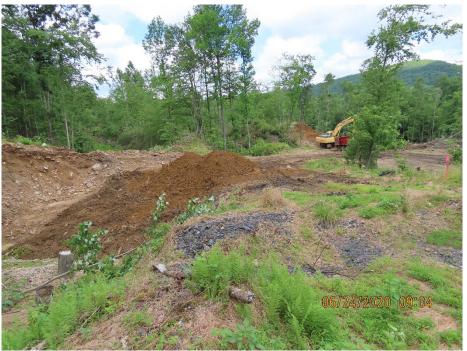
Backfill of subsidence in progress: looking Northwest. Excavator is removing mine refuse from designated borrow area.

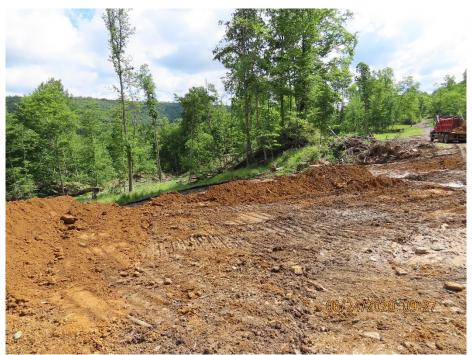
Looking Northeast, contractors utilize the ATV trail as a haul road to remove backfill from borrow area.

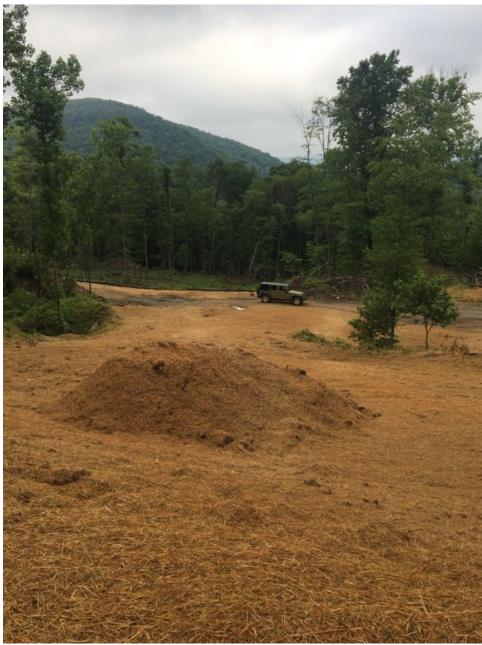
Looking North, vertical opening feature is reclaimed, filled completely with mine refuse, and a six (6)-foot mound placed atop the feature. Project area seeded for revegetation.
