**MANAGEMENT AND CONTROL OF ABANDONED MINE POOL DISCHARGES –  
PENNSYLVANIA CASE STUDIES WORKSHOP**

**Eric E. Cavazza, P.E., and Richard L. Beam, P.G.**

Pennsylvania Department of Environmental Protection  
Bureau of Abandoned Mine Reclamation  
Cambria District Office  
286 Industrial Park Road  
Ebensburg, PA 15931-4119

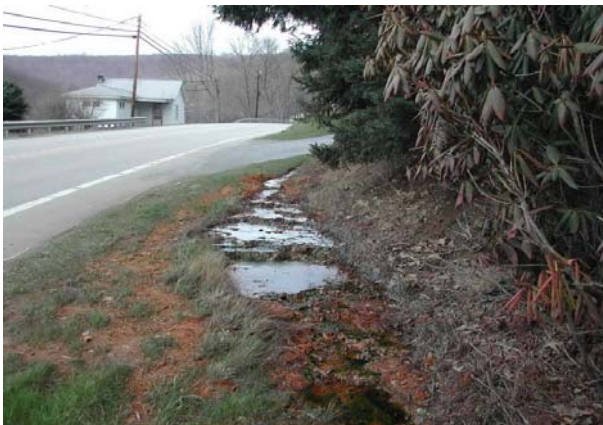
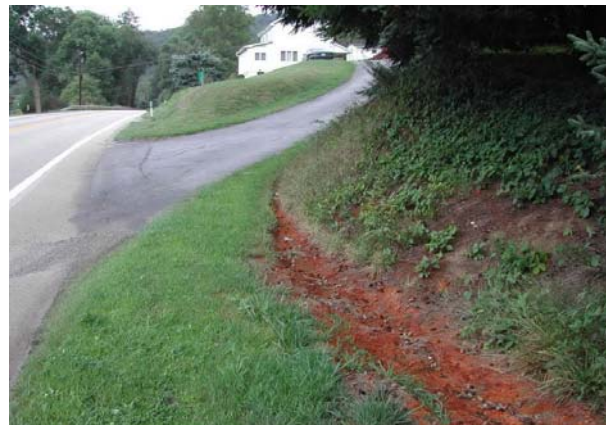
***Before and after photos showing a typical cropline discharge area at the Kalp site***

Remediation efforts at both sites relied on in-seam directional drilling to facilitate control of the mine pools and collection of the mine discharges. Directional drilling is used extensively in underground mining applications; however, this was the first time that this approach was used on a Pennsylvania AML site to convey and control abandoned mine pool discharges. In-seam directional drilling relocated the current discharges to areas proximal to the proposed (phase 2) treatment systems. Approximately 30 feet of mine pool hydraulic head was gradually and permanently removed at both project sites. Directional drilling provided both a mechanism to address and reduce the blowout potential along with providing a lower cost and minimal disturbance alternative to the construction of overland mine drainage pipelines that would be required in order to route the existing discharges to the treatment areas. Overland pipelines from the current discharge locations would not lower the head in the mines and would result in substantially increased disturbance to properties, homes and public roads located between the discharge areas and the treatment system locations. An overland pipeline would also have required partial dewatering of the mine pools during construction in order to gain access and to stabilize the current discharge locations.

After completion of drilling activities BAMR released two contracts to dewater and chemically treat the Kalp and Melcroft mine pools. Twin objectives were to expeditiously address the aforementioned health and safety concerns and to aid in the design and construction of the pending phase 2 treatment projects. At the Kalp site a total of 80,655,000 gallons of mine pool water has been removed and chemically treated. At the Melcroft site a total of 48,630,000 gallons of mine pool water was removed and chemically treated. The directional boreholes functioned flawlessly in dewatering and controlling the mine pool discharges. At the Kalp site crop line seeps and discharges, including the original discharge point for the mine (Kalp discharge), have been eliminated. The potential for a mine pool blowout has been significantly reduced and homeowners who had been experiencing problems with mine drainage in their yards and basements no longer are subject to these problems. The mine is currently discharging from the directional boreholes at its baseflow condition. Significant reduction of flow has been noted in existing discharges from the mine complex at the Melcroft site (Melcroft #3 Mine). Homeowners have reported substantially improved conditions. Monitoring of impacts of these sites and of adjacent homes with mine drainage problems is continuing.

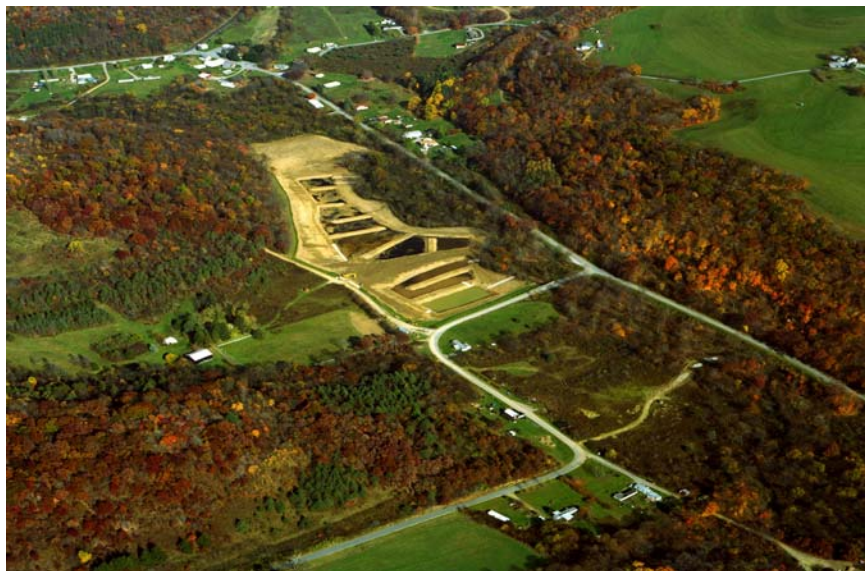
***Aerial view of the completed Tanoma Mine Drainage Treatment System***

**Project Background/Description:** Mine Drainage from the defunct Clearfield Bituminous Coal Corporation's underground mines has impaired the upper Crooked Creek watershed in Indiana County, Pennsylvania. The mines form an interconnected and partially inundated complex, covering 4,500 acres. The primary mine drainage outlet, known locally as the 'Tanoma Borehole' has discharged continuously since mining completion in the 1950s, averaging 2,500 gpm (3.6 mgd), and degrading Crooked Creek for several miles. In 1995, at the request of the Crooked Creek Watershed Association, the Pennsylvania Department of Environmental Protection, Bureau of Abandoned Mine Reclamation, PA-DEP-BAMR, decided to address the Tanoma borehole discharge. BAMR established a monitoring program and initialized water sampling, stream bioassessments, and a hydrogeologic study to evaluate the potential for relocating the discharge to a suitable site for passive treatment. Critical to this evaluation was the protection of an aquifer located above the mine and used for domestic consumption. The relationship of mine discharge volume to in-stream iron concentration was evaluated to determine an effective design sizing criteria. A two-phase construction approach was undertaken, with new cased and grouted boreholes installed in the first phase. After evaluating the new boreholes, phase two treatment system construction and sealing of the original boreholes occurred. An overflow borehole was left open for monitoring and for mine pool discharge in the event that system capacity was exceeded. Since full-scale treatment of the mine discharge began in June of 2001, the passive treatment system has removed an average of ~70% of the total iron while experiencing flows up to ~3,000 gallons per minute (gpm).

**Project Quantities and Costs:** installation of new discharge boreholes - \$19,783.50 (3 wells – 90 ft. deep each); property acquisition cost - \$38,000 (~10 acres); sealing abandoned Tanoma boreholes - \$7,535 (2 boreholes sealed); and construction of the passive treatment system - \$351,367.31 (7.5 acre passive treatment system – aerobic wetlands and settling ponds).

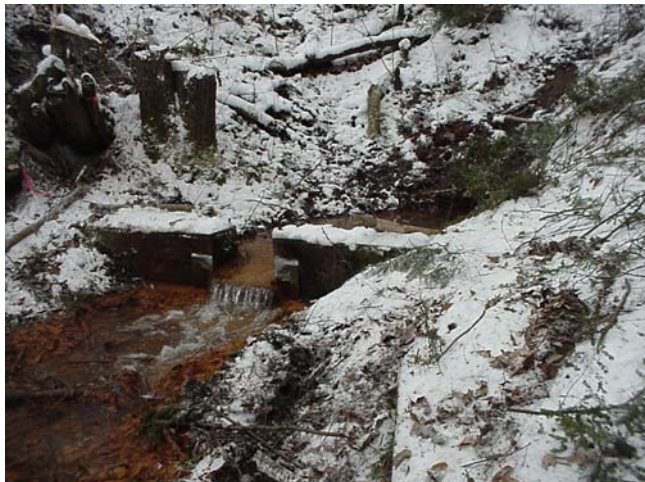
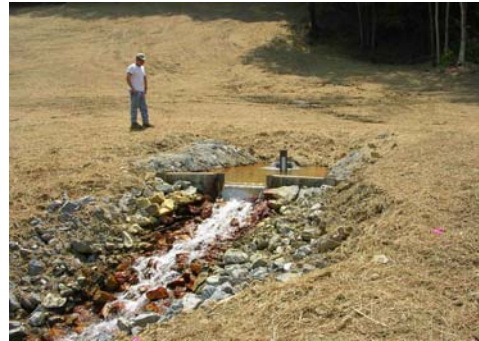
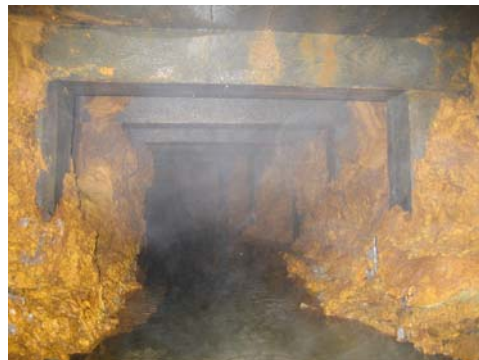
***Discharge and weir prior to construction (lower left); drainage tunnel following mine pool release (lower right); and completed mine seal and weir following construction (upper right)***

During construction of the mine seal at the discharge site located at the up dip section of the mine, an uncontrolled release of several million gallons of mine water occurred. The contractor had excavated down to the base of the coal and still not encountered the source of the mine discharge. Continued excavation found a rock tunnel that had been driven into the mine approximately 10 feet lower in elevation than the base of the coal. This rock drain had been constructed to dewater a large portion of the mine workings to keep the main haulage way open. Once daylighted, the drainage tunnel dewatered a large section of the mine in roughly six hours. The receiving stream is severely impacted by a number of other mine discharges and supports little or no aquatic life consequently, there were no additional aquatic impacts. At the time of the event, most rivers and streams in the area were flowing at bank full. By the time the mine water reached a good quality stream, dilution minimized the impacts.

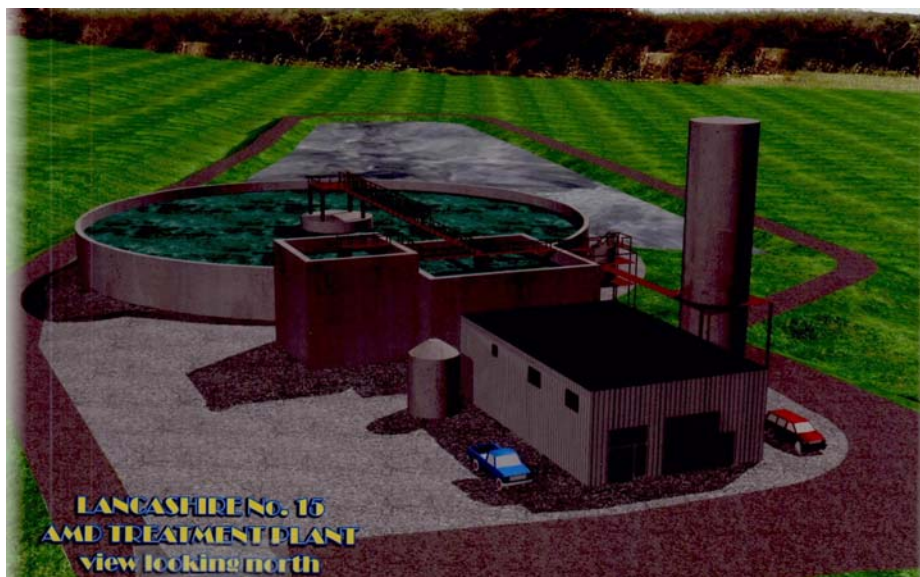
*Artist rendering of the proposed Lancashire No. 15 Treatment Plant*

The CSF, with direction from the DEP has been operating the facilities and managing the assets received since 9/11/01. However, the treatment process is antiquated and inefficient and in need of replacement. Annual treatment cost is approximately \$600,000 a year. A new treatment plant will be located so that the treated water is discharged to the Susquehanna River Basin to augment water volume in this drainage basin. The Susquehanna River Basin Commission has established a trust fund for the long term operational and maintenance needs. It is anticipated that upwards of 10 MGD (near 7,000 gpm) will be treated and discharged to the Susquehanna River Basin during the low flow season each year. During the remainder of the year pumping rates will routinely average 4,000 to 6,000 gpm to maintain the mine pool at a constant level.

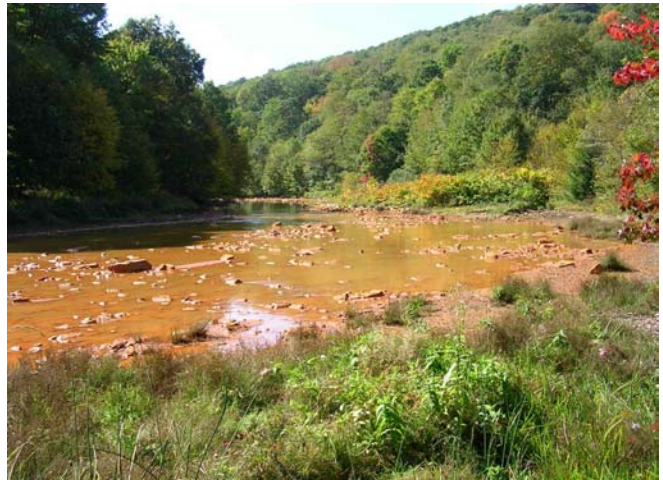
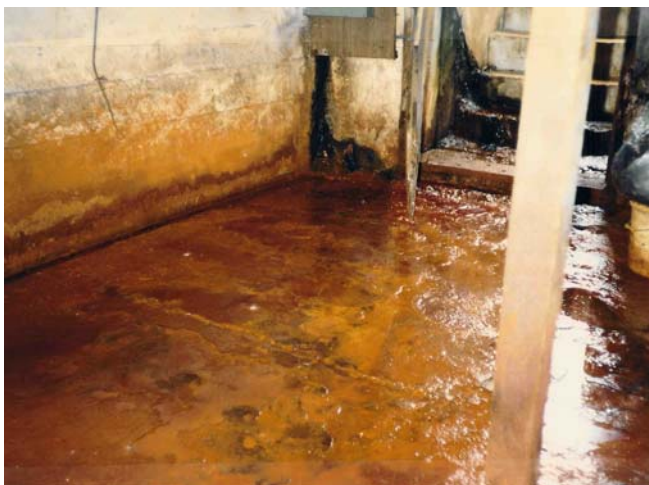
***AMD in basement (lower left); relocated mine pool outfall discharge wells (lower right); and Blacklick Creek below the Wehrum Shaft discharge during low flow stream conditions (upper right)***

**Project Background/Description:** Mine Drainage from the abandoned Vinton No. 6 underground mine located in Blacklick Township, Cambria County began to enter basements along Main Street in the Village of Vintondale in the early 1980s due to artesian pressure. Many options to alleviate the situation were evaluated, but due to the geologic structure and the elevation of the basements, the only viable way to lower the mine pool to an elevation that would assure no infiltration of mine water into the homes was to drill several mine pool relief boreholes in the stream bed of Blacklick Creek. This would result in the relocation of the Vinton No. 6 outfall over 1,000 feet downstream from its then current discharge location. So in 1994, three stainless-steel cased boreholes were drilled into the mine pool to relieve pressure and lower the mine pool approximately 10 feet. This project corrected the mine drainage problems impacting the residents living along Main Street in the Village of Vintondale.

Since that time, the DEP has been working with the Blacklick Creek Watershed Association to develop a plan to collect and treat both the Vinton No. 6 discharges and the Wehrum Shaft discharge to help restore water quality in the Blacklick Creek Watershed. The current plan is to collect and route the Vinton No. 6 discharges over a coal barrier and transfer them into the structurally down dip Wehrum Mine. Once transferred, the combined discharges would be collected at the Wehrum Shaft outfall and conveyed to location where a large-scale chemical treatment facility is planned.

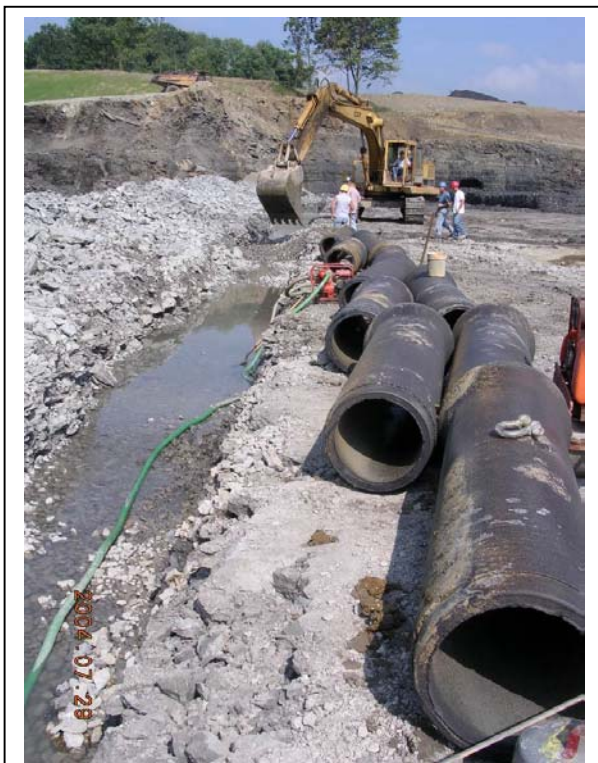
**July 2004 Drain Construction**

During construction, PTC consulted with the PA DEP Bureau of Abandoned Mine Reclamation (BAMR) in an effort to determine if any options were available to improve the quality of these encountered discharges. It was agreed that a modification to PTC drain structures would be employed to provide in-situ neutralization of the mine discharges. Immediately underlying the Pittsburgh Coal seam is a 12 foot thick Limestone unit (Pittsburgh Limestone). This material was shot and left in place and the open joint pipe drains were placed on top of the shot limestone. The outlet of the drain structures was directed to existing sedimentation pond facilities that will remain in place for oxidation and precipitation of metals.
