# City of Pittston Mine Subsidence Study <sup>1</sup>

Dennis M. Palladino, P.E.

## **Abstract**

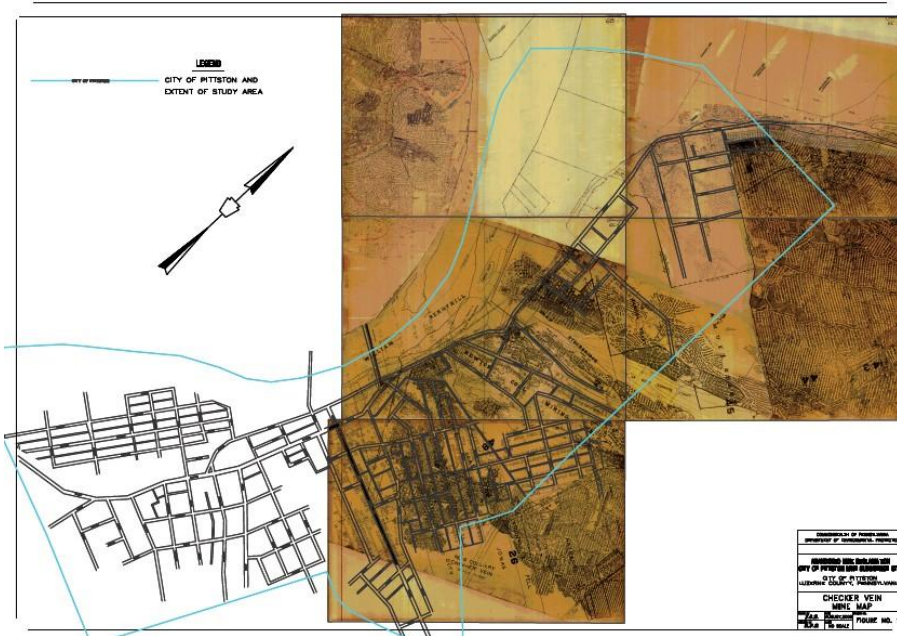
Figure 1 - Mine Map of the Checker Vein in the City of Pittston

Historical mine maps indicate that portions of the Checker and Marcy veins were deep mined using traditional room and pillar mining. The mine maps also show crosshatched areas that indicate culm and refuse material may have been placed into the workings by the coal company to reduce the possibility of subsidence. In addition, the maps show numerous tunnels, some of which may possibly have been located above or below the coal veins, but are shown superimposed on the mine maps.

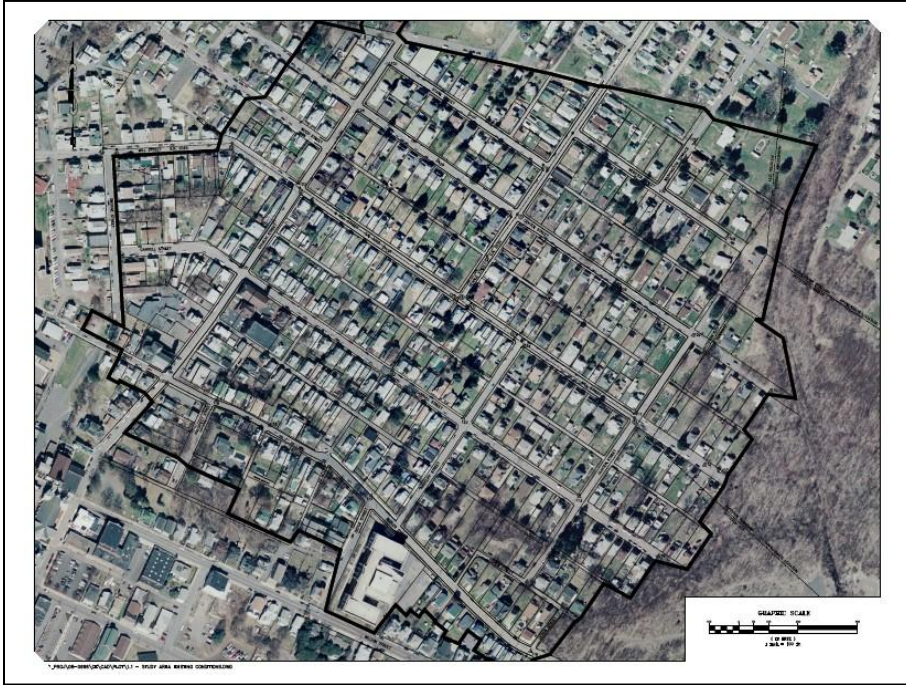
Figure 4- Mill Street Study Area.

Of these areas, Area 1C (the Mill Street area) was identified for further exploration. The site boundary of Area 1C is shown in Figure 4.

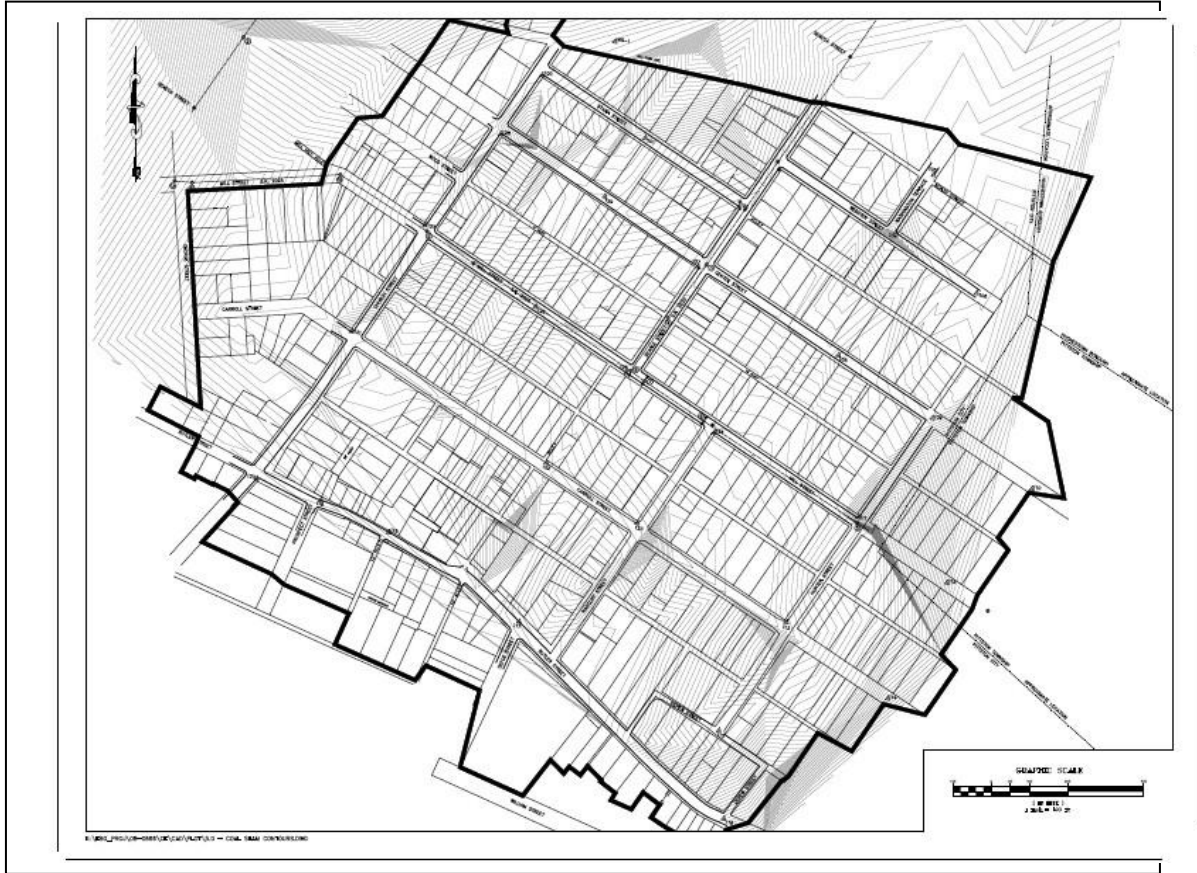
Figure 5 – Checker Vein Model Structure Contours.

To build the solid three-dimensional model of the study area geology, Kimball first generated a surface topography layer using available Light Detecting and Ranging (LiDAR) data. Next, using the querying capabilities of the ArcGIS system, the bottom elevation of each stratigraphic layer was extracted from the boring database. A Triangulated Irregular Network (TIN) model of the bottom of each stratigraphic layer and coal vein was then produced. The coal vein contours derived from the computer model for the Checker vein is shown in Figure 5.
