# **THE SUGAR CREEK COAL REFUSE PILE AND MINE DRAINAGE DISCHARGE RECLAMATION PROJECT**

**Eric E. Cavazza, P.E., Thomas C. Malesky, P.E., and Pamela J. Milavec  
Pennsylvania Department of Environmental Protection  
Bureau of Abandoned Mine Reclamation  
Cambria District Office  
286 Industrial Park Road  
Ebensburg, PA 15931-4119**

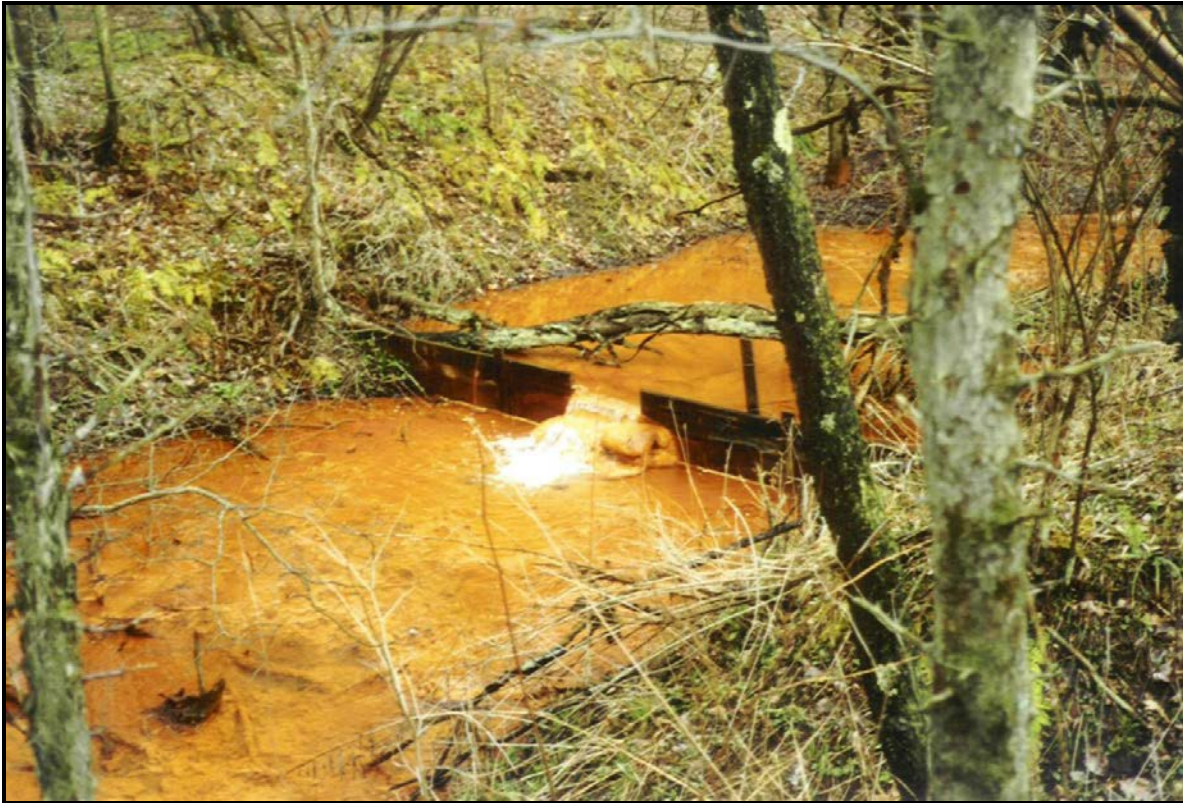
**FIGURE 3** – Photograph of the mine drainage discharge from the abandoned North Penn Coal Company’s Snow Hill Mine showing the flow monitoring weir

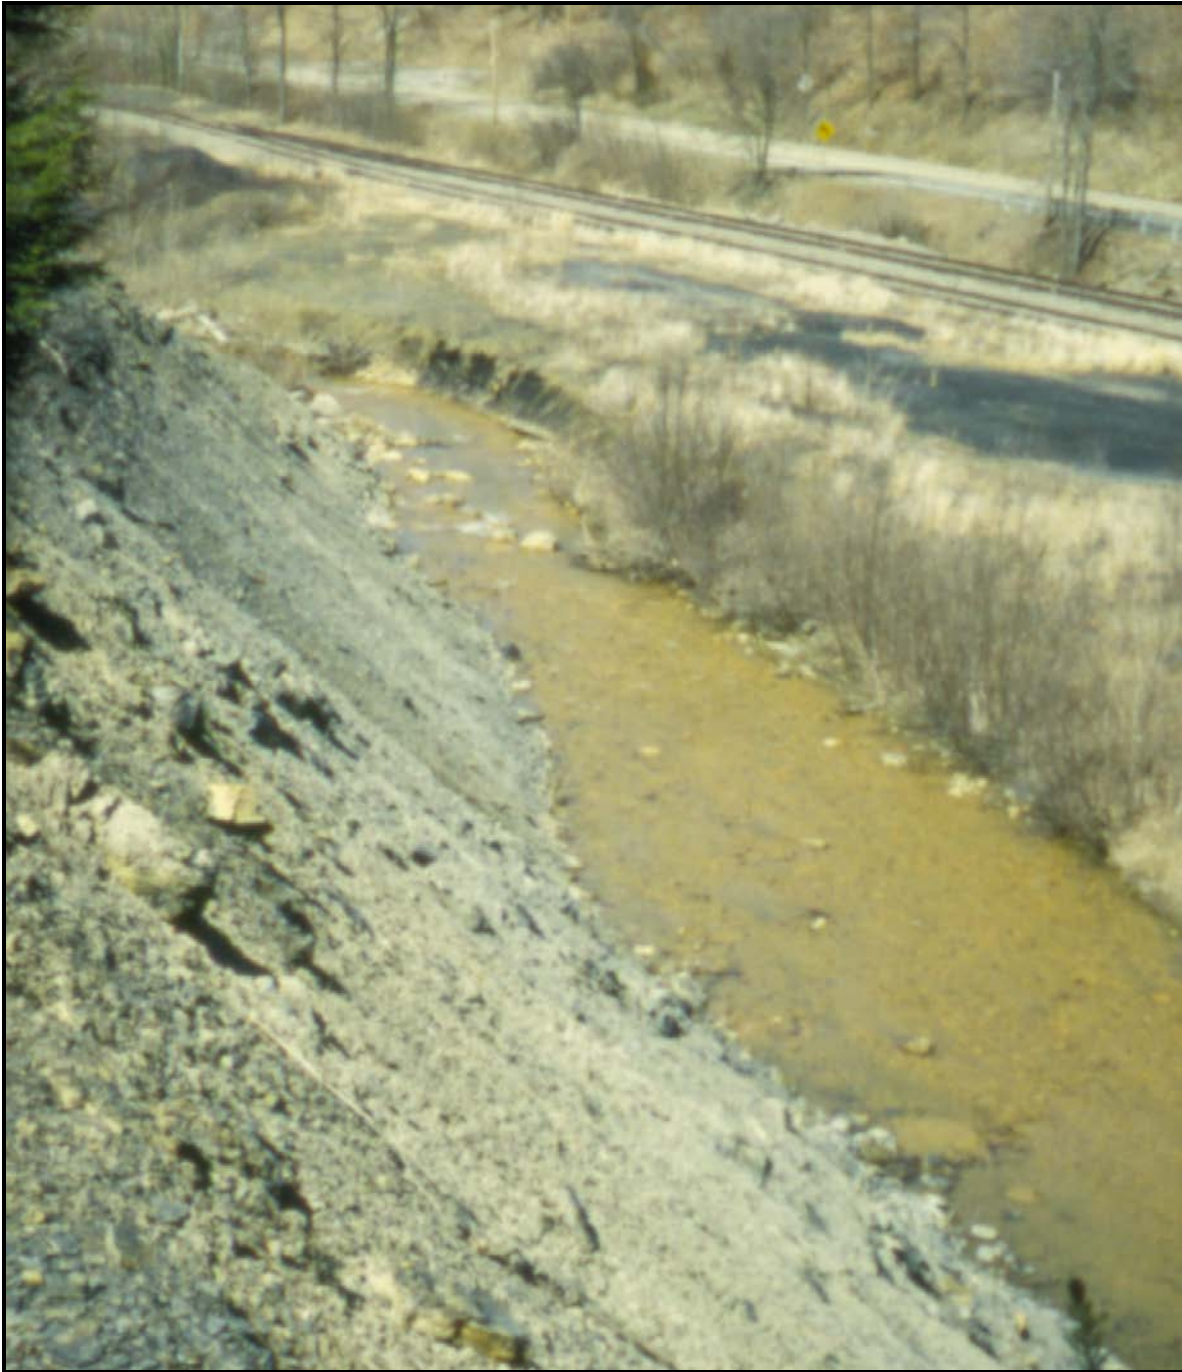
**FIGURE 4** – Photograph showing the extremely steep outslope of the coal refuse pile with the toe of the pile extending into the stream channel. The iron stained stream bottom of Sugar Creek is also evident in the photograph.

In order to reclaim the pile, the refuse material would need to be pulled back from the stream bank. The pile would require regrading and capping to establish more stable slopes and adequate vegetation. Erosion protection in the form of riprap lining would also be incorporated into the project design to ensure the long-term stability of the re-contoured refuse pile.

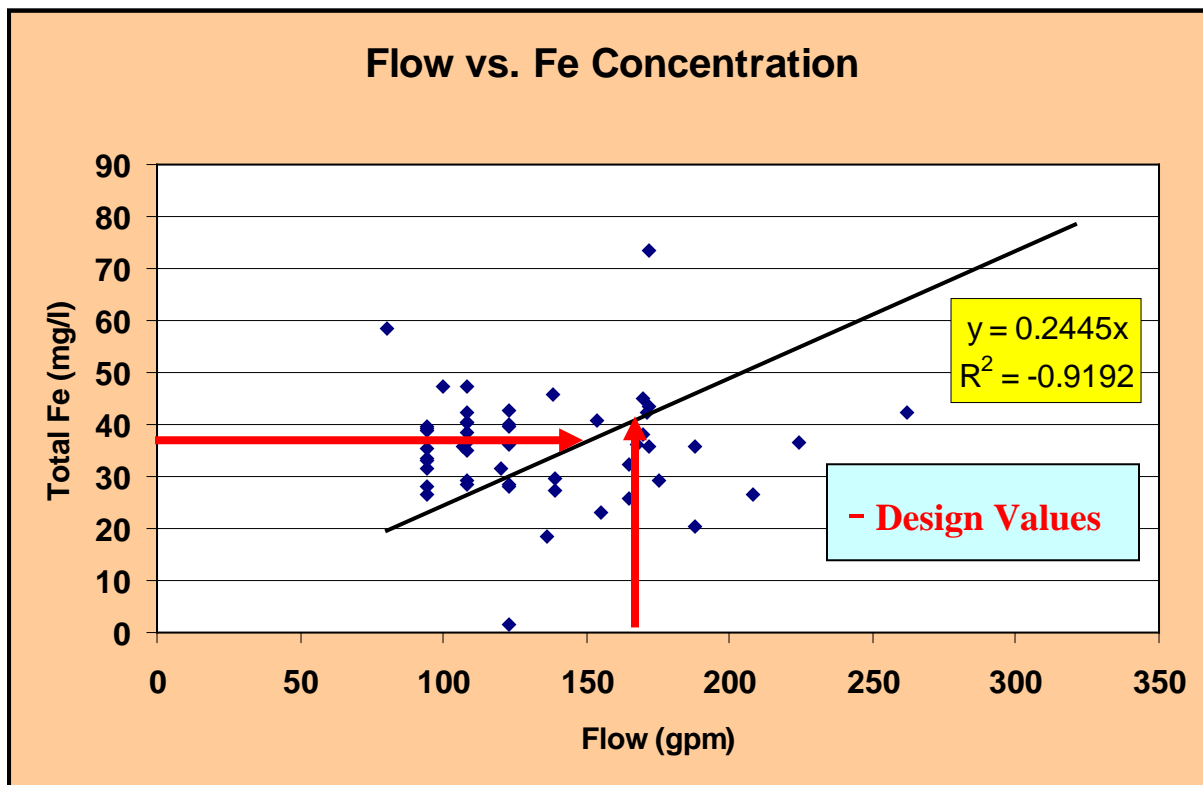
**FIGURE 5** –Graph showing a summary of the pre-design flow versus total iron concentration data and the treatment system design

Using the discharge monitoring data collected during the evaluation and planning phase of the project, a design flow rate of 170 gpm (the 80<sup>th</sup> percentile) or 0.25 MGD was selected. A decision was also made to target the 80<sup>th</sup> percentile of the total iron concentration observed during the pre-design discharge monitoring which was 37.6 mg/L. Figure 5 shows a summary of the pre-design monitoring data and the design flow and iron concentration.

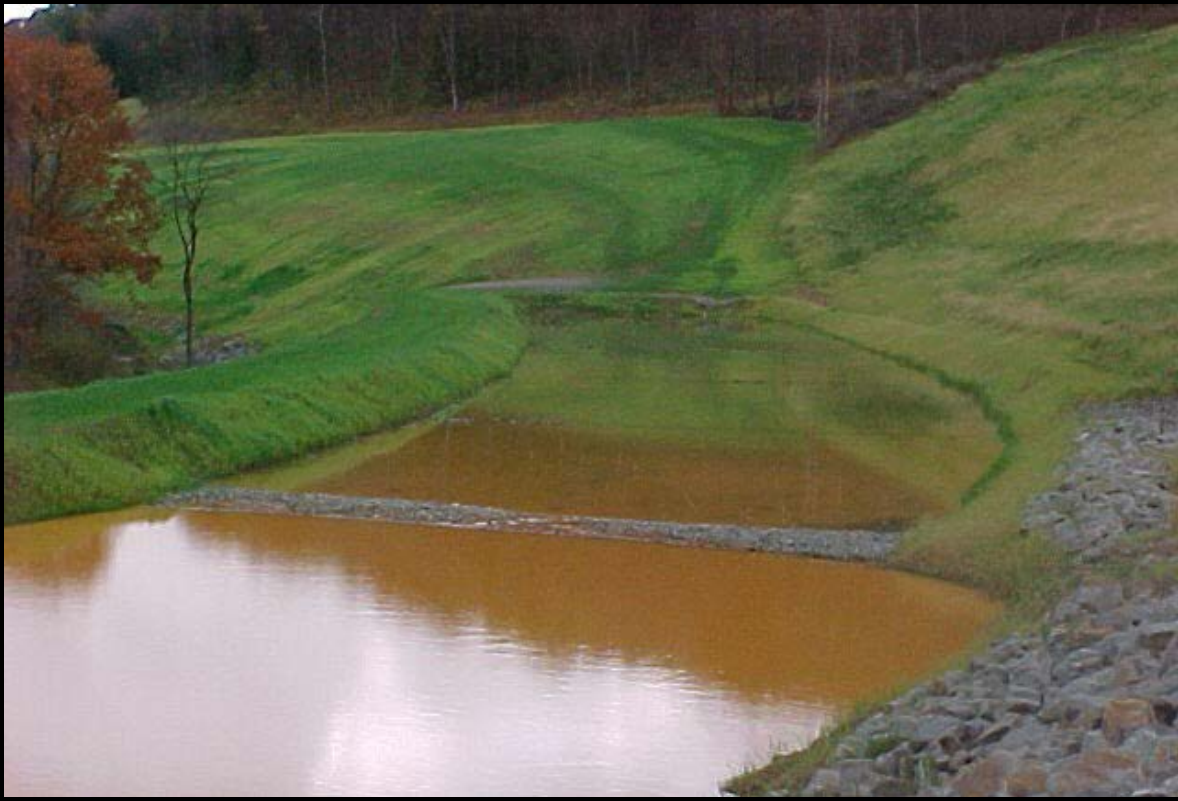
**FIGURE 6** – Photograph of the completed passive treatment system and the reclaimed coal refuse pile restored as part of the Sugar Creek Project

The principal items of work included 63,314 cubic yards of grading to re-contour the dangerous refuse pile slopes, 9,706 cubic yards of excavation for construction of the passive treatment system cells, placement of 22,748 cubic yards of soil cover material, construction of a new mine seal, 336 tons of high calcium carbonate ( $\text{CaCO}_3$ ) content limestone (originally planned for use in the ALD) used for construction of limestone diversions, construction of several permanent channels, and placement of R-7 riprap for rock toe buttress to stabilize the toe of the regraded refuse pile. Figure 6 shows a photograph of the completed project with the passive mine drainage treatment system in the foreground and the re-contoured and reclaimed refuse pile in the background.

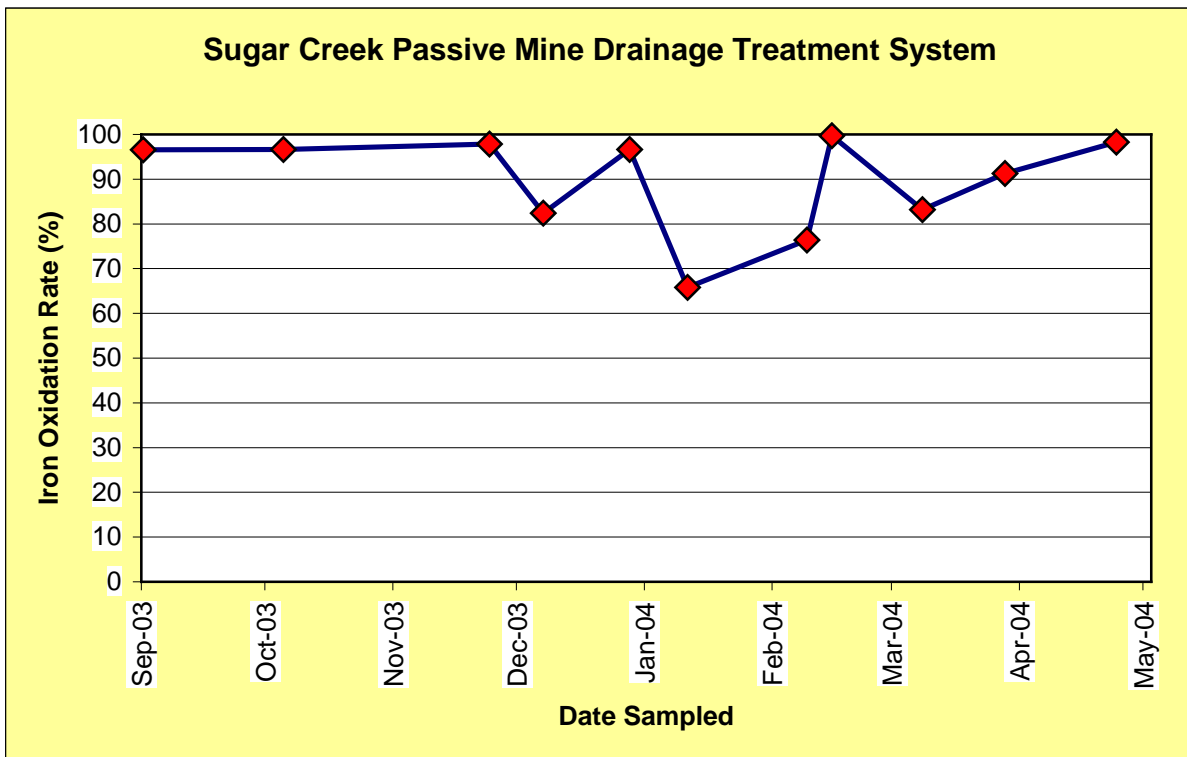
**FIGURE 7** – Iron oxidation rate for the Sugar Creek passive mine drainage treatment system

The treatment system went on-line in August 2003 and has been monitored for performance monthly since that time. Chemical and biological sampling of Sugar Creek has also been conducted to evaluate the effectiveness of the treatment system and to monitor the recovery of the aquatic ecosystem within Sugar Creek downstream of the project site. The primary contaminant in the mine drainage discharge was ferrous iron. Figure 7 shows the effectiveness of the treatment process in oxidizing the ferrous iron and converting it to ferric iron. While the treatment system has been in full-scale operation for only six months, Sugar Creek is already showing signs of recovery. The in-stream iron concentration within Sugar Creek below the old discharge site has consistently been below 1.0 mg/l except for a single sampling event in January 2004. Figure 8 shows in-stream total iron concentration as monitored just downstream of the treatment system. Other metals associated with the mine drainage discharge have been reduced to only trace amounts. Evidence of the severe iron coating and staining is already beginning to be flushed away. And most importantly, a macroinvertebrate study completed in November 2003 shows that the number and diversity of aquatic species is already on the increase. The total number of taxa when compared to the pre-construction survey data increased from four to seven just below the site and from seven to 12 near the mouth of Sugar Creek. The increases also show some pollution-intolerant species beginning to colonize the stream below the reclamation project site. Biological surveys conducted prior to construction showed no pollution-intolerant mayfly genera below the point where the mine drainage discharge entered Sugar Creek. The post-construction survey found three genera of mayflies downstream of the treatment system. The numbers of macroinvertebrates and the diversity of taxa are expected to continue to increase as the stream habitat recovers further. Mayfly, minnows and other fish species have also been observed in the stream below the project site providing more evidence that the stream is recovering.

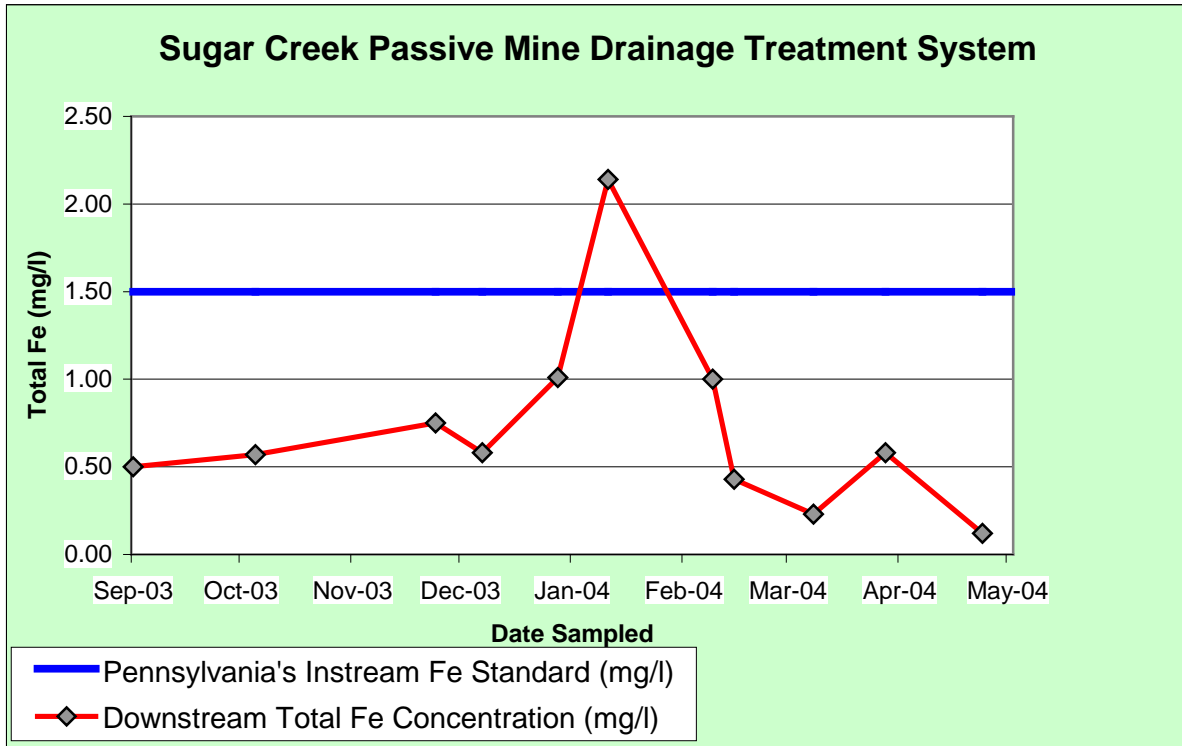
**FIGURE 8** – In-stream total iron concentration monitored downstream of the treatment system in comparison with Pennsylvania’s in-stream iron standard
