Technology, Resources for Reclamation ¹

Martin Edwards, Dean Baker, Dennis Palladino ²
Pennsylvania Department of Environmental Protection
Bureau of Abandoned Mine Reclamation
400 Market St.
Harrisburg, PA 17105
717-783-7752
maredwards@state.pa.us

¹ Presented at the 32nd annual National Association of Abandoned Mine Land Programs Conference, September 20-22nd 2010.

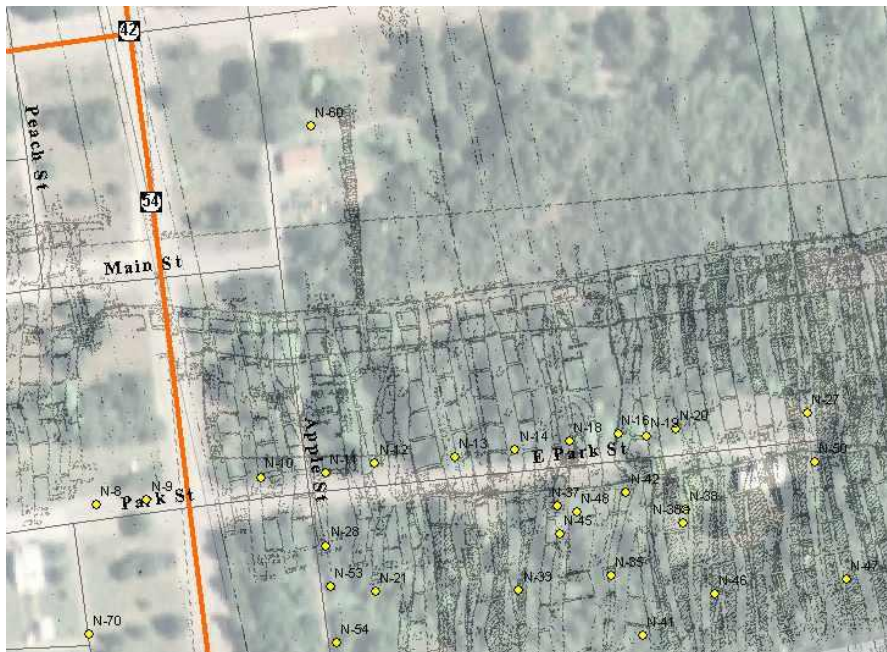
Figure 1 - Centralia Air Photo with Folio Mine Map and Drill-holes.

Figure 1 is a Folio mine map of the Centralia mine, the most famous, but not the biggest or oldest, mine fire in Pennsylvania. This mine map, representing only one of ten mining levels beneath Centralia, is geo-referenced to a 2008 ortho-photograph of the abandoned town. Accurate dimensioning and positioning of these maps is imperative to locate the rock tunnels connecting the mining levels, and the framework of coal pillars that keep the air and mine fire pathways open. Fire control measures depend on a detailed knowledge of the geology and mining configuration.

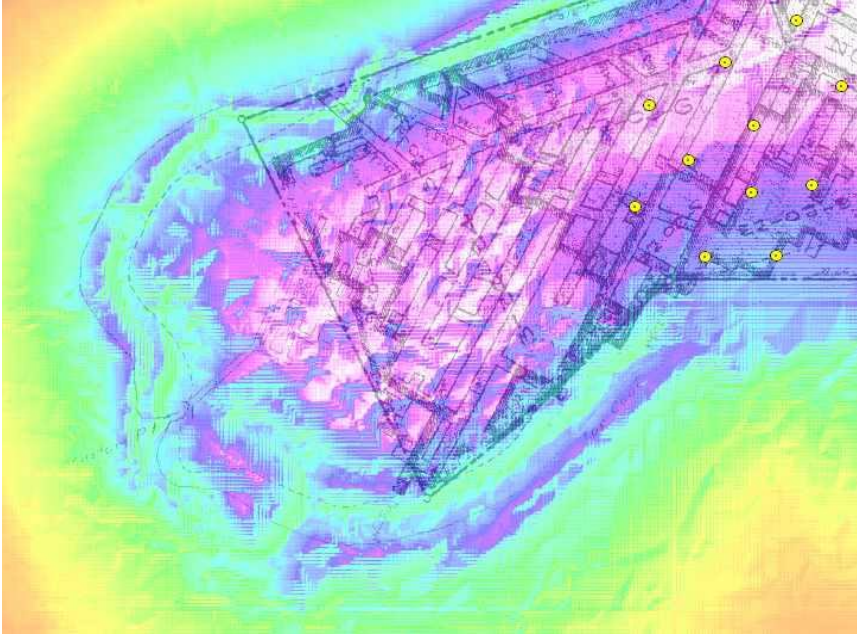
The Pennsylvania Geologic and Topographic Survey performed LiDAR topography on the entire state as part of the PAMAP program, <http://www.dcnr.state.pa.us/topogeo/>. The processed information has elevation accurate to about a foot and a horizontal accuracy specification of 5 feet or less. Elevation is calculated for every square meter and has proven invaluable for surface reclamation and subsidence evaluations. Figure 2 is a LiDAR model of an underground mine fire in Fayette county Pennsylvania superimposed on a geo-referenced mine map. Drilling to determine the extent of the fire may allow us to adjust and improve the vertical and horizontal location of the mine map. The detail of subsidence and crop-line stripping becomes evident by adjusting the color symbology over a narrow elevation range thereby highlighting the features of interest. This model will be used in GIS and transferred into CADD, where mining software applications will calculate accurate volumes for remedial trenching and excavation contracting.

Figure 2 – Color Enhanced LiDAR Elevation with Mine Map.

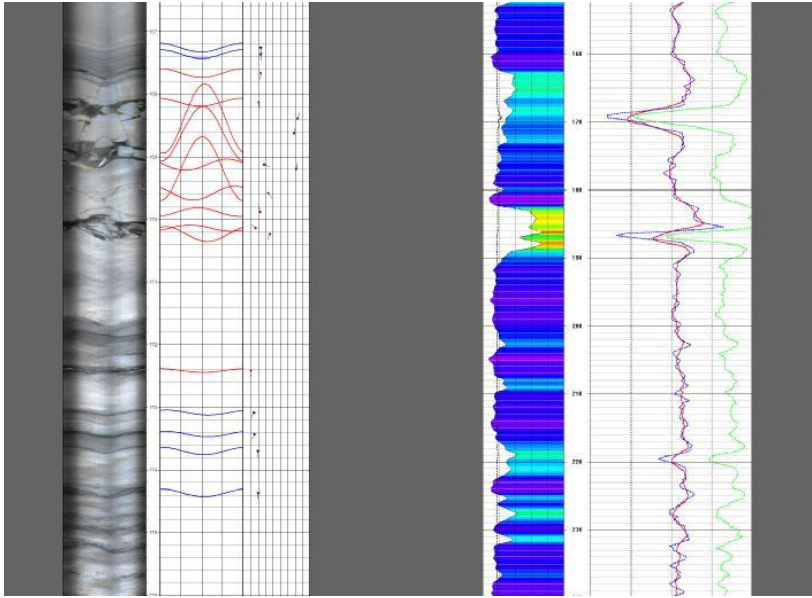
Many geologic investigations require drilling, the information generated is key to solving your reclamation problems. Down-hole geophysics, observations and measurements are performed in a very confined space well suited for the application of microcomputers. . Figure 4 is a portion of a down-hole geophysical log and micro-graph of the borehole, http://www.armgeophysics.net/Services_BoreholeLogging.aspx . The high resolution of the camera outperforms the old TV camera videos and rivals photo logs of the core with the advantage of being in-situ. Down-hole cameras that used to require a dedicated truck, generator, and winch, now fit in the back of your SUV and run from the 12 volt DC port. These cameras are invaluable for evaluating void spaces for flushing of material to prevent mine subsidence.

Figure 4 – Down-hole Micrograph and Geophysical Log.

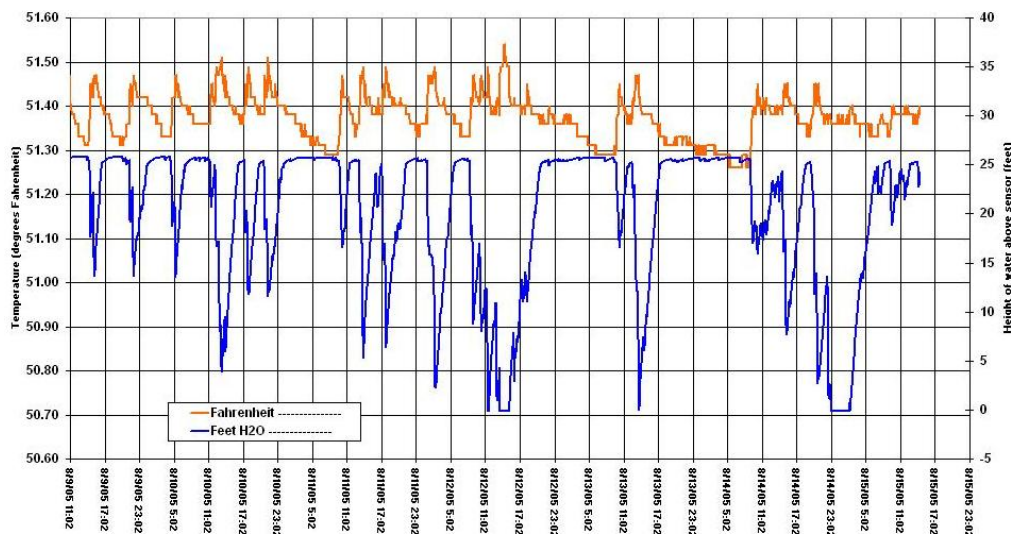
Down-hole photographs and video can also provide useful information for mine drainage or water well diminution investigations. Figure 5 is a water level and temperature log from a domestic water well. A MiniTroll pressure transducer and thermocouple, manufactured by In-Situ Inc., was installed in the well to evaluate a water loss complaint, <http://www.in-situ.com/>. The data can be used to evaluate home water use requirements and recharge. Water level recovery data can also be loaded into the TIPS software program, Aqtesolv, and used like pump test data to estimate aquifer characteristics.

Figure 5 – Well Temperature and Water Level Log.

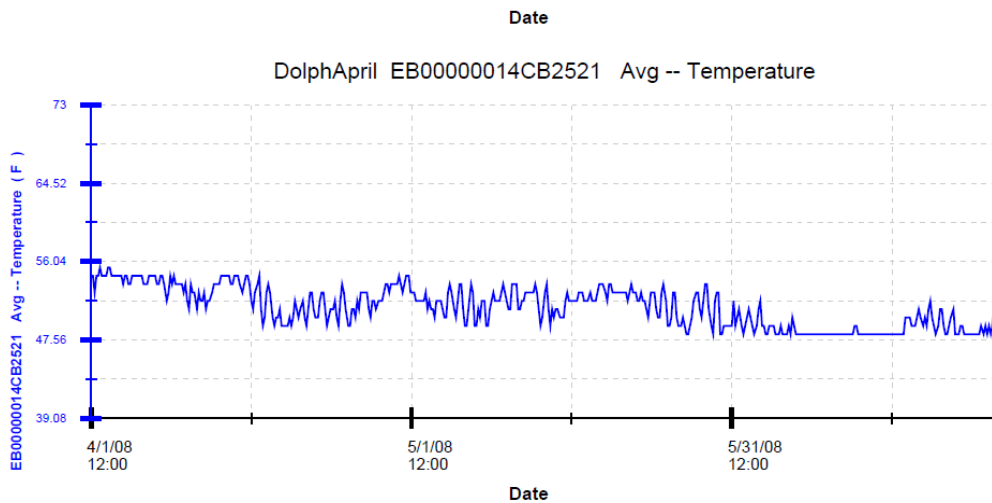
Ground temperature measurement, from the surface with probes and infrared meters, or underground through boreholes help define the limits of mine and refuse fires. Figure 6 is a temperature graph downloaded from a Maxim Integrated Products Inc., Thermochron iButton. These microchips in a protective stainless steel case can record and store temperature and humidity readings every hour for 256 days, or up to ten years with programmable interval settings, <http://www.maxim-ic.com/products/ibutton/>. They were originally developed for tracking temperature of refrigerated cargo, but have found uses in many industries including monitoring mine fire temperatures up to 140 degrees Celsius. This data was recorded from a borehole on the cold side of a trench, excavated to isolate an underground mine fire. The overall trend is cooling of the rock mass since it lost contact with the mine fire and hot gasses, minor variations are caused by sunshine and barometric breathing, as this hole is only 20 feet horizontally from a 100 foot deep trench.

Figure 6 – iButton Temperature Log.

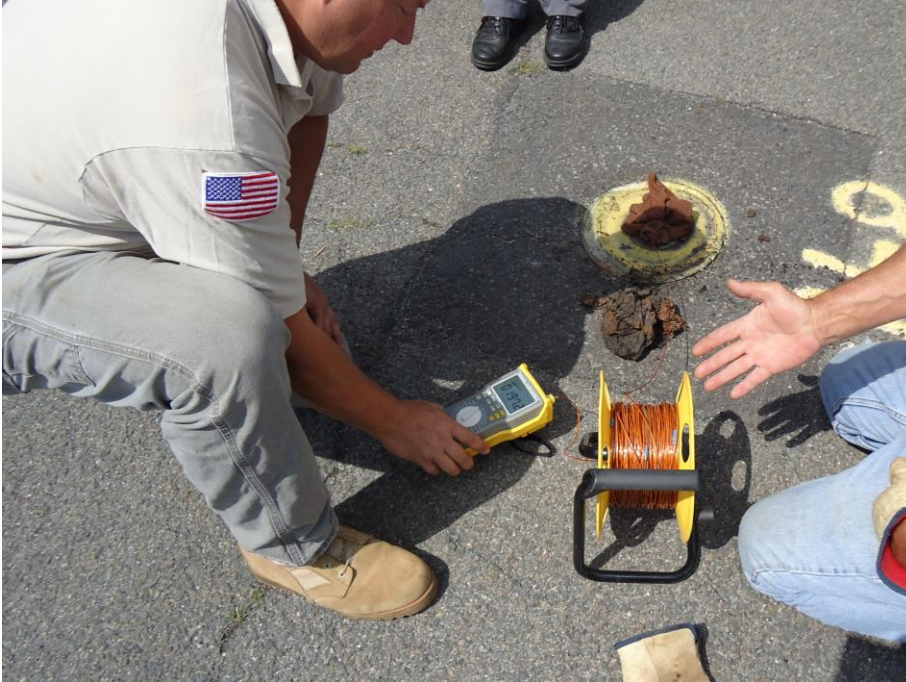
Portable analyzers can be purchased to monitor gas or water. Figure 7 is a MSA Solaris Multi-gas meter measuring Oxygen, Carbon Monoxide, Hydrogen Sulfide and Carbon Dioxide, <http://www.msanorthamerica.com/catalog/catalog505.html>. This tool and a Lower Explosive Limit (LEL) meter to detect combustible gasses are essential for evaluating the danger of mine fire gases collecting in homes or businesses. In this picture we are collecting borehole measurements from the Centralia mine fire. The DEP has received numerous inquiries from “stimulated” entrepreneurs interested in extinguishing or using abandoned mine fires for geothermal energy and the accompanying lawyers wanting to adsorb the carbon credits.

Figure 7 – Temperature and Gas Measurement of Mine Fire.

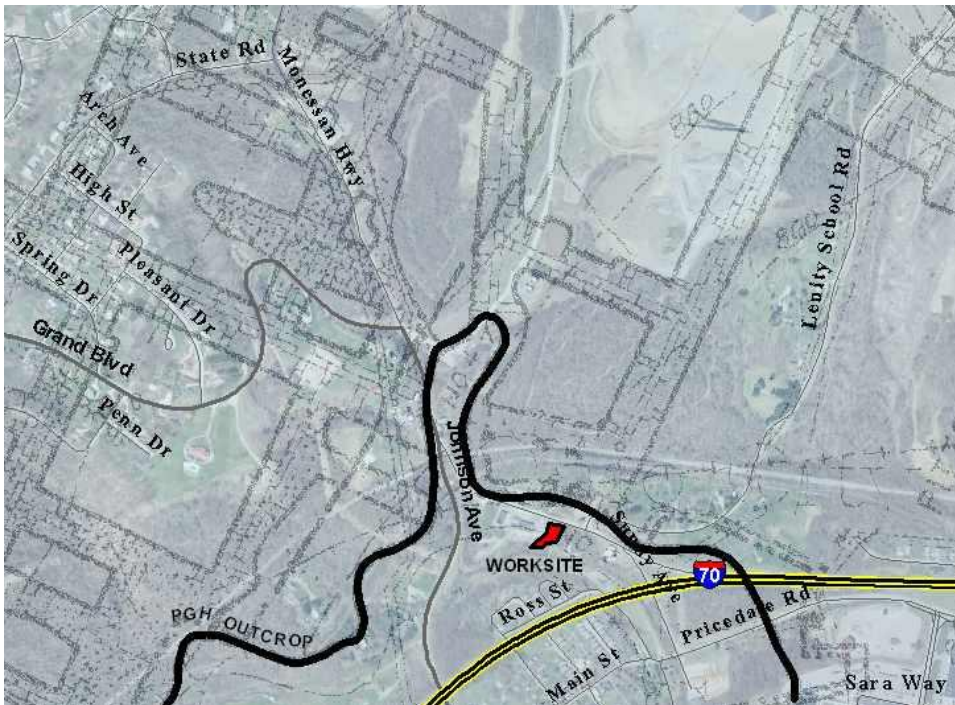
location of the project area can be found on the Donora, 7.5 minute, U.S.G.S. Topographic Quadrangle Map at North Latitude 40° 8' 28" and West Longitude 79° 51' 22". The project site lies outside but adjacent to the outcrop of the Pittsburgh Coal Bed. The strata dip less than two degrees, to the southeast. Federal floodplain maps indicate that the FEMA 100 year floodplain borders the project area on the south, but is five to ten feet below the lowest level of fill. Figure 8 is a 2008 ortho-photograph with transportation layer and the WPA mine map superimposed.

Figure 8 – WPA Map and Air Photo.

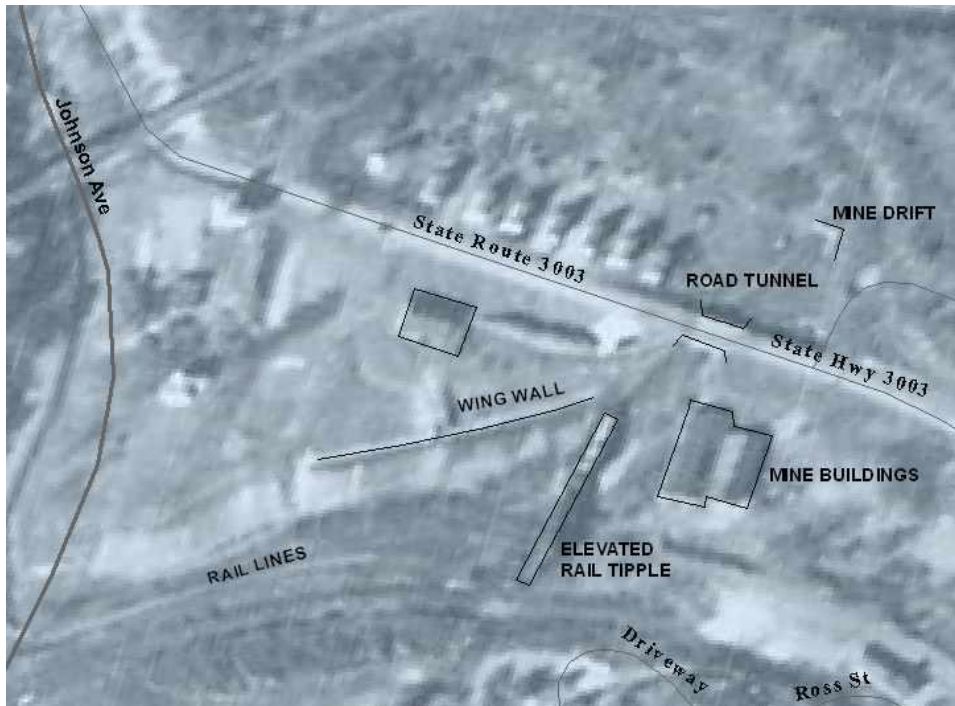
Figure 9 – 1949 Air Photo of Mine Facilities.

A 1949 aerial photo of the site shows the refuse probably originated as spillage and coal reject from a tunnel access and tipple load-out facility for the underground mine (Figure 9). A wing wall to contain the stockpiled coal, the tunnel, and train load-out are visible and could be geo-referenced using roads and buildings that still exist. The concrete buttress of the road tunnel was encountered during drilling and the wing wall was exposed during excavation, both features were used to guide the drilling program and were found to limit the extent of coal refuse. Another historical document that was geo-referenced to help determine the extent of the refuse and exploratory drill-hole locations was an as-built plan from the Pennsylvania Department of Transportation (PADOT). When the mine access Tunnel was removed and the roadway was improved, this map was created with surveyed property information and water main location. Figure 10 is the PADOT survey, LiDAR, and a 2005 ortho-photograph overlain.

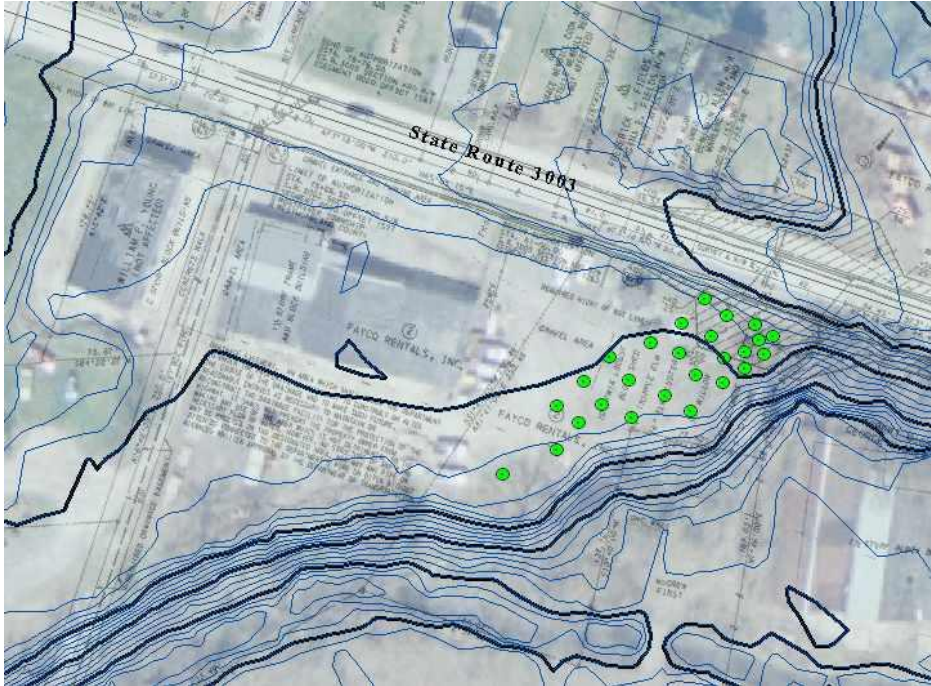
Figure 10 – LiDAR Contours, PADOT As-built, and Drill-holes.

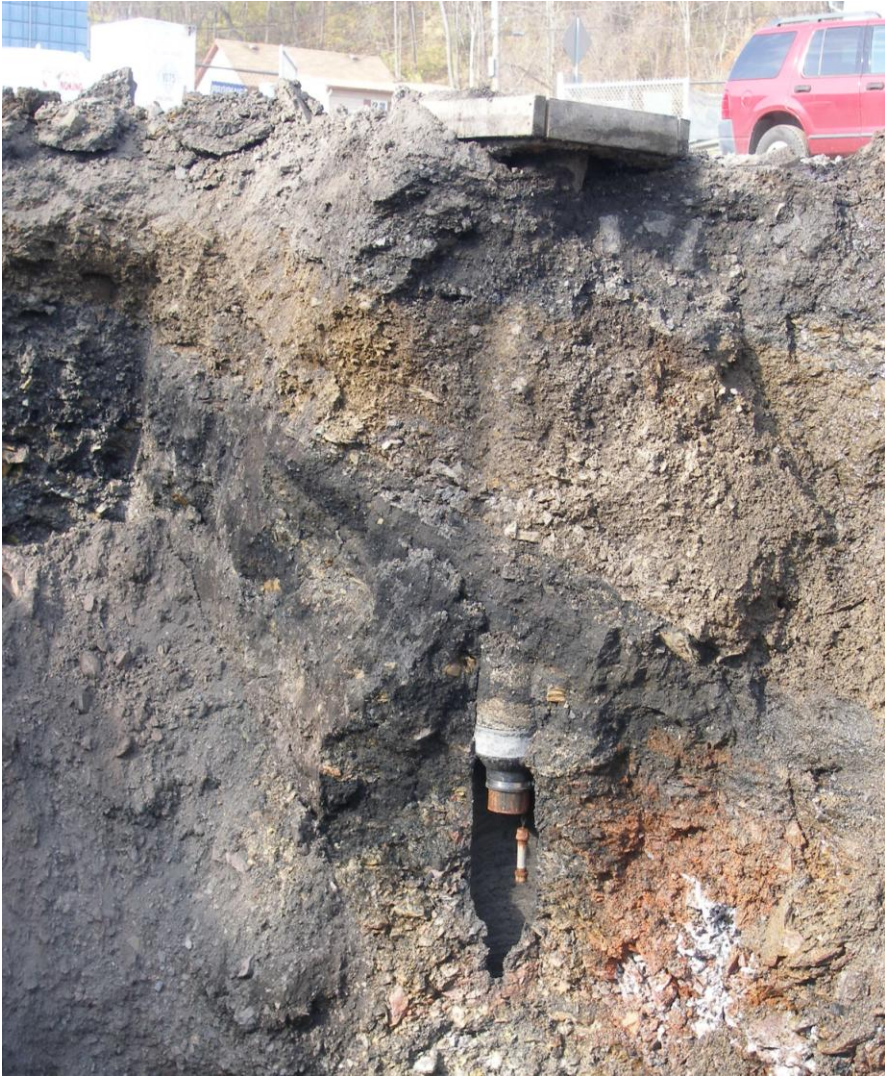
A row of cold boreholes surrounding the burning area was drilled and instrumented to monitor temperature long term after the fire was excavated. Figure 11 is the well completion setup of an iButton monitor, later exposed during excavation. A small pipe cylinder is suspended on a stainless steel cable, generally 5 to 10 feet above the heated zone. Steel casing can extend through the entire burning zone if excessive heat or sealing the combustion from oxygen is important. The iButtons can be double sealed in small zip-lock baggies if you expect extreme moisture or corrosive conditions. When the baggies melt, the iButtons we used will have already failed. Newer, and more expensive iButtons are available for higher temperatures and wet applications. A thermocouple profile of the well prior to installation is advisable to locate your monitoring points. In good monitoring conditions with a smooth or cased borehole, dry and with moderate temperatures, the iButton can be mounted on a cable with a special nylon fob provided by the manufacturer.

Figure 11 – iButton Drill-hole Installation Exposed by Excavation.

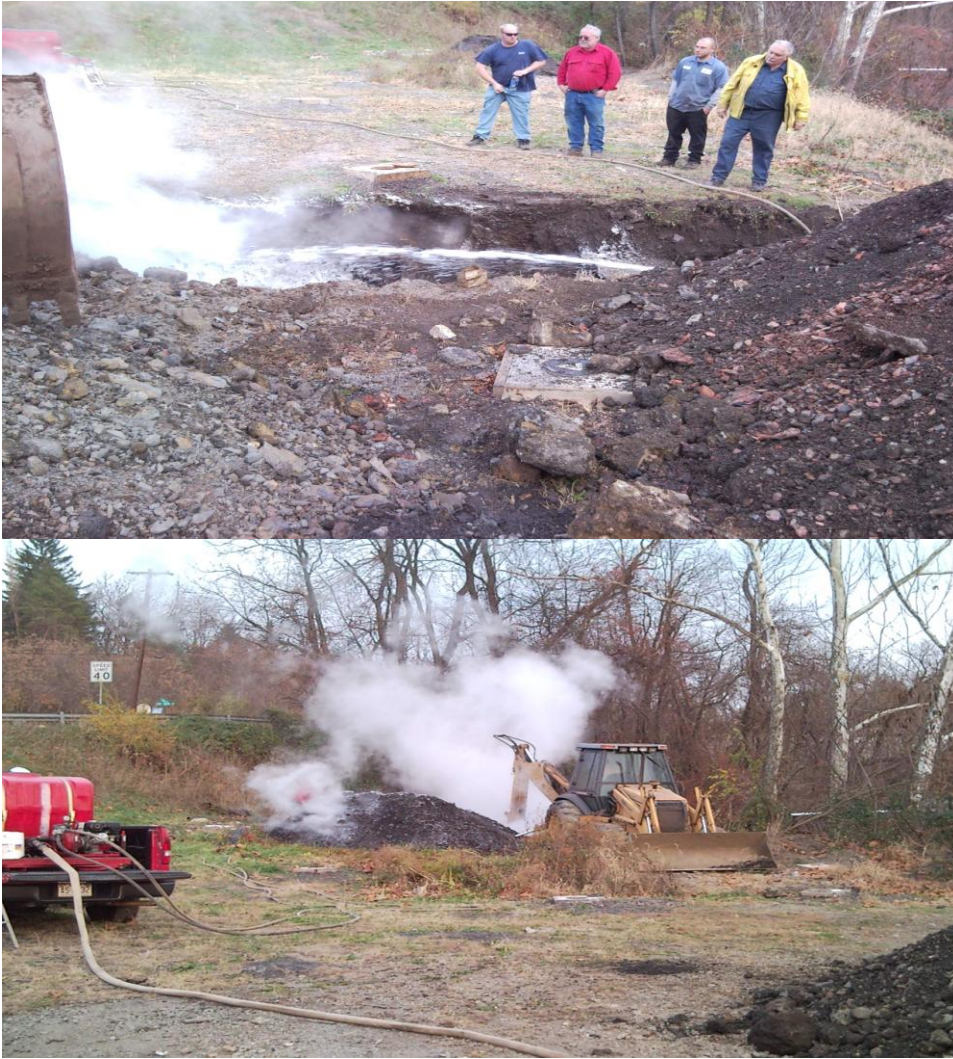
Excavation began around the isolated hotspot on the southern end of the project area, this created a lay-down area for quenching material on the edge of the worksite. Excavation proceeded guided by an infrared detectors and scope to locate hotspots and evaluate quenched material prior to re-burial (Figure 12). During excavation foam was continually sprayed over the bucket, pit, and lay-down pile. The foam had excellent wetting characteristics, knocking down the dust, cutting the water requirements, and totally precluding any runoff from the site. Most important the Novacool reduced the time for quenching and allowed for less re-handle of the material (Figure 13).

Figure 13 – Excavation Photos.

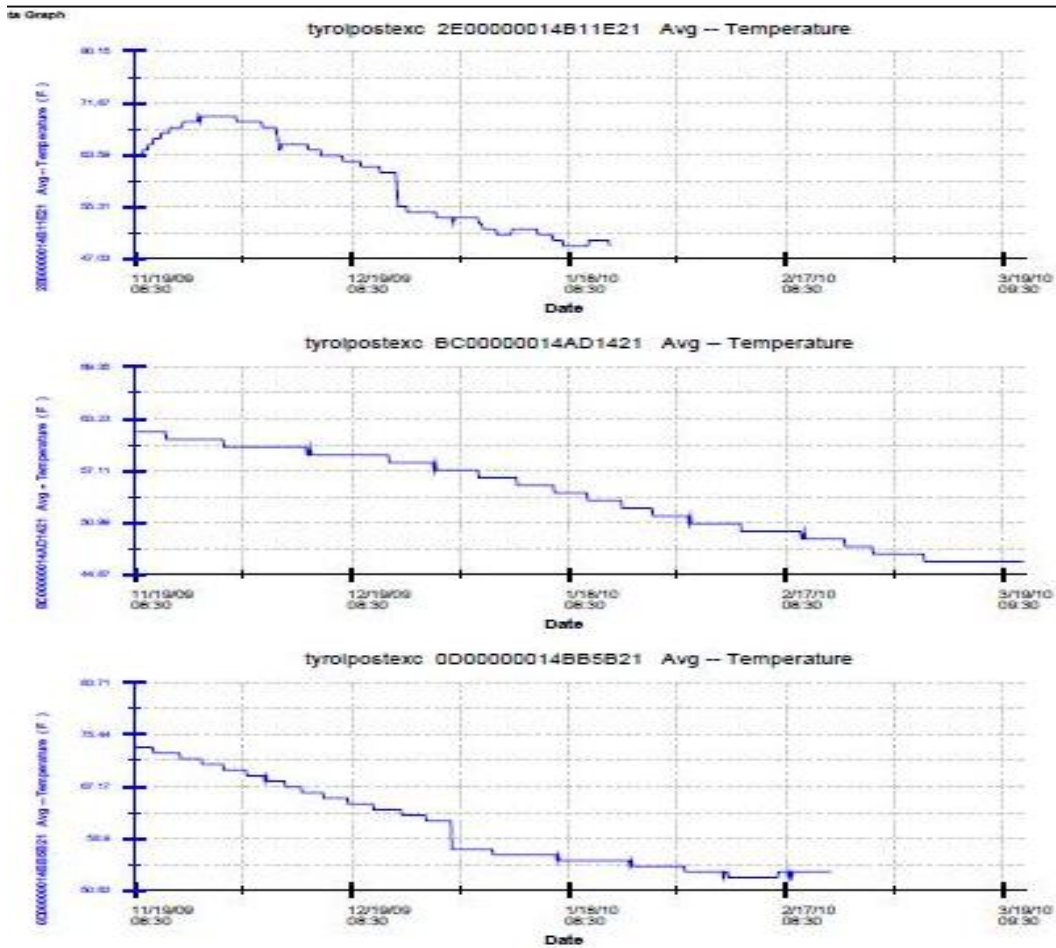
Figure 14 is three iButton graphs showing steady declines in ground temperature post excavation. Most significant, borehole #1, which could not be excavated because of the water line, has decreased from 252 degrees Fahrenheit during drilling to 76.8 degrees

at our last reading of iButtons this last April. DEP will continue to monitor iButtons surrounding the excavation for an additional year.

Figure 14 – iButton Temperature Graphs

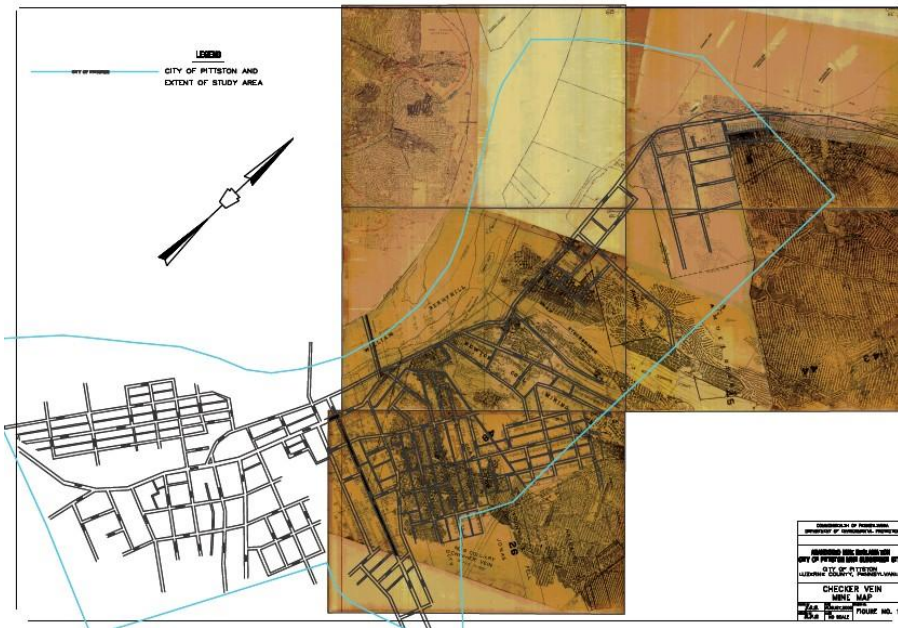
The DEP, Bureau of Abandoned Mine Reclamation (BAMR) was tasked to further investigate the cause of these subsidences which had impacted several houses in the City of Pittston and to develop possible solutions to this problem. The results of this study were documented in an August 2008 report. The study summarized the history of mining and the geology of the region and identified 24 potential high risk mine subsidence areas. A major source of information for the study was the mine maps of these seams, their relationship with the surface, the slope of the seam, and other information on them. (See Figure 15). The OSM maintains a map repository in Wilkes-Barre that contains most of the available mine maps for the Anthracite Region.

Figure 15 - Mine Map of the Checker Vein in the City of Pittston

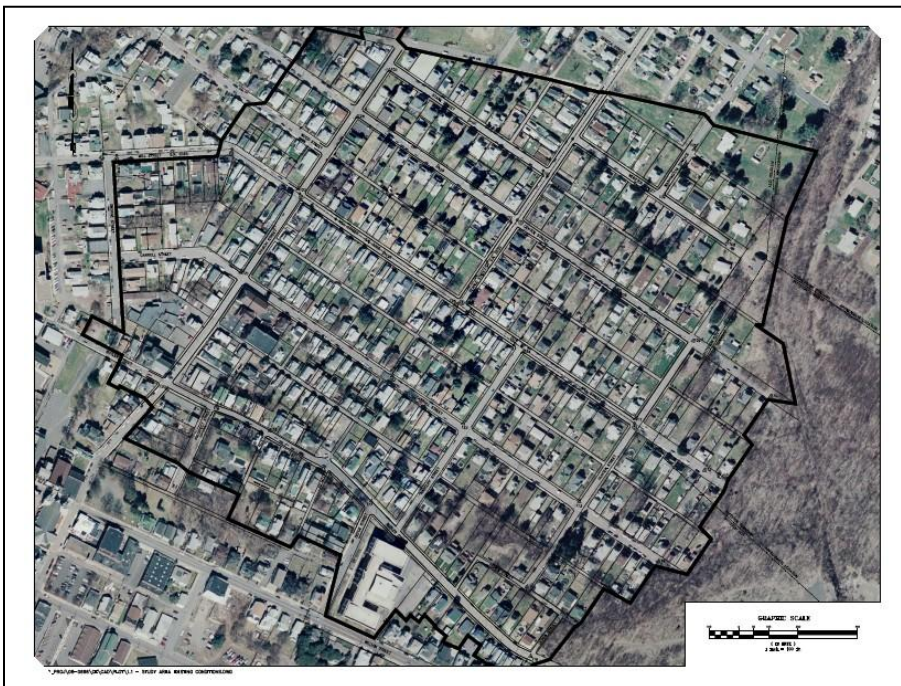
Of these areas, Area 1C (the Mill Street area) was identified for further exploration. The site boundary of Area 1C is shown in Figure 18.

Figure 18- Mill Street Study Area.

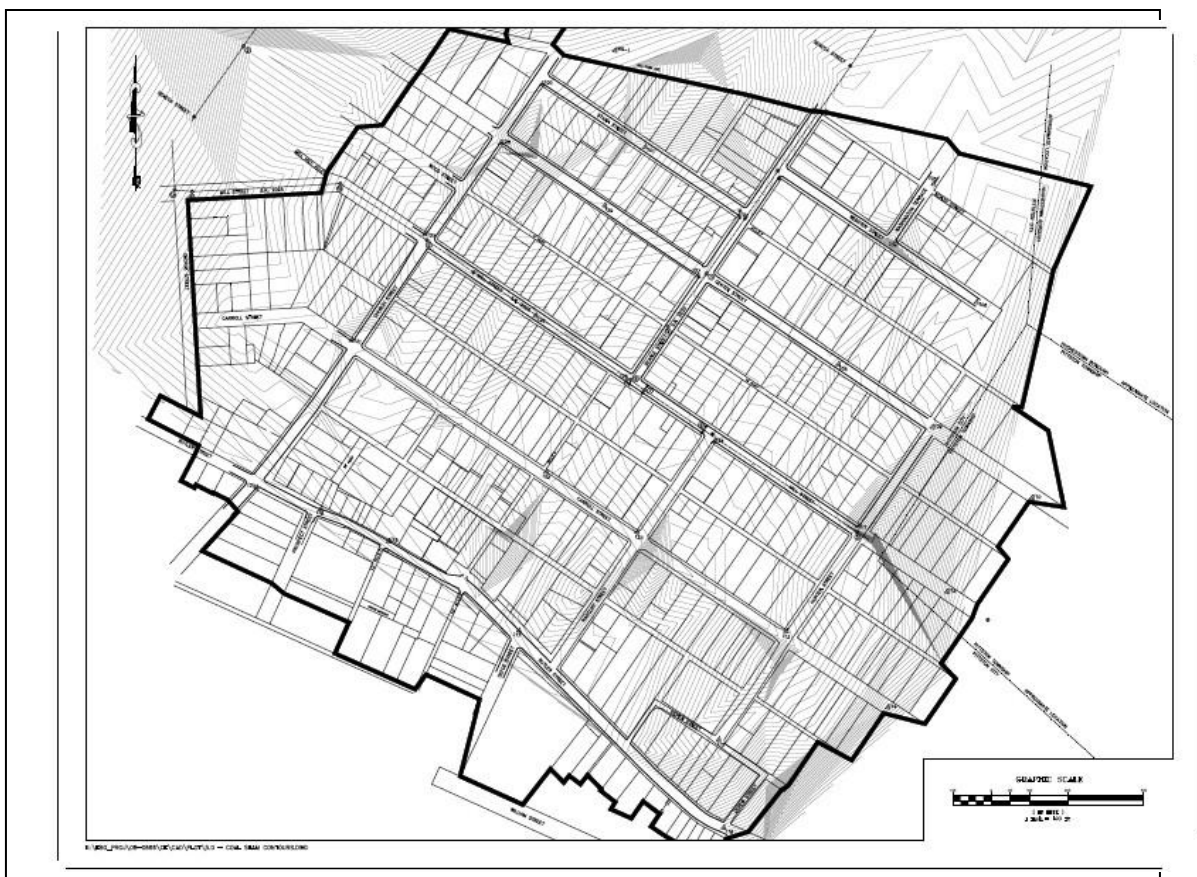
To build the solid three-dimensional model of the study area geology, Kimball first generated a surface topography layer using available Light Detecting and Ranging (LiDAR) data. Next, using the querying capabilities of the ArcGIS system, the bottom elevation of each stratigraphic layer was extracted from the boring database. A Triangulated Irregular Network (TIN) model of the bottom of each stratigraphic layer and coal vein was then produced. The coal vein contours derived from the computer model for the Checker vein is shown in Figure 19.

Figure 19 – Checker Vein Model Structure Contours.

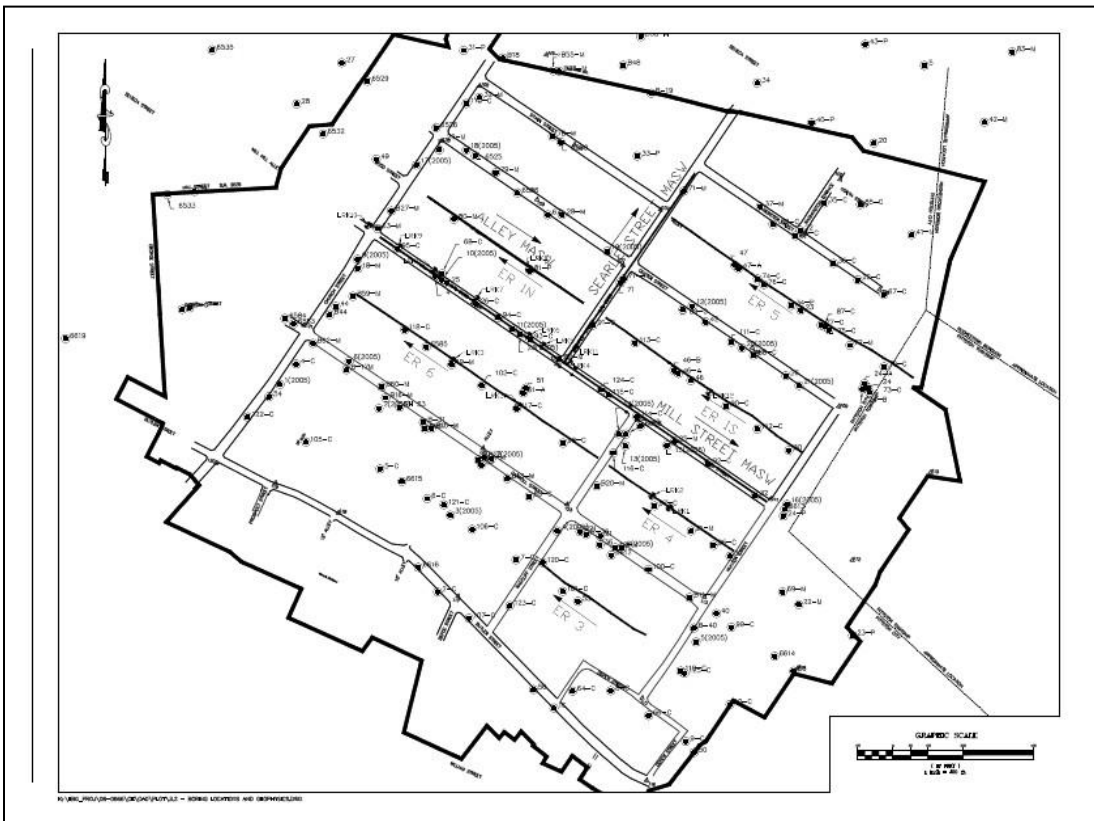
As an initial field effort to define the mine void limits, and to attempt to assess mine subsidence/mine void issues associated with the existing brick sewers that run along Mill and Searle Streets, a geophysical assessment was completed by ARM Geophysics, a division of ARM Group, Inc. (ARM), Hershey PA, <http://www.armgeophysics.net/>. ARM collected 6 electrical resistivity (ER) traverses, 3 multi-channel analysis of surface wave (MASW) traverses, and ground penetrating radar (GPR) profiles within the survey area. The geophysical traverse locations are shown in Figure 20.

Figure 20 – Geophysical Traverse Locations.
