SECTION 10: Effects of Mine Subsidence on Wetlands

10.A – Overview

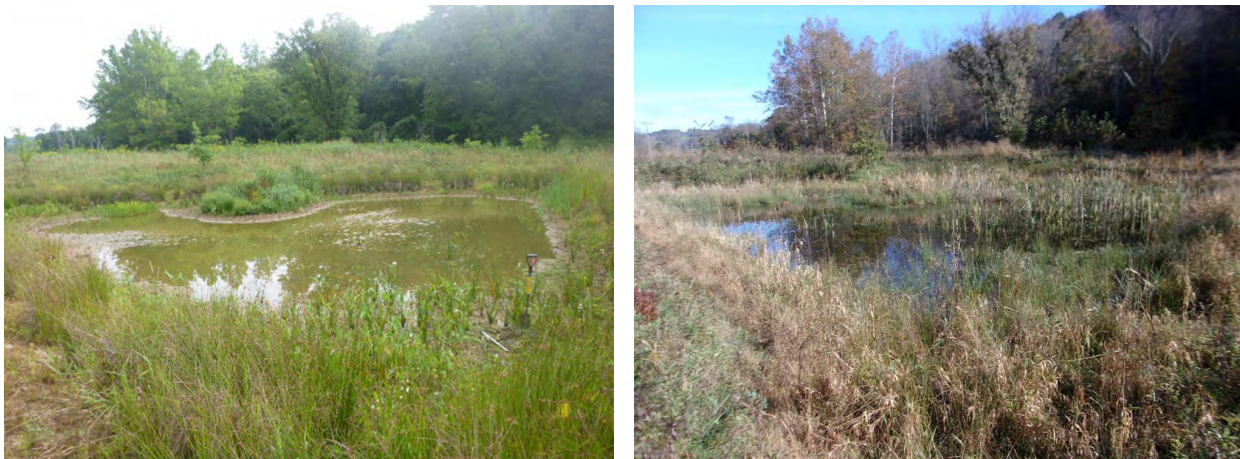
Results from the year one monitoring survey conducted in November 2014 revealed that the three cells possessed all three wetland criteria (wetland hydrology, hydric soil, and hydrophytic vegetation). A mixture of upland and wetland herbaceous vegetation provided dense ground cover over much of the mitigation site, with mature hydrophytic trees showing no signs of being negatively impacted by the construction.

Year two monitoring conducted in October 2015 revealed a vegetative community that was transitioning from a mixture of upland and wetland species to facultative and obligate wetland plant species. The three cells continued to maintain all wetland criteria. Year three monitoring conducted in August 2016 yielded similar results as year two, with the continued progression of the vegetative community to wetland species. No monitoring was conducted in year four (2017), but year five monitoring conducted in October 2018 showed progression of the wetland cells with all three gaining at least one hydrologic indicator. Comparison photos of Wetland Cell 1 from year one to year five can be found in Figure 10-1.

Figure 10-1. Wetland Cell 1 of the Dutch Run mitigation area photographed during year one monitoring in 2014 (left) and during year five monitoring in 2018 (right). Photos from Wallace and Pancher.

The report concludes that the Dutch Run mitigation project was successful in creating 0.96 acres of PEM and PSS wetland habitat. However, the original project plan proposed to create 2.22 acres of wetland habitat. The remaining 1.26 acres were to be created by expanding an existing wetland at the project site, DR-27. Grading at this site was not done according to plan, however, and plantings did not take place. A field investigation conducted in 2016 determined that the DR-27 expansion site did not exhibit any wetland characteristics and any wetland construction would ultimately fail, so this project will not be implemented. Combined with the wetland acreage created at the Whiteley Creek site, 0.56 acres of additional wetland habitat still need to be created to offset wetland losses over Cumberland Mine. This five-year report also includes an action plan for creating this additional wetland acreage, which involves expanding a different pre-existing wetland. Plans are currently being developed, and construction may begin as early as late 2019 pending approval by PADEP.

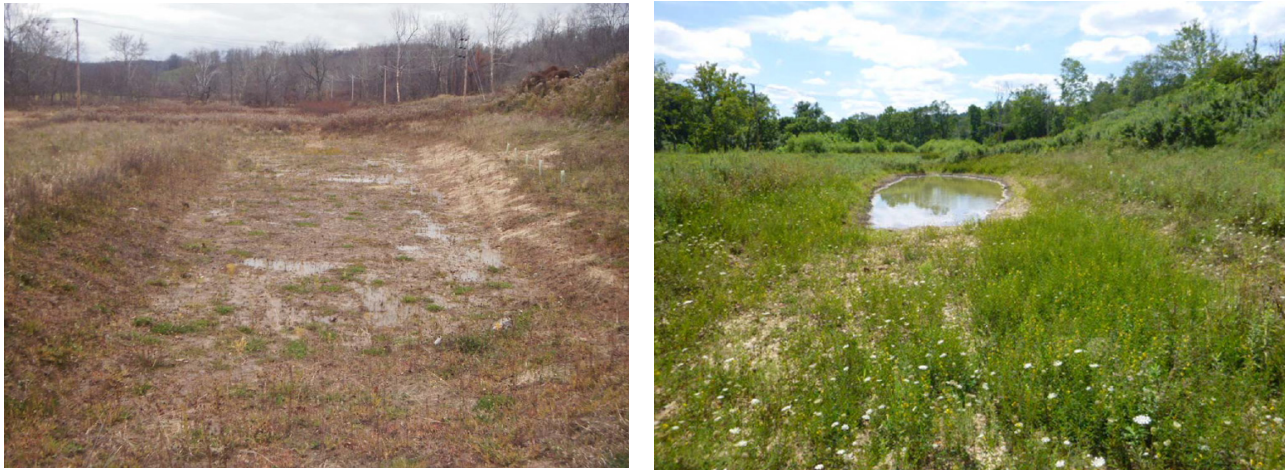
Results from the Year 1 monitoring survey conducted in 2014 indicated that 4 of 5 cells were covered with a mix of wetland and upland vegetation. Cell 2 (Figure 10-2) was only sparsely

vegetated with upland plant species. It was determined that Cells 1 and 3 did not meet the criterion for hydrology, and Cells 1 and 4 did not meet the criterion for hydric soils. Following this survey, Cells 2 and 3 were re-excavated and replanted in order to improve hydrology, soil, and vegetation.

Figure 10-2. Wetland Cell 2 of the Whiteley Creek mitigation area photographed during year one monitoring in 2014 (left) and during year three monitoring in 2016 (right). Photographs from Wallace and Pancher reports.

Results from the Year 3 monitoring survey conducted in 2016 were more detailed, and outlined the deficiencies found in each of the five cells. The Whiteley Creek wetland mitigation project was reported as 60 % successful, and therefore the remaining 40 % of the project area would need corrective action. The final section of the report provided specific recommendations for such corrective action within each of the five wetland cells. For all five cells, it was recommended that 1) any upland vegetation be removed, 2) portions of the cells either be excavated to a lower elevation in order to better intercept groundwater from adjacent areas or backfilled to prevent over-inundation, 3) compacted soil be loosened to a depth of 12 inches, 4) hydrophytic trees and shrubs growing within the cells should be relocated and placed back in the cells after grading, 5) soil additives be used to promote establishment of new vegetation, and 6) the cells be revegetated appropriately. Specific recommendations were also included for particular cells, such as the removal of dense cattail colonies from Cells 4 and 5, and additional measures to direct the flow of groundwater in Cells 3 and 4.

PADEP quickly granted approval for this corrective action plan to be implemented at the Whiteley Creek mitigation site and the work was completed in October and November of 2017. A follow-up report was submitted to the PADEP as an addendum to the Year 1-3 report in August 2018 (Wallace & Pancher 2018). This report contained results of an as-built survey of the repairs conducted in December 2017, which reflected the recommendations outlined above. These repairs restored an additional 1.96 acres of wetland habitat. When combined with the successful portion completed earlier, the Whiteley Creek project mitigated a total of 4.12 acres of wetland habitat. The area will continue to be monitored for success and reports will be submitted accordingly.
