APPENDIX D1: *Bailey Mine* -- Information on Streams Undermined by Longwall Mines during the 3rd Assessment Period and Surveyed by the University of Pittsburgh

D1.A - Unnamed Tributary to Wharton Run / 32507

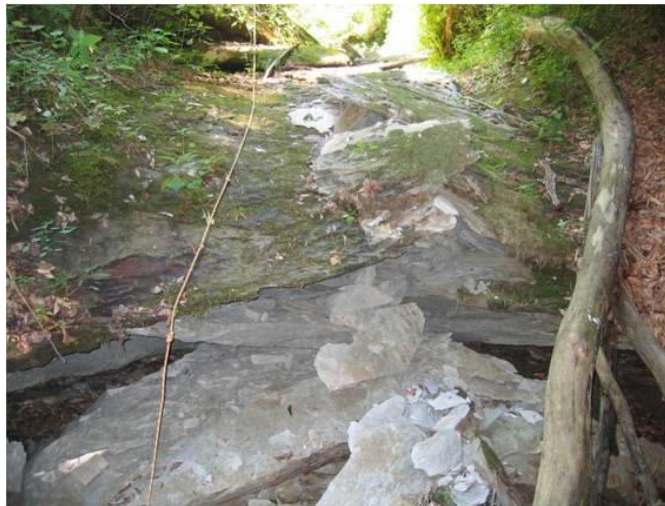
- **May 16, 2005:** Trib. 32507 was flowing. (This was a pre-mining observation because mining a week earlier was ~ 1,900-ft. away).
- **August 24, 2005:** the stream had no surface flow and large *compression heaves* (ruptures) had formed.

Figure D-1 - Compression ruptures observed by PA DEP during post-mining survey of the 7H panel in Bailey Mine (Photograph from PA DEP files).

- **April 2, 2008:** grouting occurred on the upper third of the stream; over half of the stream was dry.
- **June 2, 2008:** the upper reaches of the stream were dry; flow was observed close to where the grouting was completed and continued all the way to the confluence with Wharton Run.

- **June 5, 2008:** grouting operations continued; continuous flow was reported over most of the stream.

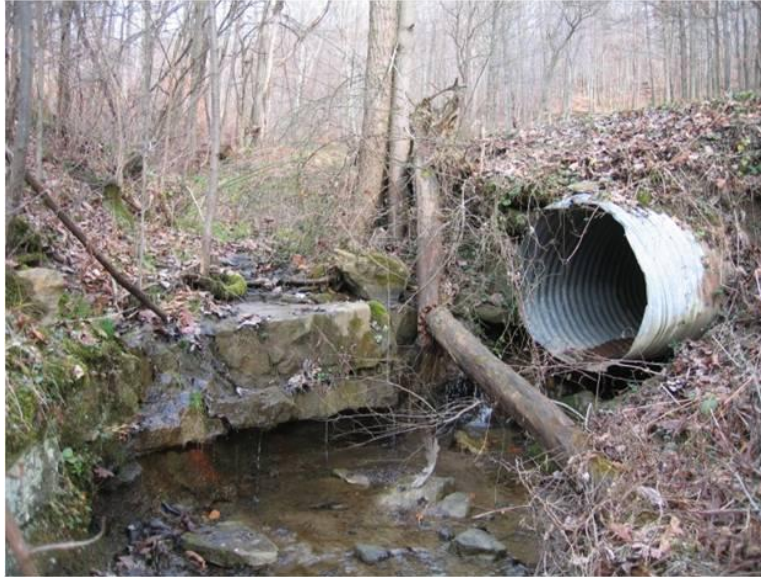
- **July 31, 2006:** dry stretches totaling nearly 2,000-ft were observed - there was a pooling area about 65 feet in length and total flowing length of about 465-ft.

- **November 30, 2006:** 1,780-ft of dry stream were observed with some pooling in a total of 1,070-ft of flowing stream.
- **June 4, 2007:** pooling and flow loss over panel 2I.

Figure D-2 – A main stem waterfall (left) and a ‘no flow’ tributary (right – corrugated pipe) observed by PA DEP during post-mining survey over 32530 in Bailey Mine (Photograph from PA DEP files).

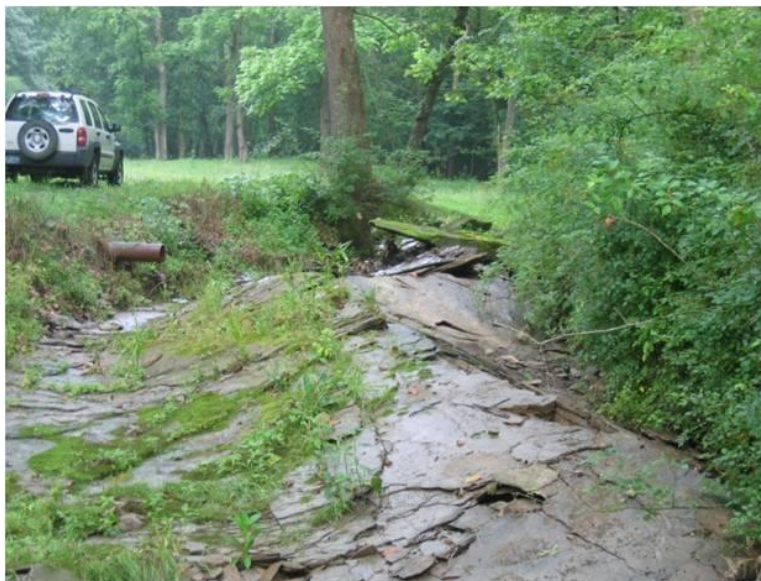
- **June 26, 2006:** a large compression heave (rupture) over the 8H panel to the mouth of the stream (stream dry).
- **July 17, 2006:** the stream was still dry from 8H to the mouth, approximately 3150-ft.

Figure D-3 - Compression rupture observed by PA DEP during a post-mining survey of the 8H panel in Bailey Mine (Photograph from PA DEP files).

- **July 11, 2008:** flow was observed in the stream over the 6H and 9H panels, but was dry over the 7H, 8H, 10H and 11H panels, grouting was being done in the 10H and 11H areas.

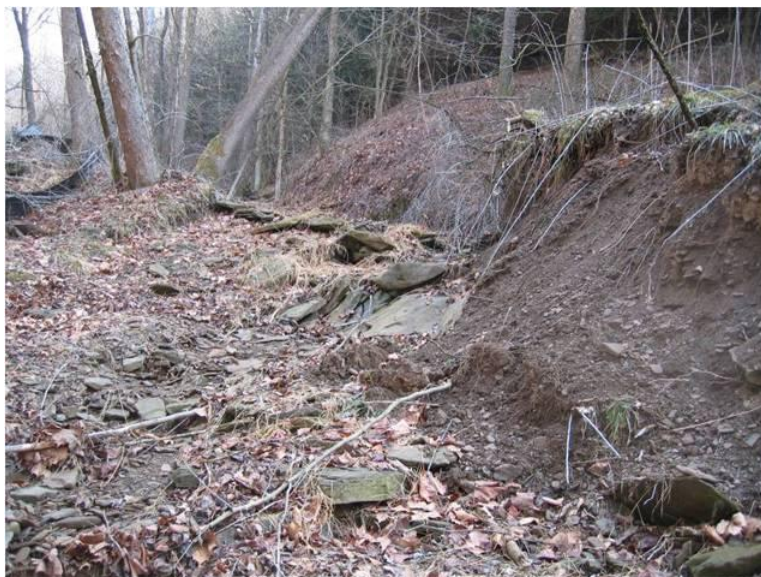
- **April 14, 2005:** the stream was dry over the entire 3I panel.
- **August 23, 2005:** the 4I panel passed under the stream and the entire length of stream over this panel was dry and had cracks and compression heaves in it.

Figure D-4 – Photograph of the post-mining condition of stream 32596. PA DEP agents noted compression ruptures (Photograph from PA DEP files).

- **March 12, 2008:** all grouting had been completed and the stream was naturally flowing (without augmentation on) through its entire length.
- **May 28, 2008:** augmentation was off and most of the stream was flowing except for two areas measuring 60 ft and 670 ft over the 4I tailgate and panel.

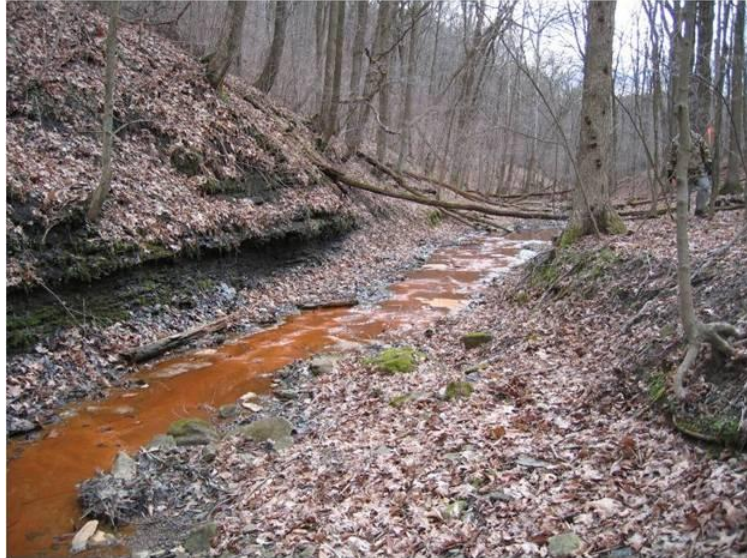
- **December 1, 2005:** a stream investigation into lengthy dry stretches was in progress.
- **February 17, 2006:** some iron staining was seen and hydrogen sulfide odor was present.

Figure D-5 - Iron staining observed by PA DEP after mining of the 4I panel (from PA DEP files).

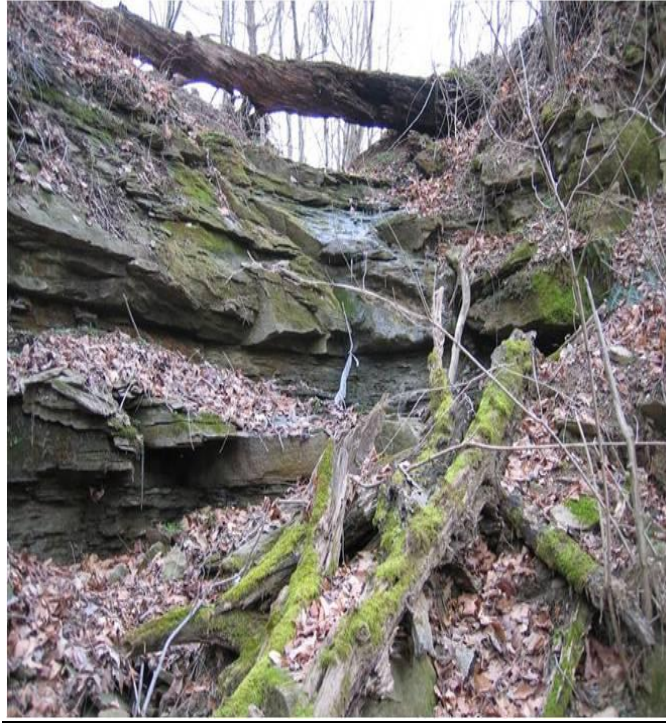
- **January 18, 2007:** the left and right forks of the headwaters were dry for 152 and 137-ft respectively. After 173-ft of flow, another 105-ft dry stretch occurred. The stream then flowed to its confluence with Dunkard Fork. Agents noted that since the tributary (and surrounding ones) was not cut very deep into the earth, it was possible that flow had always been intermittent. Macroinvertebrate life was not seen until 376-ft downstream from the headwater fork confluence.

Figure D-6 - Dry waterfall from right headwater tributary (Photograph from PA DEP files).

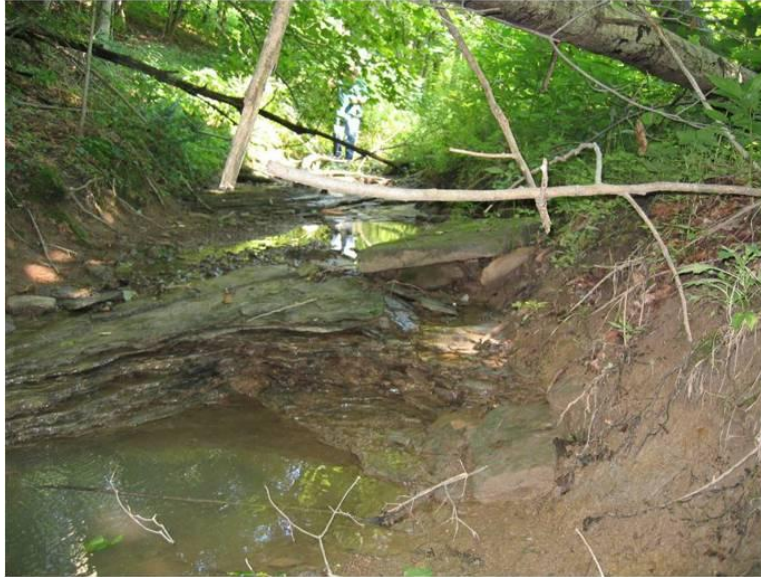
Figure D-7 - Small compression ridge observed in the 3N panel post-mining (Photograph from PA DEP files).

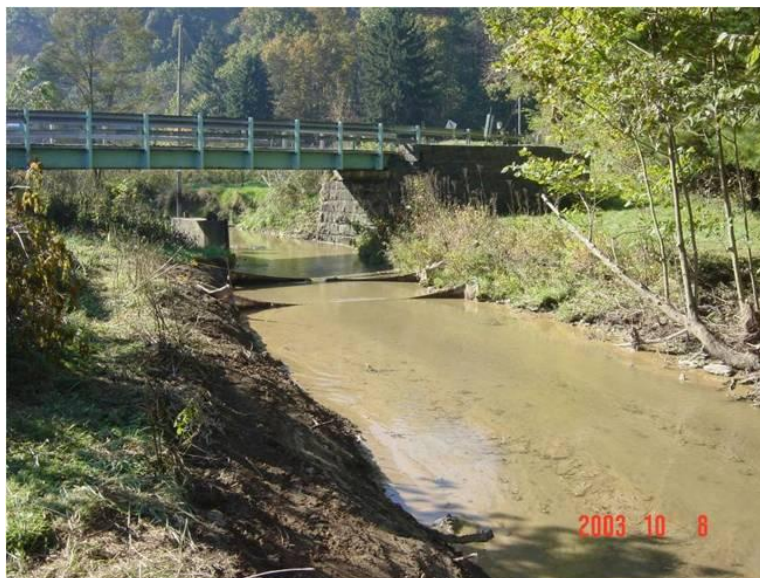
Figure D-8 - Sedimentation observed by PA DEP south of the 8R panel during mitigation work to relieve pooling in the panel (Photograph from PA DEP files).

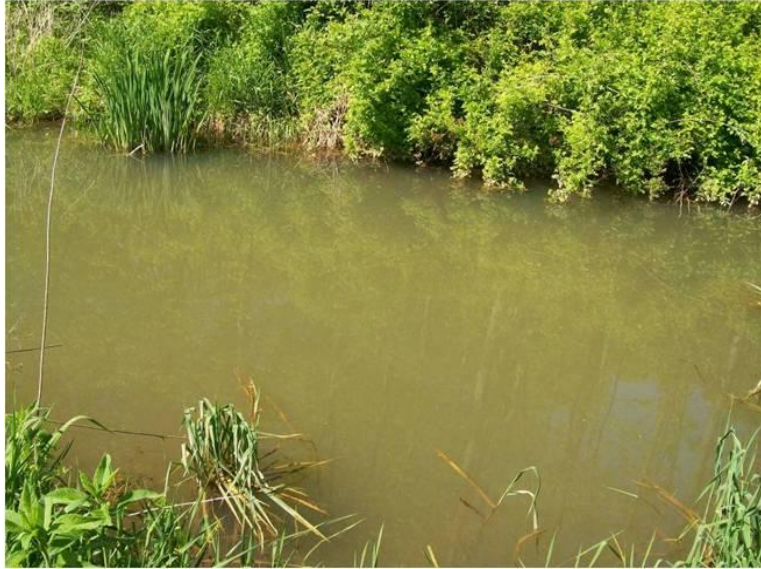
- **July 15, 2008:** pooling was seen over panel LW54 for about 400-ft.

Figure D-9 - Pooling observed by PA DEP during a post-mining survey of stream 41246 (Photograph from PA DEP files).

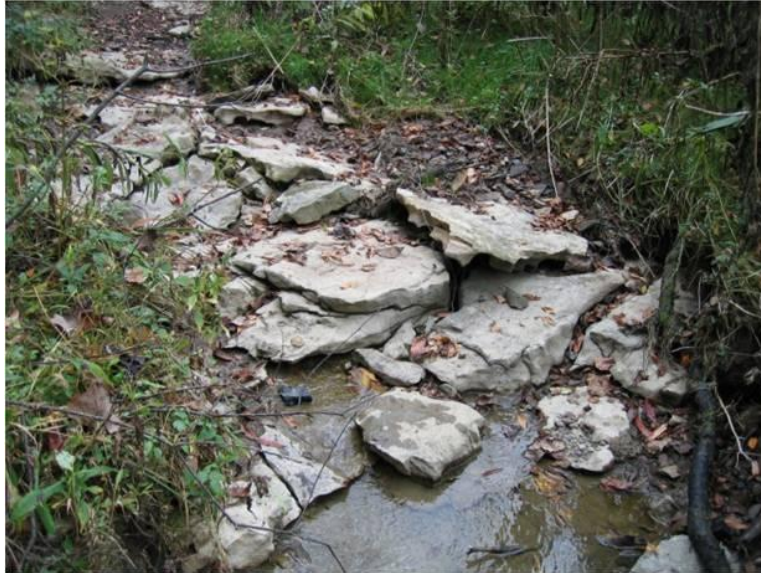
Figure D-10 – Compression ruptures observed by PA DEP in the F8 panel during a post-mining survey (Photograph from PA DEP files).

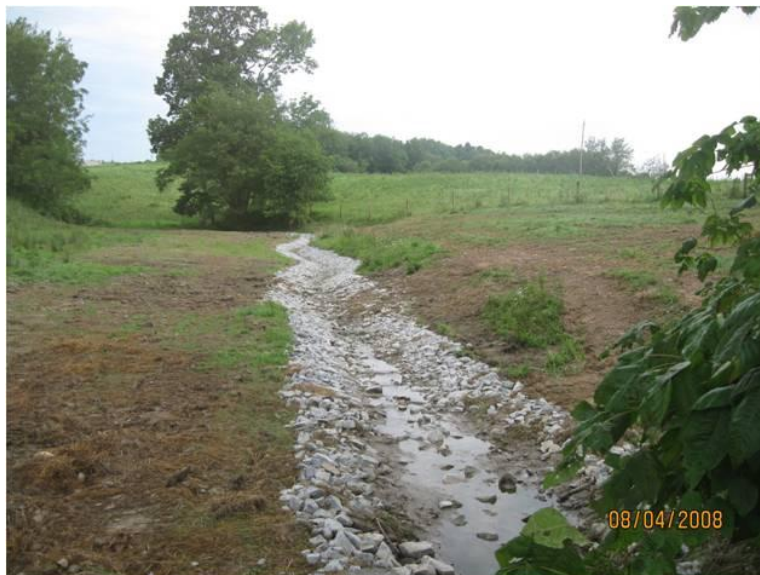
Figure D-11 - Mitigation work observed by PA DEP during a post-mining survey (Photograph from PA DEP files).

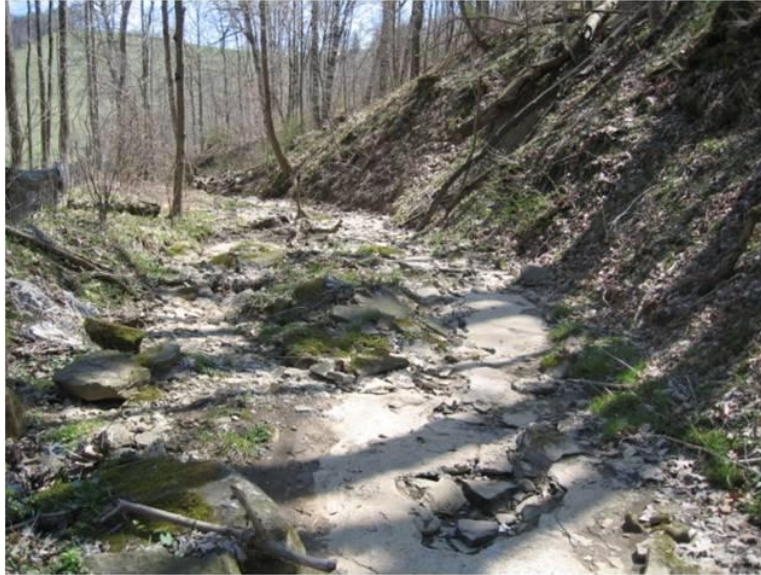
Figure D-12 - Stream channel after grouting as observed by PA DEP during a post-mining survey (Photograph from PA DEP files).
