SECTION V: Effects of Mining on Structures

V.A - Overview

V.C – Summary Information about Structures Undermined During the 3rd Assessment Period

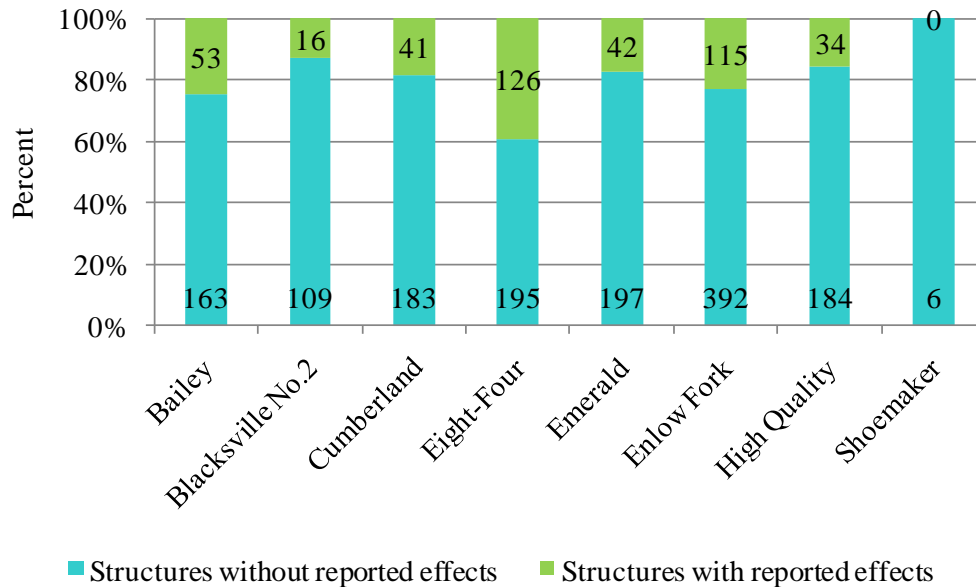
Another way to evaluate the relationship between structures and reported effects is to compare the relative percentages of each mine (Figure V-3). The mines with the highest percentage of reported effects are Mine Eighty-Four with 39-pct, the Bailey Mine with 25-pct, and the Enlow Fork Mine with 23-pct. The mines with the lowest percentages are the Cumberland Mine with 18-pct, the Emerald and High Quality Mines with 16-pct, the Blacksville No.2 Mine with 13-pct, and the Shoemaker Mine with zero.

Figure V-3 - Relationship between structures with and without reported effects, sorted by mine.

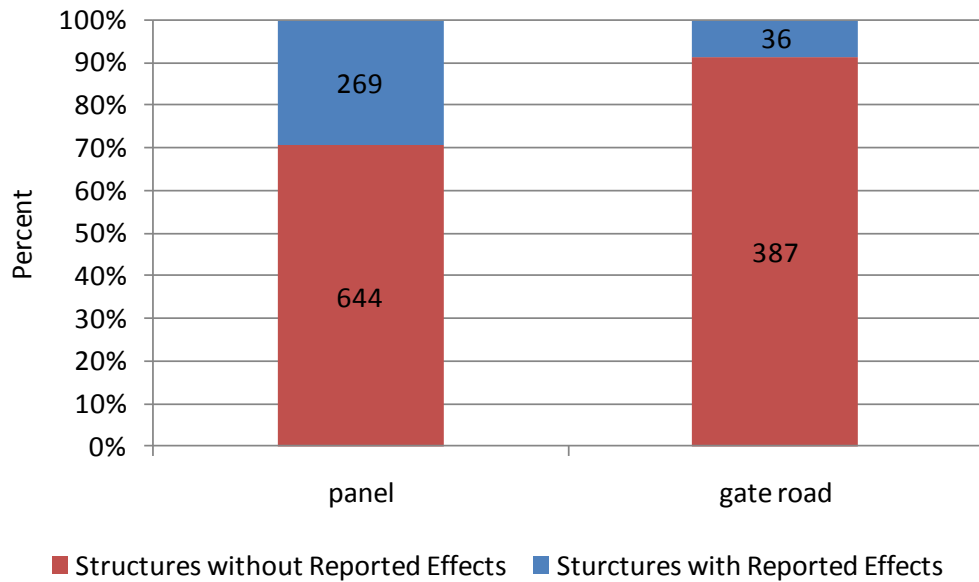
If the mid- and quarter panel categories are combined into one panel category and compared to the structures in the room-and-pillar category, a significant difference is observed (Figure V-5). Thirty percent of structures over longwall panel areas had reported effects, whereas nine-pct of structures over room-and-pillar mining areas had reported effects. These trends demonstrate the influence of the subsidence basin over the panel on structures with reported effects compared to conditions over the adjacent room-and-pillar areas.

Figure V-5- Relationship between structures with and without reported effects as per mining method.

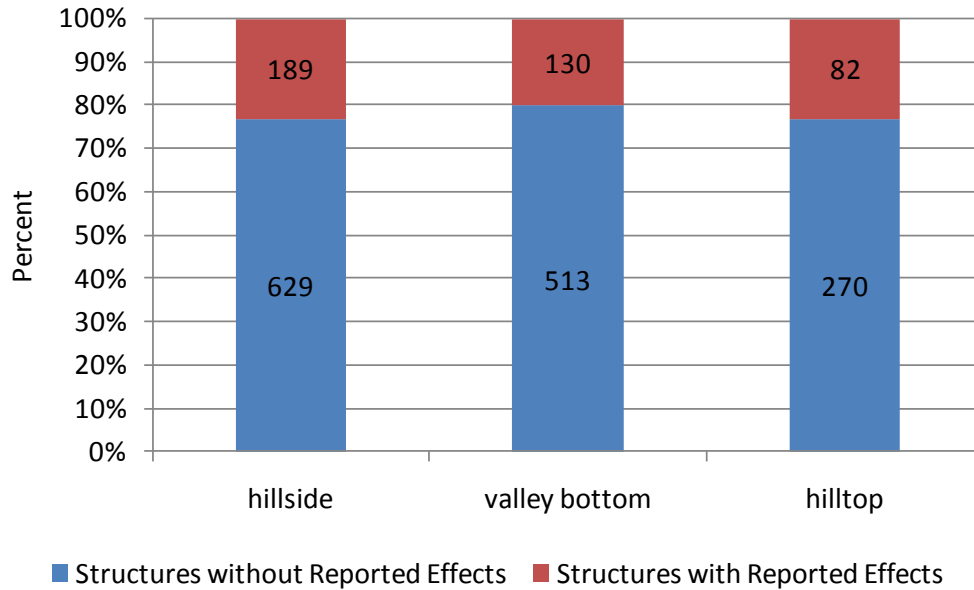
The analysis of the topographic conditions of structures undermined did not show any significance. The percentage of structures with and without reported effects over hillsides, valley bottoms, and hilltops lay within a tight range of 20.2 to 23.3-pct (Figure V-6).

Figure V-6 - Relationship between structures with and without reported effects and topography.

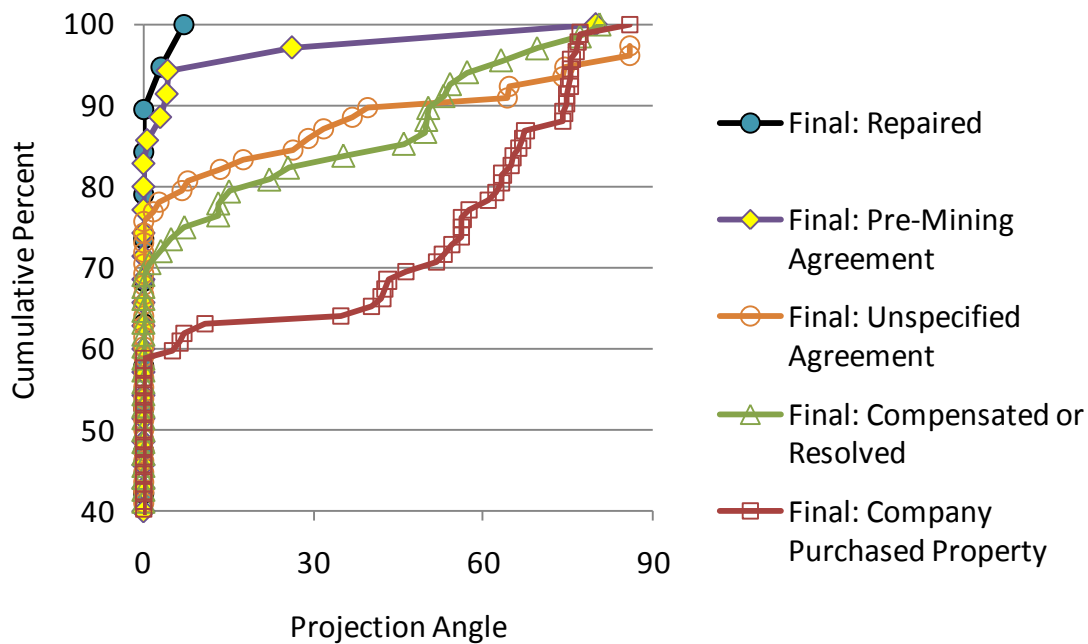
The relationship between the structure’s distance from a longwall panel and the reported effects resolution category can be determined using the projection angle discussed above. This relationship provides insight as to what resolution outcome can be expected as the projection angle increases. Figure V-7 shows that a significant percentage of structures from every resolution category were located directly over the longwall panel, i.e. zero-deg projection angles. When the entire spectrum of resolutions were examined, it was clear that Repaired and Pre-Mining final agreements occur most often when structures were located very near to a longwall panel (< 35-deg). Conversely, when the projection angle is large (> 35-deg), companies more often resorted to Compensation and Company Purchased Property as a final resolution.

Figure V-7 – Relationship between projection angles and resolution category. Each data point represents the angle between the structure and the edge of mining.

The relationship between the structures distance from a longwall panel and the reported effects provided insight as to what resolution outcome can be expected as the distance from mining increases. The final resolution of Repaired and Pre-Mining agreements occurred most often when structures were located very near to a longwall panel (< 35-deg). Conversely, when the projection angle was large (> 35-deg), companies more often resorted to purchasing properties as a final resolution.

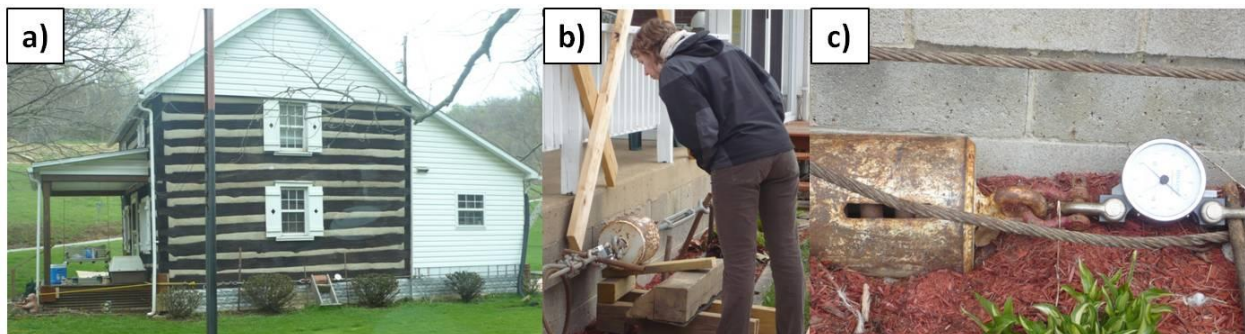
One of the most common mitigation methods is banding (Figure V-13a). Typically, polypropylene or nylon rope or steel cables are wrapped around the structures and tensioned (Figure V-13b). Most of these bands are located at the foundation level but some can be used higher on the structure as needed. The forces are distributed through wood boards placed between the rope or cables and the corners of the structure. The ropes and cables are tensioned with a turn-buckle that consistently applies the force. A spring is used to relieve sudden changes in the lateral force, and this force is monitored with a gage (Figure V-13c).

Figure V-13 - Photographs of a) residential structure with polypropylene rope around the foundation, b) steel cable spring and tension assembly, and c) spring and gage assembly (photographs courtesy of N. Iannacchione).

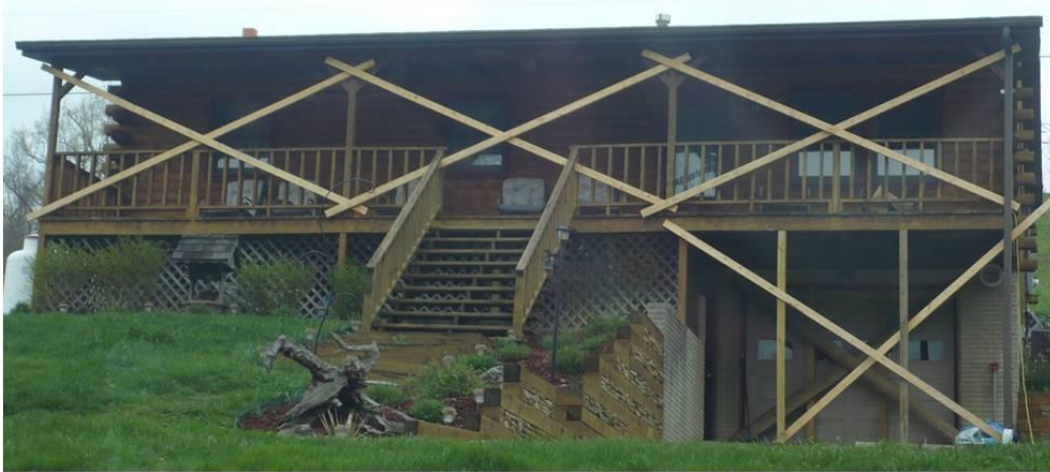
Bracing is typically applied to stiffen a structure. It does this through a supporting beam or a connecting wire or rope that steadies and holds the structure in the correct position against vertical and horizontal rotations. Bracing can be made of wood or metal. This measure is generally applied diagonally between intersecting components on the structure (Figure V-14)

Figure V-14 - Photograph of bracing (photograph courtesy of N. Iannacchione).

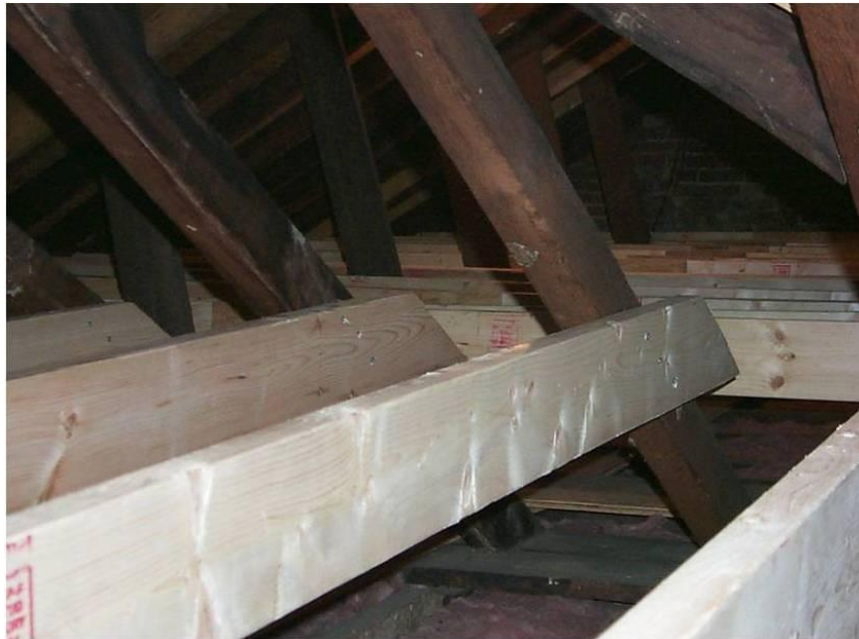
Bridging is used to strengthen and stiffen a structure against differential movement. It is generally applied within the attic of the structure (Figure V-15). Bridging reinforces levels within a structure, decreasing the impact of differential settlement. This can be an effective means of withstanding the passage of a subsidence wave propagating through a large structure.

Figure V-15 - Bridging applied to a structures attic to stabilize the roof (Photograph from PA DEP files).

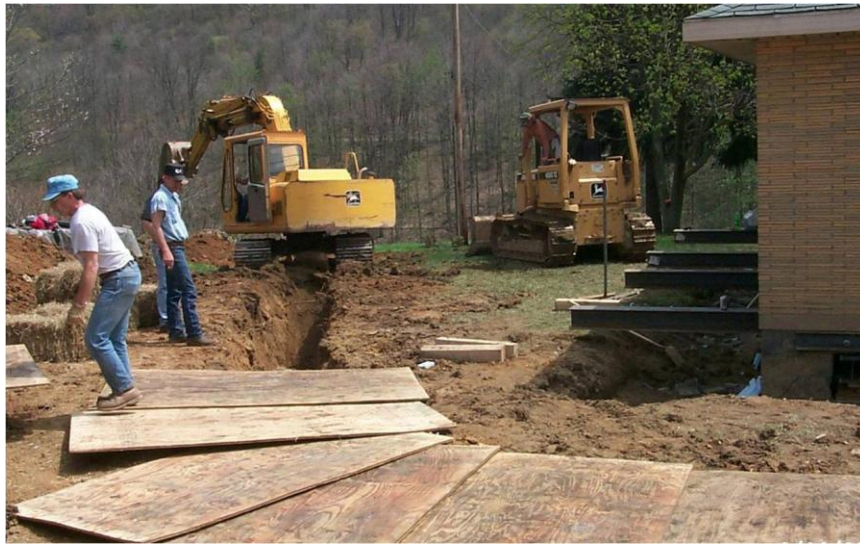
One of the most effective measures to reduce high surface horizontal strains is trenching (Figure V-16). In general, a trench is excavated near the structure to absorb horizontal strain. The trench

should extend to a depth approximately 2-ft below the lowest point in the structure's foundation. Typically, the trench is covered over with planks to satisfy safety concerns.

Figure V-16 - Photograph of a trench excavated adjacent to a structure to mitigate high horizontal strains (Photograph from PA DEP files).

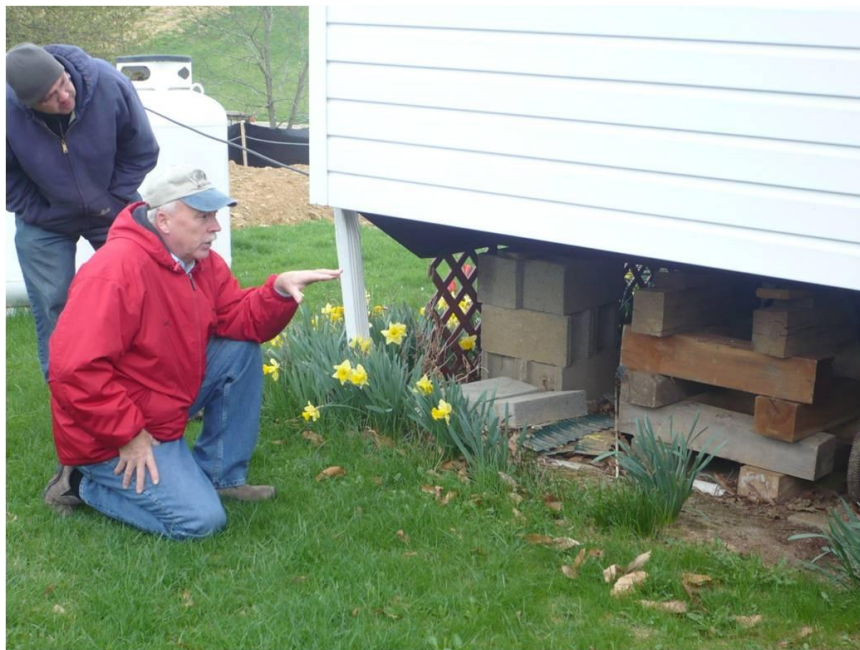
Cribbing is one of the most cost effective mitigation measures. In general, cribbing is used to arrest vertical movement within a structure (Figure V-17). Most cribs are constructed of wood and can withstand considerable vertical movement without losing their load bearing capacity. Wood cribs are not effective when significant horizontal movement occurs.

Figure V-17 – Photograph of cribbing (photograph courtesy of N. Iannacchione).

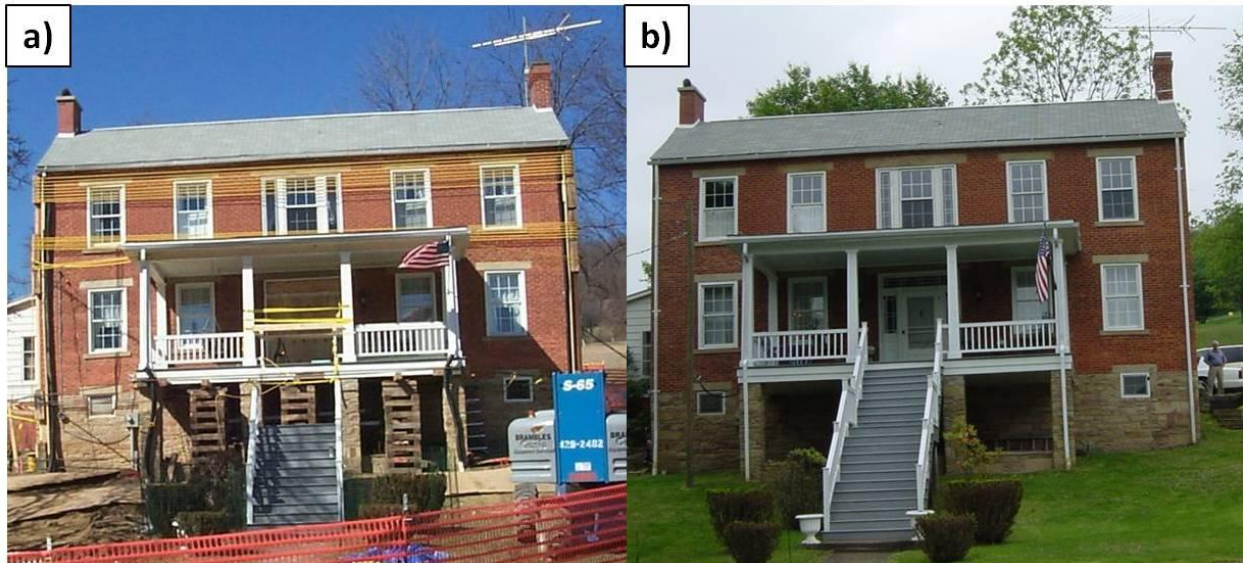
Some companies rely on these measures, while others prefer compensation to the property owner. Regardless, there is little doubt that these measures can be effective. For example, Figure V-18a (before) and Figure V-18b (after) photographs show the application of mitigation measures applied to this historic structure. It should be noted that this structure did sustain some minor damage that was later repaired.

Figure V-18 – Photographs of a) historic farm house in 2001 treated with several mitigation techniques, i.e. banding, cribbing, and trenching and b) farm house on May 21, 2003 (Photograph from PA DEP files).
