Experimental Studies of the Effects of Blasting on Structures

By A. T. EDWARDS* and T. D. NORTHWOOD†

The results are presented of controlled blasting tests on six buildings on two different soils. Damage was correlated with size of charge and distance, and with displacement, velocity, acceleration, settlement, and strain measurements in the buildings. Peak velocity appears to provide the best correlation with damage for all soil conditions.

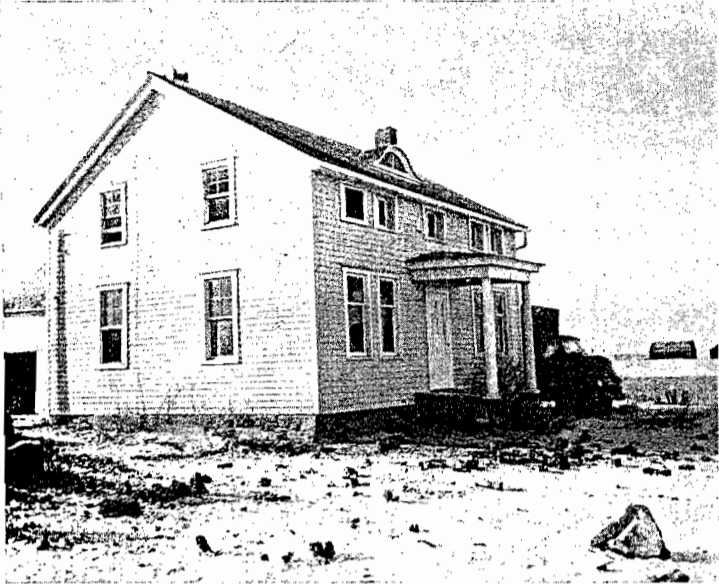
Fig. 1—Building R (after Test R3)

Building R.—No damage occurred until Test R3 (120 lb at 29ft) when some horizontal cracks, up to about $\frac{1}{2}$ in wide, developed in the basement walls. These extended out in the two walls, longitudinal with the blast, about 12ft from the rear wall. Nearly all the tell-tales across original cracks broke, although none were opened up. Somewhat fewer tell-tales broke in the walls normal to the blast. Most of the windows in the ground floor longitudinal walls broke while those in the walls normal to the blast remained intact. The top section of the chimney was sheared through.

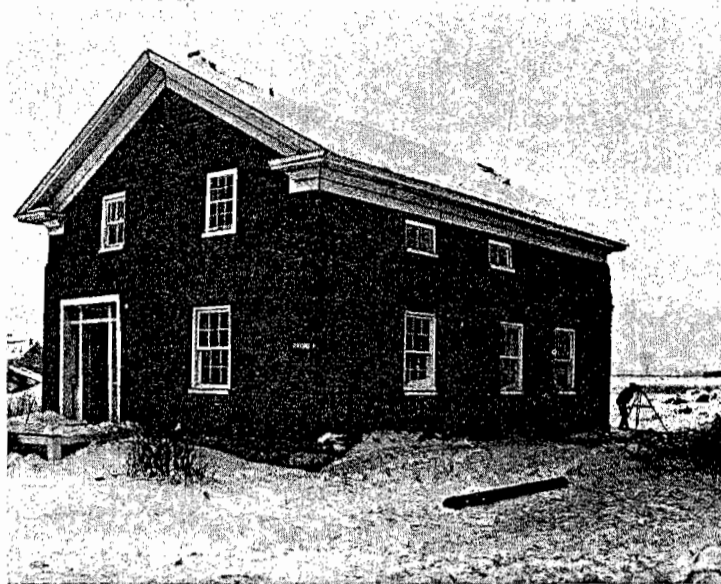
Fig. 2—Building E (after Test E11)

All structures were in good condition except for quite localized areas in one or two of them. Building R and part of building F were of frame construction above masonry basement walls. In the other buildings, structures above ground level were mainly of 12in solid brick, which was in good condition except that the bond between the bricks and the mortar was weak in two of the buildings. House E had a 45 deg. crack across the front wall which had been patched up and which was said to have been caused by the Cornwall earthquake of 1945. The crack may be seen in Fig. 2. Rock was encountered about 15ft down at house F.

Building E.—Damage first occurred with Test E10 (140 lb at 50ft) when some vertical and diagonal cracks developed in the basement and upper walls. An original diagonal crack in the front wall was opened up to $\frac{1}{2}$ in in width. Test E11 (140 lb at 25ft) demolished large sections of the two rear walls and caused the rear upper floor to collapse. The diagonal crack in the front wall opened up to about 1in in width.

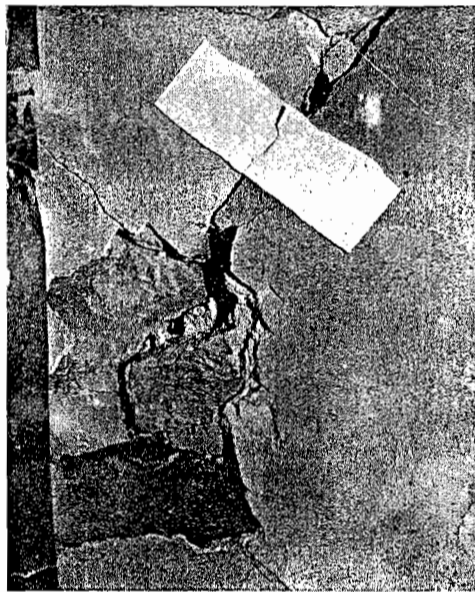
Fig. 5—Showing tell-tale across an original crack

(a) *Tell-tales*.—In order to obtain a positive indication of movement in existing cracks in plaster or in basement walls, a sheet of paper

was pasted across each crack (Fig. 5). The adhesive used was a type that is rigid when dry and thus does not yield under load. Consequently, a widening or extension of original cracking produced a tear in the paper.

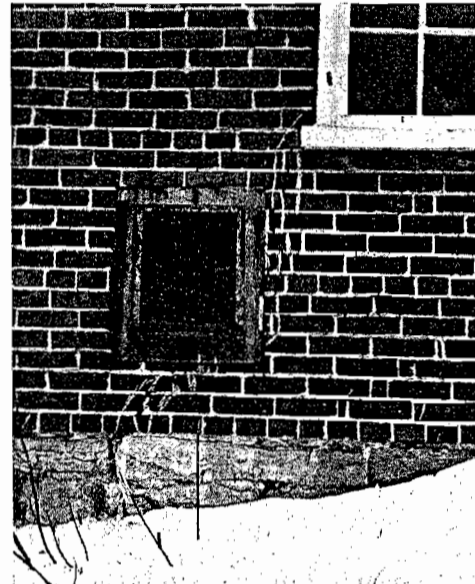
Fig. 6—Vertical crack due to settlement (school)

In general, the type of damage was found to be related to the soil condition. In the sand-clay, vertical cracks occurred which were associated with large settlement. Examples of this type of damage are shown in Figs. 6 and 7. In the till, damage was more often associated with horizontal cracking and shattering of the basement walls as exemplified by Figs. 8 and 9. It is interesting that chimneys are sometimes the first part of a

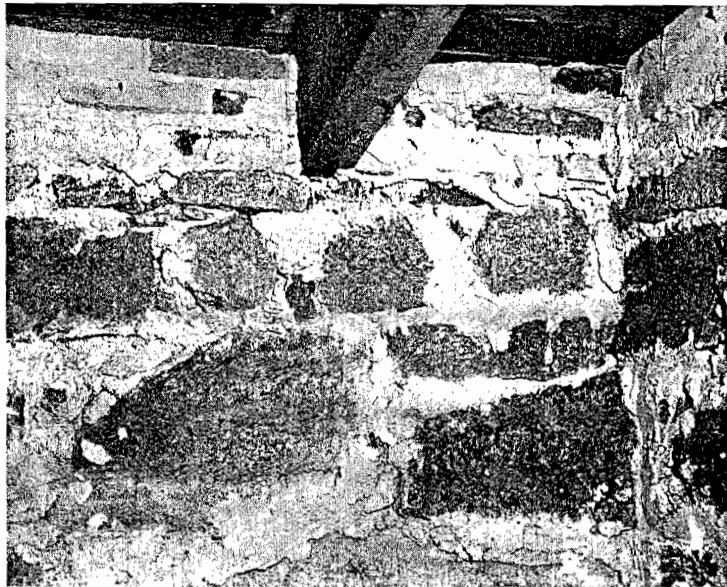
Fig. 8—Horizontal crack—building T

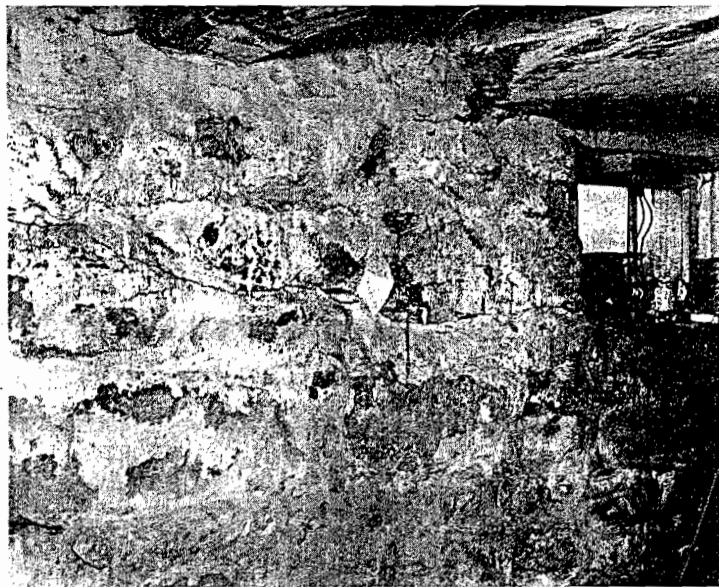
Fig. 9—Horizontal crack—building F

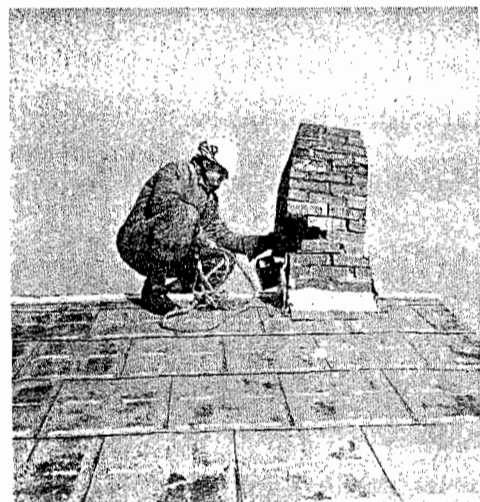
Fig. 10—Chimney damage—building R

building to show signs of weakness. Fig 10 shows an example that occurred at building R. It may be concluded that the damage in the buildings in sand-clay was caused by failure of the soil, i.e. settlement, under the buildings rather than by wave energy within the building proper.

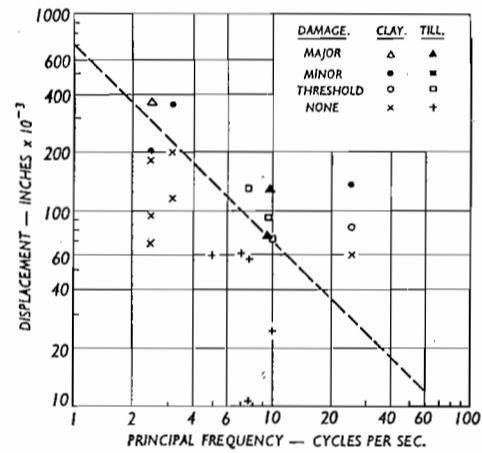
Fig. 13—Longitudinal displacement versus frequency and damage

Figs. 13 and 14 are scatter diagrams showing the relations between longitudinal and vertical displacements, frequency and damage. The results show considerable variation in damage threshold depending on the principal frequency. In fact the trend suggests that the threshold corresponds to a constant velocity. (The dashed lines in the figures represent a velocity of 4.5 in per second, a criterion that will be discussed later.) When the results are examined in detail, it is seen that a low-frequency group were all obtained in the sand-clay soils, whereas most of the higher-frequency values were obtained in the till soils. Thus there appears to be some correlation between the nature of the soil and the frequencies predominating on displacement records. It will be seen that it is not possible to assign a damage threshold in terms of displacement without some qualification regarding frequency.

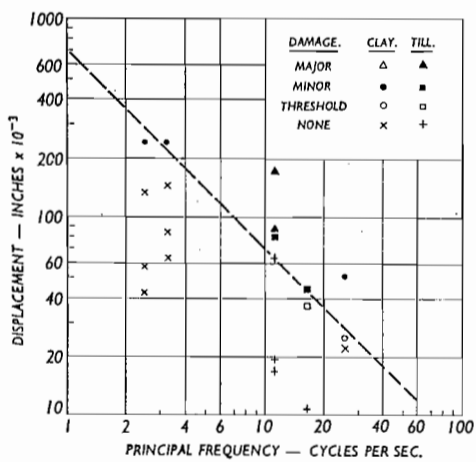
Fig. 14—Vertical displacement versus frequency and damage
