OFFICE OF SURFACE MINING
RECLAMATION AND ENFORCEMENT
TECHNICAL REPORT/1994

**INVESTIGATION OF DAMAGE TO STRUCTURES
IN THE McCUTCHANVILLE-DAYLIGHT
AREA OF SOUTHWESTERN INDIANA**

Volume 1 of 3
Part I: Composite Report

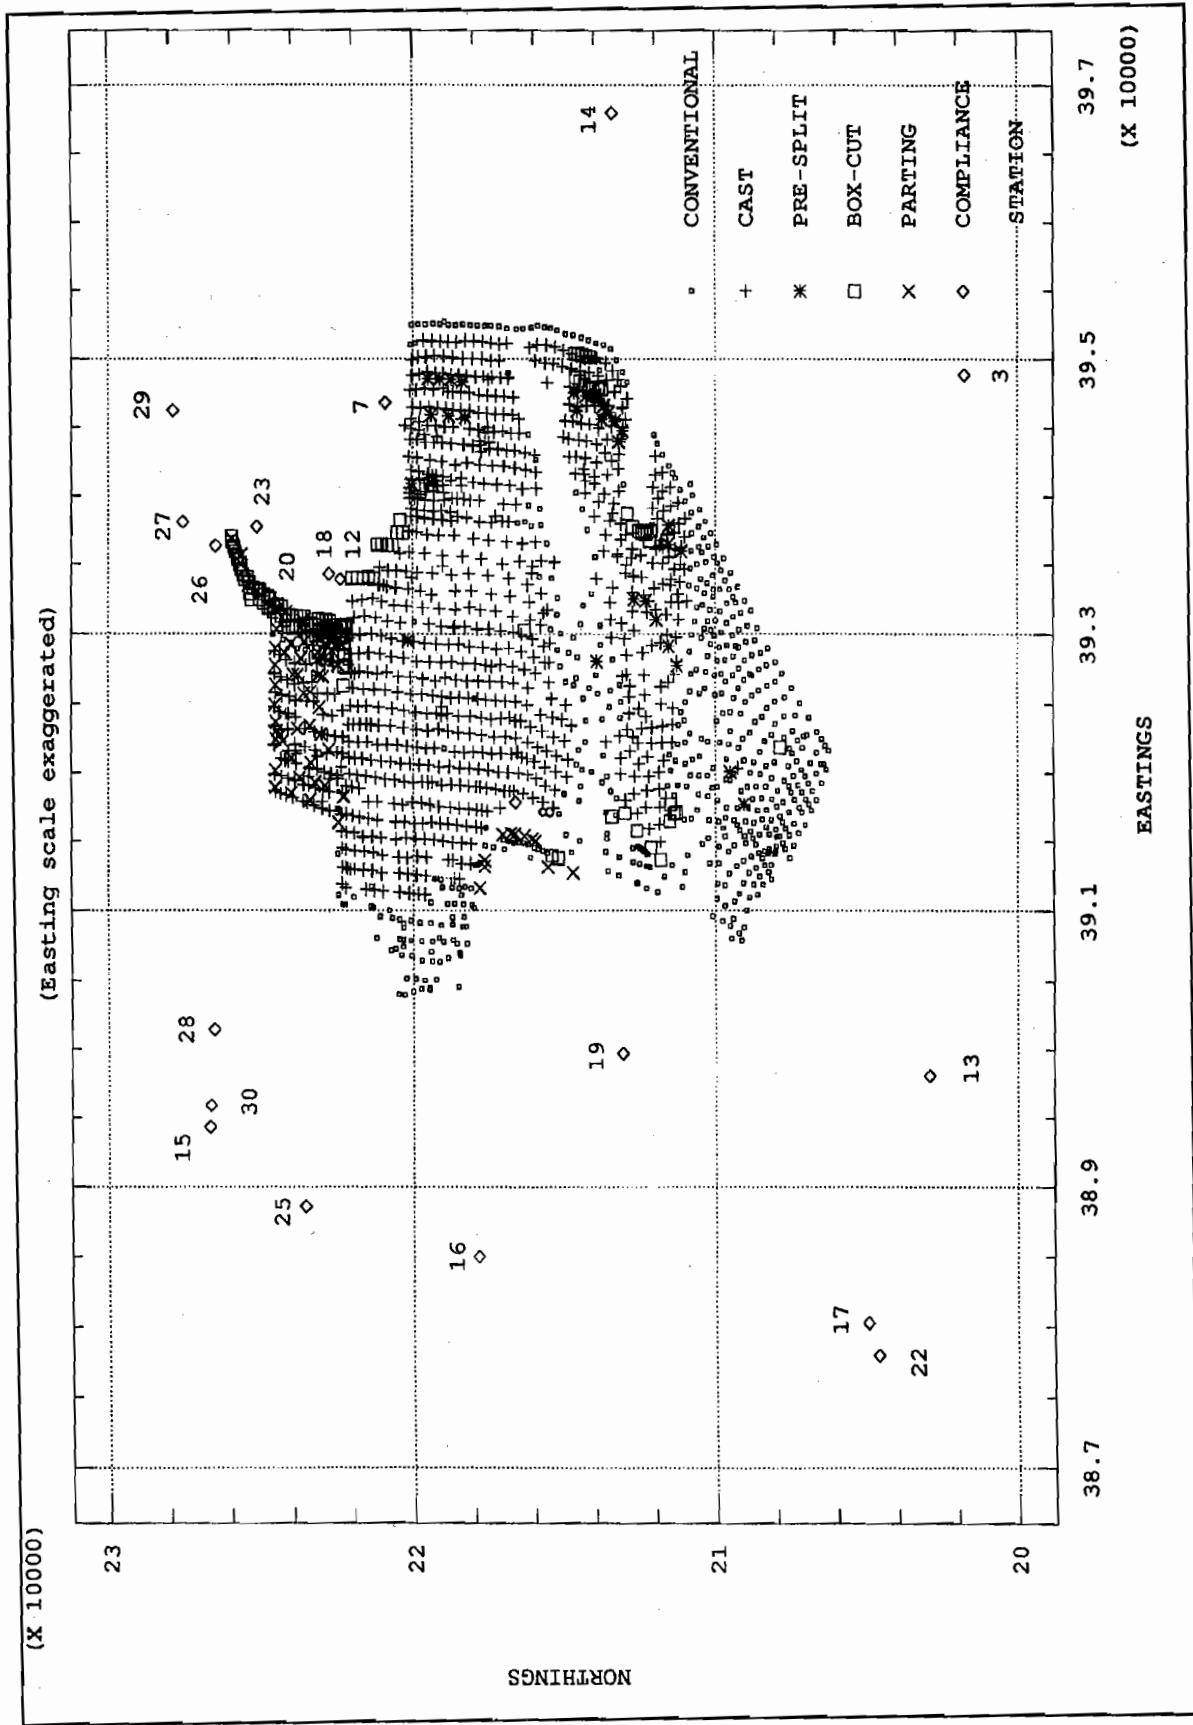
Figure 2. Blast location by pattern series. From Part III, Figure 10.

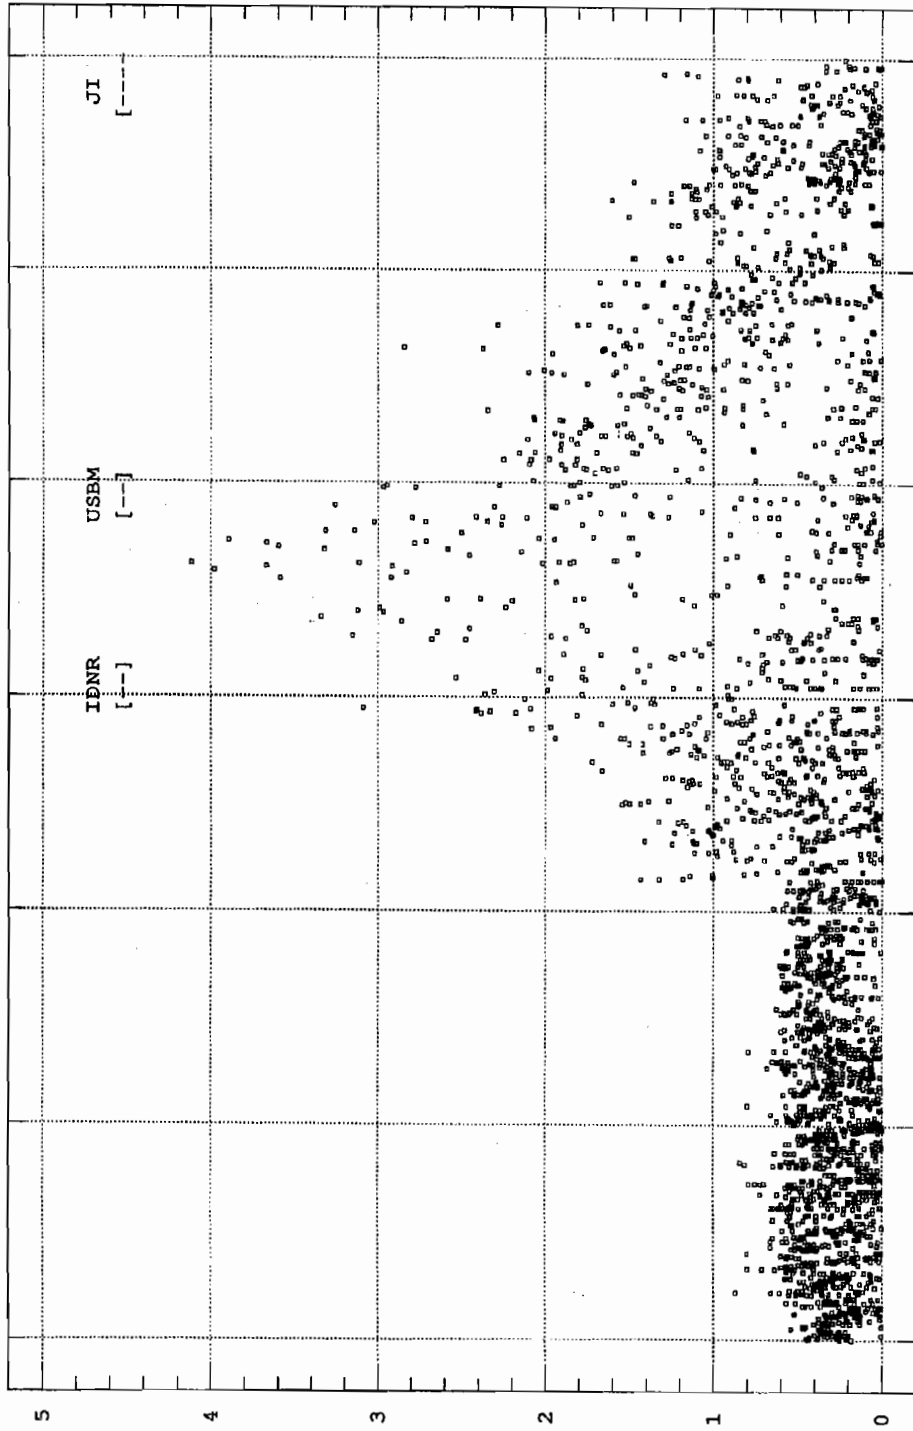
Figure 3. Ayrshire mine total weight of explosives per blast 1986 through 1991. From Part III, Figure 4.

Total pounds did not exceed 100,000 lbs in 1986 and 1987 (Figure 3). In March 1988, with the advent of cast blasting, the range of total pounds began increasing and ultimately peaked in 1989, with a maximum of 411,688 lbs. The same trend applies to pounds per delay, which rarely exceeded 2,000 lbs in 1986 and 1987 and peaked at 8,500 lbs in 1989 (Figure 4). Although cast blasting continued to occur through the period of this study, both total pounds and pounds per delay steadily declined. The peak values fall between the monitoring periods of the IDNR study and the USBM Part IV investigation. The maximum total pounds and pounds per delay covered by these monitoring periods were significantly greater than those covered by the JI monitoring period.

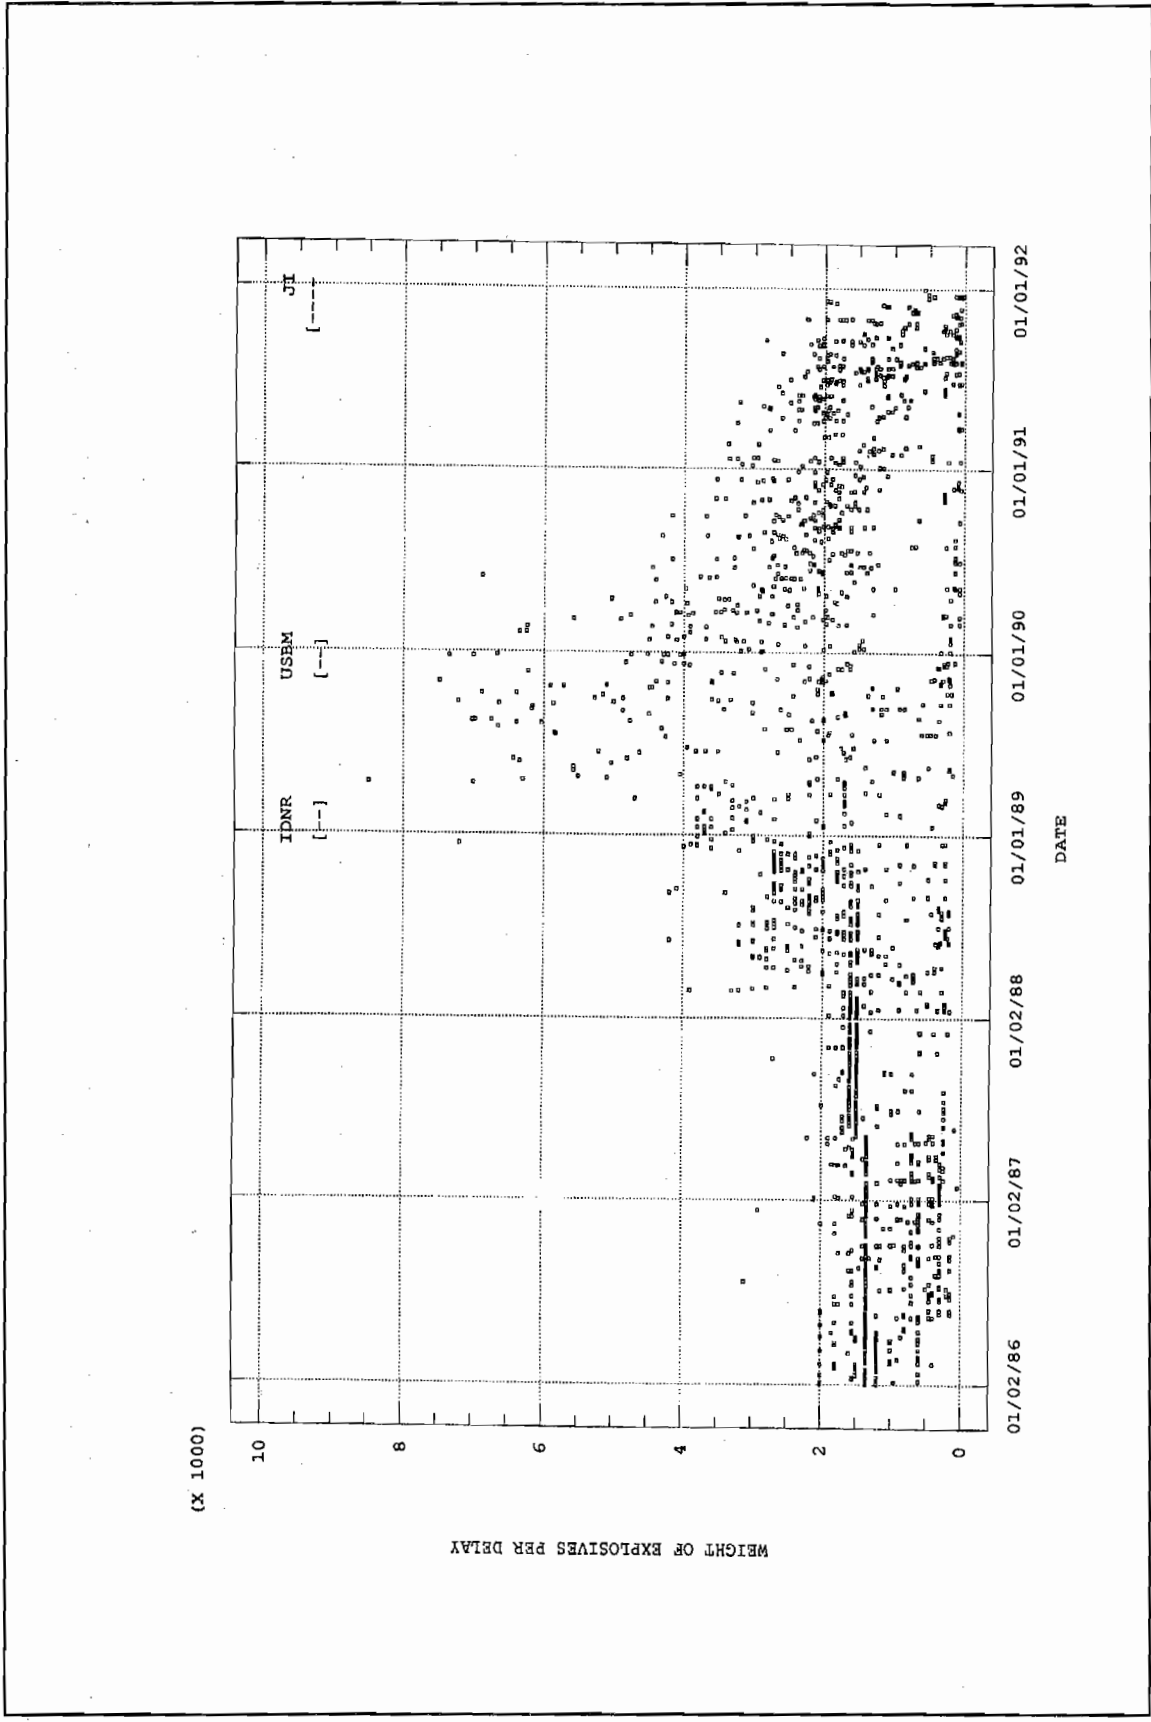
Figure 4. Ayrshire mine weight of explosives per delay per blast 1986 through 1991. From Part III, Figure 5.

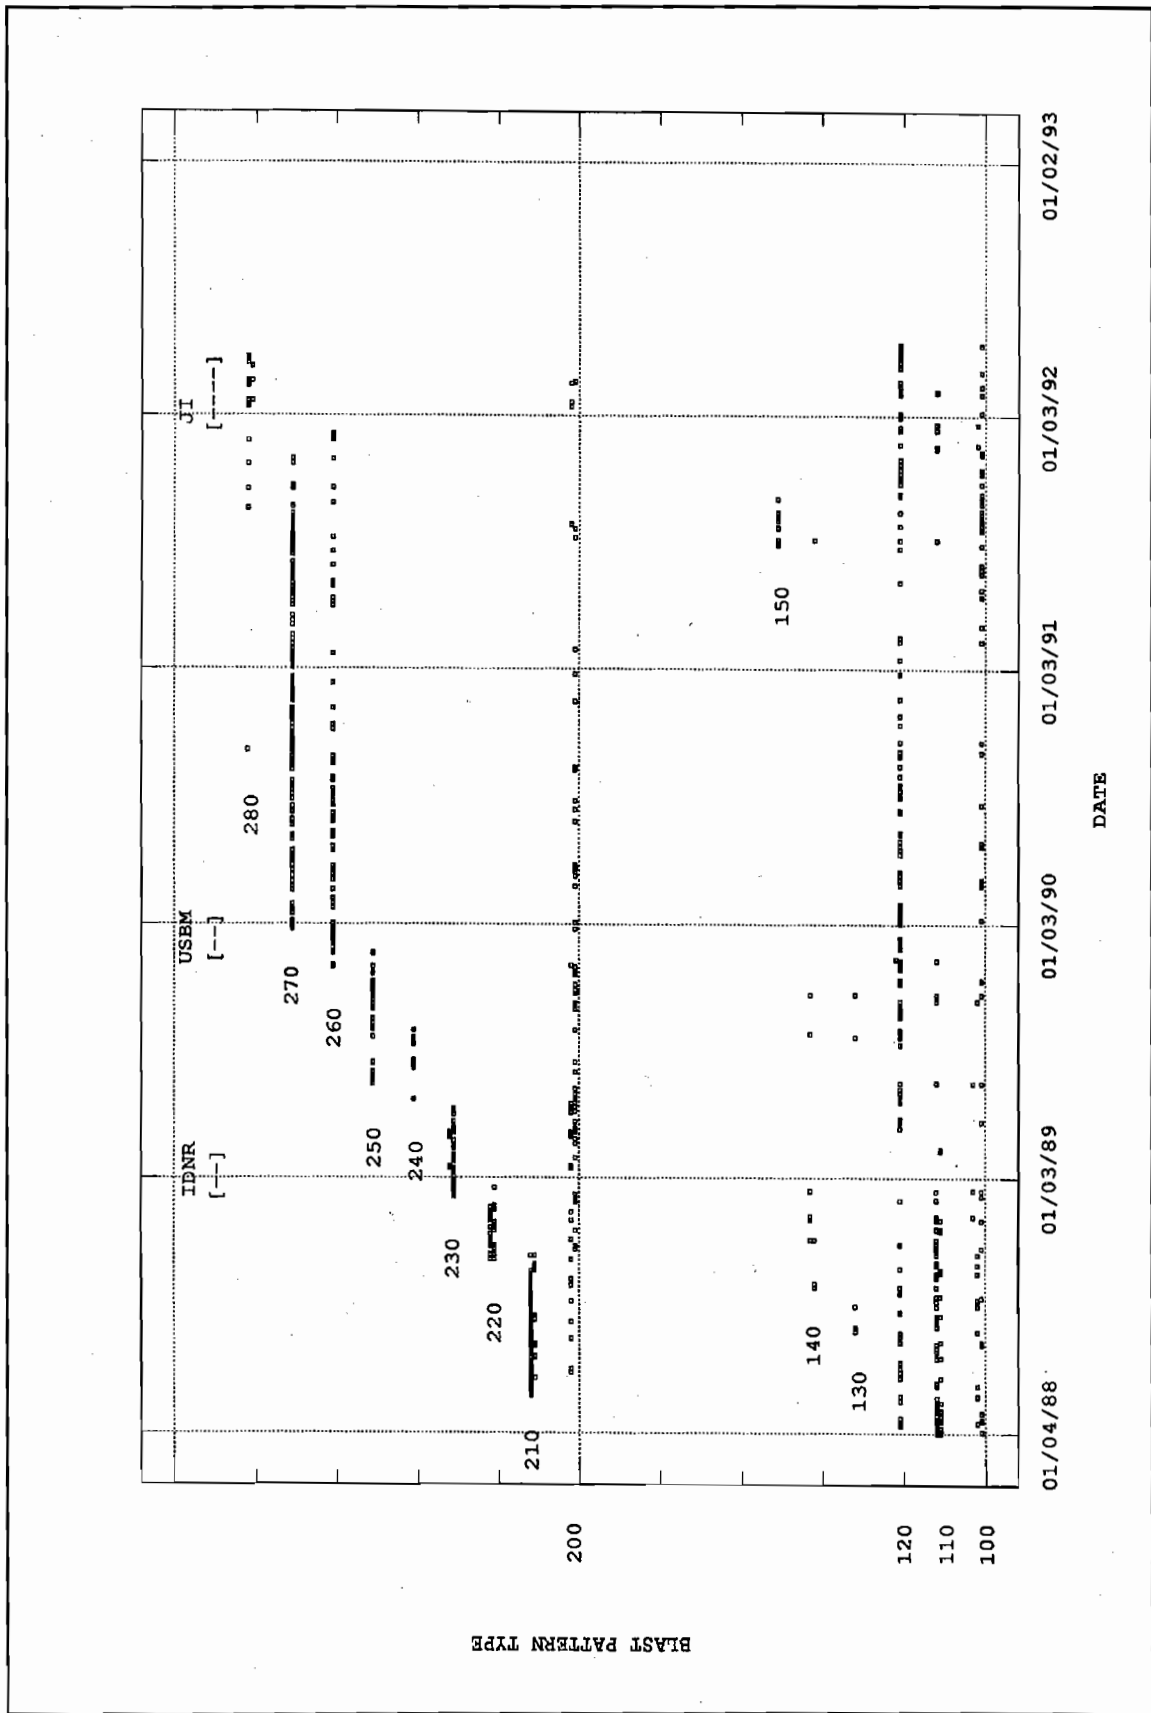
Figure 5. Time distribution of 100 and 200 blast patterns, January 1988 through April 1992. From Part III, Figure 16.

A few conventional blast patterns were frequently used from the beginning of 1988 to the early months of 1992 (Figure 5). The occurrences of five cast

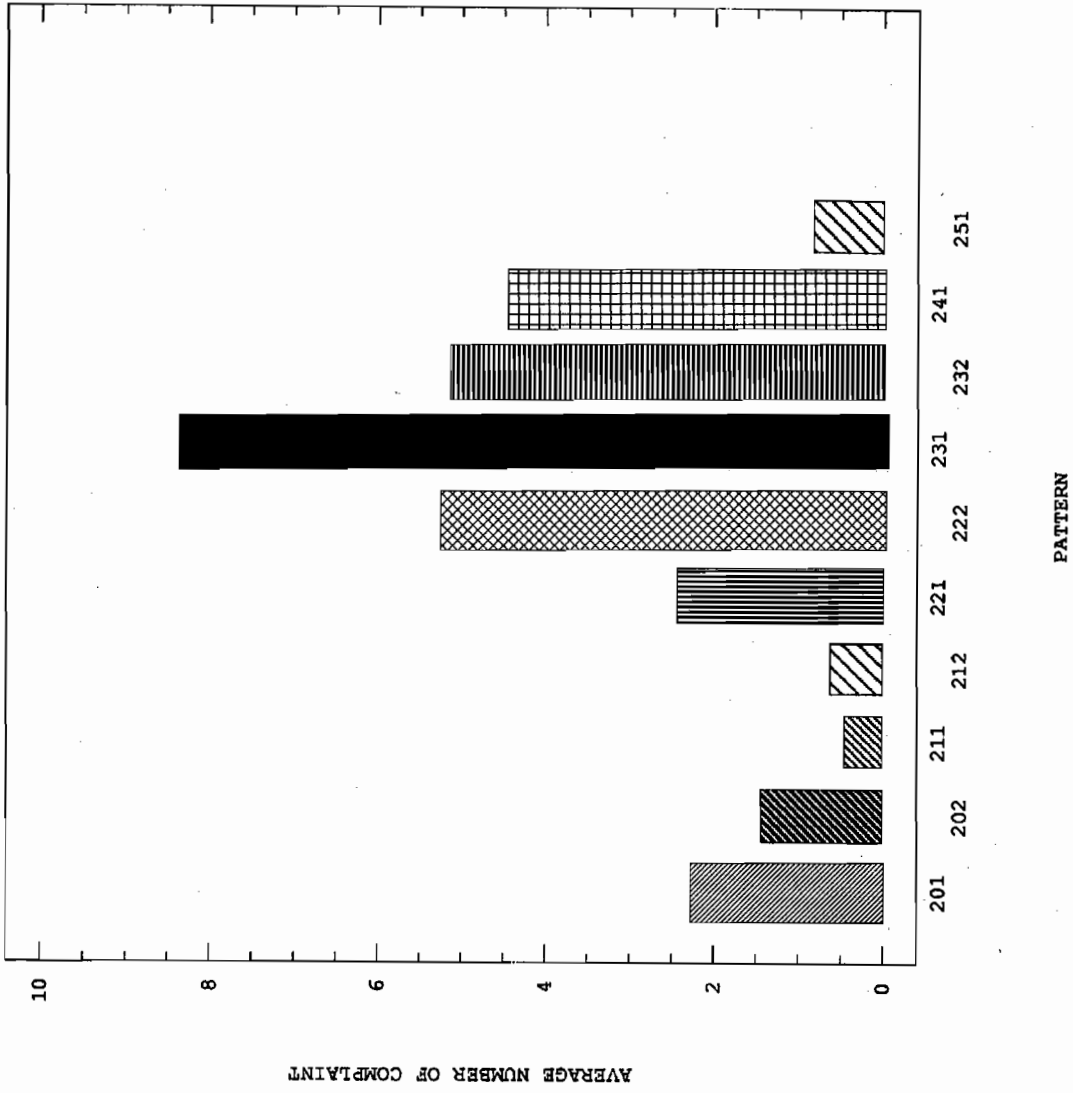
Figure 6. Average complaints per cast blast pattern. From Part III, Figure 15.

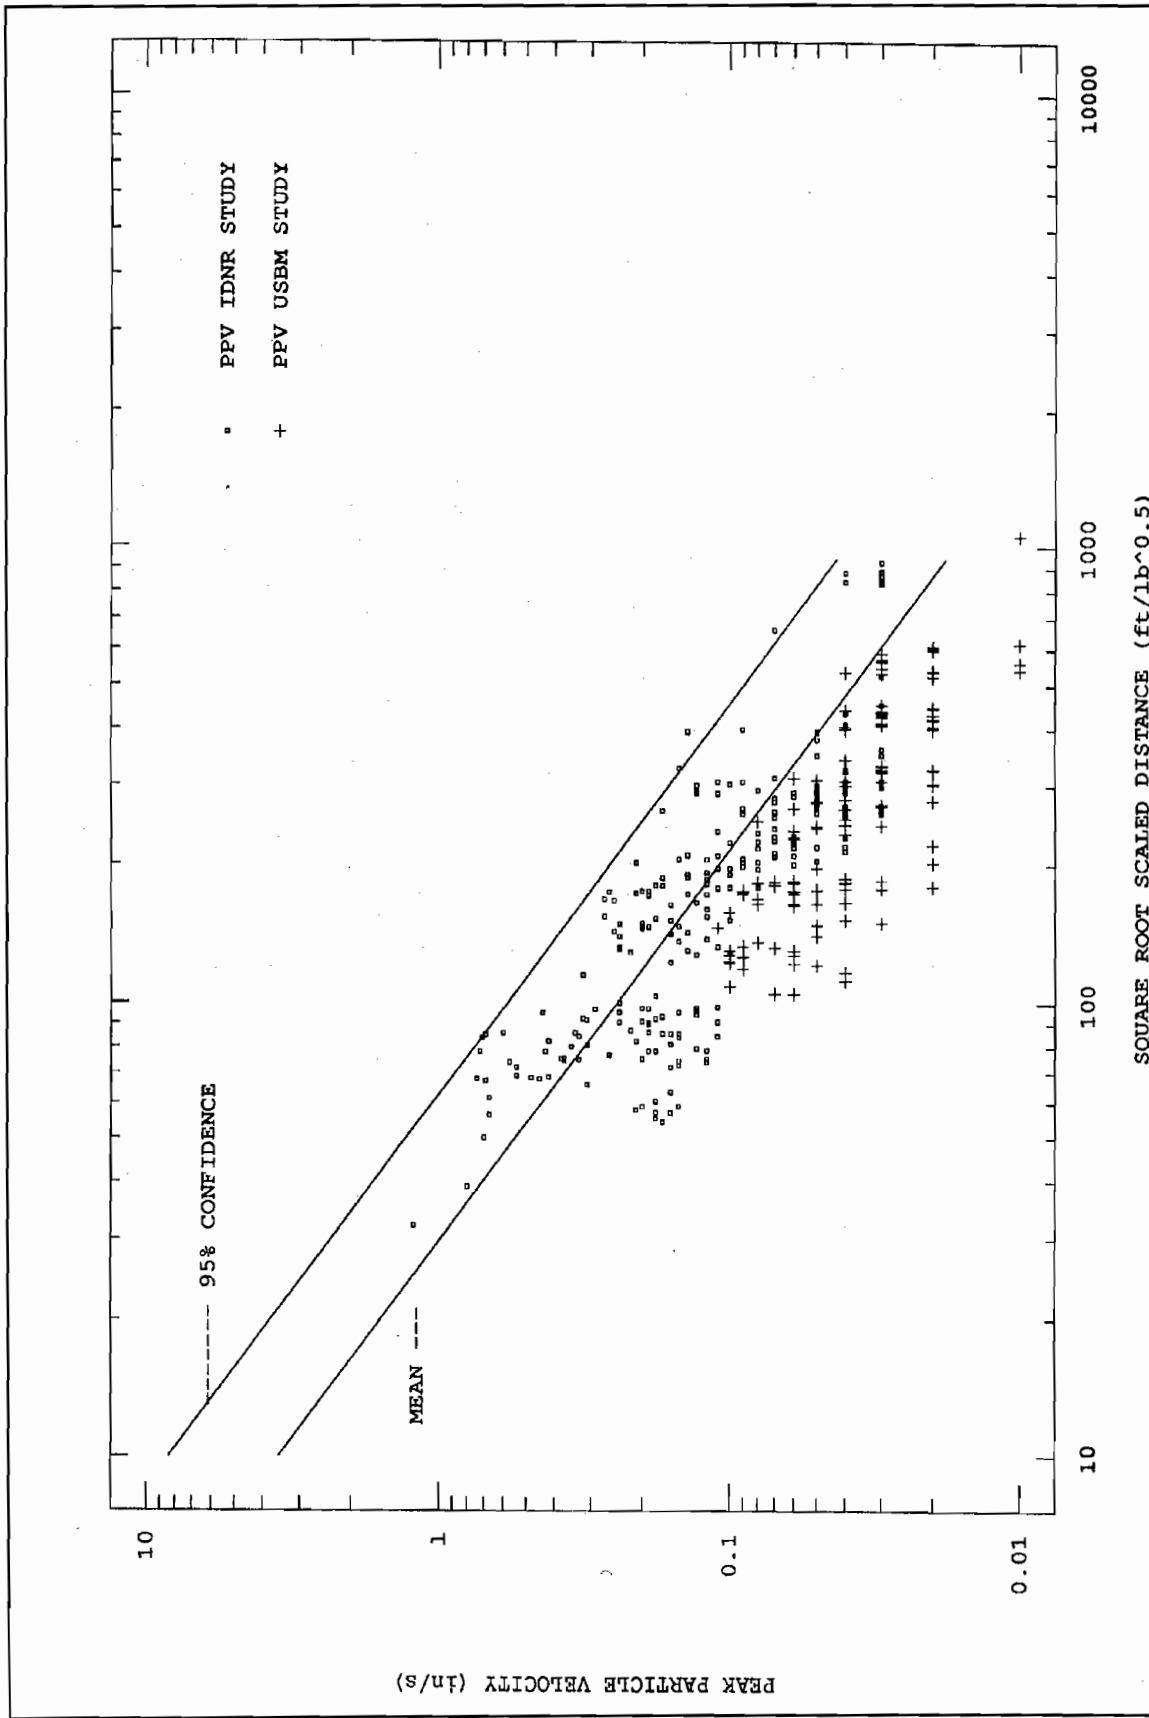
Figure 7. 1989 IDNR study regression lines (cast blasts) with IDNR and USBM peak particle velocity data. From Part III, Figure 18.

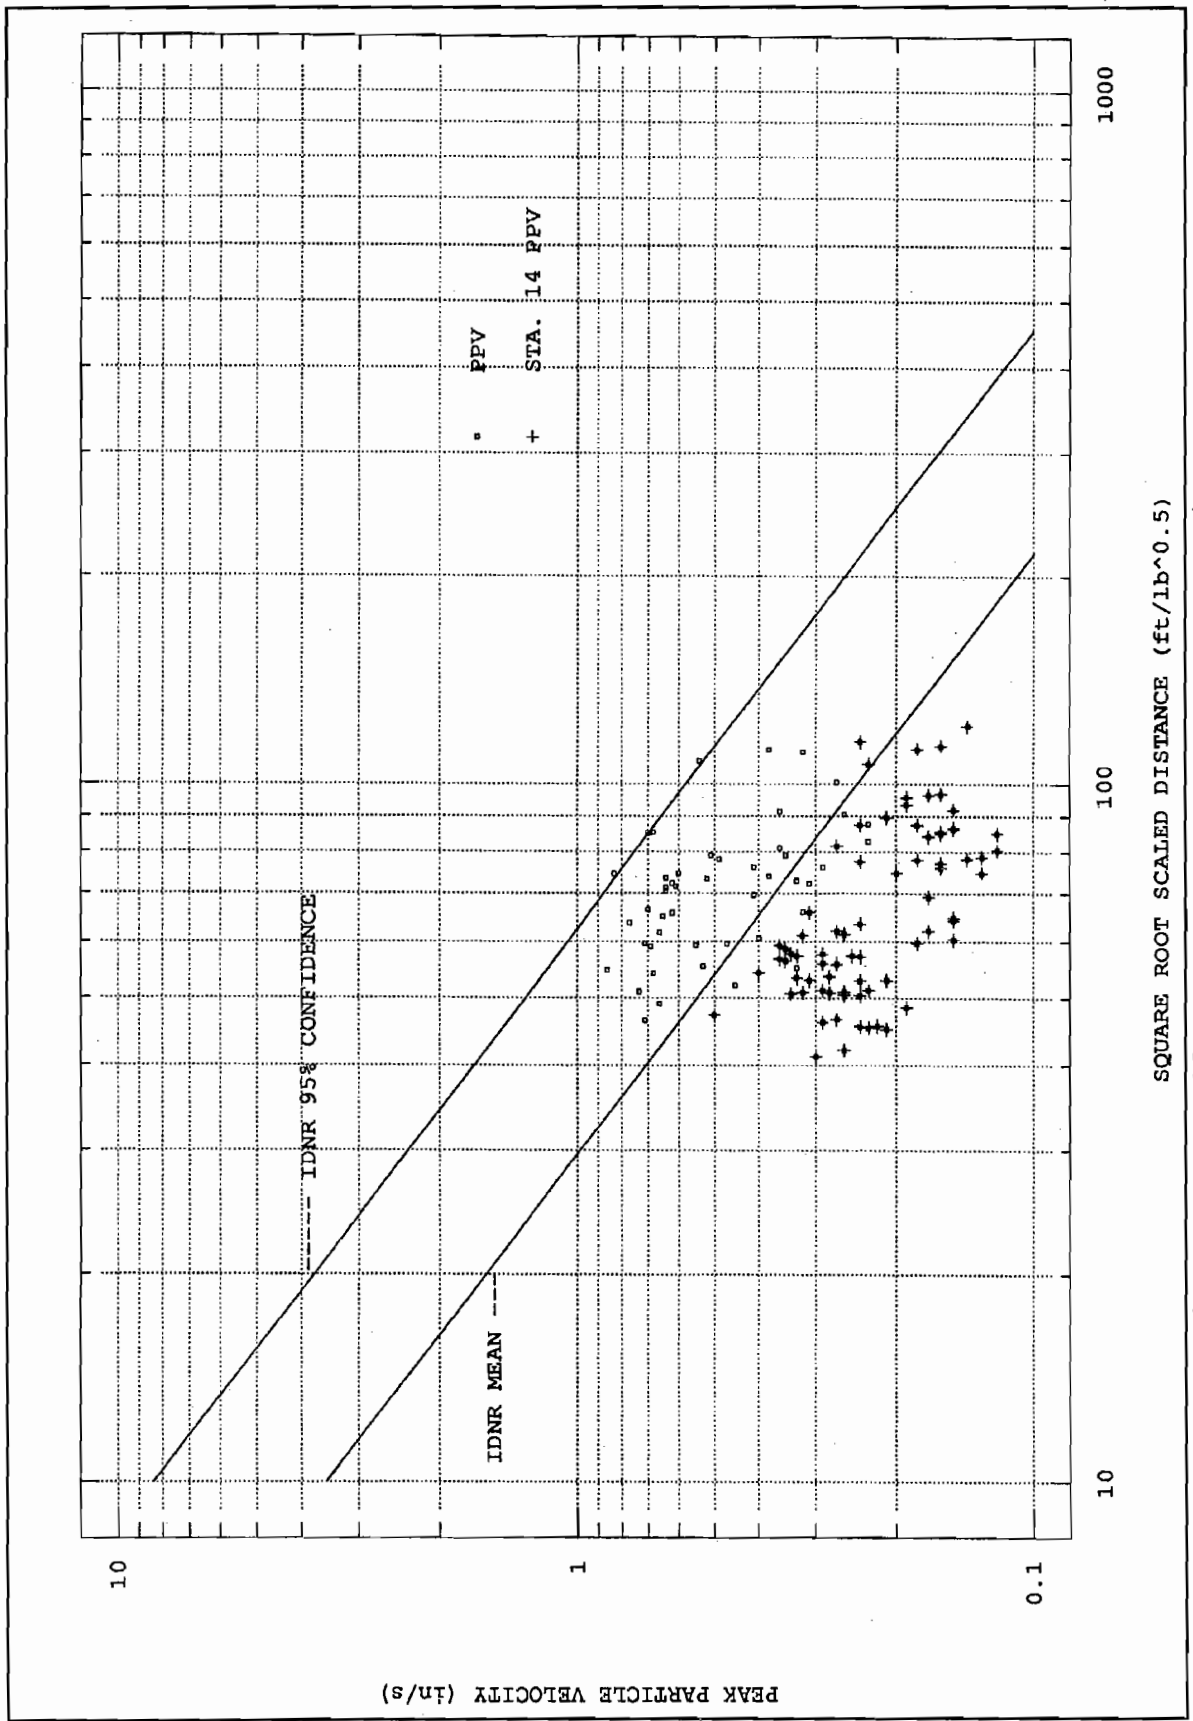
Figure 8. Compliance station data, cast blast pattern 210. From Part III, Figure 28.

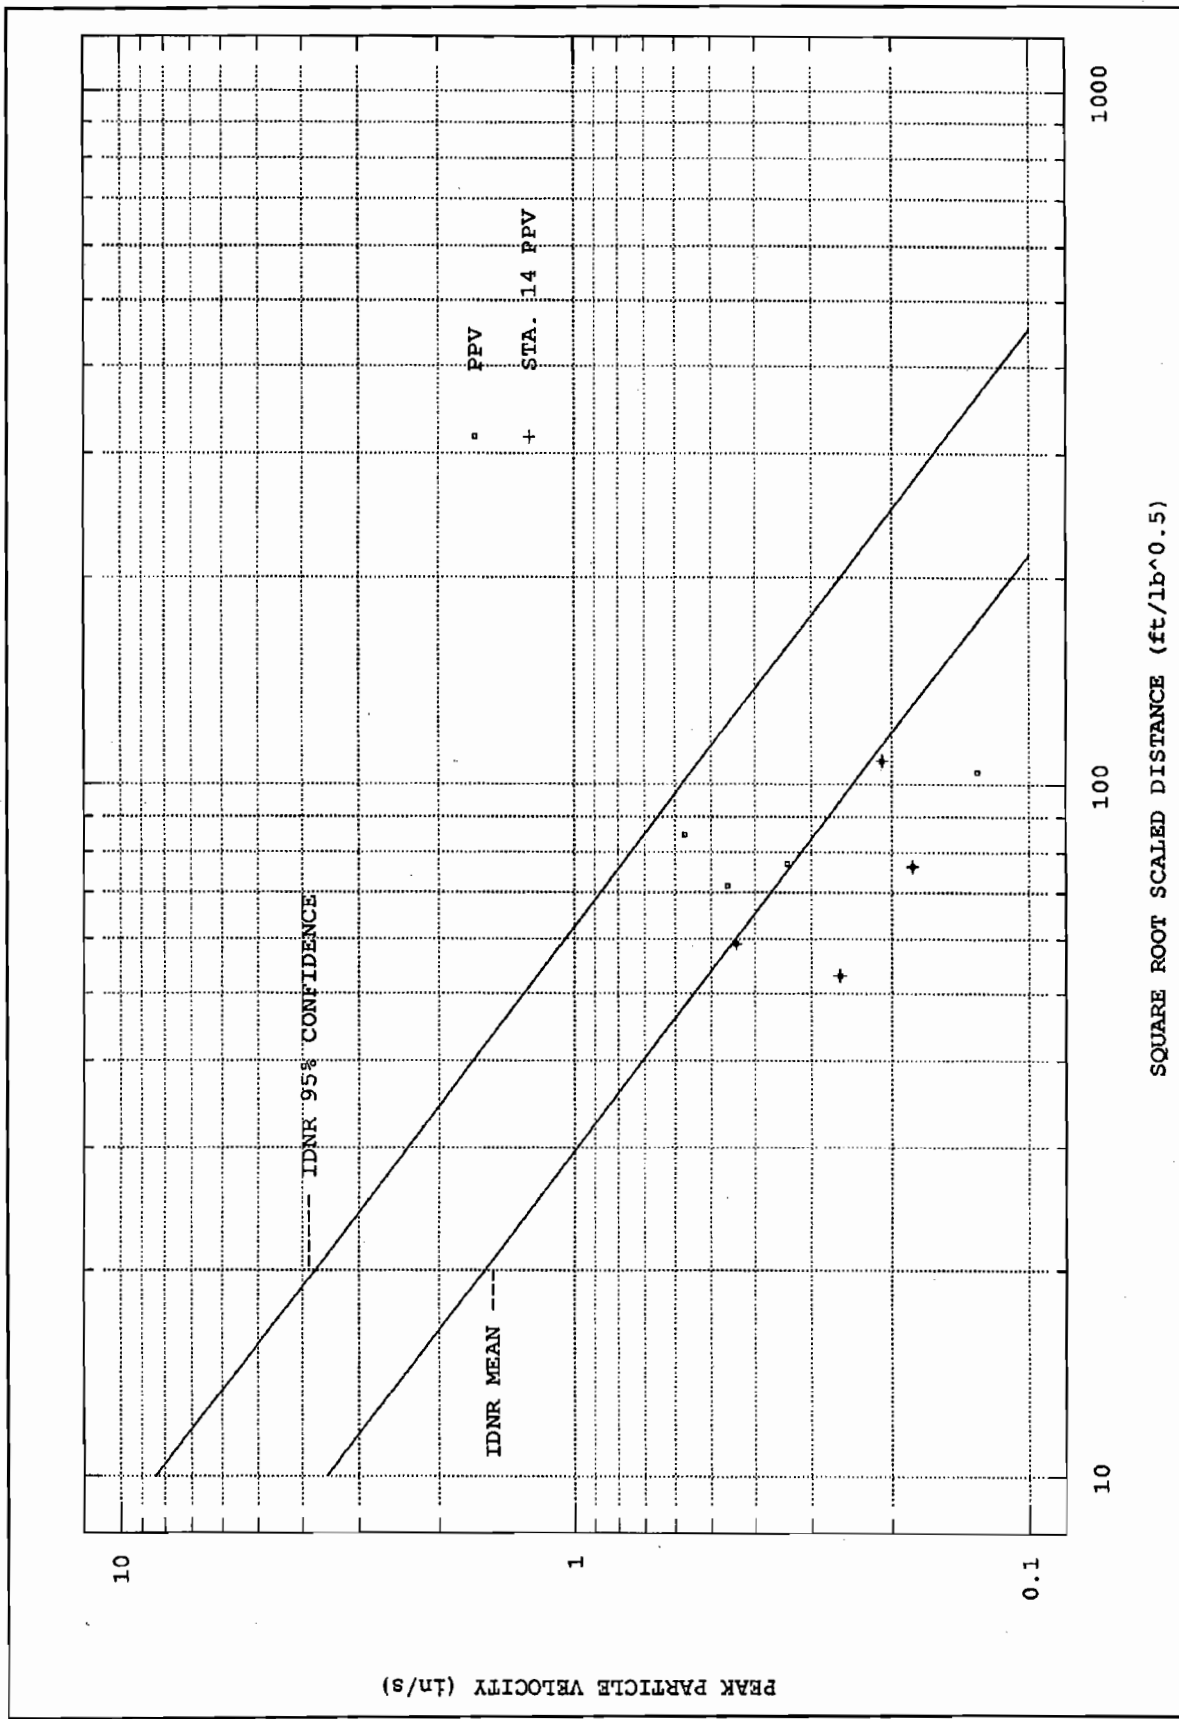
Figure 9. Compliance station data, cast blast pattern 240. From Part III, Figure 31.

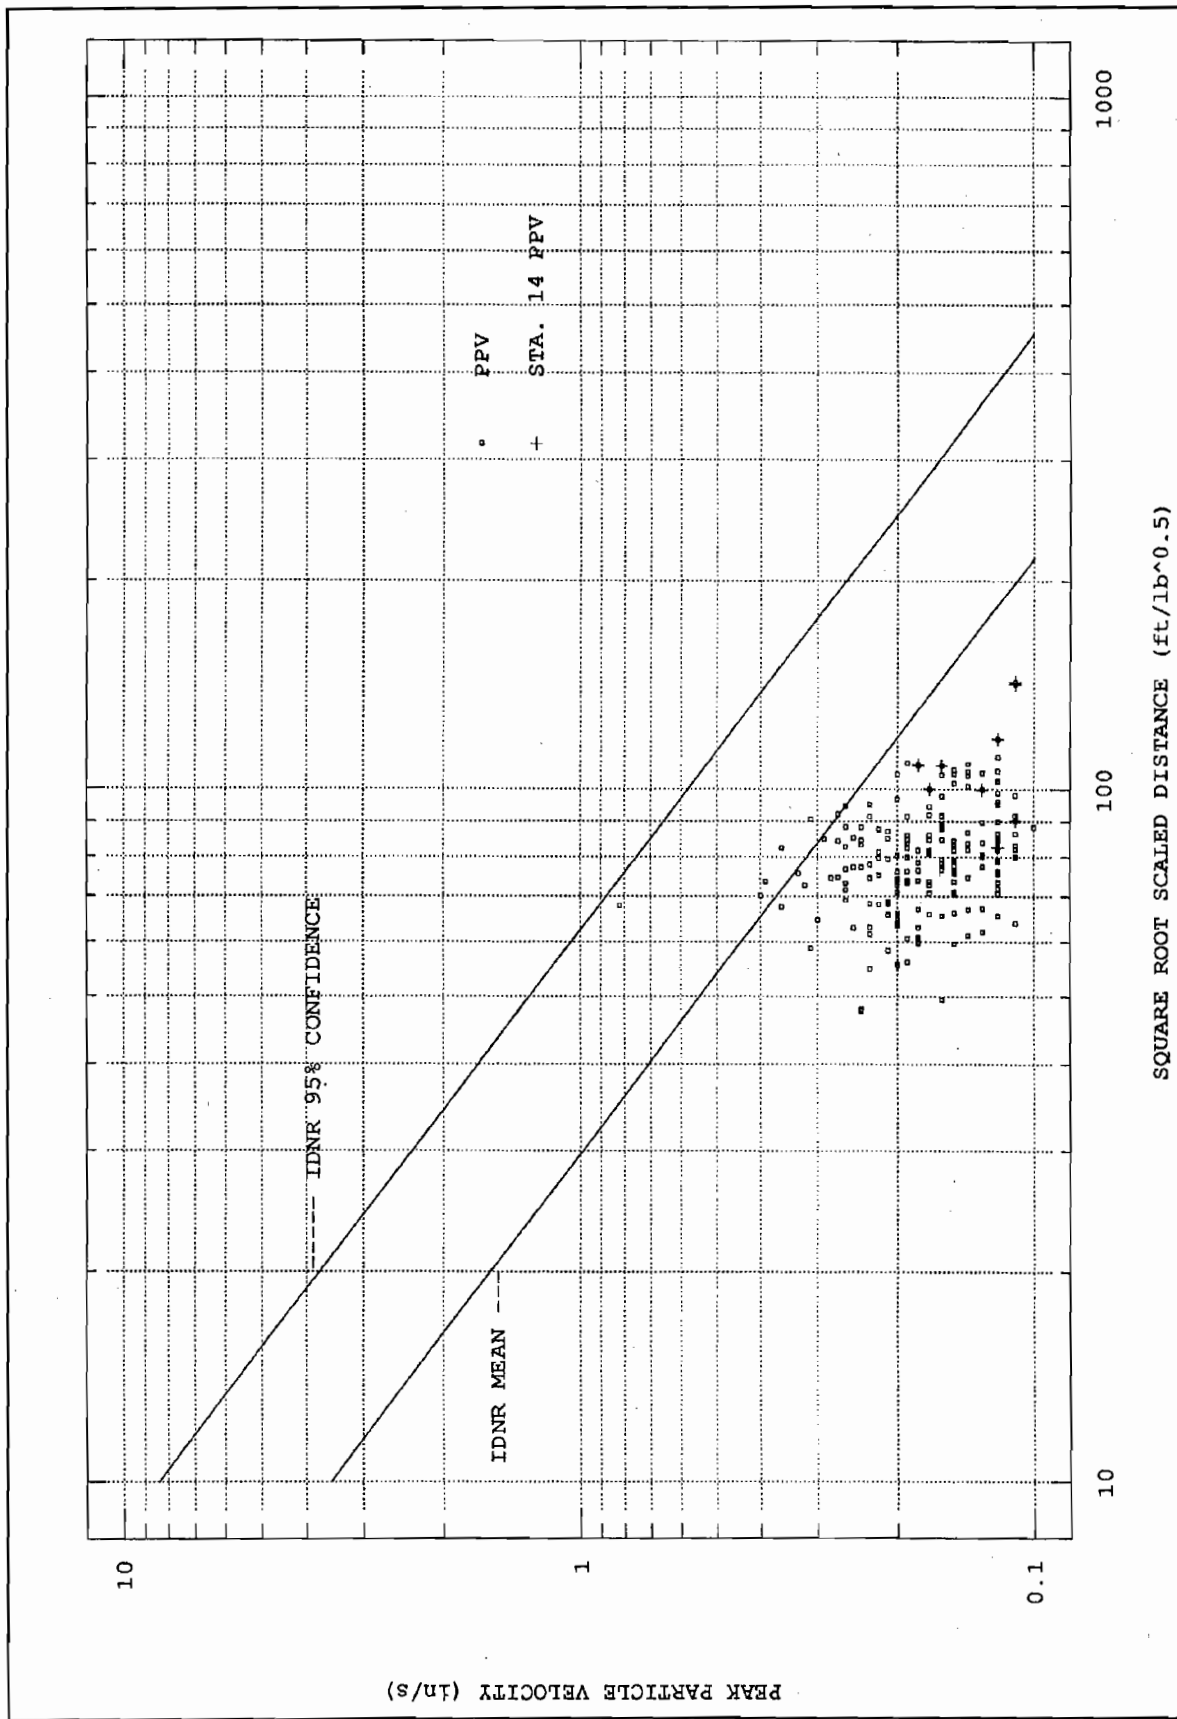
Figure 10. Compliance station data, cast blast pattern 270. From Part III, Figure 34.

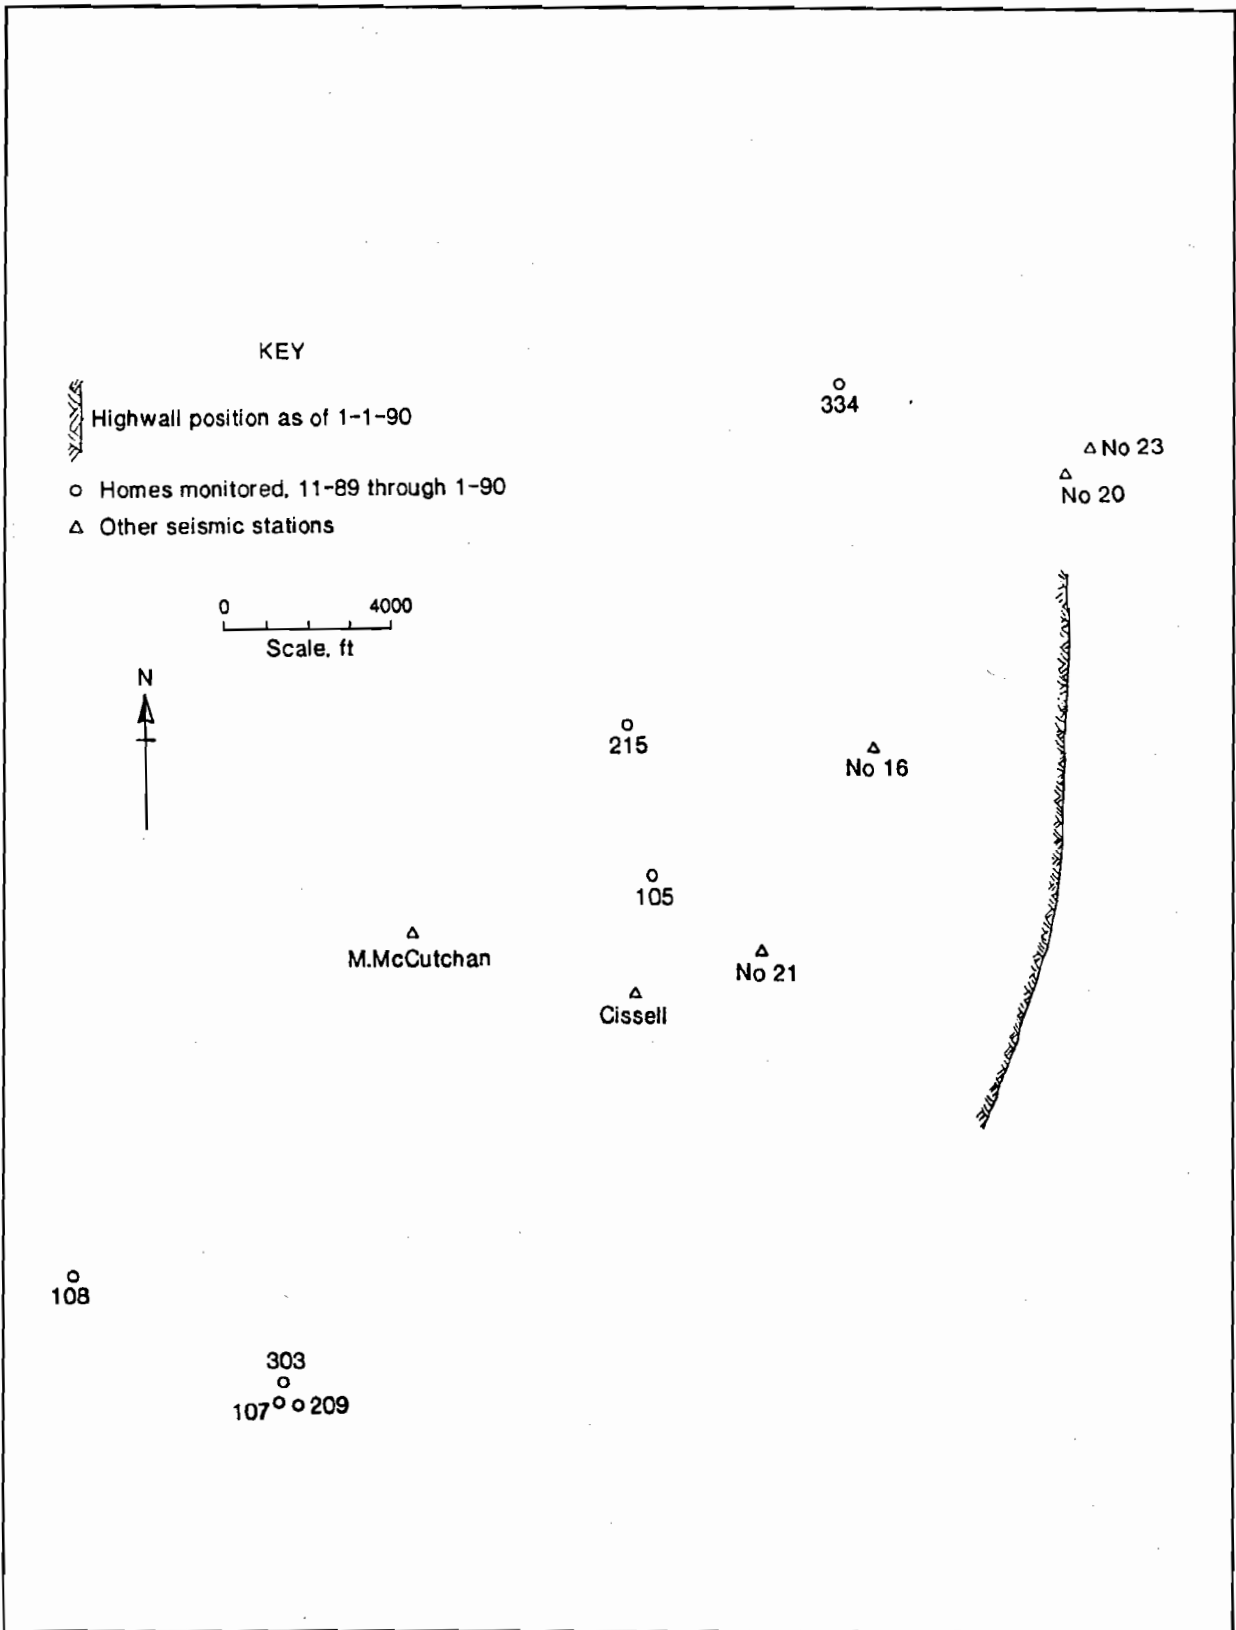
Figure 11. Monitored homes and additional seismic stations west of the Ayrshire mine highwall. From Part IV, Figure 3.

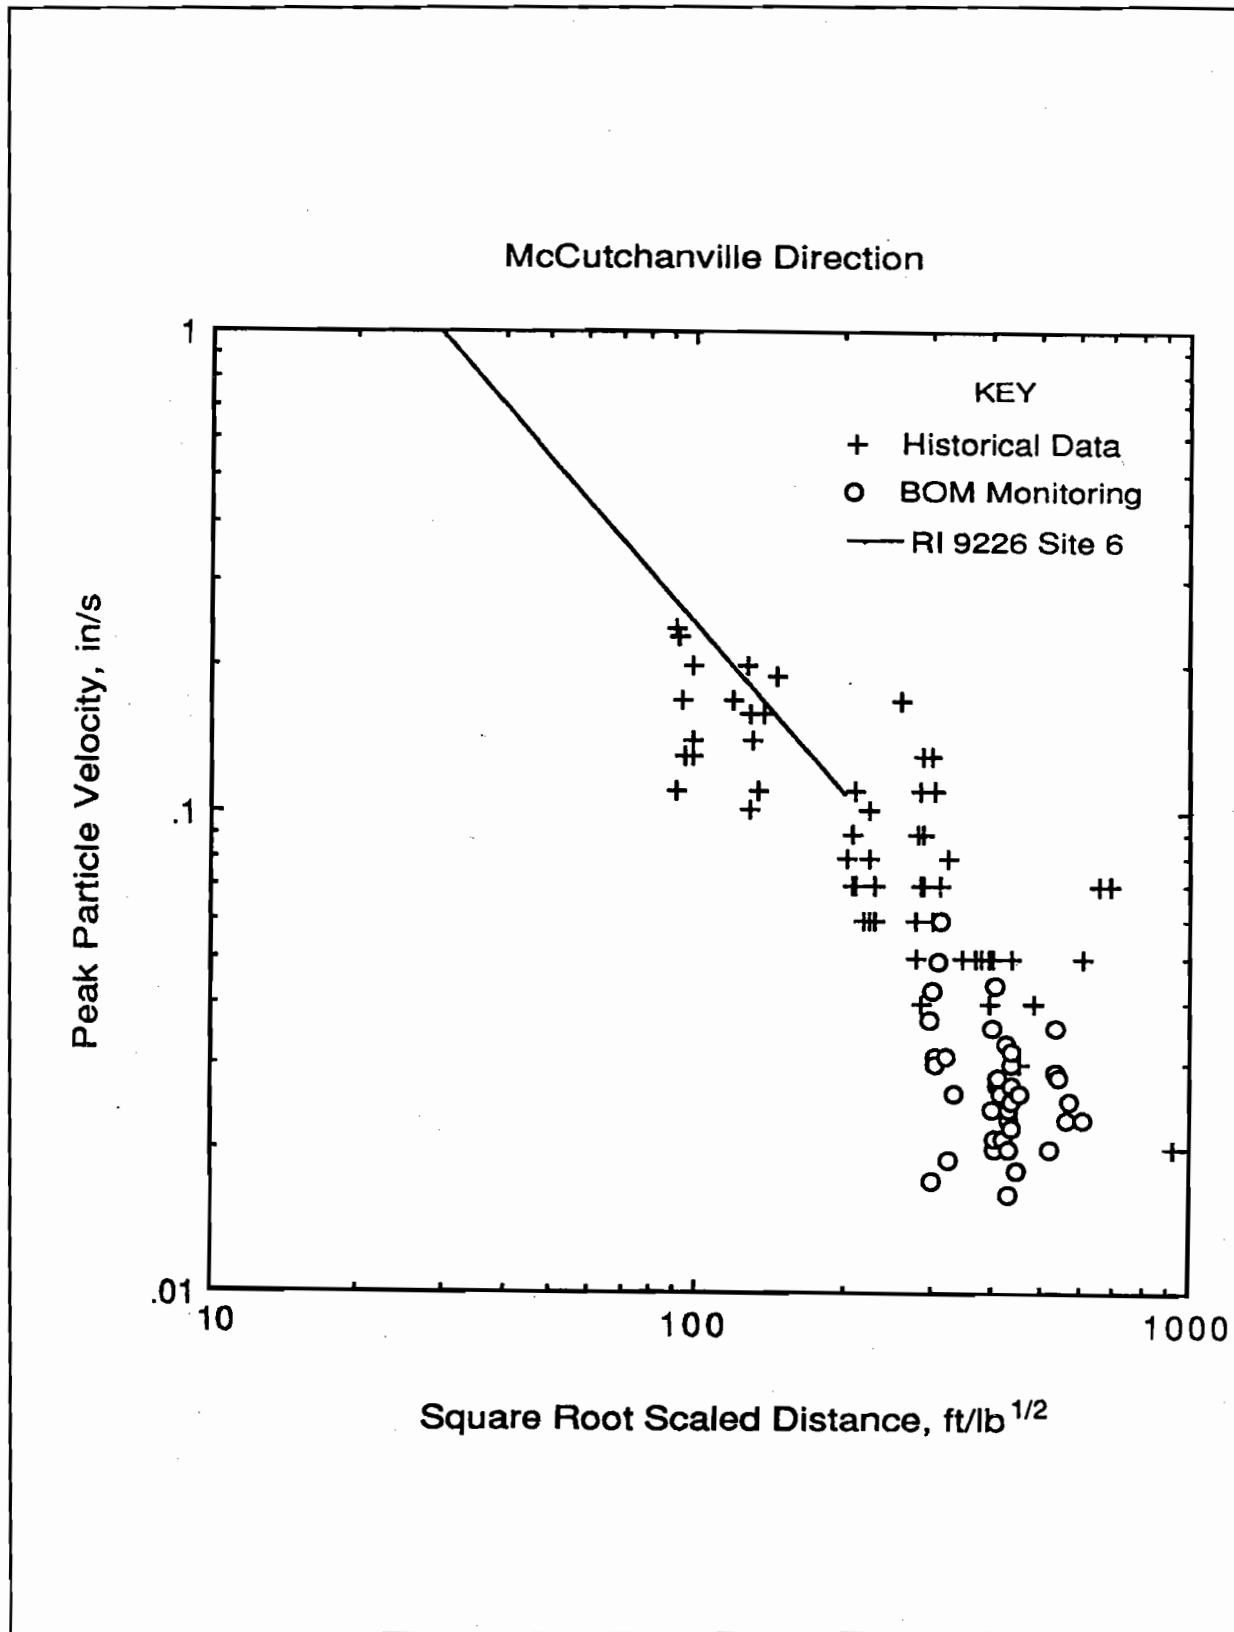
Figure 12. Historical and recent Bureau of Mines (BOM) peak particle velocity data in the McCutchanville (southwest) direction. From Part IV, Figure 16.

The USBM data showed consistently lower PPVs in both directions compared to the IDNR data at similar scaled distances.
