OFFICE OF SURFACE MINING
RECLAMATION AND ENFORCEMENT
TECHNICAL REPORT/1994

**INVESTIGATION OF DAMAGE TO STRUCTURES
IN THE McCUTCHANVILLE-DAYLIGHT
AREA OF SOUTHWESTERN INDIANA**

Volume 1 of 3
Part I: Composite Report

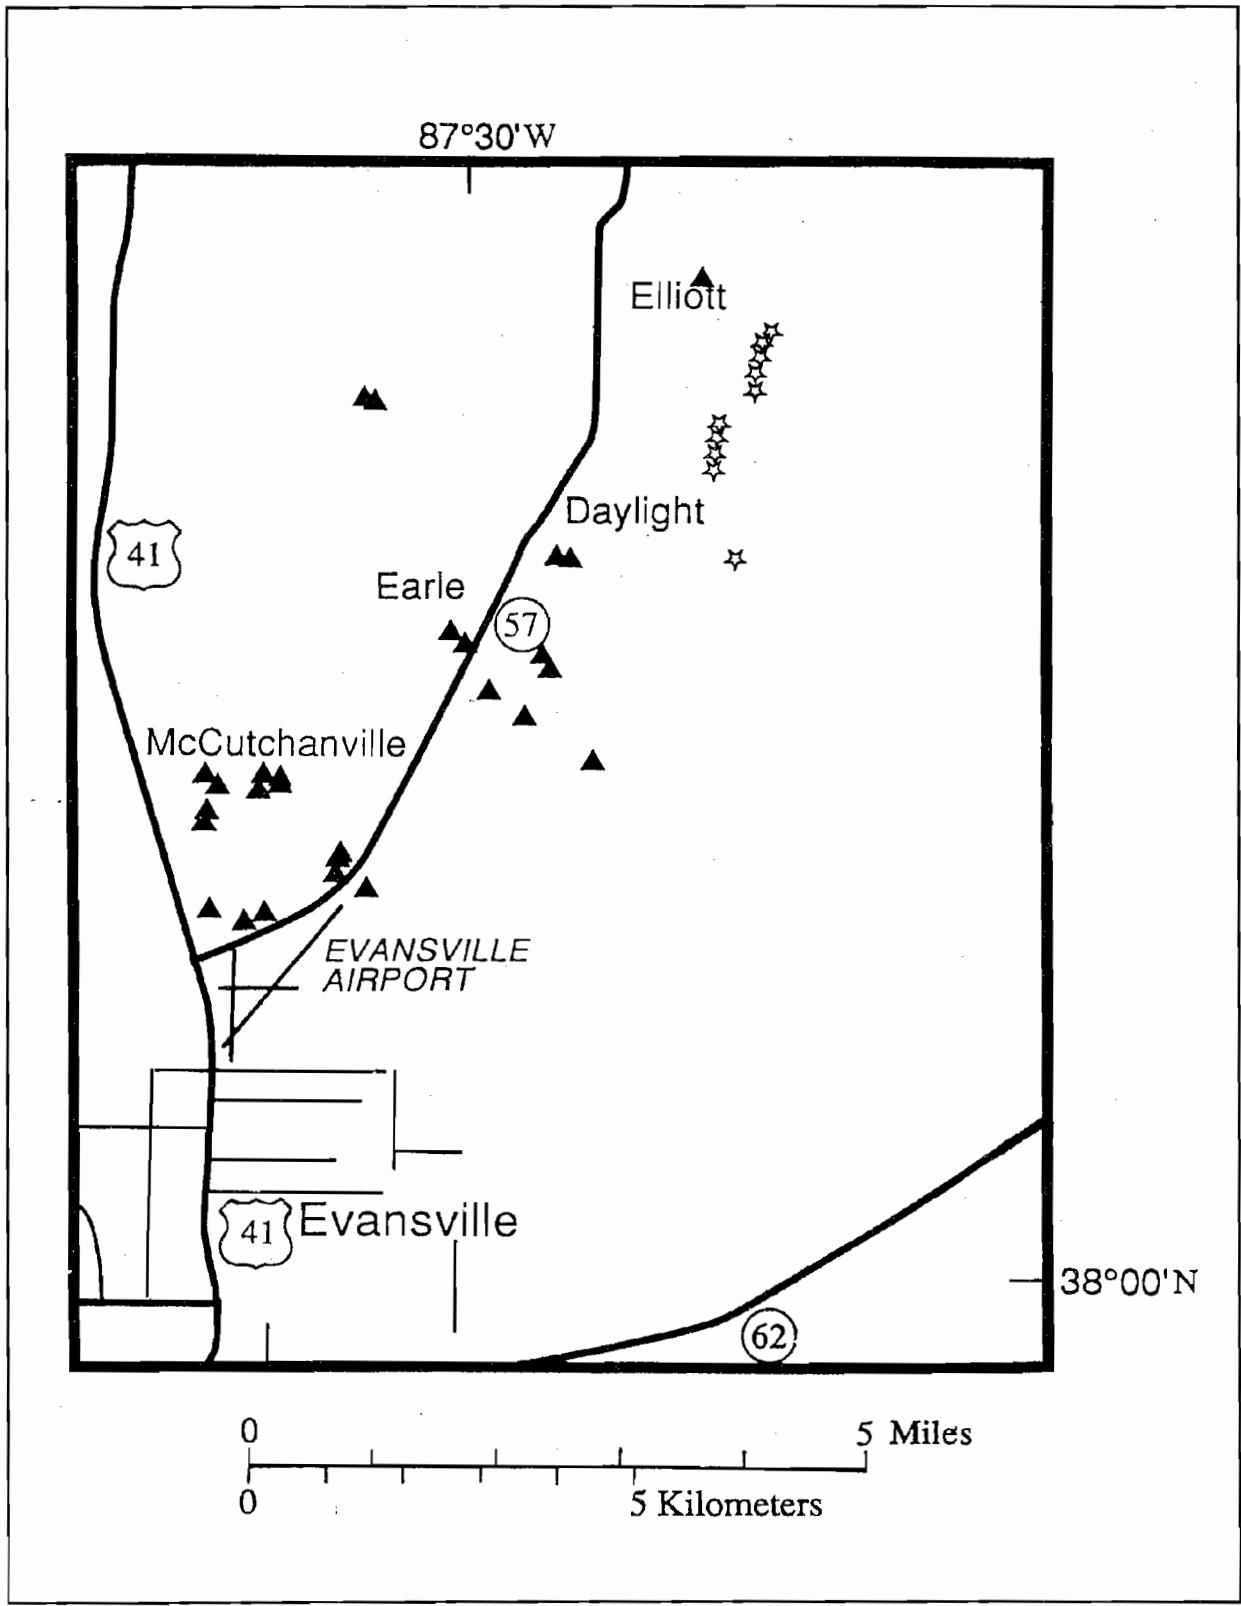
Figure 13. Locations of the mine blasts are denoted by open stars, locations of seismic recording sites are denoted by solid triangles. From Part VI, Figure 11.

USGS studied specific geologic, topographic, and soil effects on blast-induced ground vibrations. This included: (1) determining the attenuation (reduction in amplitude) of ground vibrations propagating in bedrock; (2) evaluating potential topographic enhancement effects by comparing vibrations recorded in upper and lower parts of the topography; (3) comparing ground vibrations of bedrock sites and soil sites to determine the effects of soils (or "site response" effects); (4) downhole geophysical testing; and (5) comparing ground vibrations among different soil sites. Ground vibrations from mine blasts were recorded at a total of 24 locations (Figure 13).

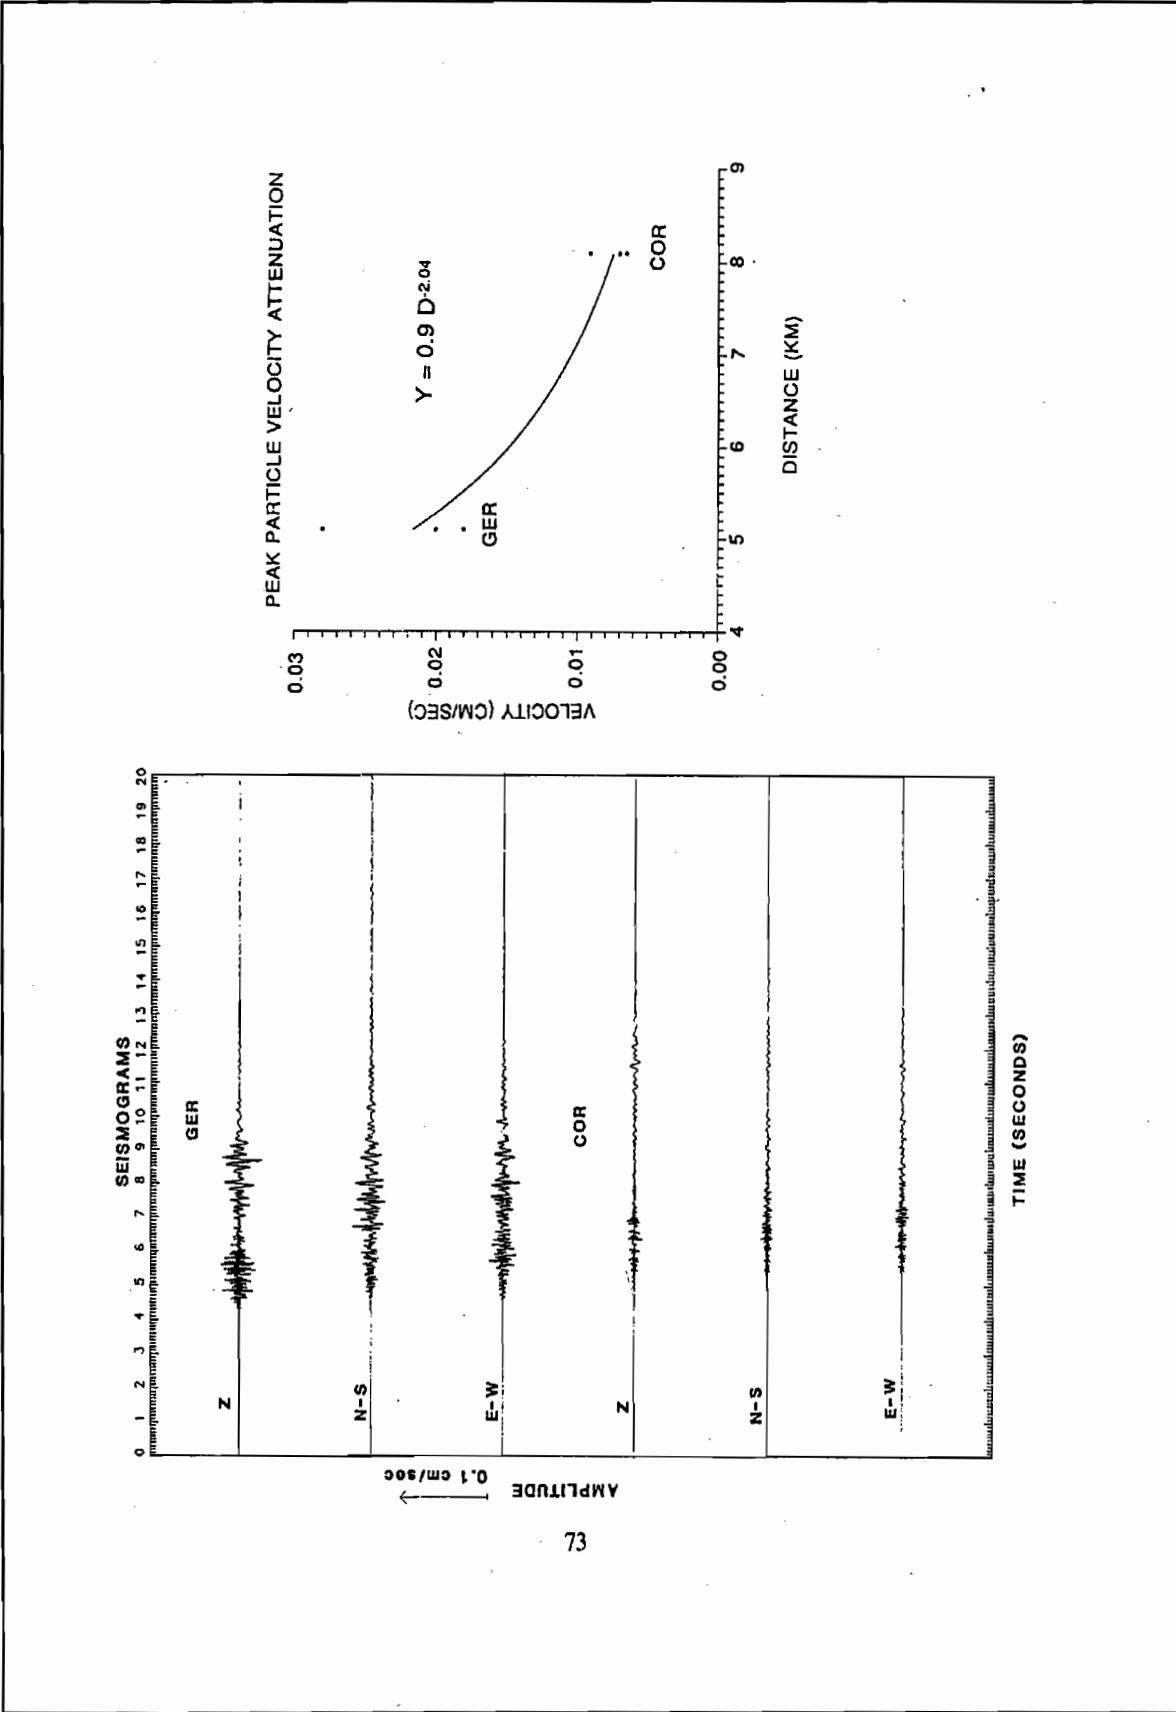
Figure 14. Seismograms and graph showing ground motion attenuation. From Part VI, Figure 13.

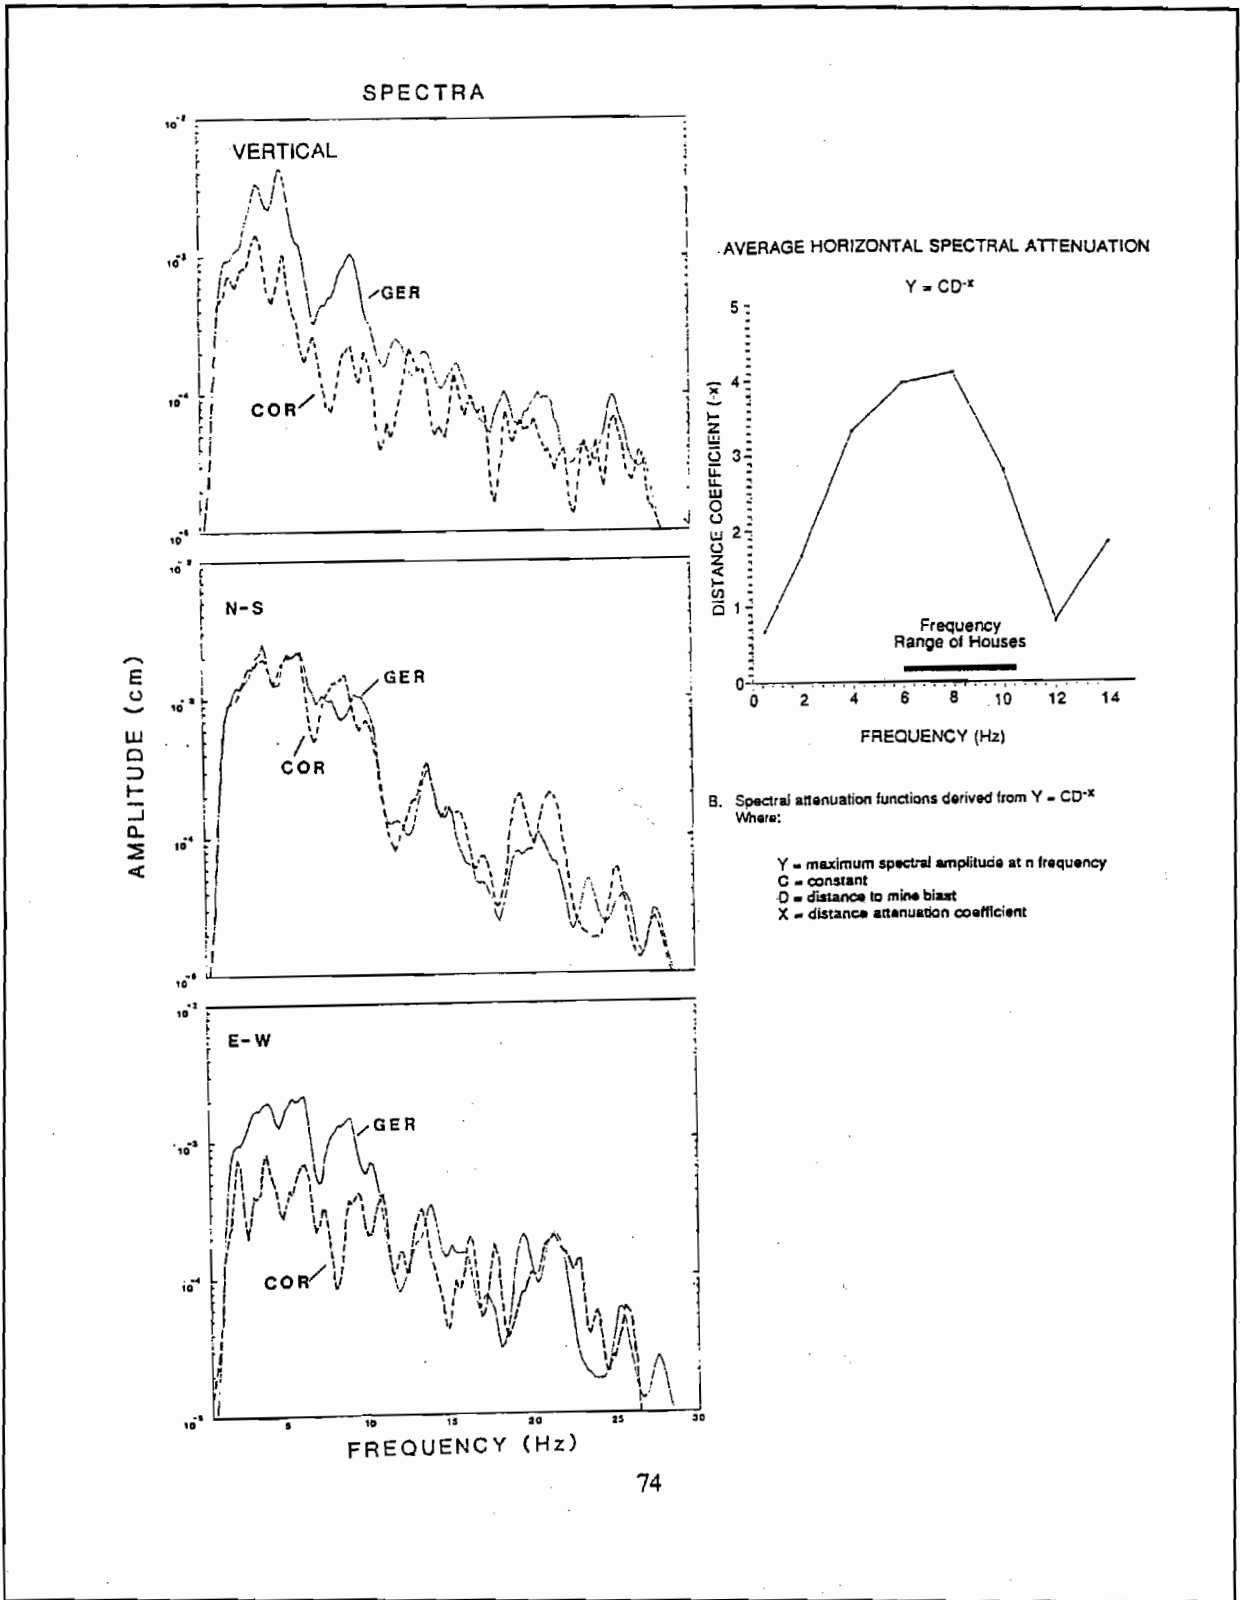
Figure 15. Spectra and spectral attenuation functions for Array No. 1. The horizontal bar in Figure B shows the bandwidth of the natural frequencies of the houses. From Part VI, Figure 14.

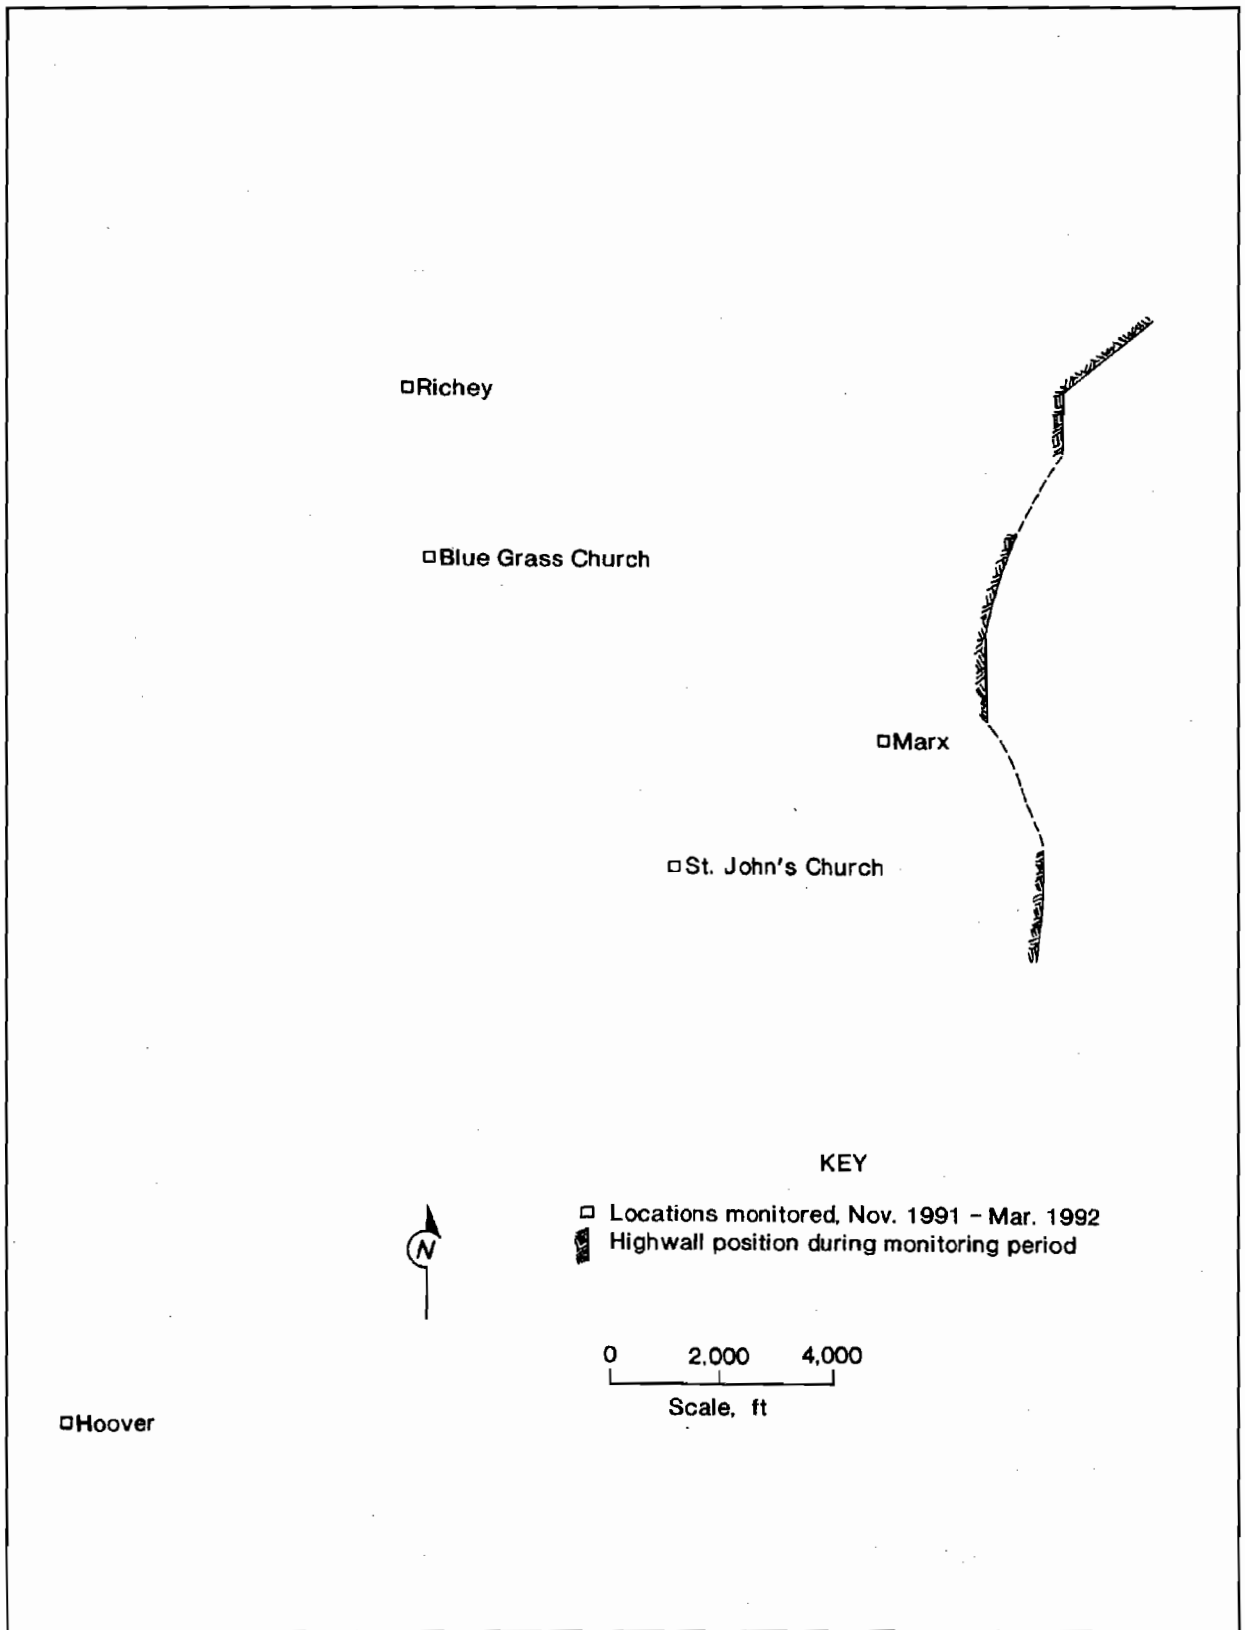
Figure 16. Monitored sites west of the Ayrshire mine highwall. From Part V, Figure 2.

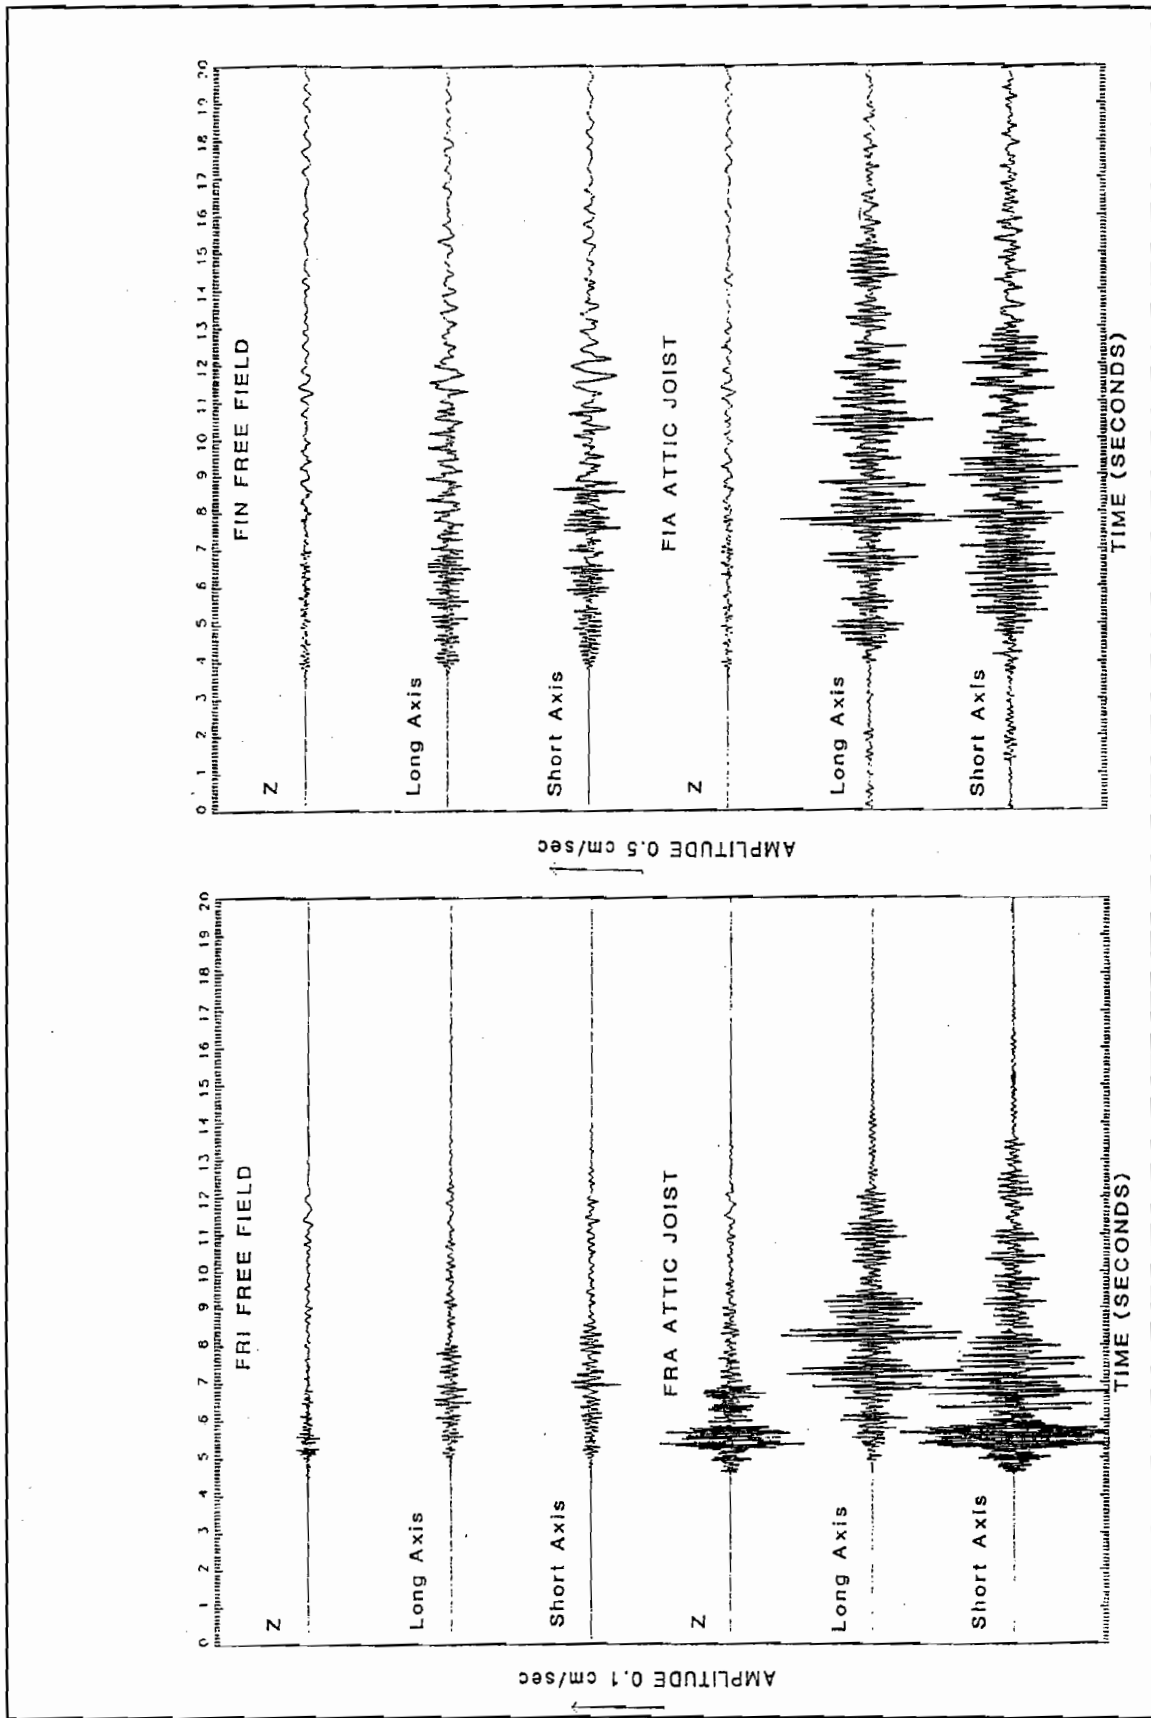
Figure 17. Seismograms comparing vibrations at attics with free-field vibrations at two complainant homes. From Part VI, Figure 29.

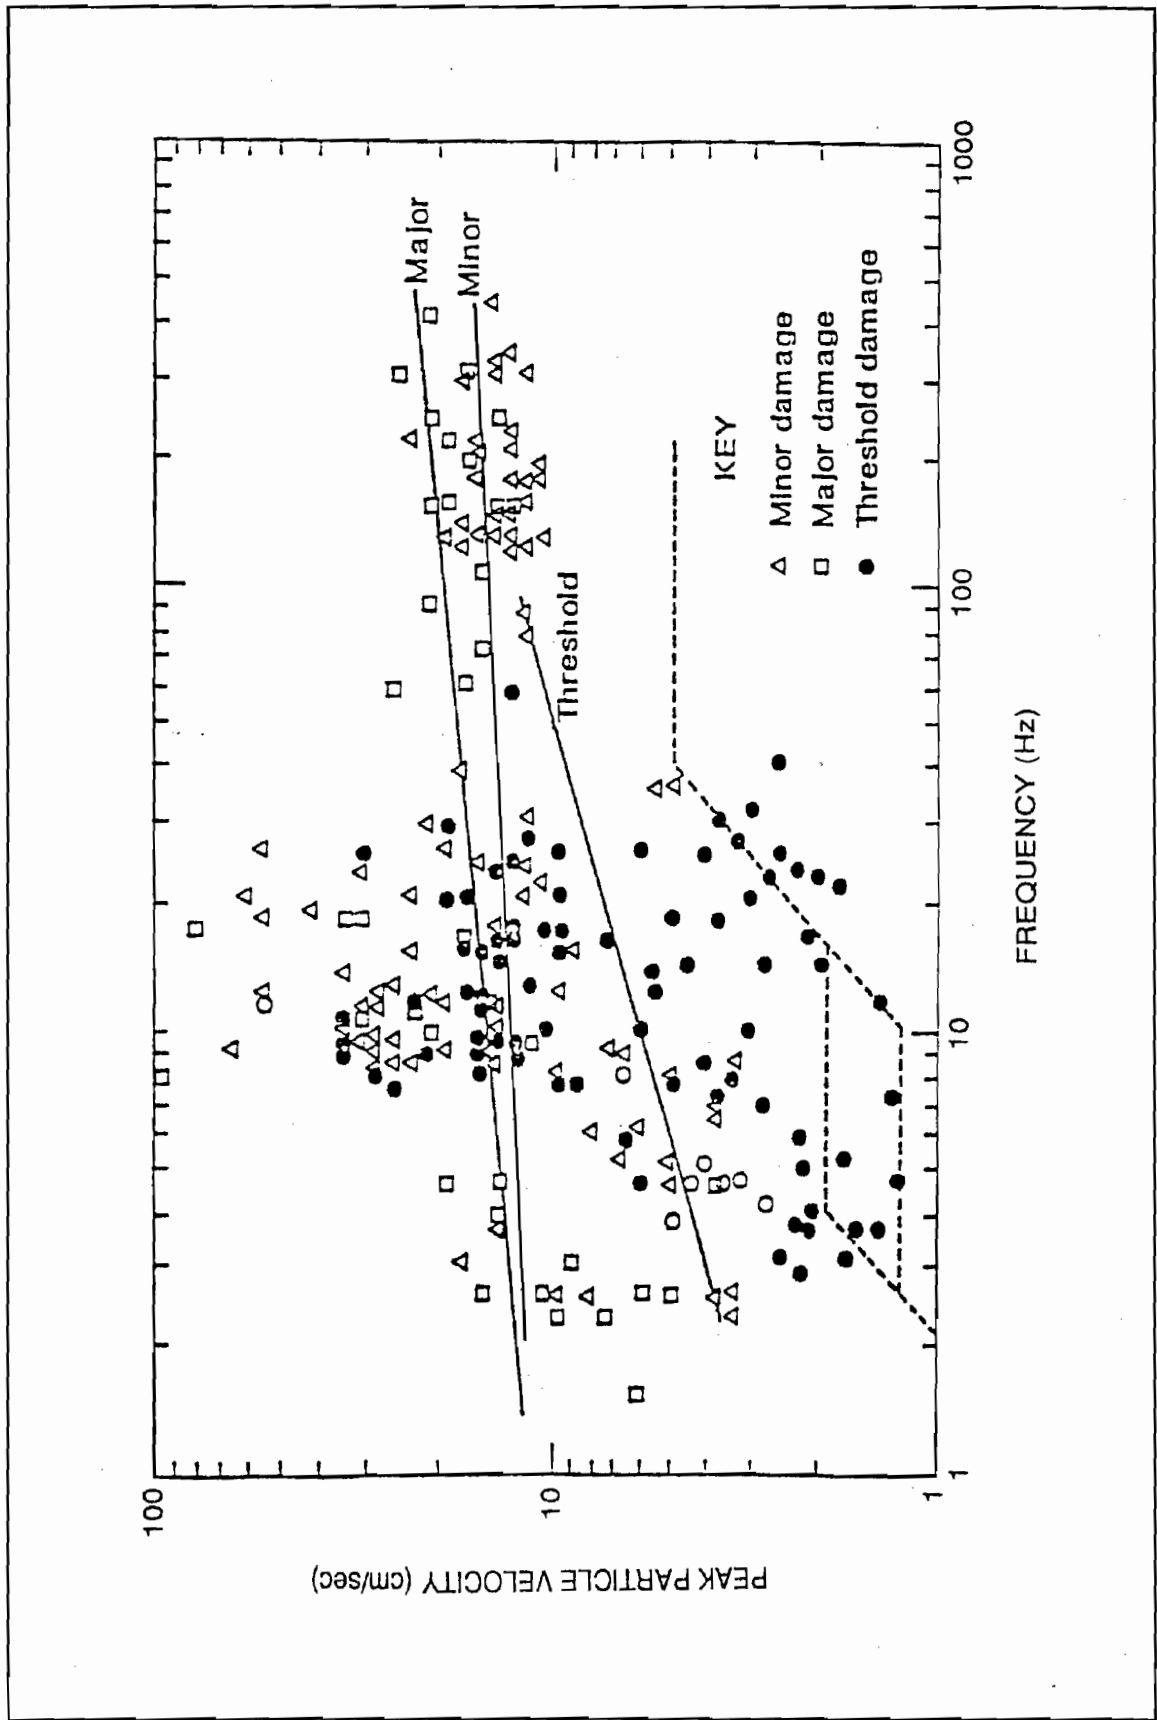
Figure 18. Envelope of safe peak-particle velocities from Bureau of Mines RI8507 (Siskind and others, 1980). From Part VI, Figure 30.

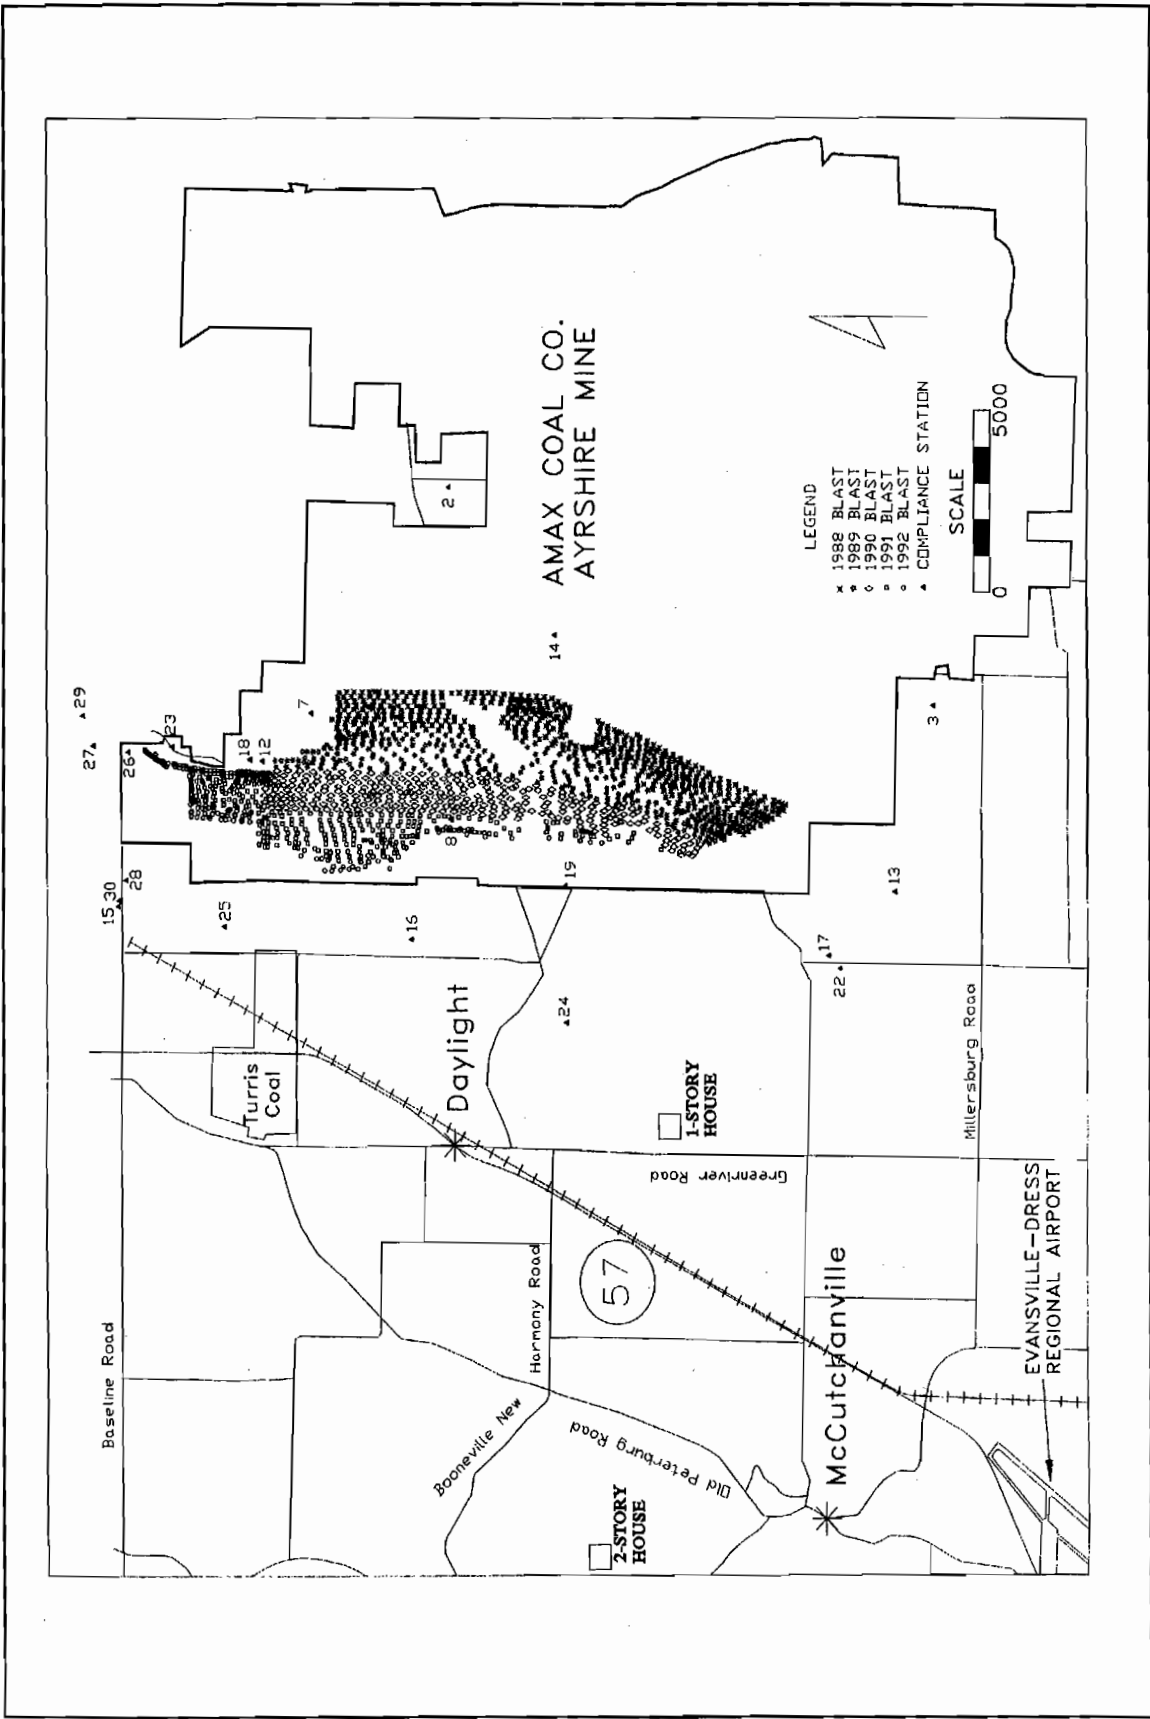
Figure 19. Study area, mine blast locations (1988-1992), and compliance monitoring stations. From Part VII, Figure 1.2.

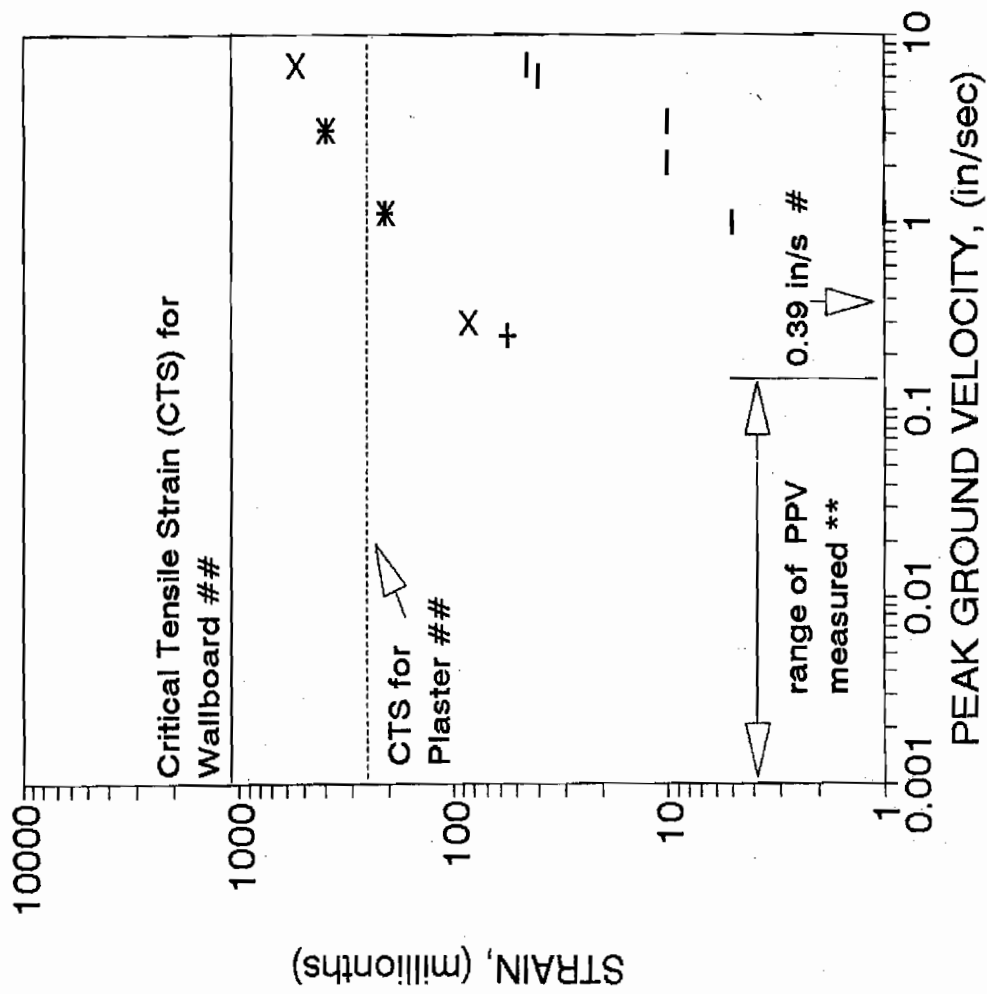
Figure 20. Strain versus peak ground velocity for wallboard, plaster, and wallboard tape joint. From Part VII, Figure 2.21.

The comparisons for wallboard, wallboard tape joint, and plaster indicate that maximum strain responses are less than all CTS levels for ground vibrations below 2.0 ips (Figure 20). Cracking in these materials is not expected for potential worst-case ground vibrations of 0.17 and 0.39 ips. The maximum strains in mortar joints easily exceed both documented failure strain levels (for the brick and block) and the WES-computed CTS levels under

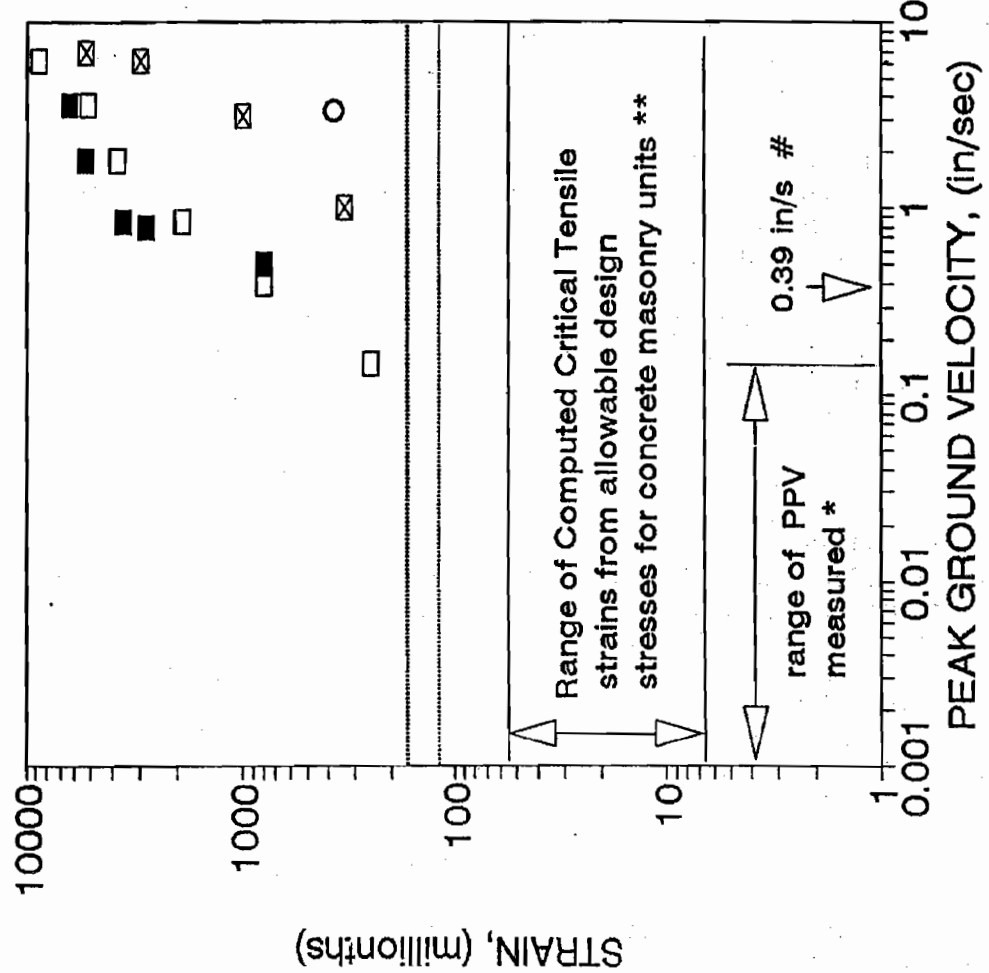
the worst-case ground vibrations (Figure 21). However, reservations concerning the comparability of the three sets of data were expressed by the USBM investigators and discussed with WES subsequent to this analysis. For instance, some of the USBM strain data were obtained from measurements across preexisting cracks in the mortar. Cracks are expected to increase displacement within a material in response to vibrations. Other problems identified pertain to: (1) different methods of measuring strains between the failure strain data and the USBM strain data; and (2) the acceptability of the low CTS values computed and utilized by WES. Because of the above concerns, conclusions related to material failures from measured or estimated ground vibrations for the study area are also dependent on the following FE analysis.

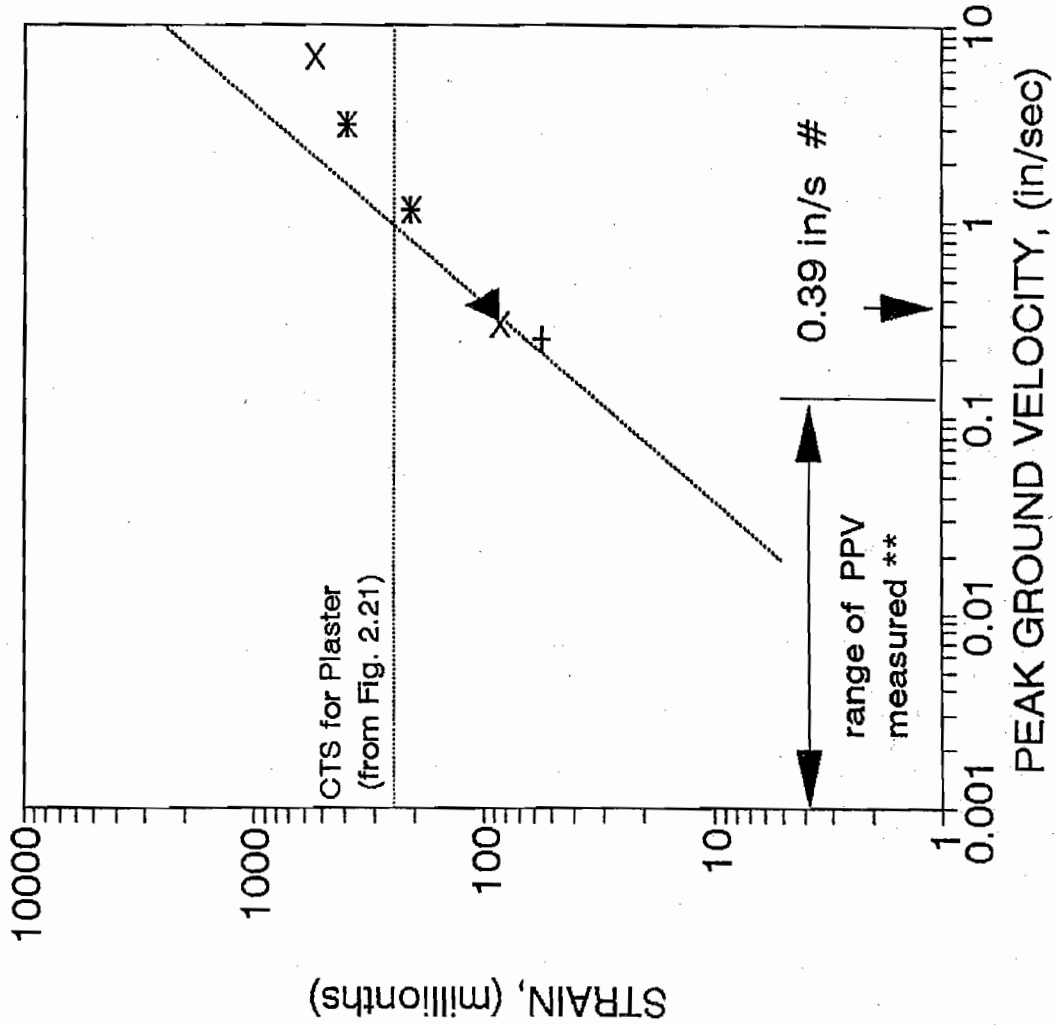
Figure 22. Peak ground velocity versus strain. From Part VII, Figure 4.22.

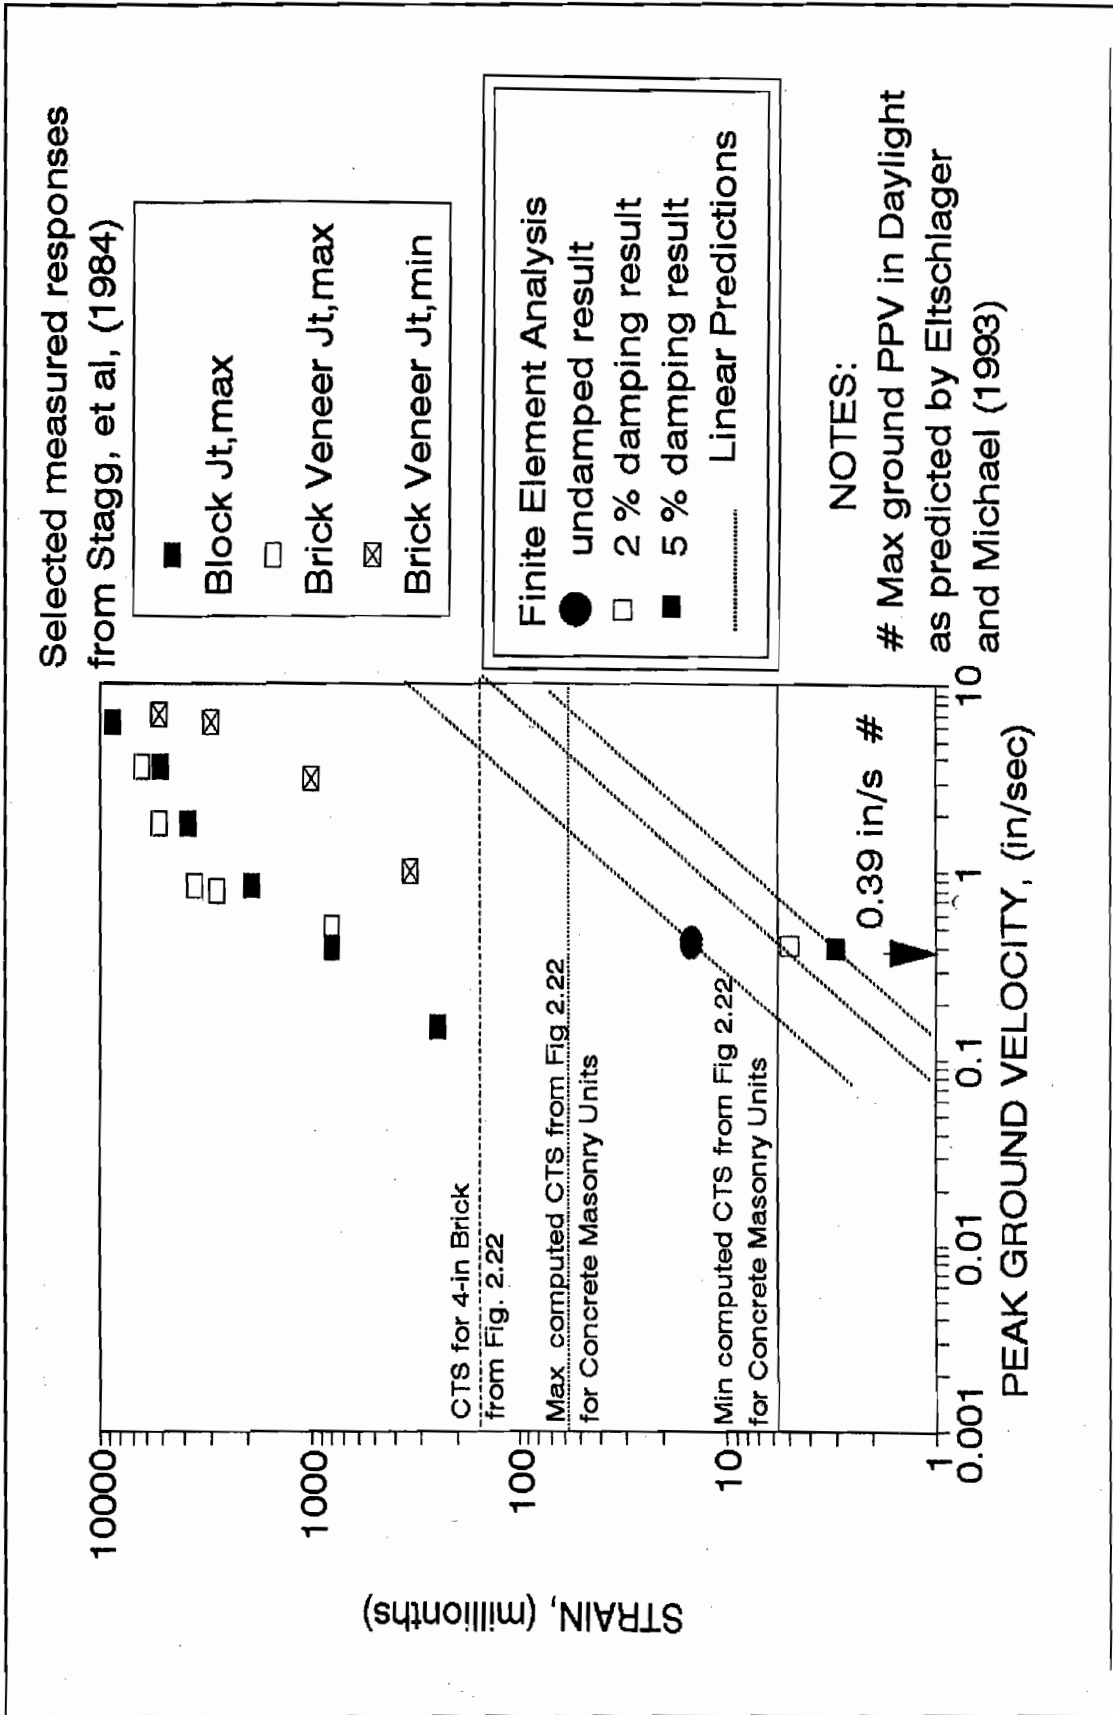
Figure 23. Selected maximum responses of block joints and selected maximum and minimum responses for brick veneer joints measured by Stagg (Stagg, et al., 1984) and fitted linear predictions. From Part VII, Figure 4.23.

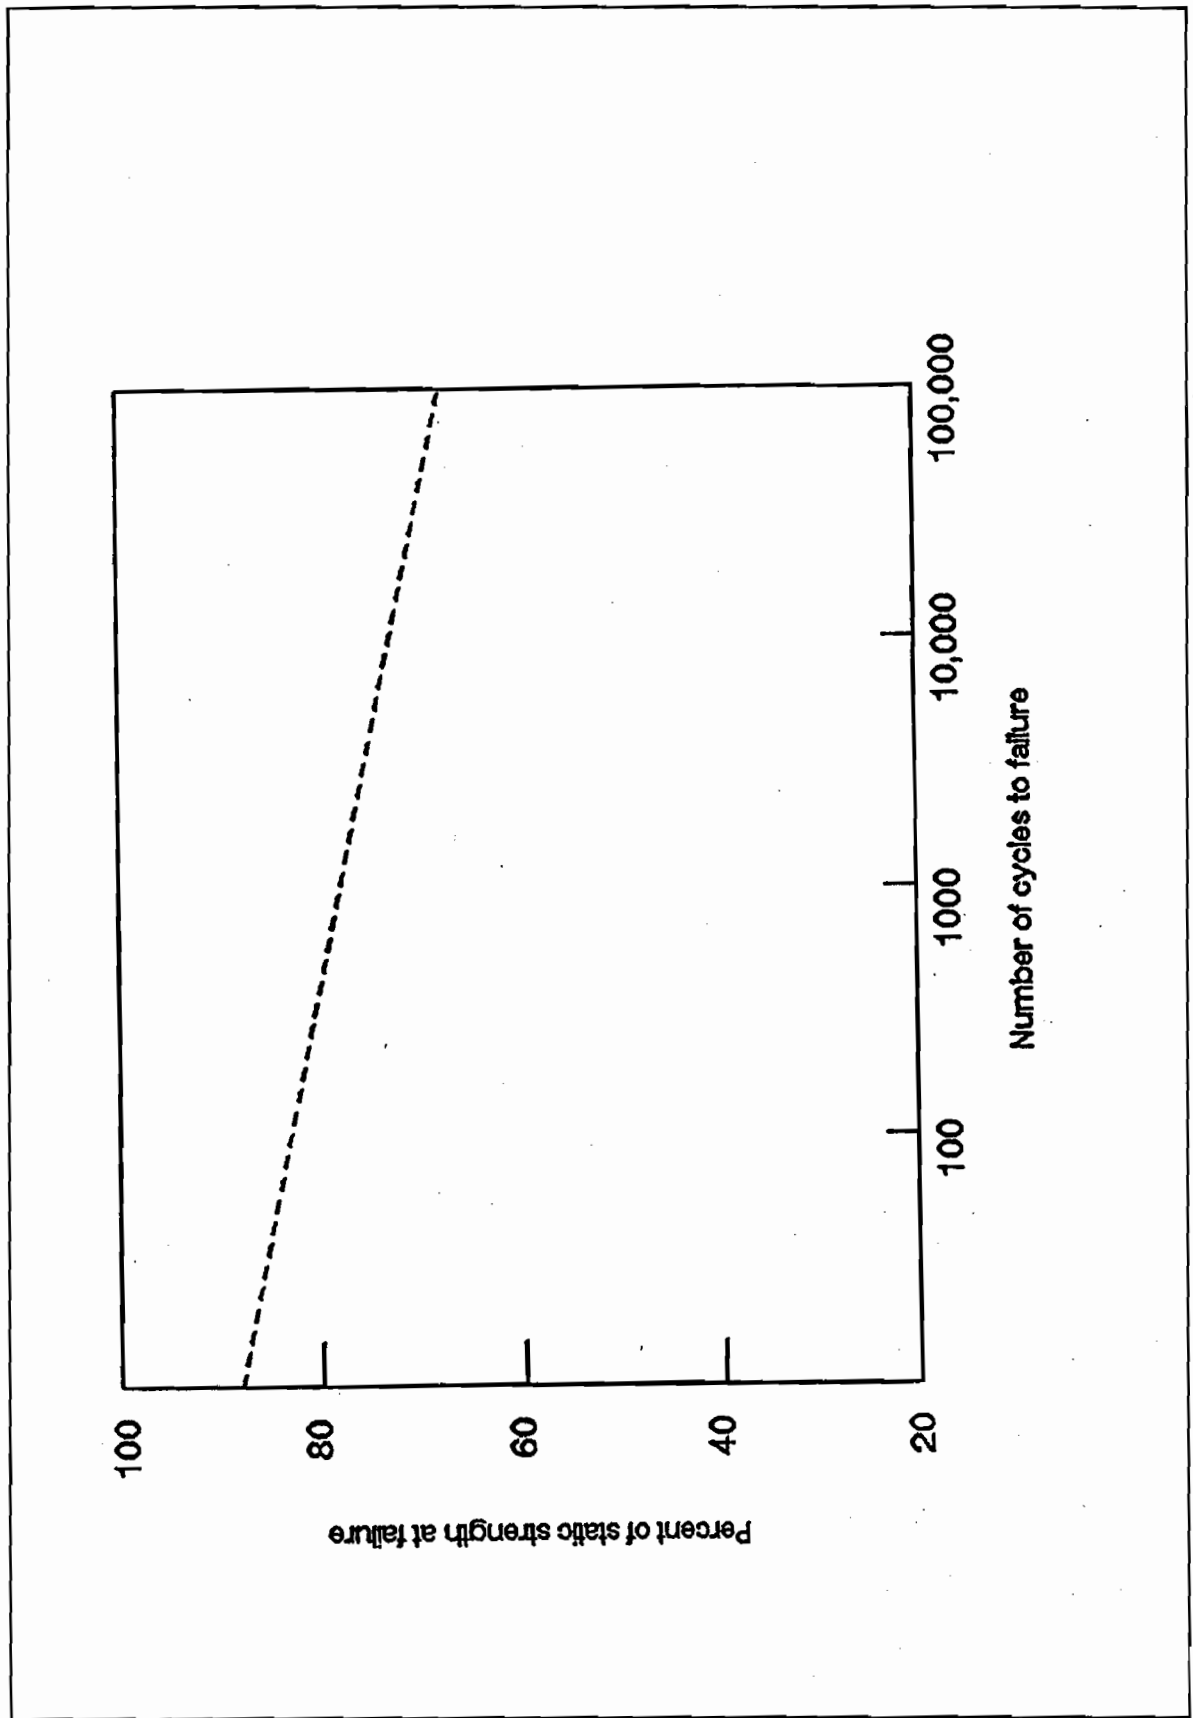
Figure 24. Fatigue behavior of gypsum panels (after Leigh, 1974). From Part VII, Figure 5.51.

The vibration amplitude 0.2 ips results in a strain of 2.3 microin/in, which is 37 percent of the CTS. This value is low compared to the 70 percent requirement for wallboard/plaster fatigue from 62,400 vibration cycles; and does not constitute evidence for the occurrence of fatigue (without the influence of prestress) in brick veneer mortar in the study area.
