OFFICE OF SURFACE MINING
RECLAMATION AND ENFORCEMENT
TECHNICAL REPORT/1994

**INVESTIGATION OF DAMAGE TO STRUCTURES
IN THE McCUTCHANVILLE-DAYLIGHT
AREA OF SOUTHWESTERN INDIANA**

Volume 1 of 3
Part I: Composite Report

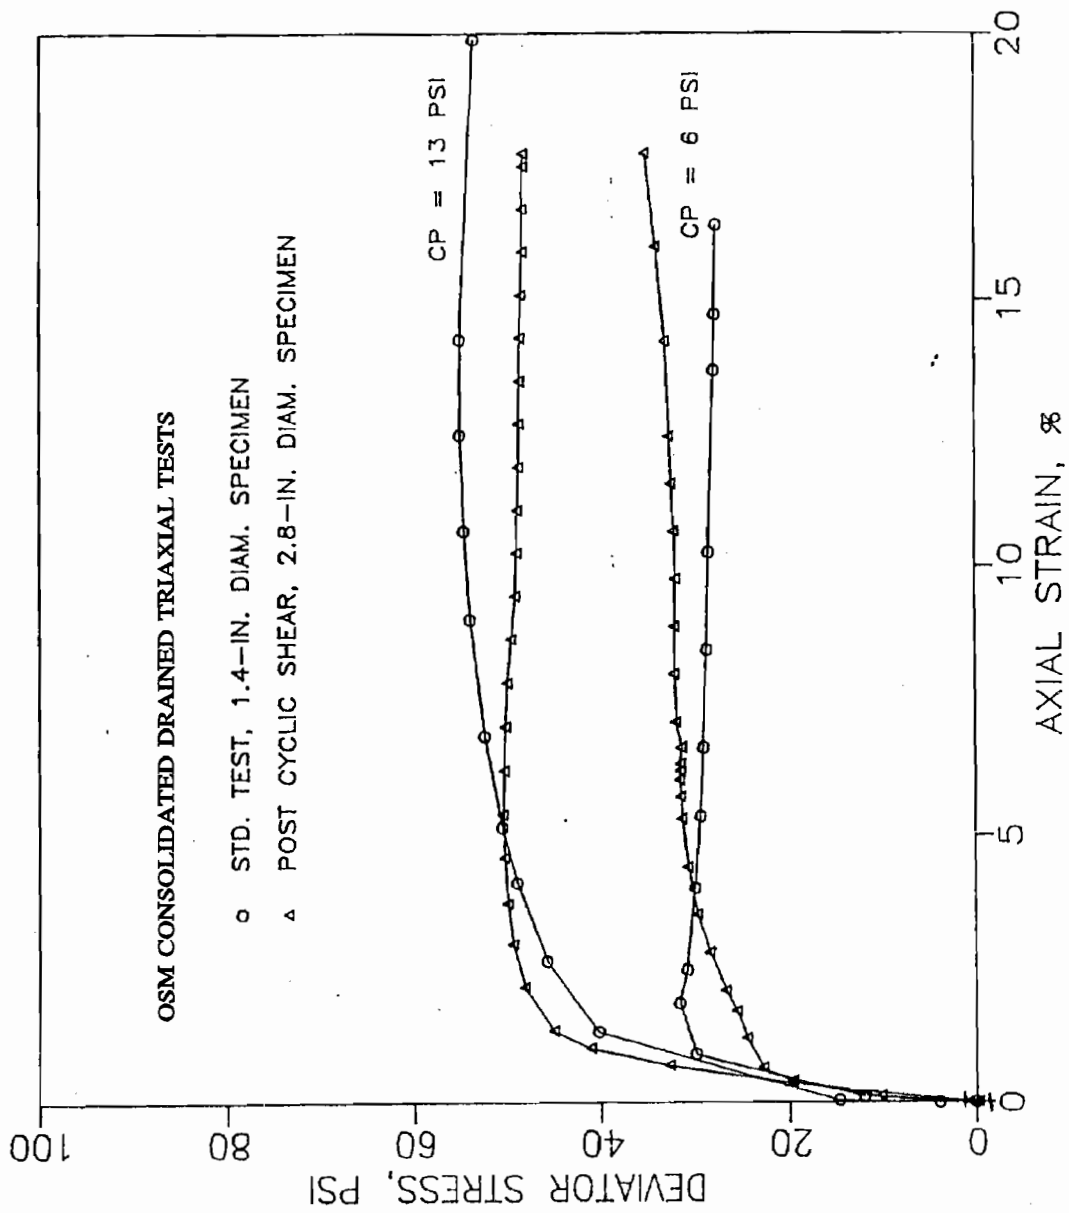
Figure 25. Deviator stress versus axial strain for triaxial tests with and without small amplitude cyclic loading. From Part VIII, Figure 6.

Back pressure saturated, consolidated, undrained triaxial compression tests were conducted on two specimens. One of them was the preliminary test discussed above, in which the specimen was sheared monotonically. The other test included an undrained cyclic loading phase following consolidation (in which the specimen was isotropically consolidated to 5 psi) and before the undrained monotonic shear phase. The specimen was subjected to 20 cycles of

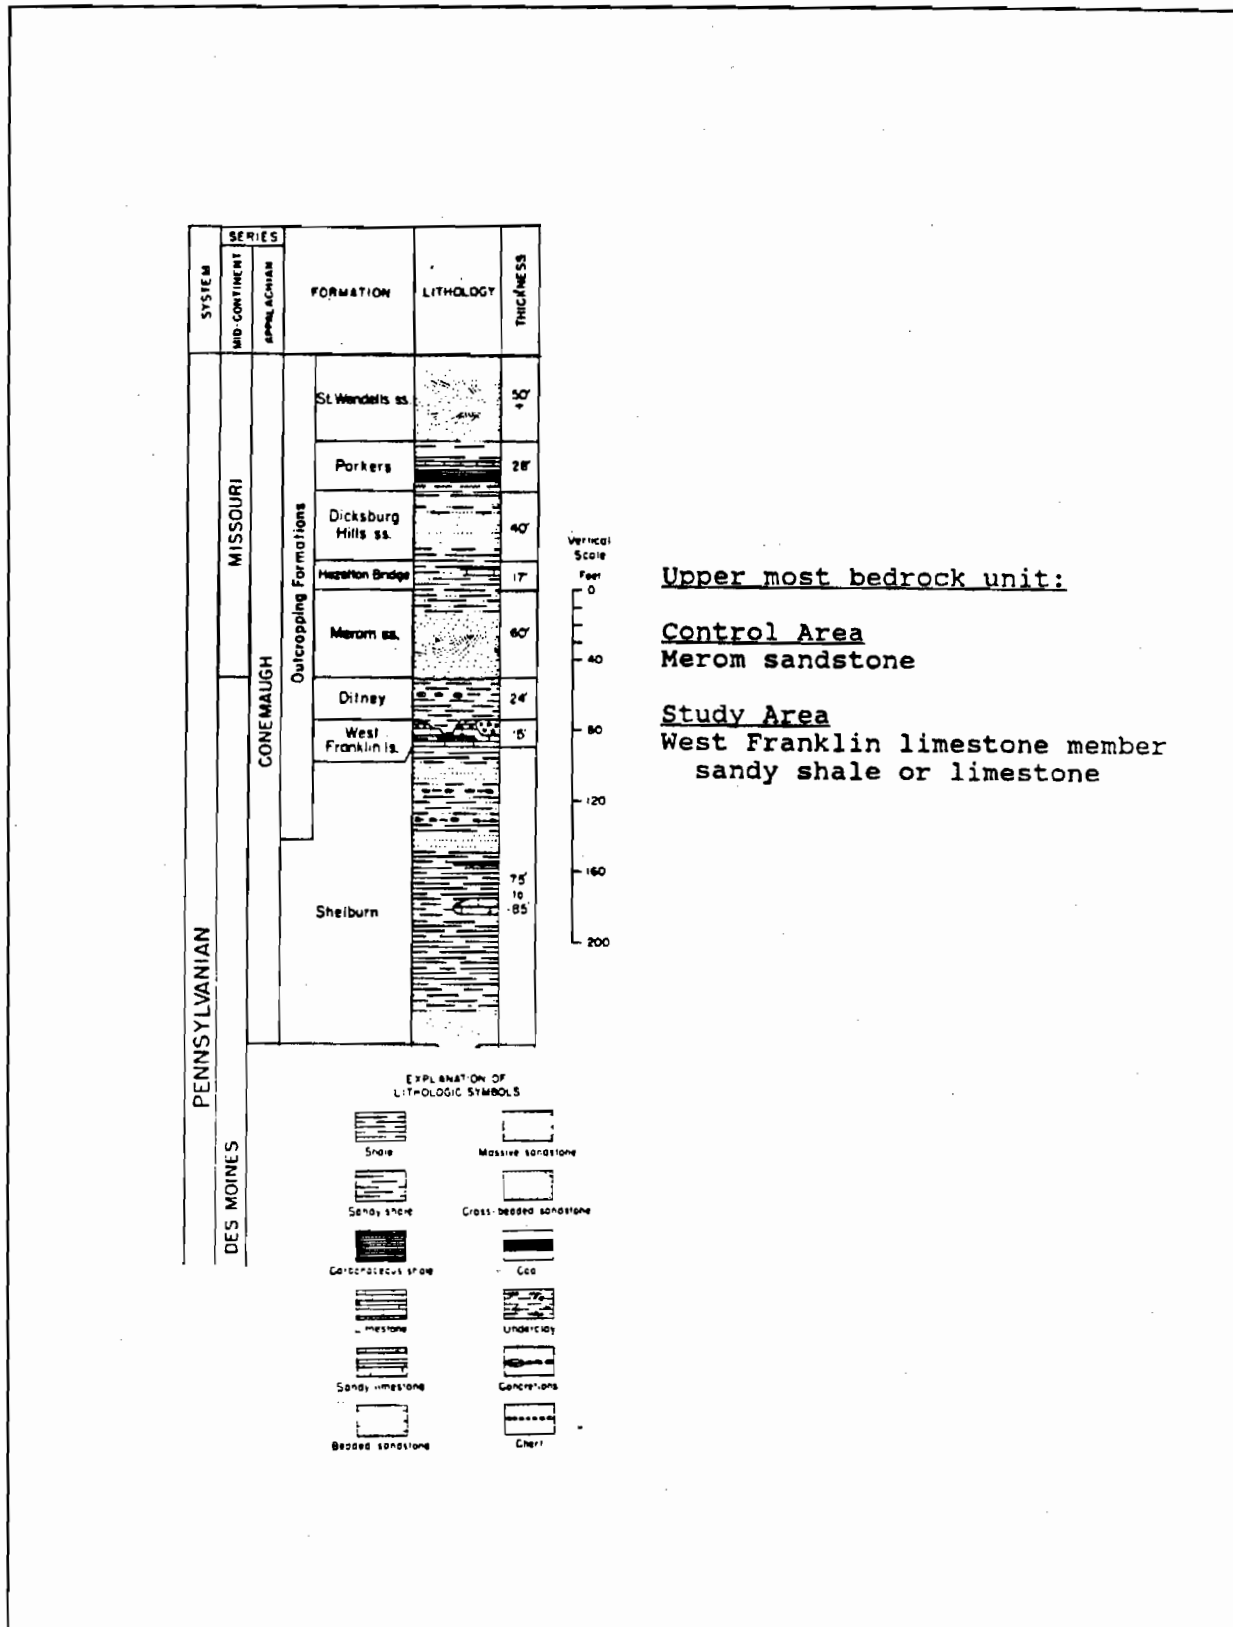
Figure 27. Generalized stratigraphic column of Vanderburgh County. From Part IX, Figure 2.

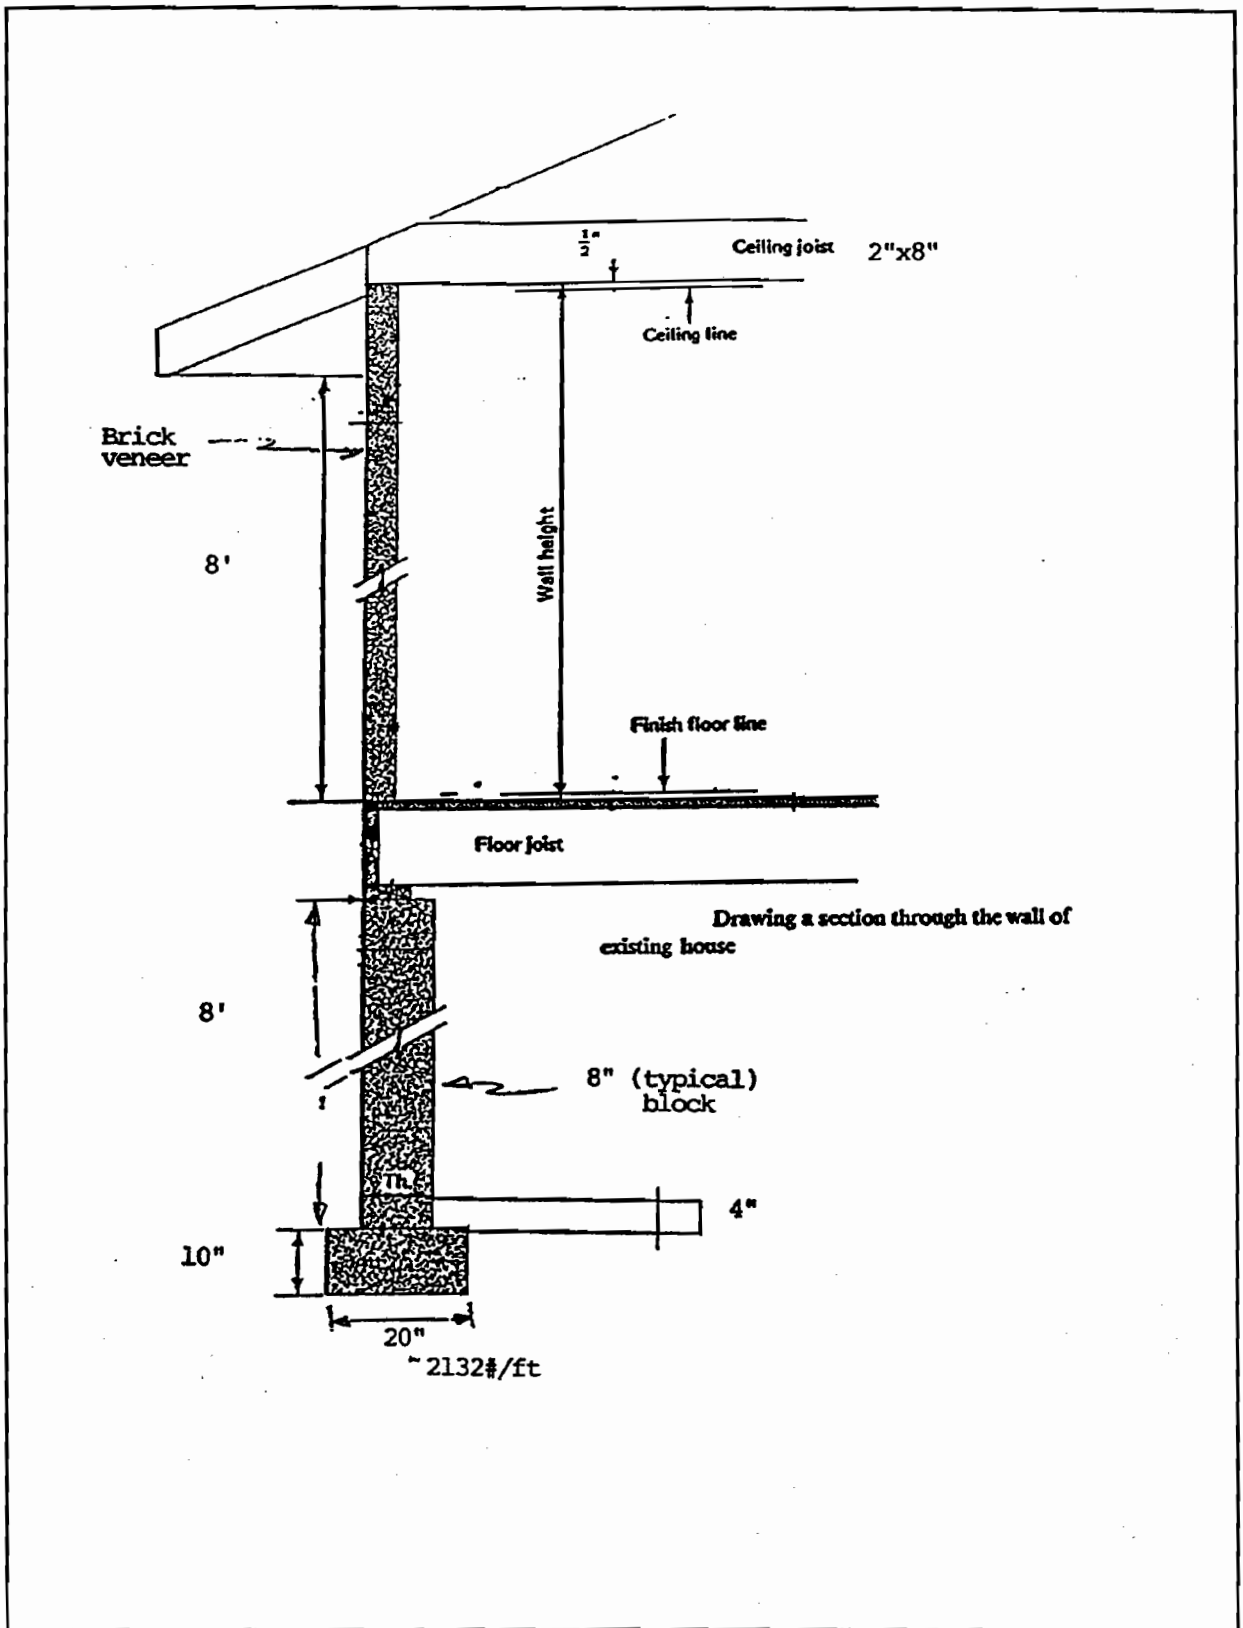
Figure 28. Idealized cross section of the one-story house for estimating footing loads. From Part VII, Figure 3.1.

Vertical stress versus depth: The Boussinesq Solution was used to calculate vertical stress increments in a linear-elastic medium under a corner and the mid point of a one-story-structure strip footing around the perimeter of a 50-foot square excavation 4 feet deep due to the combination of the excavation (a decrease in stress) and the loaded strip footing (an increase in stress). The results showed a net increase in stress in the top 7 feet below the footing. This meant that only shallow depth soil properties had any influence on settlements. It was further noted by the investigators that the maximum stresses were less than the measured pre-consolidation pressures.

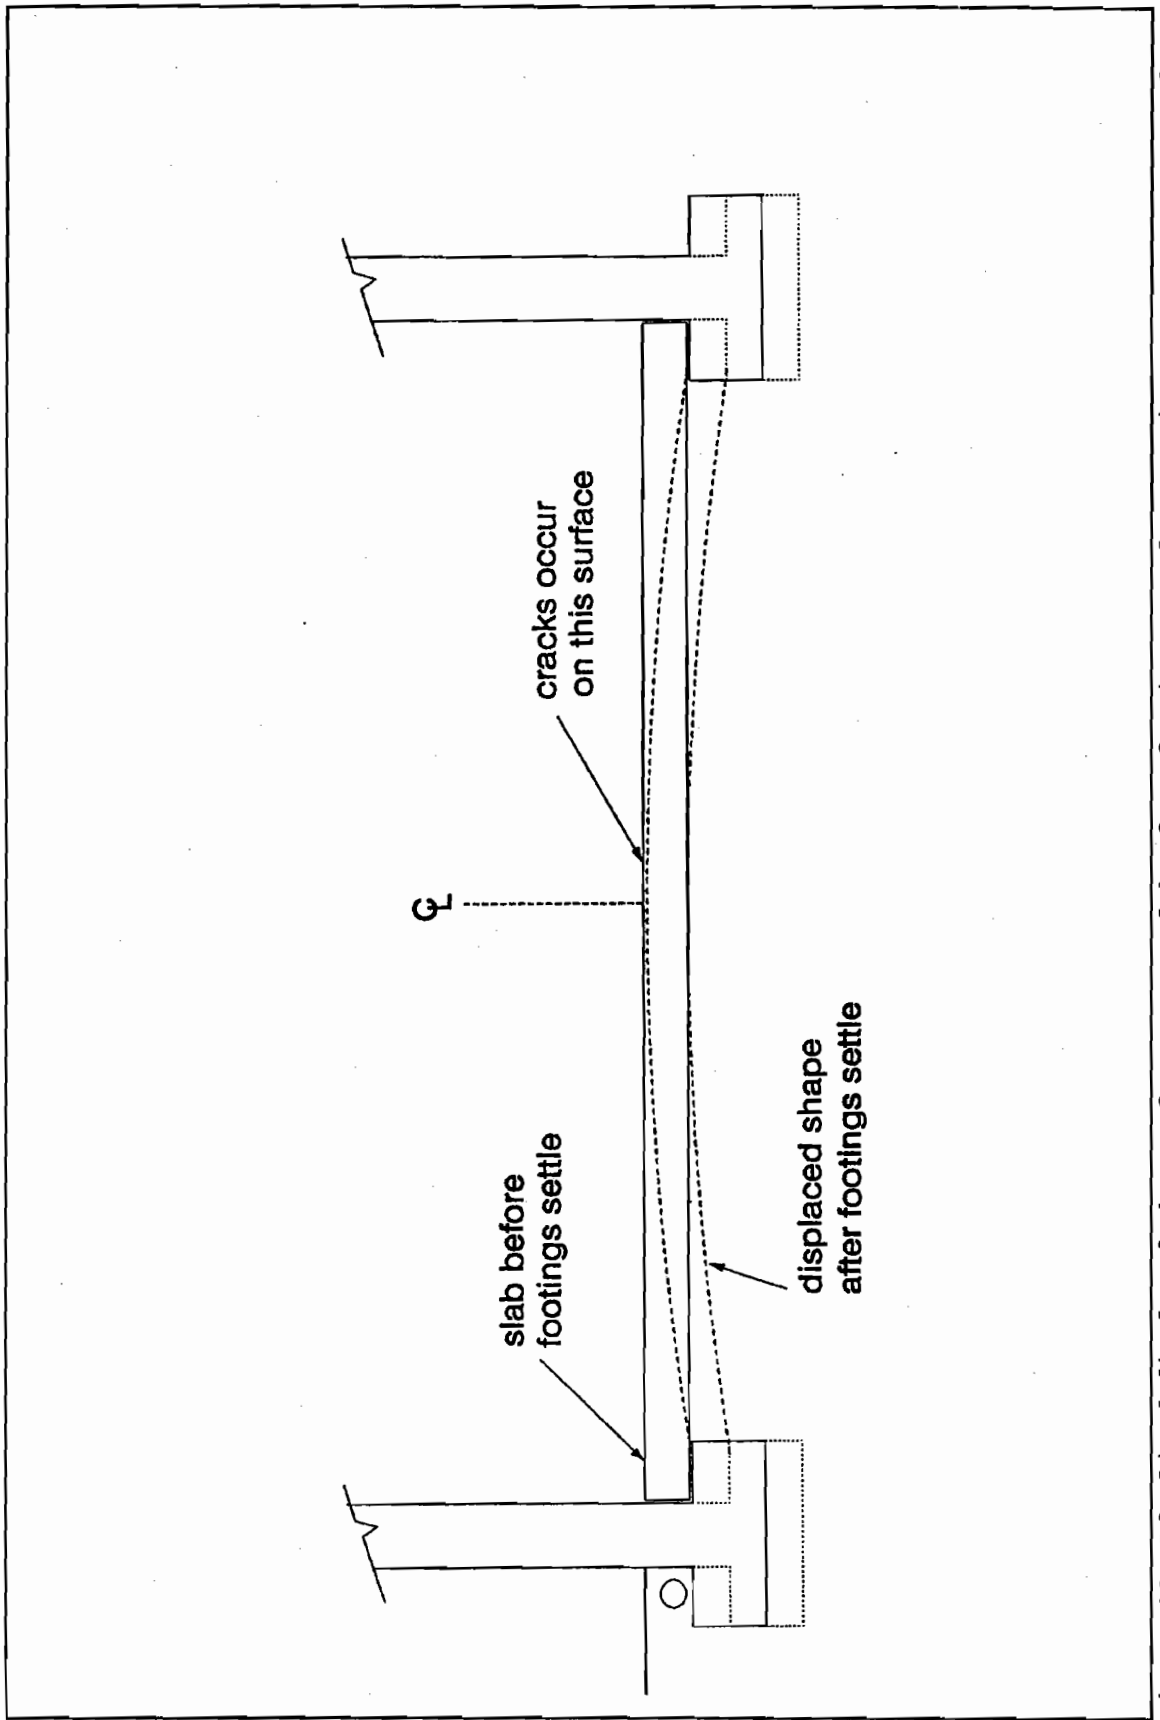
Figure 29. Idealized displaced shape of concrete slab after footings settle. Tension occurs on top surface. Amplitude of displaced shape is exaggerated to illustrate. From Part VII, Figure 3.3.

The tensile strength of concrete can range between 230 and 400 psi. The WES calculations treated a slice of the floor slab as a beam. As the footings settle, vertical soil pressures develop under the slab (Figure 29). Based on the tensile strengths above, deflection from settlement necessary for cracking ranges between 0.7 and 1.2 inches. The results indicate that settlements of approximately one inch that were observed at some houses are sufficient to cause cracking in the floors.

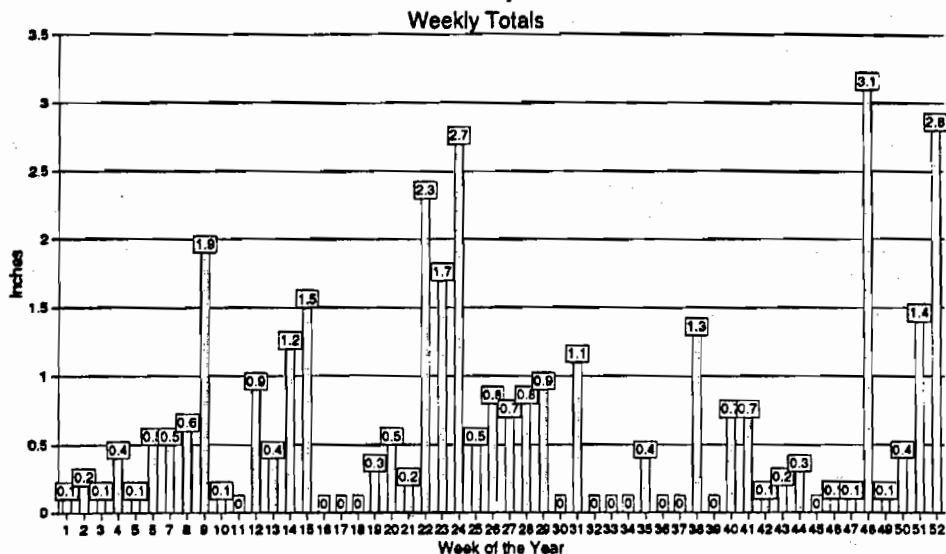
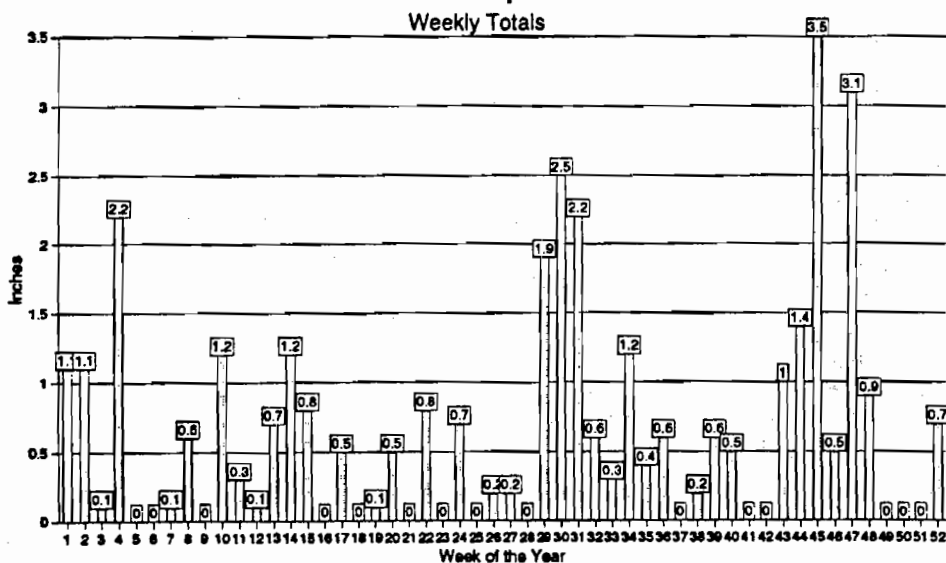
Figure 30. Weekly precipitation in inches for 1987 and 1988 (1992, USDOC, NOAA, NCDC). From Part IX, Figure 3.

Drought conditions were recorded between February and May 1988 followed by heavy rain in July. In February 1988, the first month of the drought, AMAX introduced cast blasting. In July, precipitation jumped above the 11 year average, rehydrating the dried soils. When rehydration occurs, the expansive characteristics of the clays are activated.
