**OFFICE OF SURFACE MINING  
RECLAMATION AND ENFORCEMENT  
TECHNICAL REPORT/1994**

**INVESTIGATION OF DAMAGE TO STRUCTURES  
IN THE M<sup>c</sup>CUTCHANVILLE-DAYLIGHT  
AREA OF SOUTHWESTERN INDIANA**

**Volume 3 of 3**

**Part VIII: Dynamic Soil Property Testing and Analysis of Soil Properties, Daylight and McCutchanville, Indiana.**

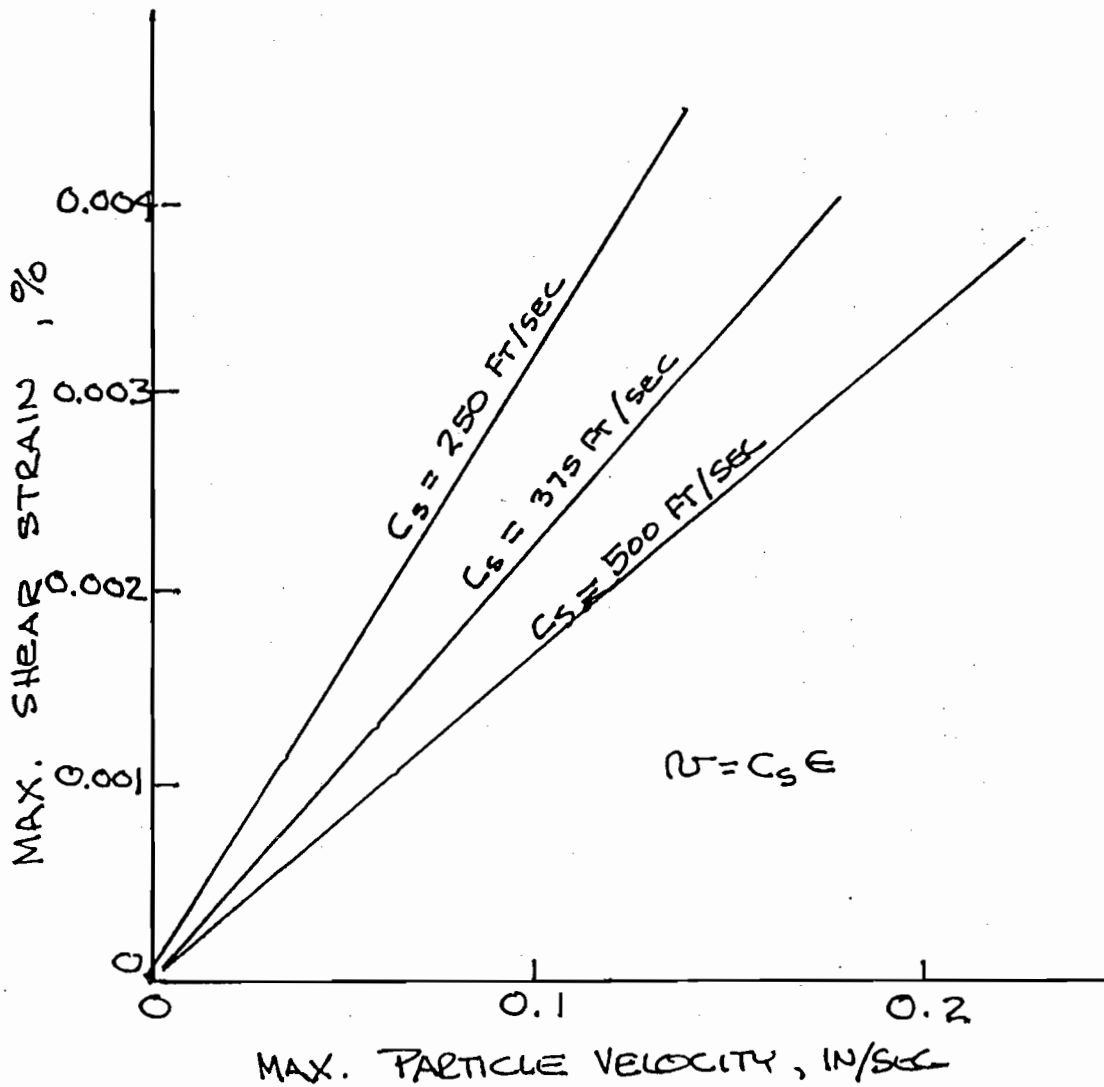
Figure 2. Shear strain versus particle velocity relationship for one-dimensional linear elastic wave propagation.

5. Shear strain levels used in these tests were selected as follows. A one-dimensional SH wave propagation model was assumed for the field condition because it was mathematically tractable and known to give results within the correct order of magnitude for three-dimensional explosion generated wave propagation strain estimates. This model leads to a relation between peak horizontal particle velocity and maximum shear strain.

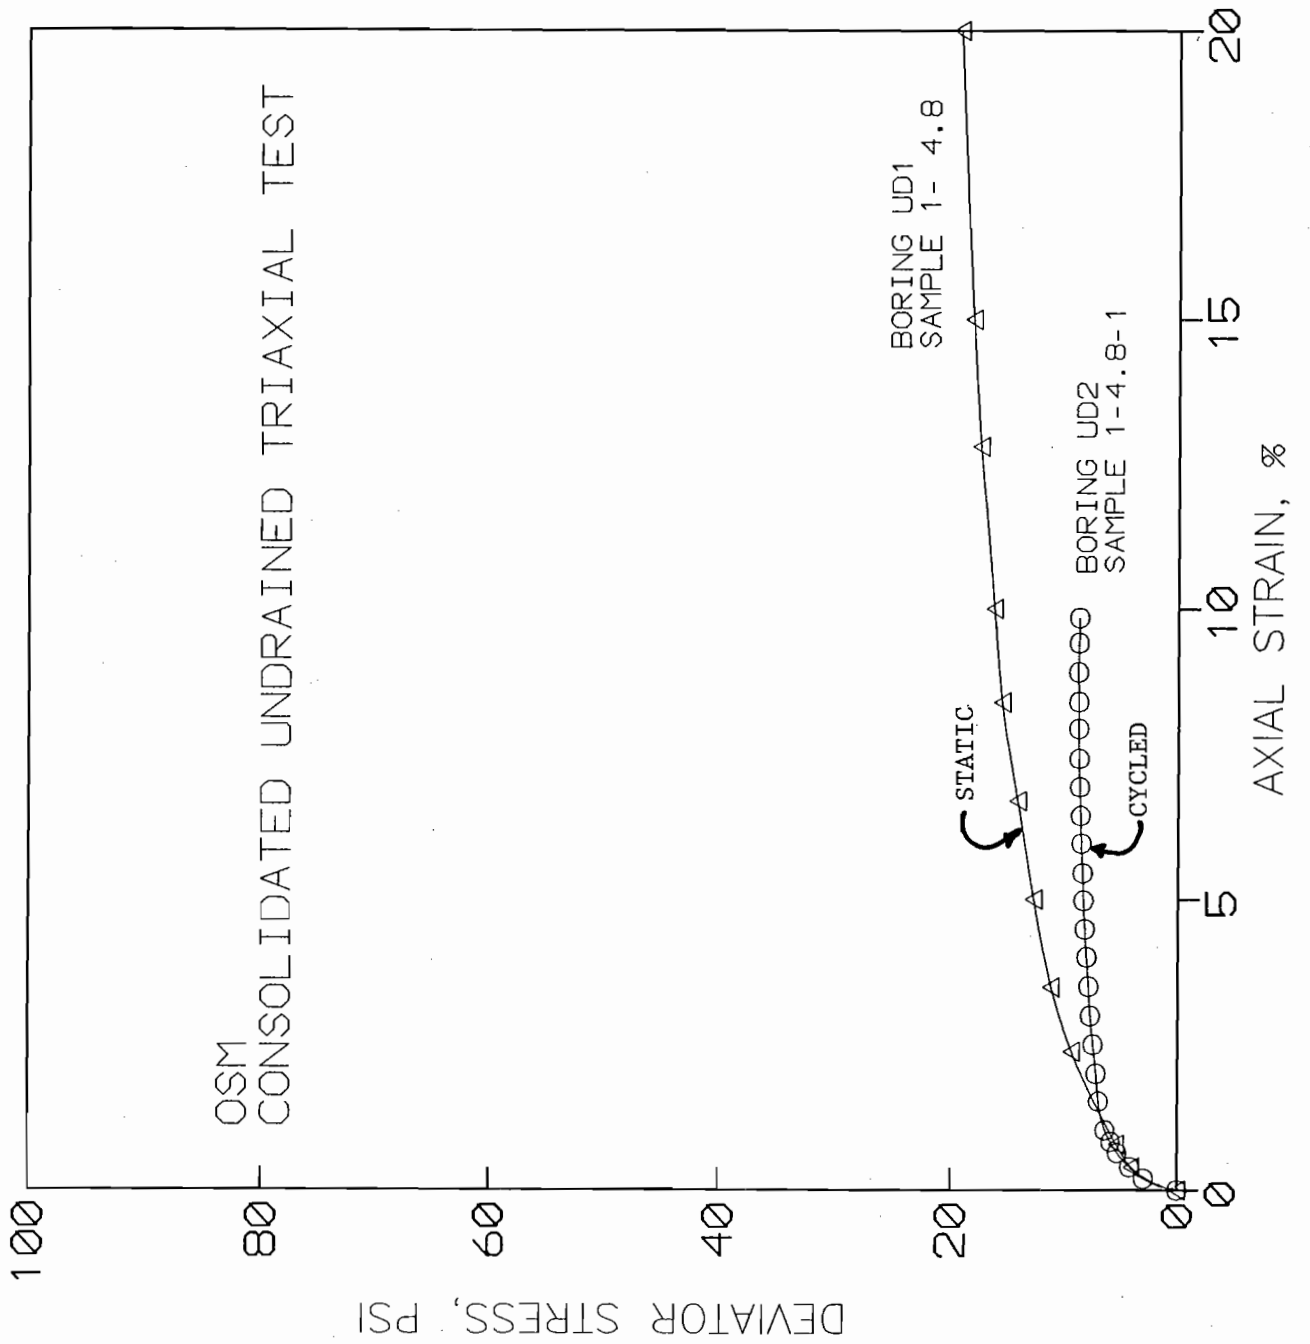
Figure 3. Deviator stress versus strain curves for consolidated undrained triaxial tests with and without low amplitude undrained cyclic loading following the consolidation phase.

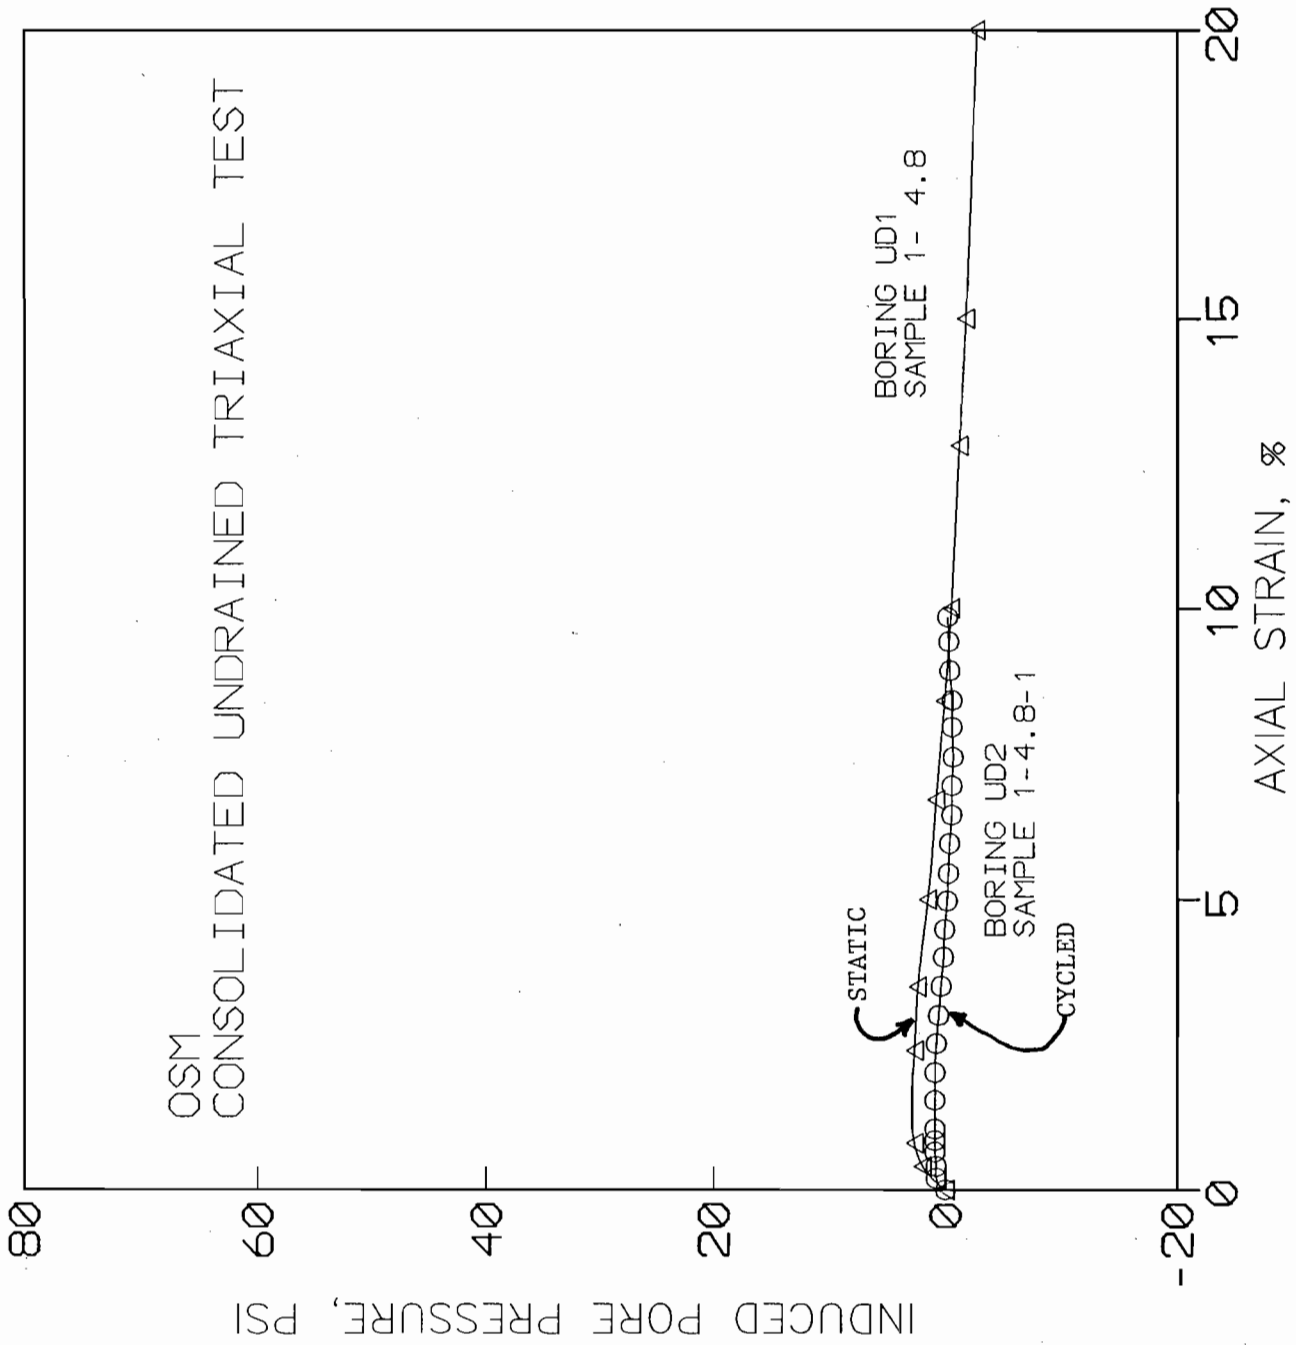
Figure 4. Pore pressure versus strain curves for consolidated undrained triaxial tests with and without low amplitude undrained cyclic loading following the consolidation phase.

e. The results of the back-pressure saturated, consolidated, undrained triaxial compression test with pore pressure measurements indicated that the artificially saturated specimen was dense and strong. Based upon the stress path data, failure occurred at an axial strain of 5 percent to 6 percent. The effective angle of internal friction was 30 degrees and the cohesion intercept was about 2 psi. An effective angle of internal friction of 30 degrees for a clay soil is fairly large. Skempton's A-pore pressure parameter was about -0.8. This value indicated that the specimen tended to dilate strongly during shear and inferred that the specimen was highly overconsolidated. It also infers that the hypothesis that positive pore pressure development and strength reduction due to cyclic loading is unlikely. The test results are summarized as a deviator stress versus axial strain relationship in Figure 3, as an induced pore pressure versus axial strain relationship in Figure 4, and as a shear stress versus normal stress relationship in Figure 5.

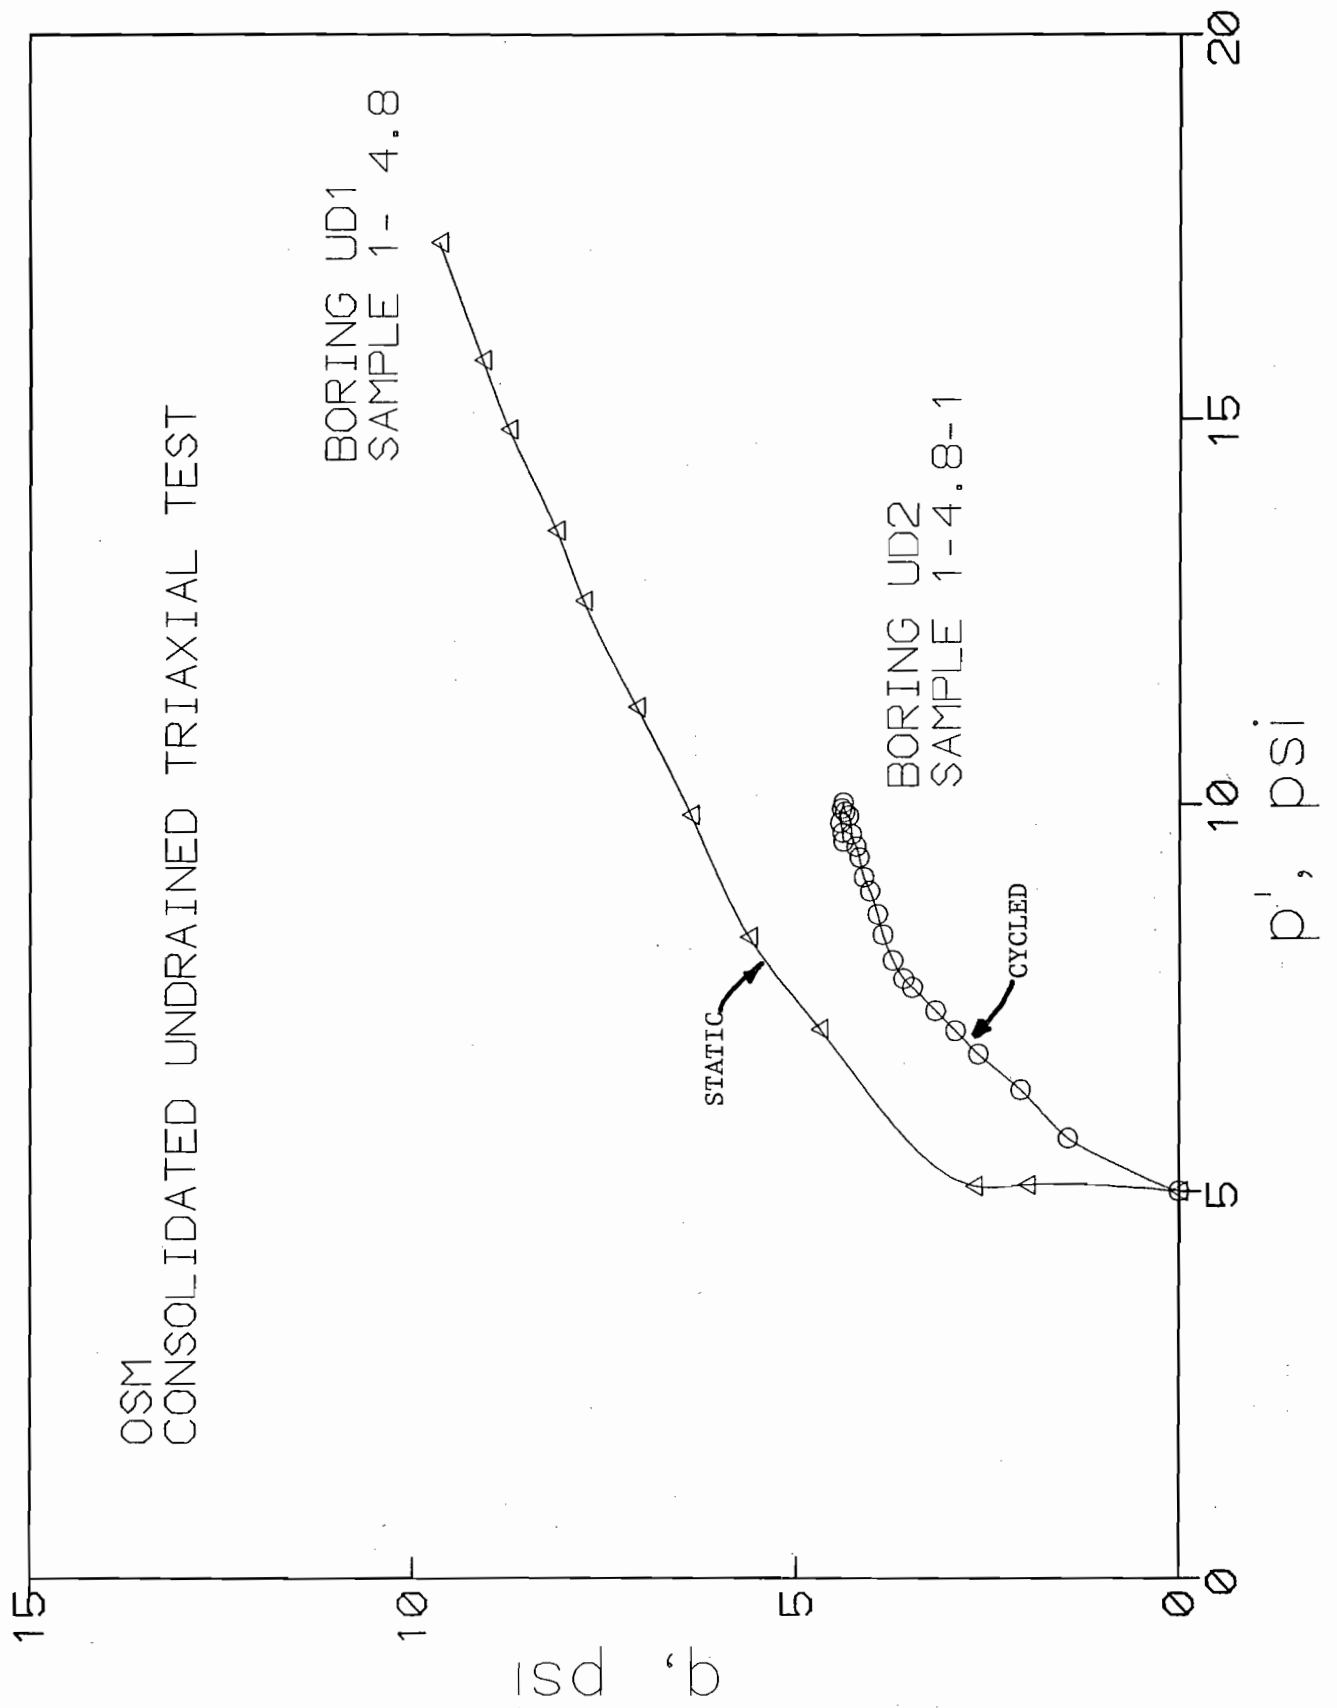
Figure 5. Stress paths for consolidated undrained triaxial tests with and without low amplitude undrained cyclic loading following the consolidation phase.

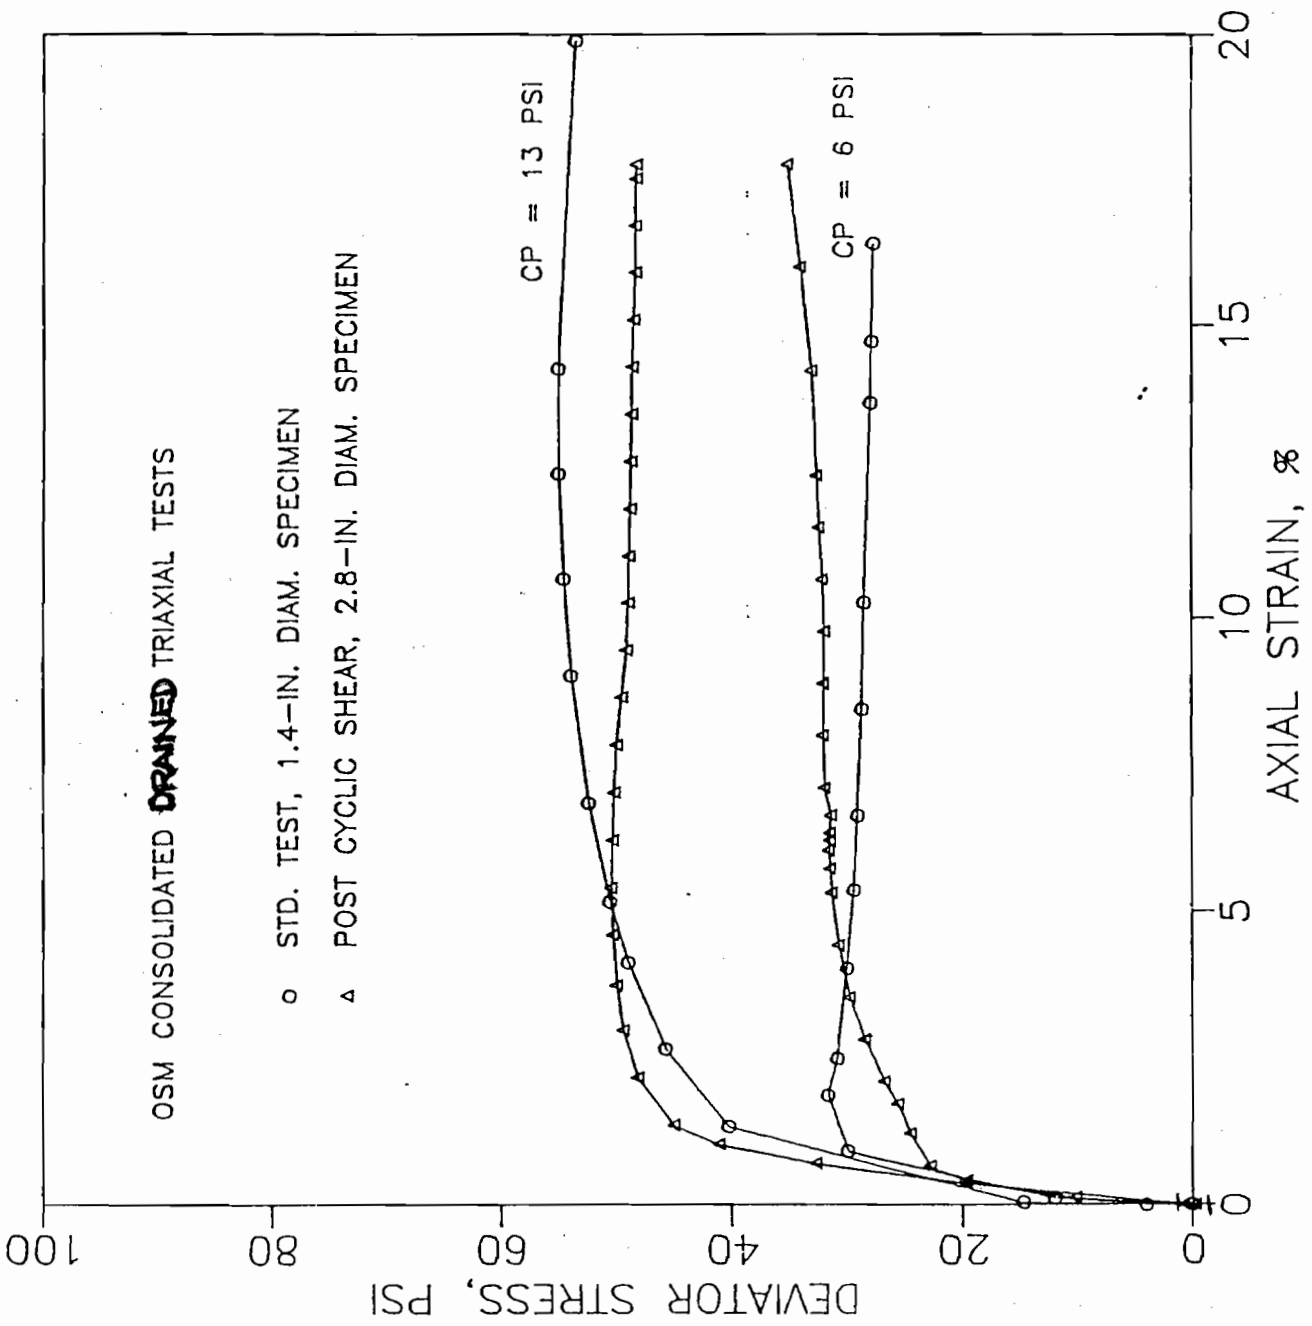
Figure 6. Deviator stress versus axial strain for triaxial tests with and without small amplitude cyclic loading.

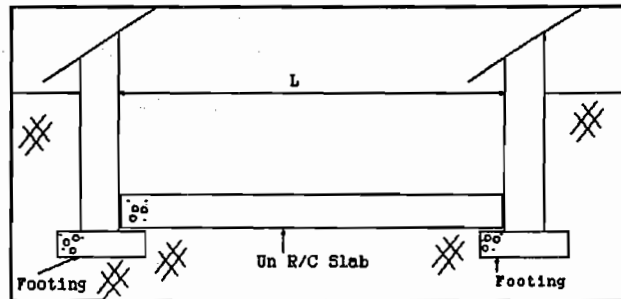
**Problem:** Determine the deflection of one-way slab (2-D slice) of an unreinforced concrete slab at point of incipient cracking.

1. Assume linear elastic 2-D response of unreinforced concrete (Un R/C) slab.

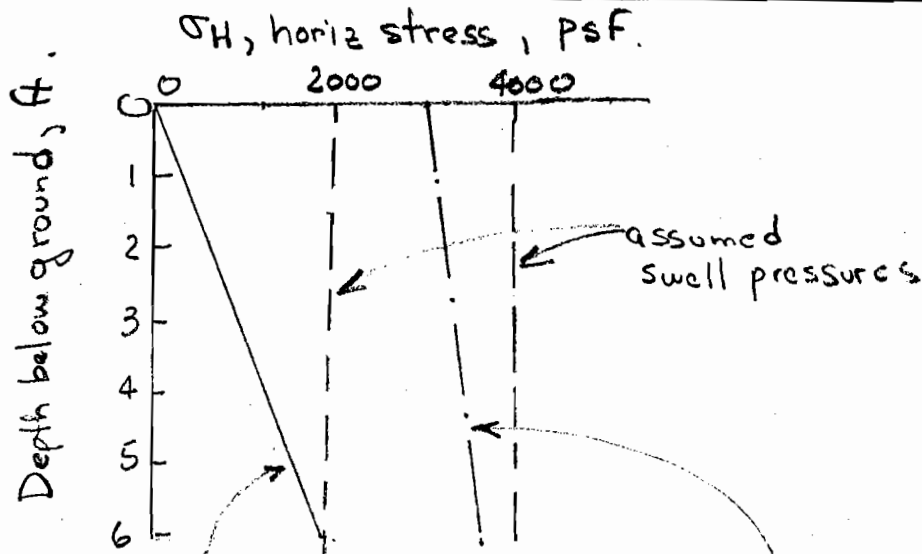
Upper limit of long term pressure against unyielding wall.  
 $H=5$

$$P_p = \int_0^5 \delta z N \phi = \frac{3 \delta z^2}{2} = \frac{3 \times 100 \times 25}{2} = 3750 \text{ lb/ft.}$$

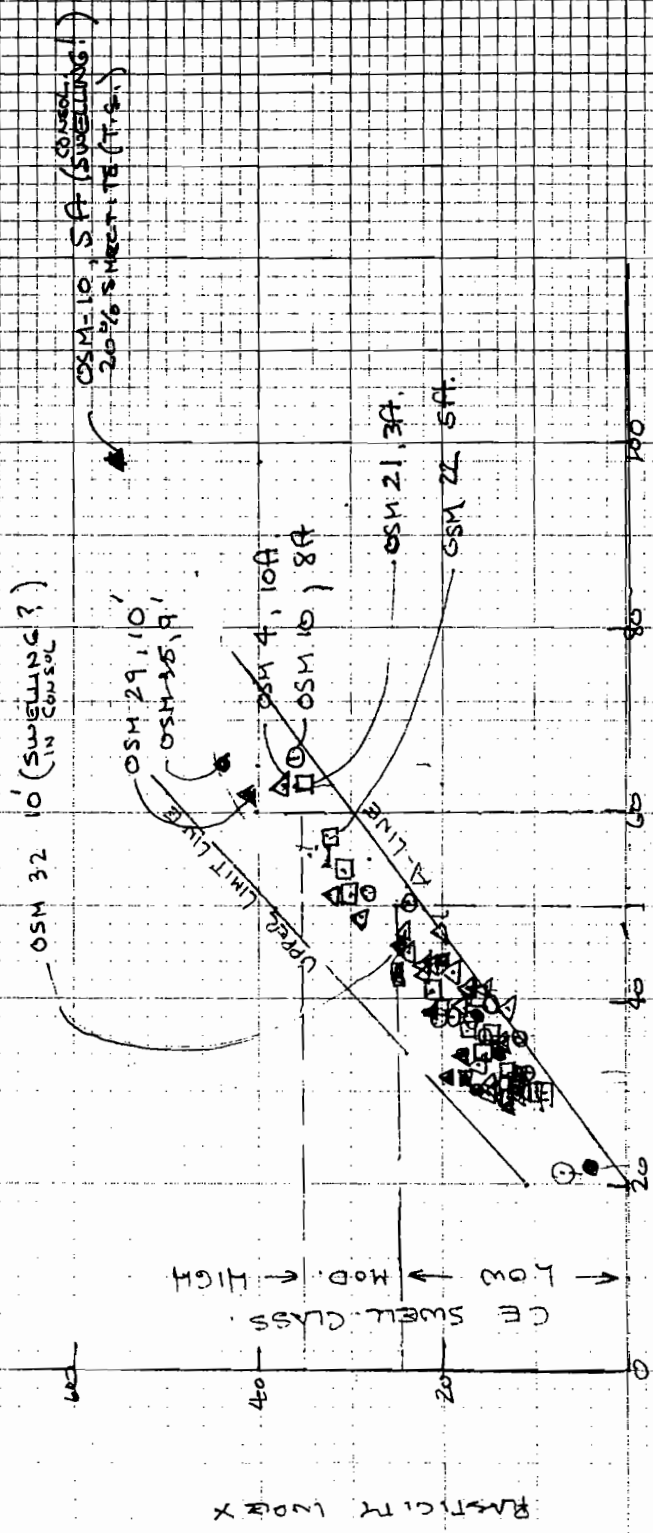
PLASTICITY CHART, DAYLIGHT & McCUTC

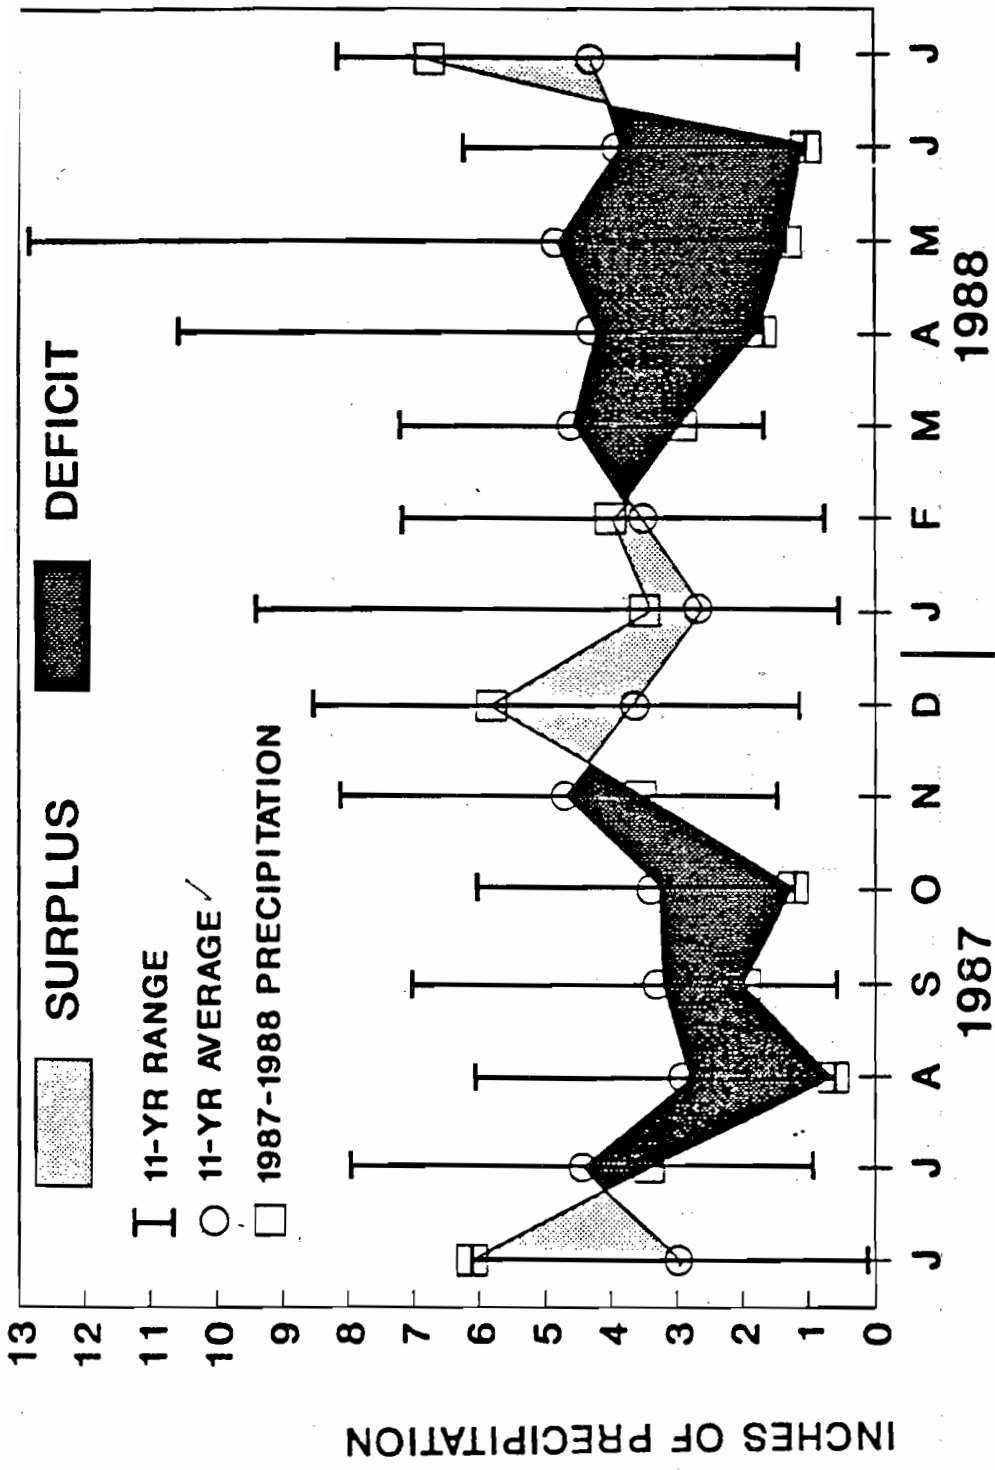
Figure 9.6-- Monthly Precipitation for Evansville, Indiana from June 1987 through July 1989.
