TRIP REPORT

Subject: Summary of Soil Infiltration Tests
Doylesburg Station
Sunoco PPP
Toboyne Township, Perry County, Pennsylvania

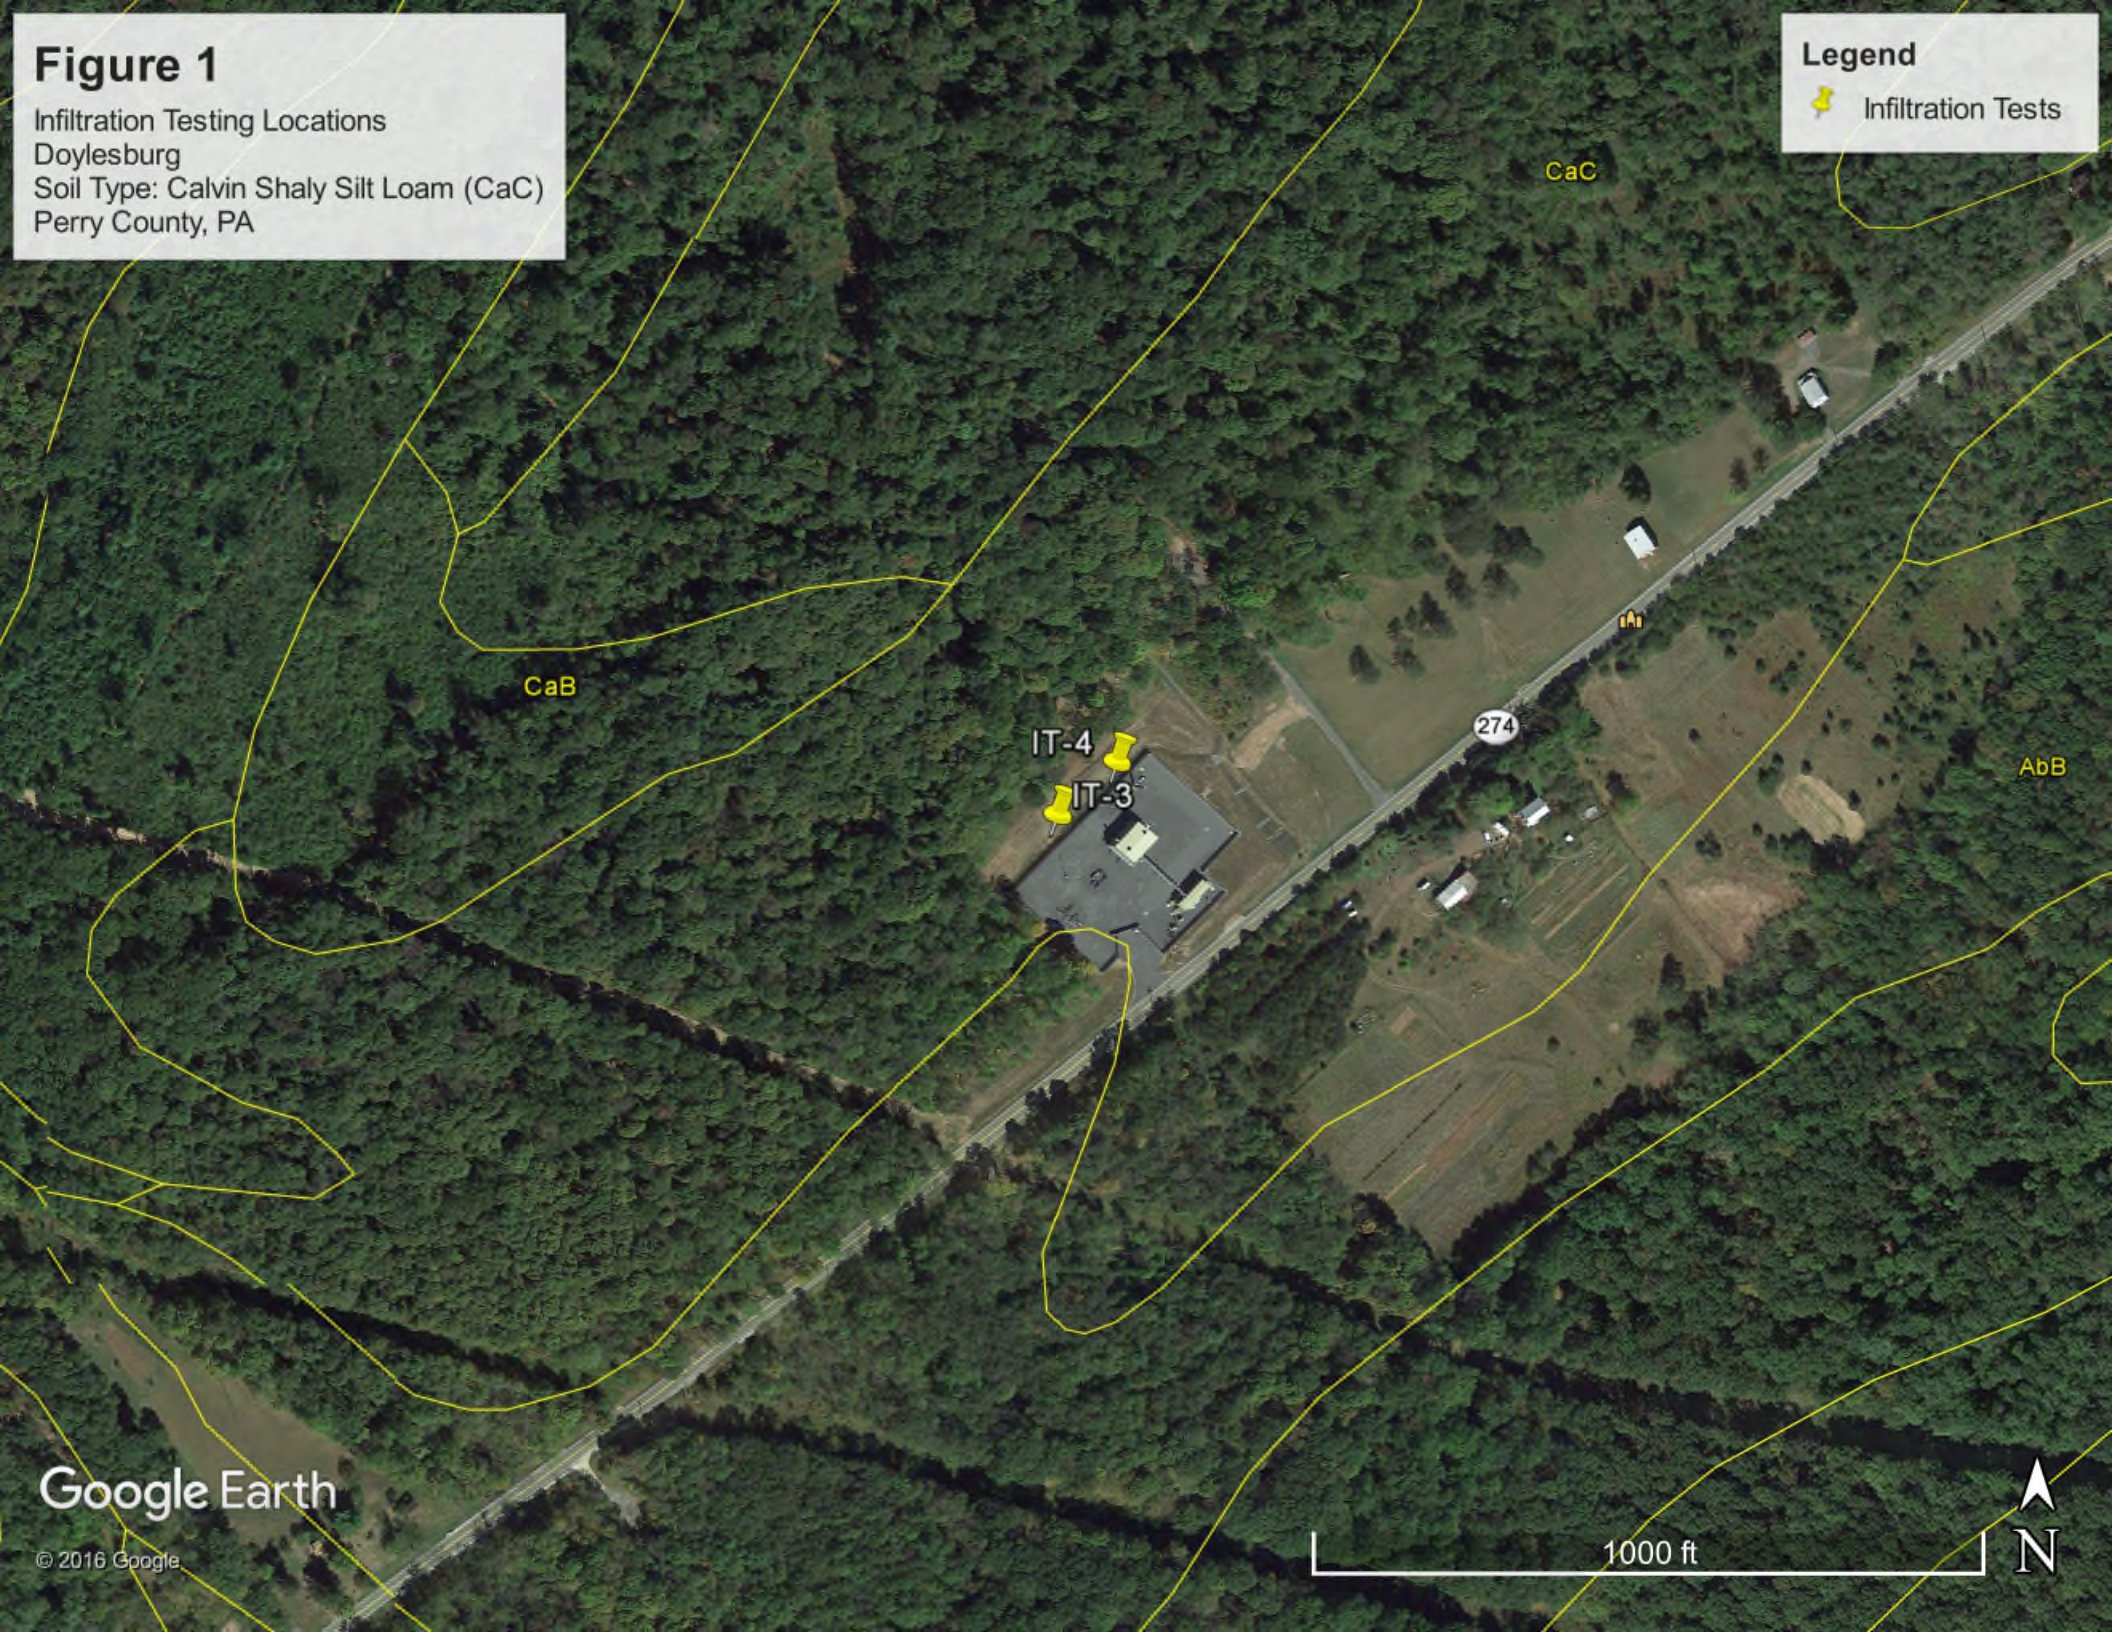
Figure 1

Infiltration Testing Locations
Doylesburg
Soil Type: Calvin Shaly Silt Loam (CaC)
Perry County, PA

This report presents the field data and results of double-ring soil infiltration tests conducted to support stormwater management system design. Two deep tests (IT-3 and IT-4) were performed at the property. Test locations are listed by coordinates in World Geodetic System 84 (WGS 84) latitude and longitude format in Table 1, and locations are also illustrated on a figure attached to this report.
