PENN PILOT PHOTO 1937, Enlargement of HDD area (red line indicates proposed HDD location): Note areas on photo (surface depressions and variation in soil moisture) near proposed HDD that may indicate additional fracture trace not shown anywhere on most recent documents submitted by Sunoco Logistics.

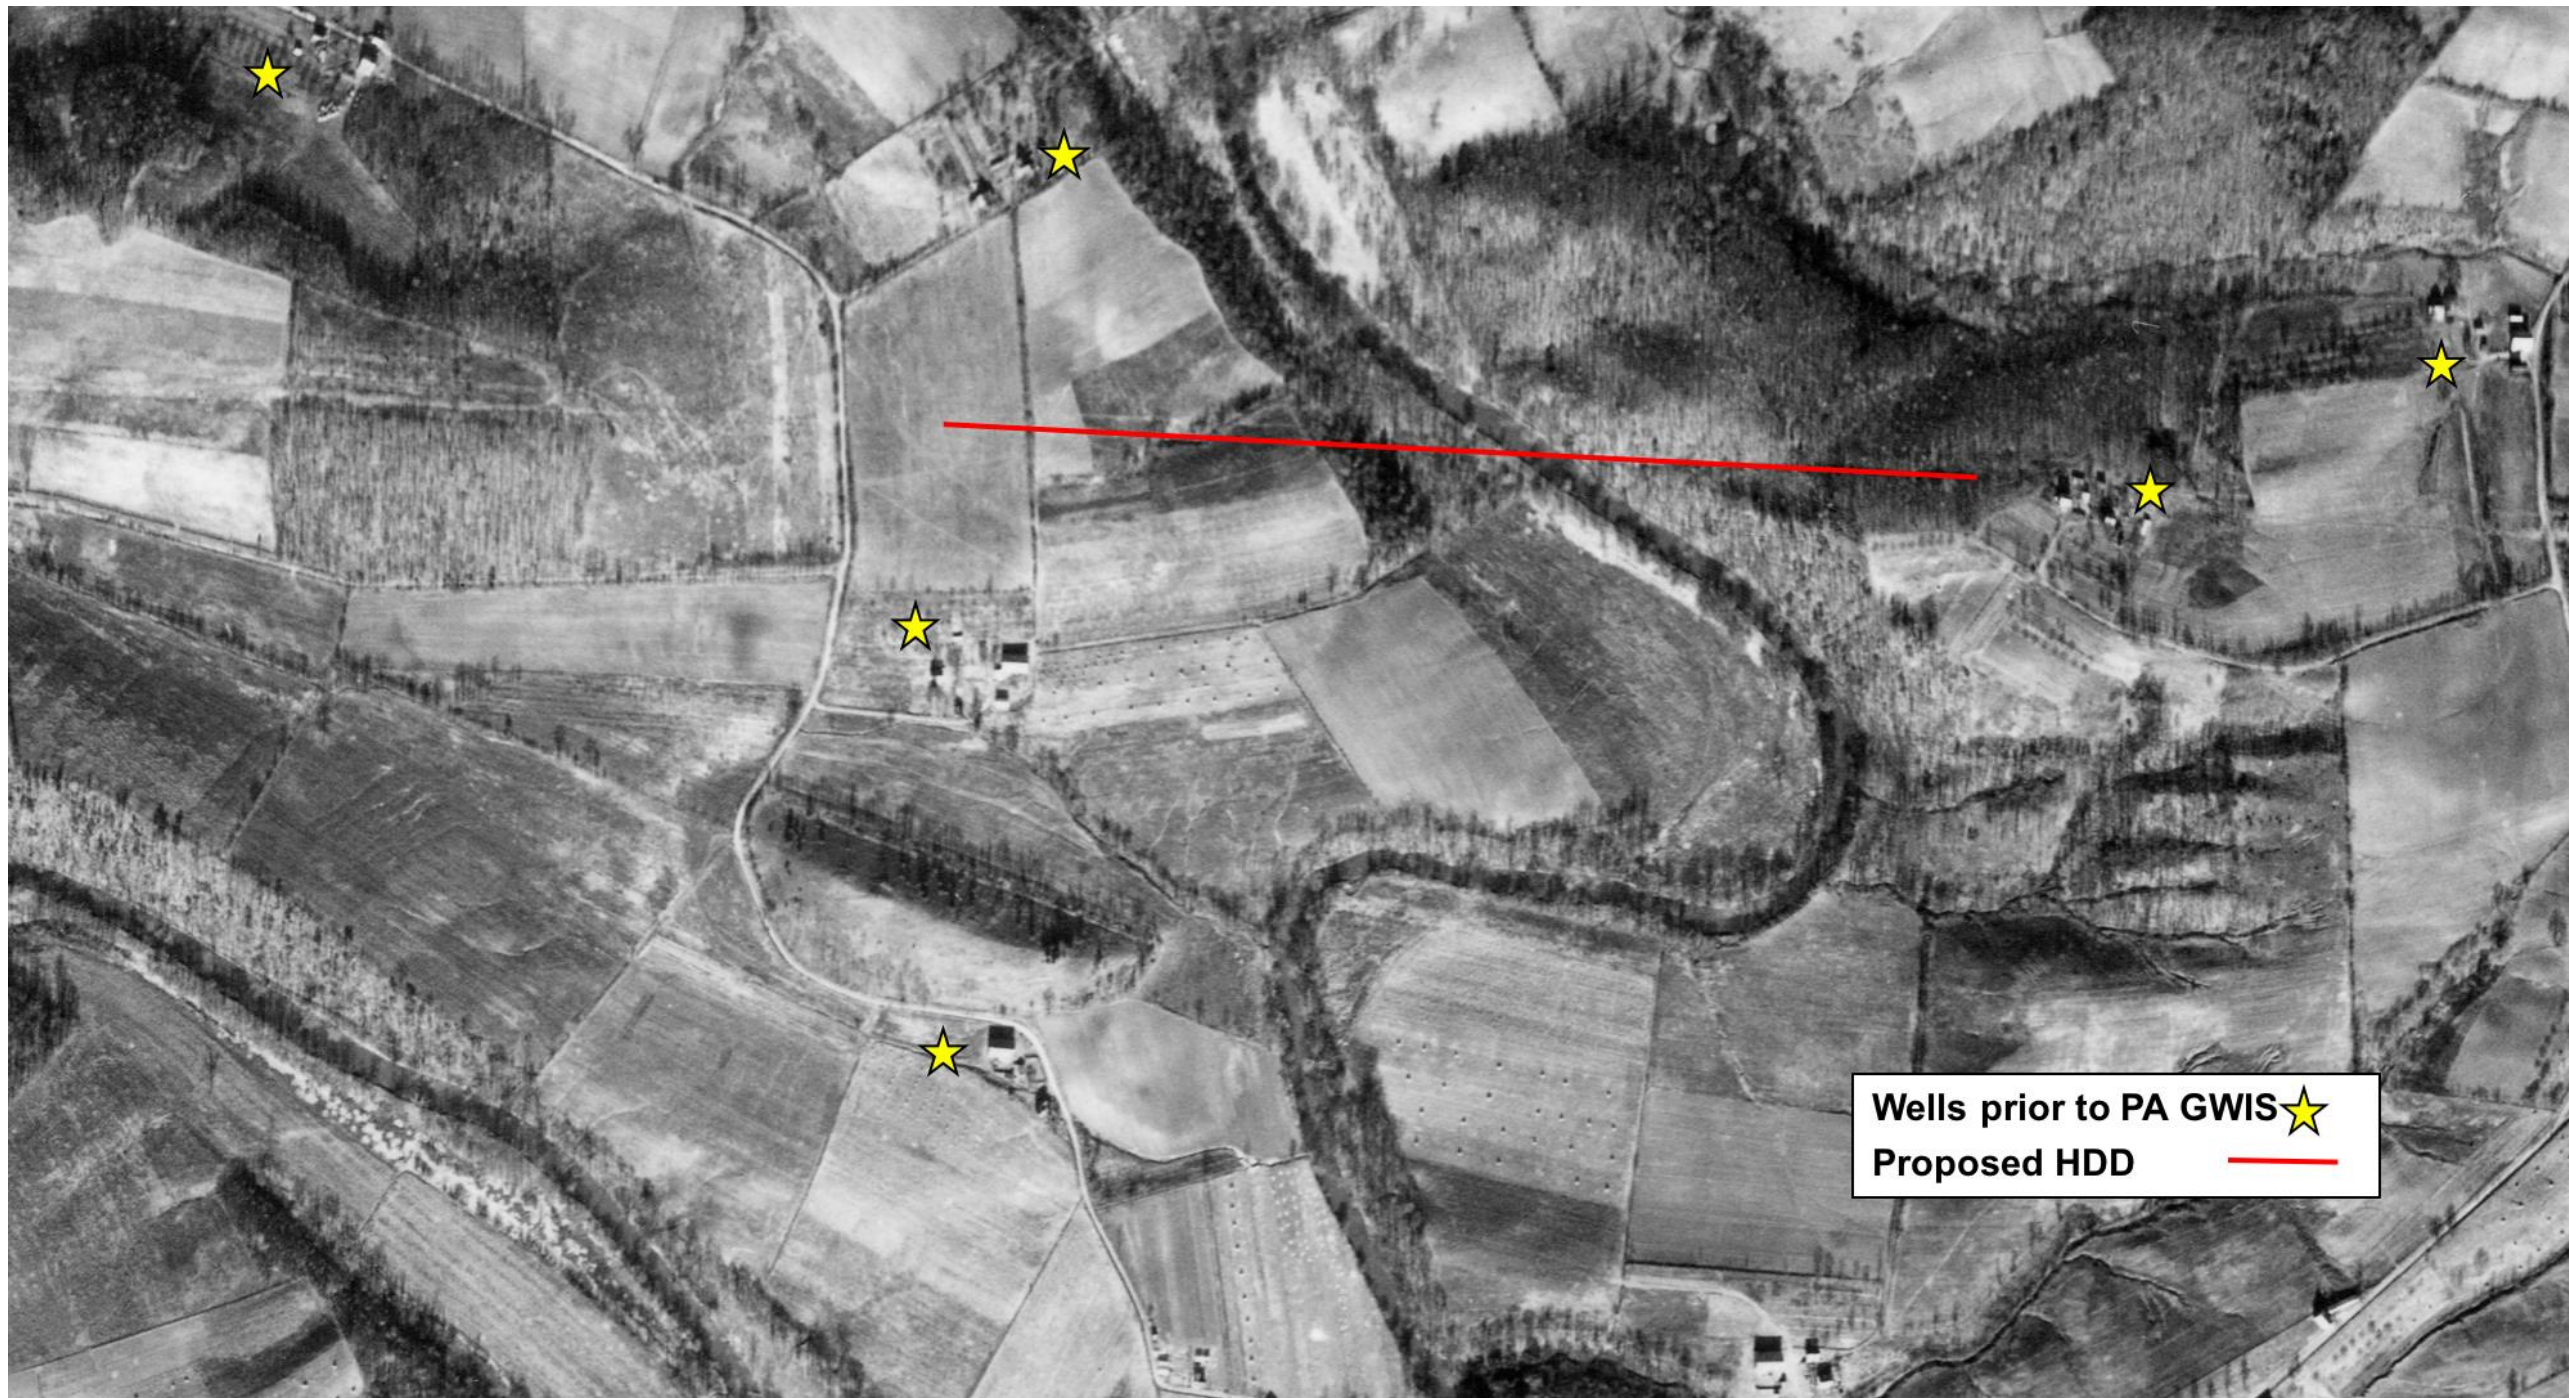
Wells near proposed HDD that are not in PAGWIS (Penn Pilot photo 1937 enlargement)

Wells prior to PA GWIS ★
Proposed HDD —
