Re: Violations of the Clean Stream Law and Temporary Discharge Approval
Pennsylvania Pipeline Project (a.k.a. Mariner East 2)
West Whiteland Township
Chester County

Attachment A - Current Conditions Reports

**Sunoco Pipeline L.P.
Pennsylvania Pipeline Project
Current Conditions Report**

PPP 6 – Wetland WL-B71 Bore
West Whiteland Township, Chester County, Pennsylvania

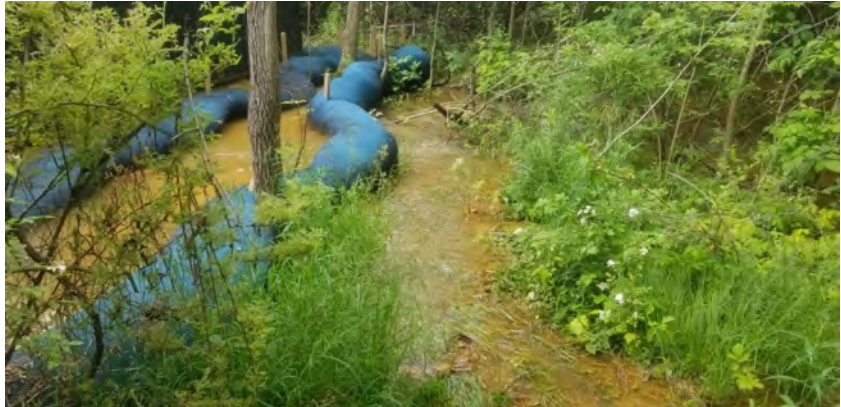
View looking southwest of section 1. Visual field observation noted no change in suspended sediment in discharge flow path.

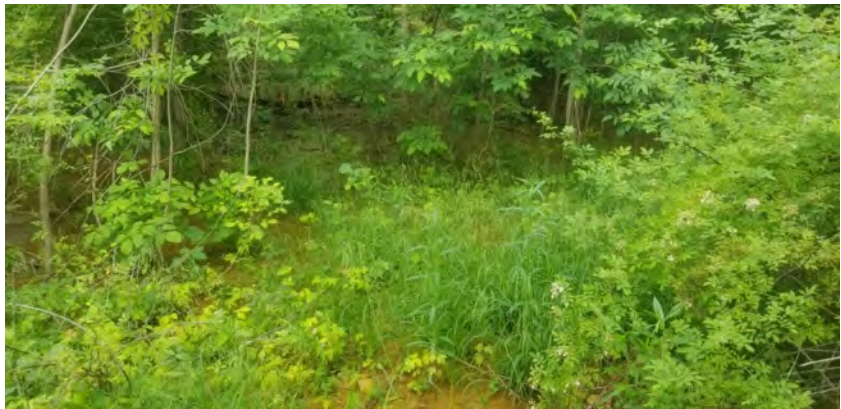
View looking north of section 2. Visual field observation noted no change in suspended sediment in discharge flow path.

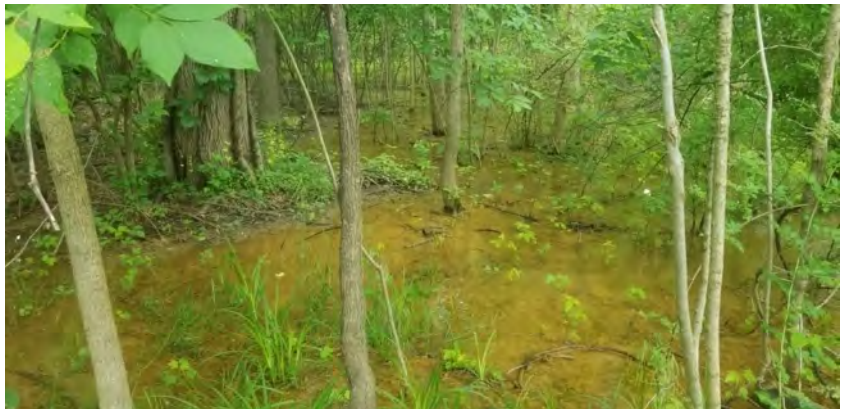
View looking north of section 3. Visual field observation noted no change in suspended sediment in discharge flow path.

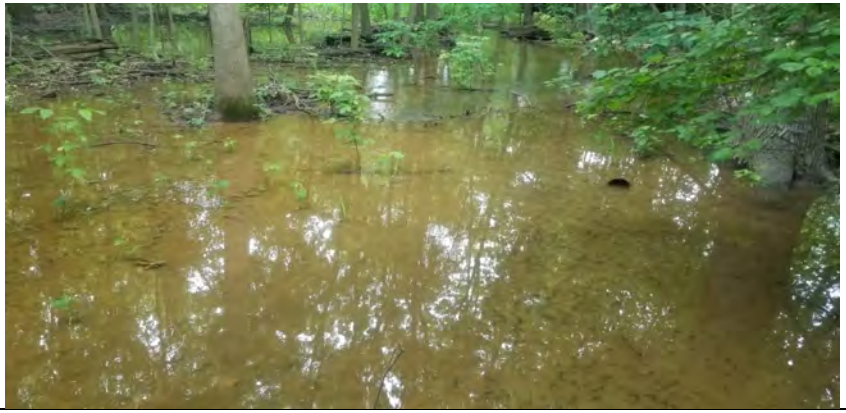
View looking north of section 4. Visual field observation noted no change in suspended sediment in discharge flow path.

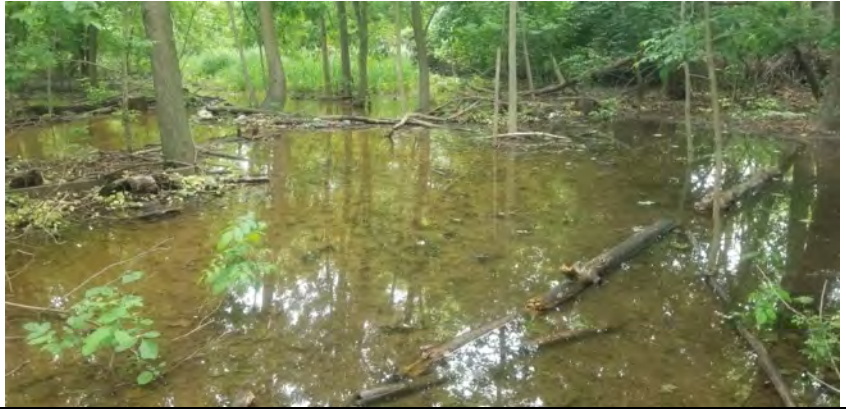
View looking west of section 5. Visual field observation noted no change in suspended sediment in discharge flow path.

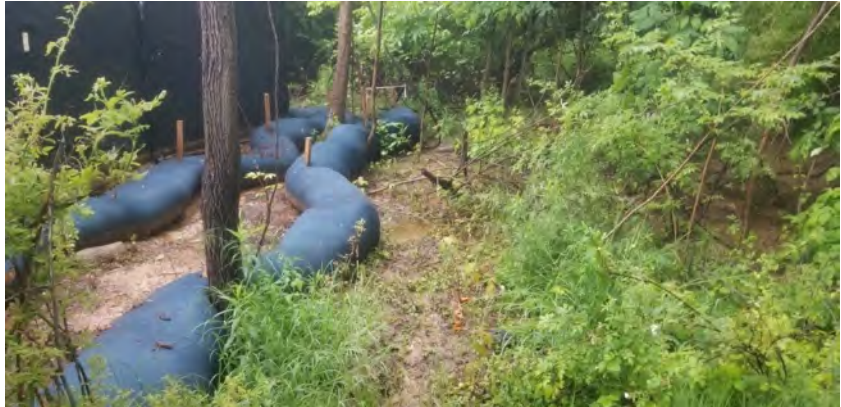
View looking southwest of section 1. Visual field observation noted no evidence of newly deposited sediment from increased turbidity on June 3, 2021.

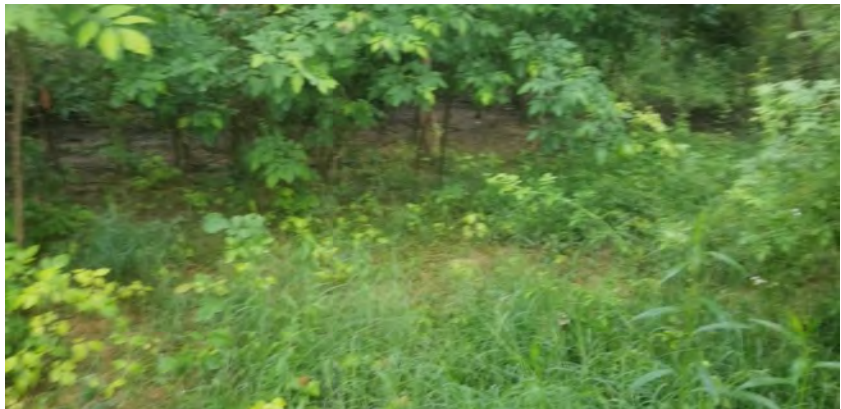
View looking southwest of section 2. Visual field observation noted no evidence of newly deposited sediment from increased turbidity on June 3, 2021.

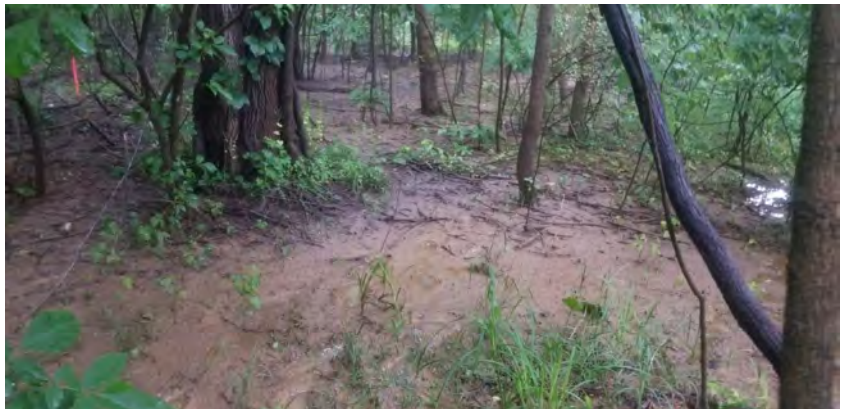
View looking southwest of section 3. Visual field observation noted no evidence of newly deposited sediment from increased turbidity on June 3, 2021.

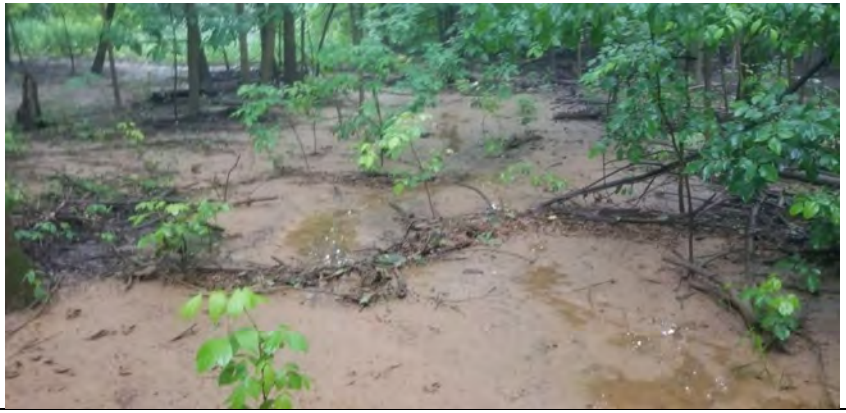
View looking southwest of section 4. Visual field observation noted no evidence of newly deposited sediment from increased turbidity on June 3, 2021.

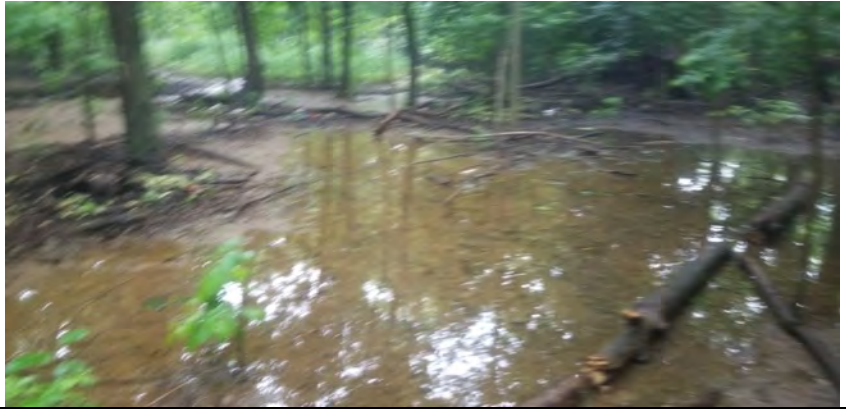
View looking southwest of section 5. Visual field observation noted no evidence of newly deposited sediment from increased turbidity on June 3, 2021.

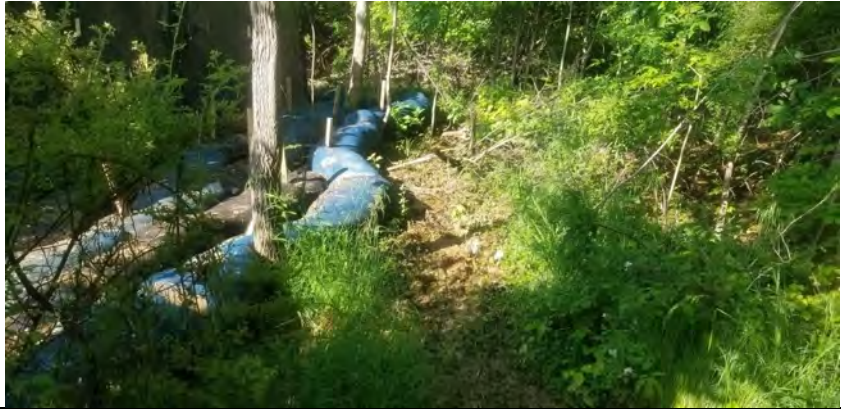
View looking southwest of section 1. Visual field observation noted no evidence of newly deposited sediment from increased turbidity on June 3, 2021.

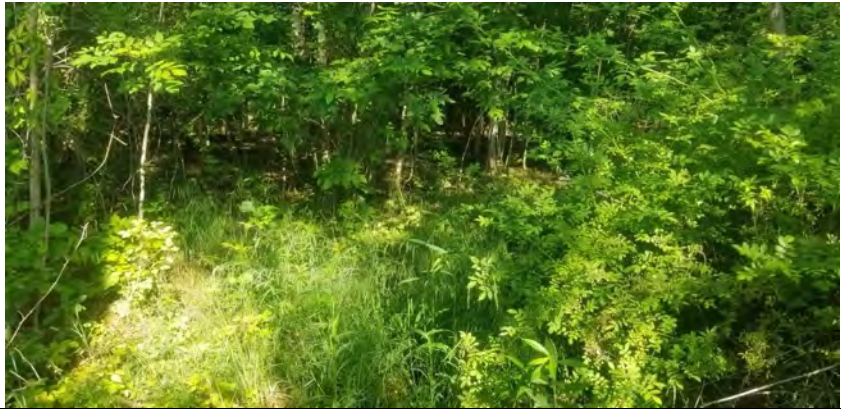
View looking southwest of section 2. Visual field observation noted no evidence of newly deposited sediment from increased turbidity on June 3, 2021.

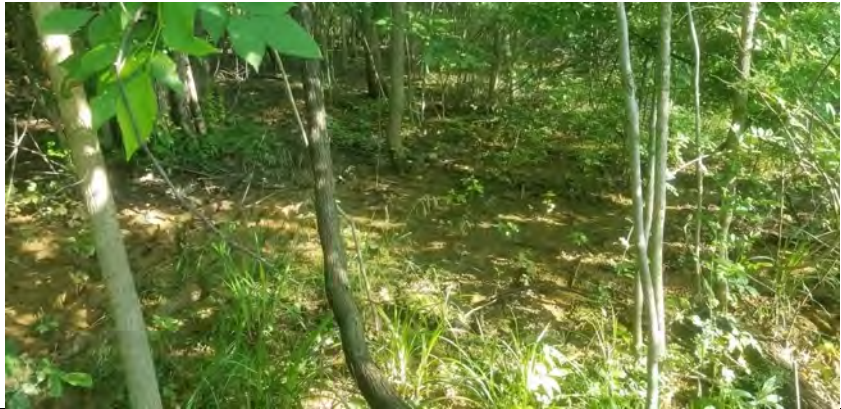
View looking southwest of section 3. Visual field observation noted no evidence of newly deposited sediment from increased turbidity on June 3, 2021.

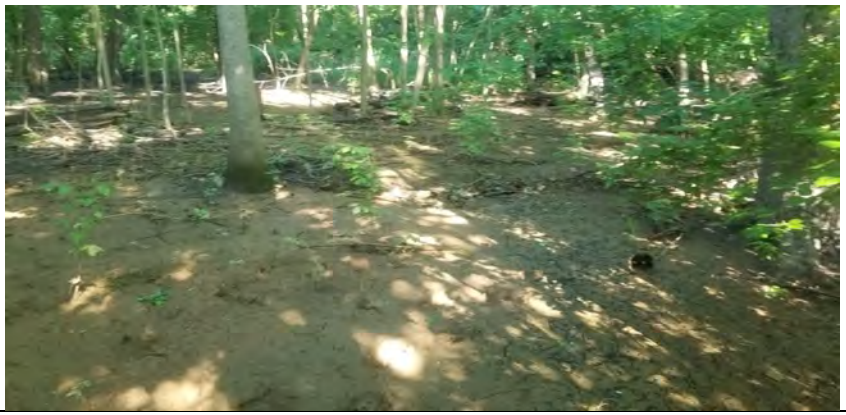
View looking southwest of section 4. Visual field observation noted no evidence of newly deposited sediment from increased turbidity on June 3, 2021.

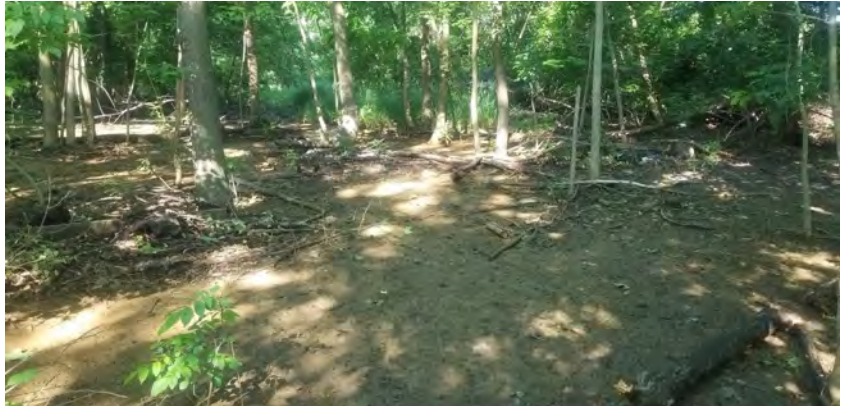
View looking southwest of section 5. Visual field observation noted no evidence of newly deposited sediment from increased turbidity on June 3, 2021.

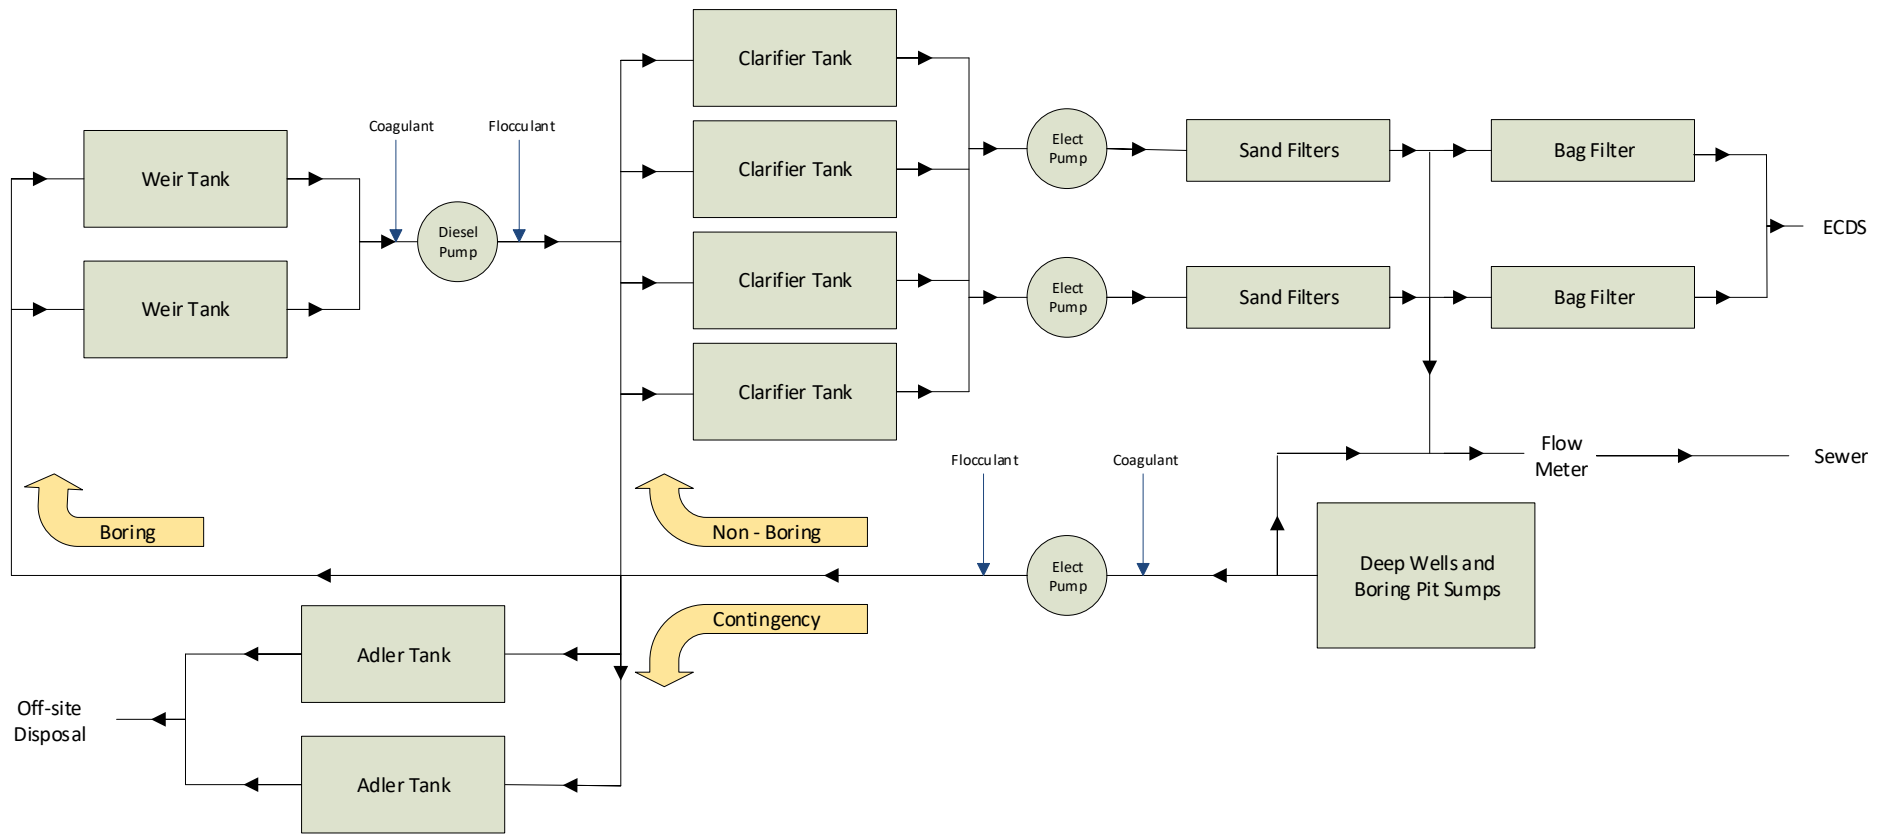
Attachment B - Flow Diagram

SPLP Response: *As stated in response 1, SPLP proactively shut down the system at approximately 1:15 pm to allow for additional adjustments and maintenance. Onsite personnel continued to adjust the system between 1:15 and 4:30 pm. These adjustments included changing out the sand/filter media, replacing filter bags, cleaning out weir tanks and adjusting water treatment chemical concentrations. The water was recirculated through the system and pumped back into the bore pit until it reached a visual clarity level indicating it was acceptable for discharge, which occurred at approximately 4:50 pm. At that point the water was allowed to flow into the filter bag in preparation to resume discharge into the wetland, per SPLP's temporary discharge approval. A courtesy notification was made to the Department, as discussed with DEP onsite field representative's and NTU's were monitored while this discharge was taking place. The Department verbally ordered SPLP to discontinue discharging at approximately 5:52 pm. To address potential heavier solids loading of the raw water while actively boring, an additional heavy sediment removal step is proposed where pumped water will first pass through two over/under weir tanks in parallel as pretreatment prior to introduction to the water treatment system. A revised flow diagram is attached (Attachment B).*
