Exhibit B

In re: Sunoco Mariner East 2 Pipeline Project

Summary and Recommendations

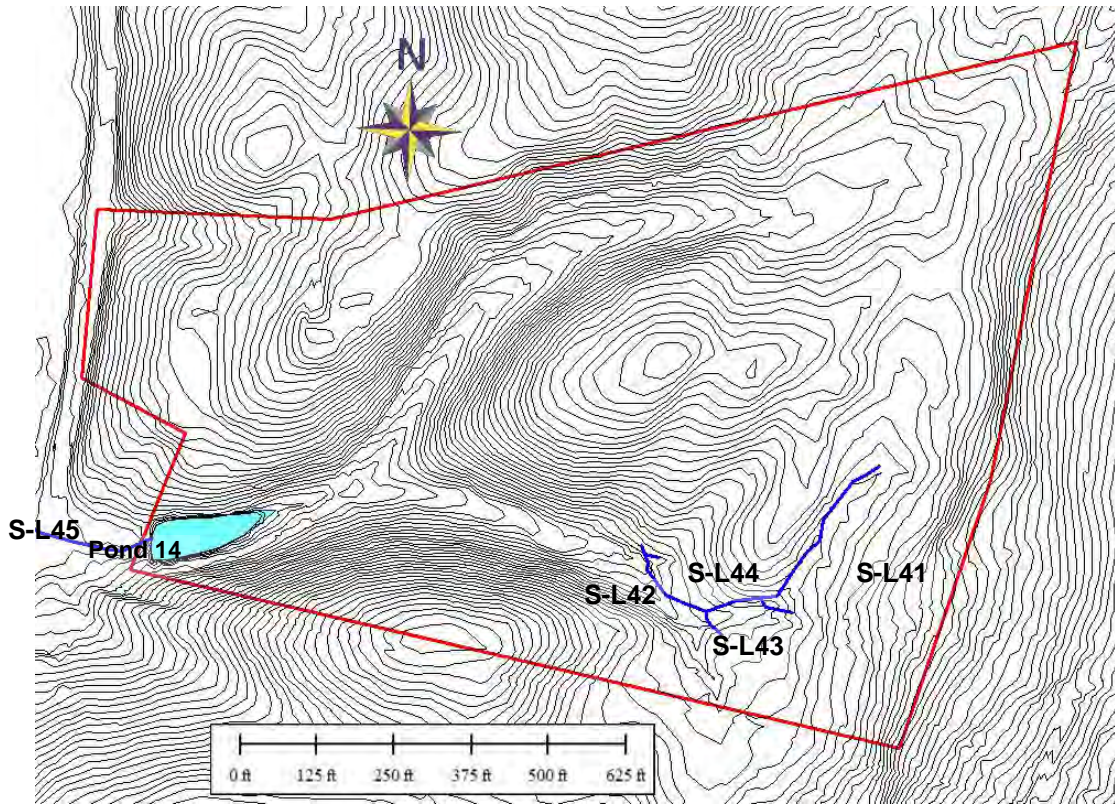
FIGURE 3. Comparison of streams (blue lines) identified on the property by Sunoco pipeline consultant (above) versus what the LiDAR-based data show and the Schmid & Company field inspection confirms (below). The subject property is outlined in red. The LiDAR 2-foot contour lines cluster together in areas of steep slopes.

As listed above, the pipeline drawings identify five stream segments on this property (Figure 3, top), all of which are identified as being intermittent except for Stream S-L43, which is identified as ephemeral. These onsite waterways are shown as disconnected

In fact, there are two main bed-and-bank watercourses on the subject property that feed your pond, plus at least one smaller connected tributary drainageway (Figure 3, bottom). The two main streams can be described as relatively permanent, inasmuch as they have prolonged flow of groundwater and a diverse streambed community of benthic invertebrate organisms. The two main streams converge within wetlands about 100 feet upslope from your pond. As noted in State technical guidance, ponds in Pennsylvania generally constitute evidence that their tributary streams have permanent flow. State regulations apply equally to permanent and intermittent streams. West of the pond a single stream flows through a culvert beneath Trough Creek Valley Pike and converges with Little Trough Creek within a large wetland downstream from your land. Your northern onsite stream is of less concern at present because it is largely remote from currently-proposed pipeline activities. We do not focus on it here. The pipeline-designated S-L41 and S-L42 are upstream segments of the southern stream that feeds your pond. The northern stream is not shown on the pipeline drawing at all, even though its confluence with the southern stream lies immediately outside the edge of the ATWS rectangle shown on the pipeline drawing.

The onsite streams as depicted by us at the bottom of Figure 3 are taken from the PADCNr LiDAR-based topographic mapping¹ of drainageways for this area. During Schmid & Company field investigations on 17 March 2016 Mr. Kunz and I confirmed the general accuracy of the LiDAR topographic and streamcourse mapping. We added one short tributary which arises as a bed-and-banks feature in the existing Buckeye pipeline ROW along the south side of the property. A very short segment of this same waterway is identified by the pipeline consultant and labeled Stream S-L43. The pipeline mapping of this waterway is deficient in two respects: (1) it does not show the full extent of the intermittent channel on your property, and (2) it describes this stream as ephemeral. On the day of our field inspection, we observed this waterway to have an established bed and banks, as well as water within or just below the streambed, from its connection with the southern main onsite watercourse up to and into the existing Buckeye pipeline ROW (Photos 1 and 2). This flow originated from groundwater, not from surface runoff.

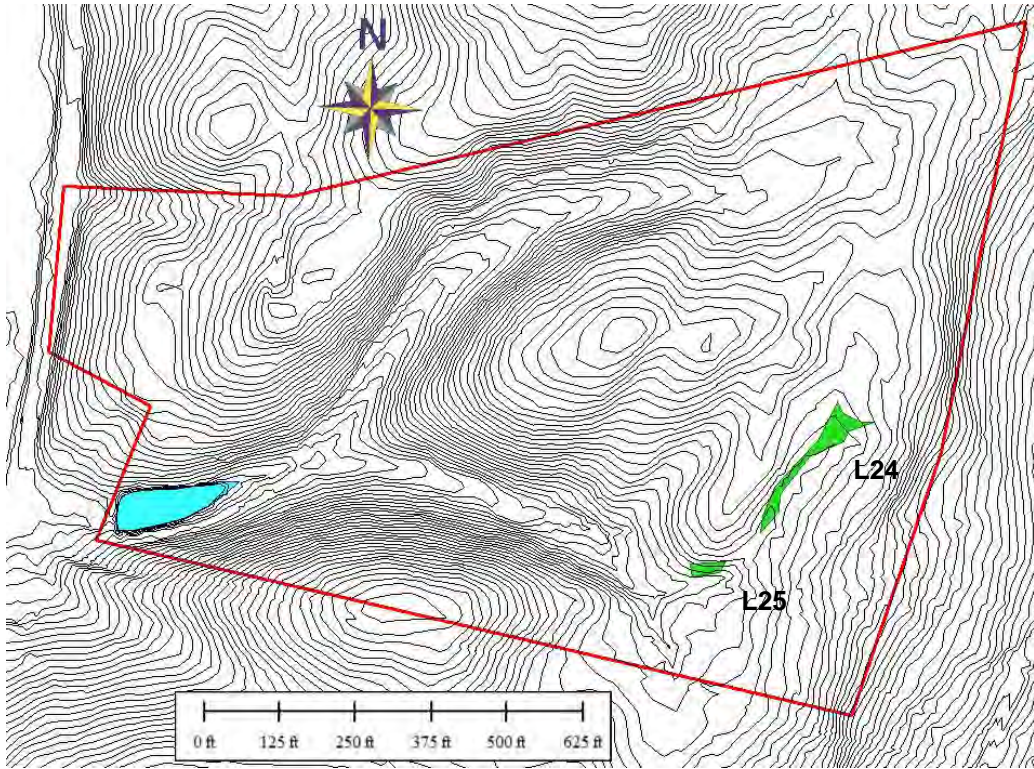
FIGURE 7. Comparison of wetlands (green, 0.13 acre) identified on the subject property (red outline) by Sunoco consultant (above) versus likely extent based on Schmid & Company field investigation (1.6 acres, below). Pond also is shown (blue). Schmid & Company did not investigate wetlands along the entire northern unnamed stream, but only near its confluence with the southern stream.

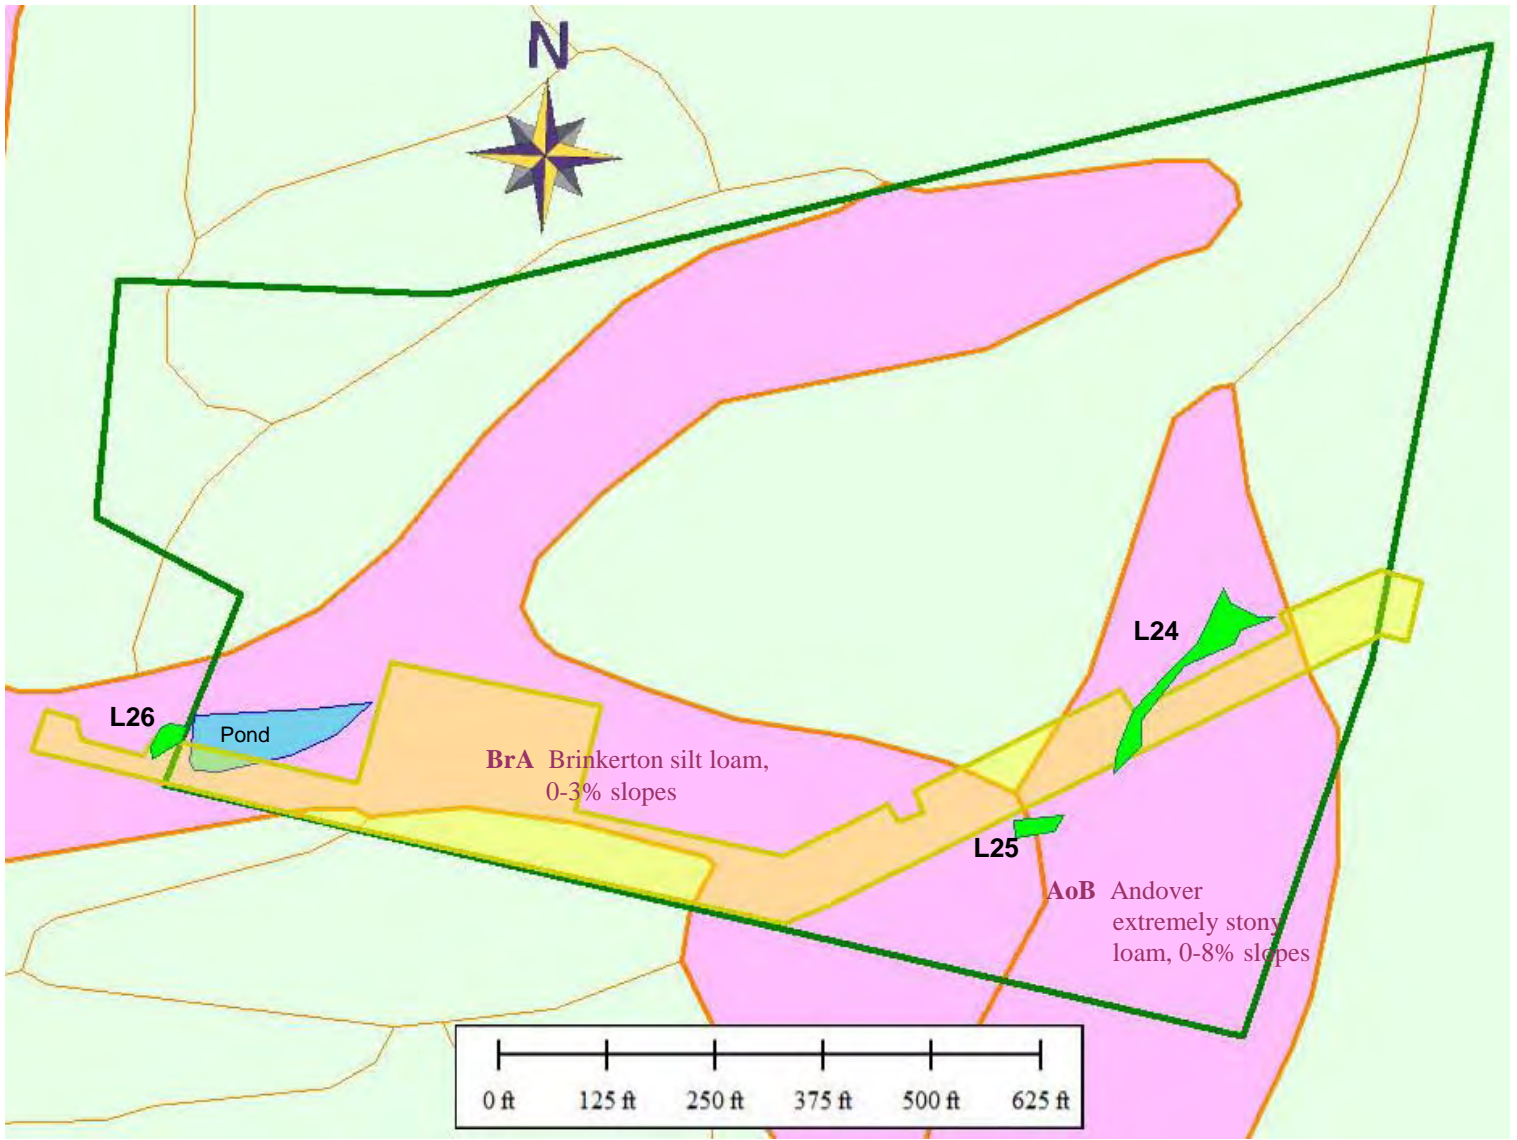
FIGURE 6. Hydric soils (BrA and AoB; pink) mapped on and near the subject property (dark green outline) compared with Sunoco consultant wetlands (green) and pond (blue) delineated in and near the proposed limit of disturbance (yellow). County-mapped hydric soils cover 12.6 acres of the property. Pipeline consultant-delineated onsite wetlands cover 0.13 acre and the pond covers another 0.22 acre. The pipeline consultant seriously undermapped streams and wetlands at risk on the subject property.

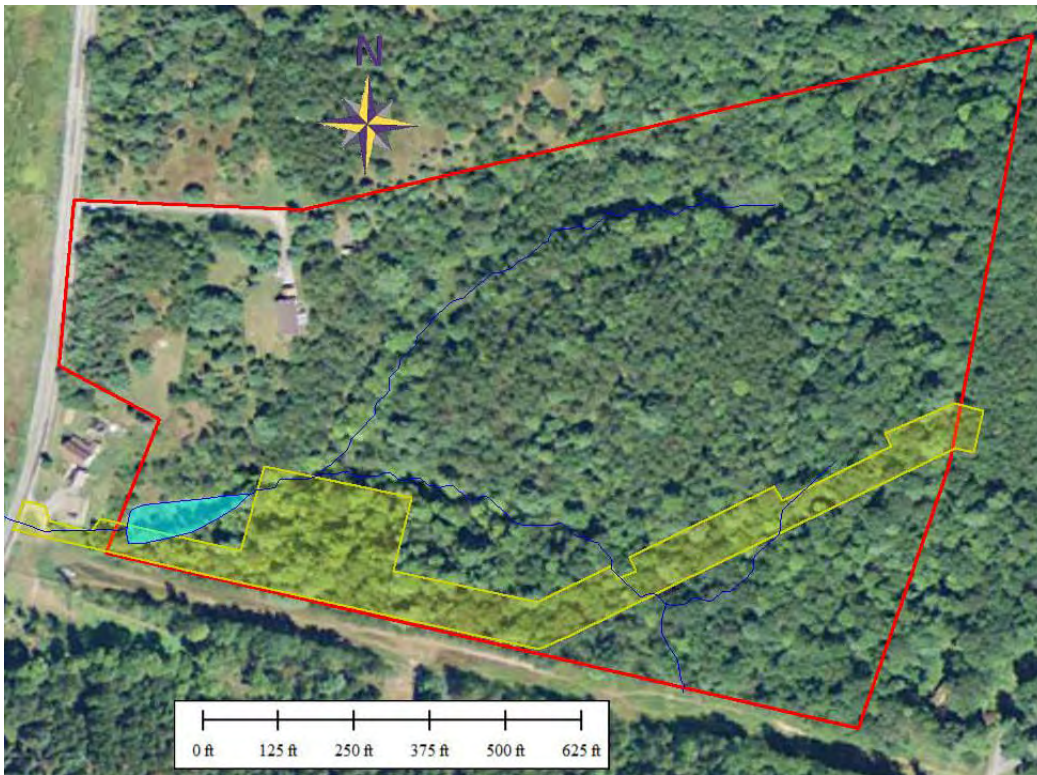
FIGURE 8. The proposed limit of disturbance (yellow) in the southern section of the subject property (red outline) is both heavily wooded (above) and largely consists of very steep slopes (below). The cutting of forest on steep slopes can cause immediate and long-term impacts to the downslope waterbodies. Streams are indicated in dark blue; pond, in pale blue. The clearcut corridor of the Buckeye Pipeline is conspicuous along the southern border of the subject property. USDA airphoto.

The outer limit of disturbance (LOD) for proposed pipeline activities is depicted in yellow on Figure 8, based on the temporary and permanent disturbance areas shown on Site Plan Drawing Sheet 21 of 51 for Huntingdon County. Within the pond watershed the pipeline proposes to disturb 4.5 acres for construction. We measure the proposed disturbance area within the subject property itself to be 2.97 acres. As shown on Figure 8, the LOD is virtually all forested and is largely characterized by steep slopes, such as the nearly 0.5 acre of Klinesville (KID) soils ranging from 15 to 25% slopes on the immediate south side of the pond and the 1.5 acres of Buchanan (BxD) soils on 8 to 25% slopes at the top of the watershed. Proposed tree cutting and clearing of surface vegetation within these forested and steep slope areas is likely to result in significant short-term erosion and sedimentation unless extraordinary measures are successfully implemented to avoid it. Construction activities in those areas probably will cause significant degradation of the adjacent waterways and the balance of the downslope pond in addition to the areas directly destroyed by clearing and grading.

Of particular concern is the proposed rectangular, 0.83-acre ATWS work area just upstream from the pond. That area contains some of the steepest slopes on the property and extends into the stream and associated wetlands where the two unnamed tributaries converge. Because the pipeline drawings identify no stream or wetlands there, however, those impacts have not yet been included in the acknowledged totals. I understand that the pond provides recreational and aesthetic benefits to your family, as well as habitat for fish and for resident and migratory wildlife. The proposed drilling under Little Trough Creek as currently planned will not avoid any impacts on your pond.

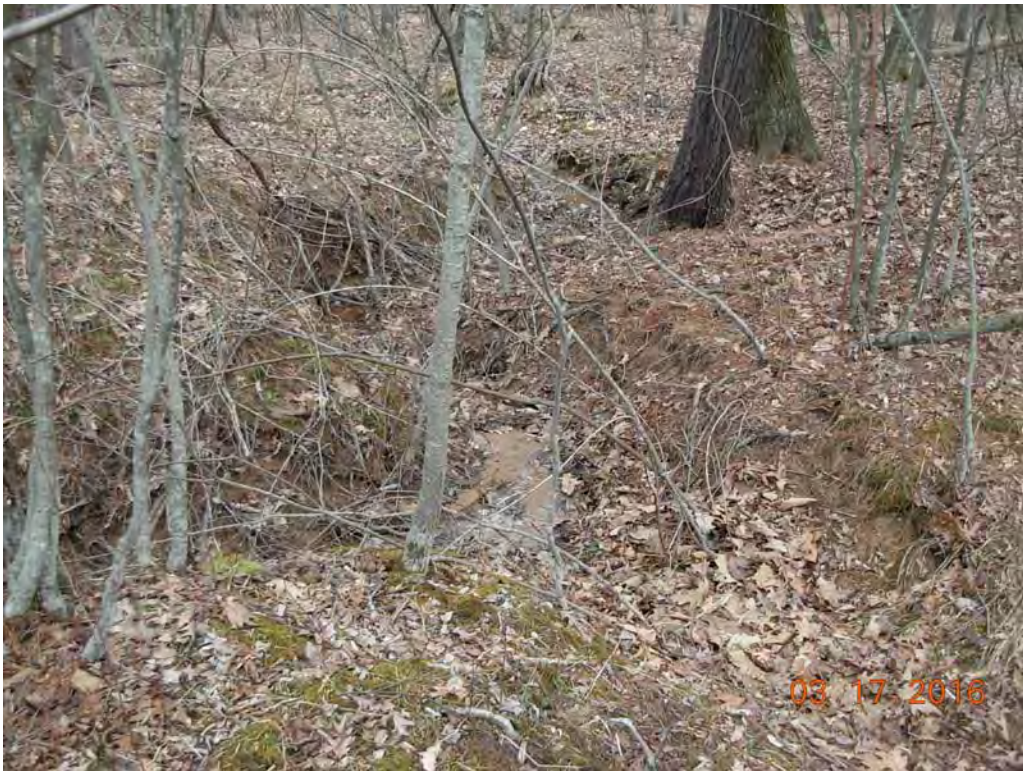
Photo 1. View northward from the Buckeye Pipeline ROW into the upper section of an unnamed tributary incorrectly mapped by Sunoco consultant as ephemeral (S-L43). Water within the defined bed and banks can be seen here near where it meets the existing ROW.

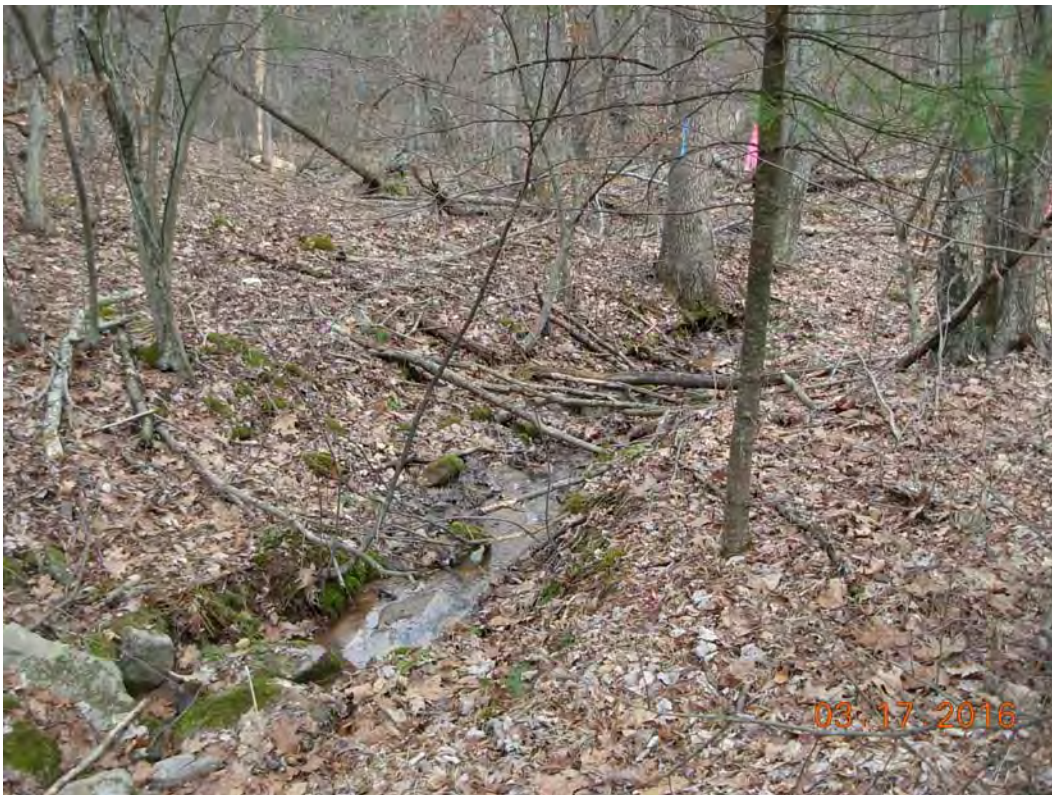
Photo 2. View northward on same drainageway as above except further downgradient, just upslope from where Sunoco consultant stopped its mapping of S-L43 (blue flag, midground).

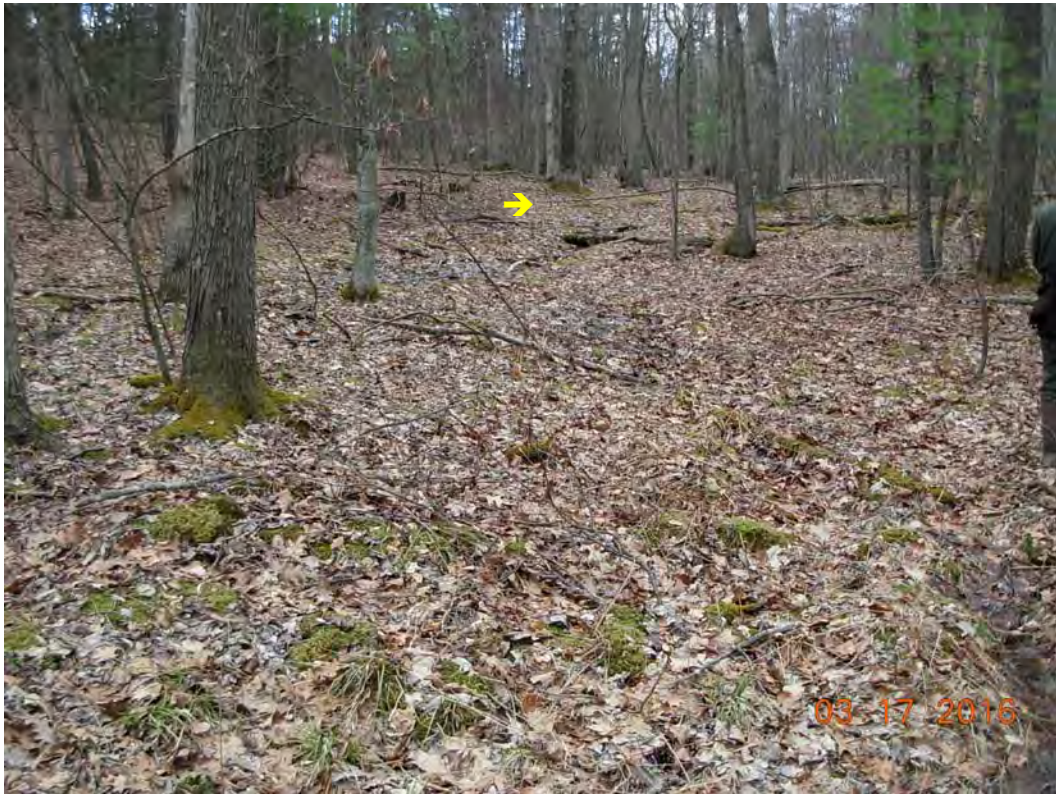
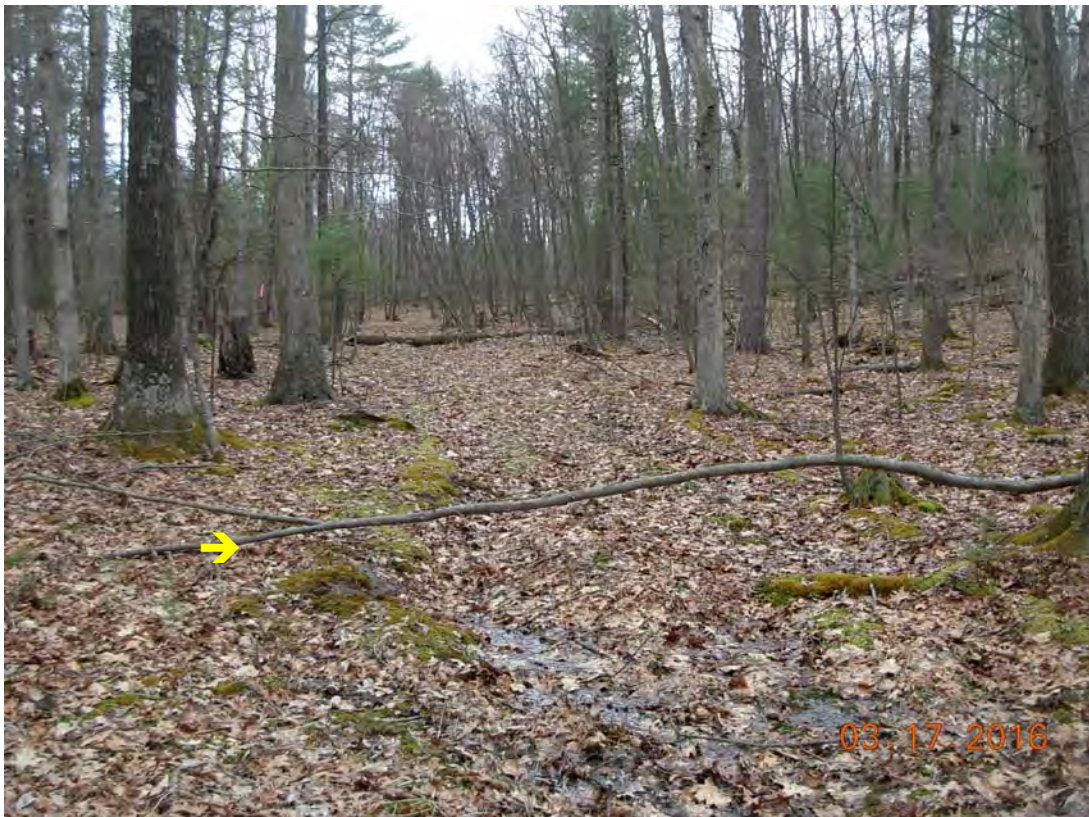
Photos 3 (above) and 4 (below). Views northward of wetlands extending beyond the end of pipeline-consultant mapped Wetland L24. The fallen branch in the foreground in Photo 4 is the same as the one in the background in Photo 3 (yellow arrows). The bed and banks of the stream here becomes a swale, but the surface hydrology is evident, and the soils are clearly hydric (low chroma matrix, prominent mottles).

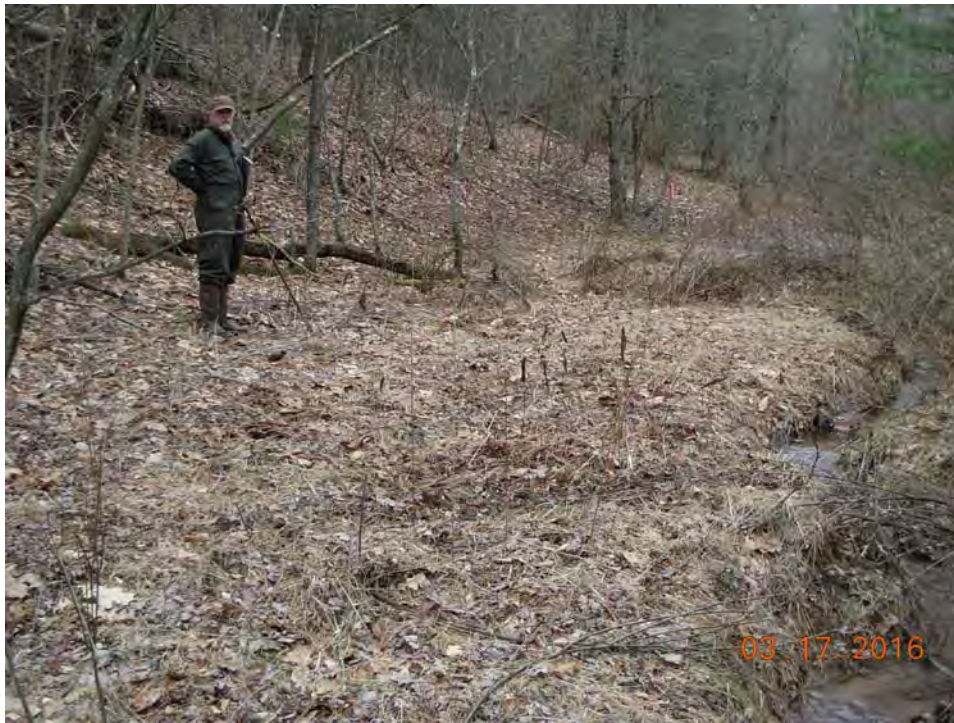
Photo 5. View eastward on the southern stream between the pond and pipeline consultant-mapped Wetland L-25. The area between the man and the stream channel exhibits all three wetland field characteristics but has not been identified on project drawings as a wetland. Similar patches of wetland are found along one or both sides of this entire stream.

We also observed wetlands within the 100-foot wide State-regulated floodway along one side or the other (and sometimes both sides) of the southern unnamed stream on the property between L24 and L25 and downstream from L25 to the pond (Photo 5). We left occasional pink tracer flags at the edge of observed wetlands along this middle section of the watercourse, but did not attempt to flag the entire extent of wetlands along this reach.

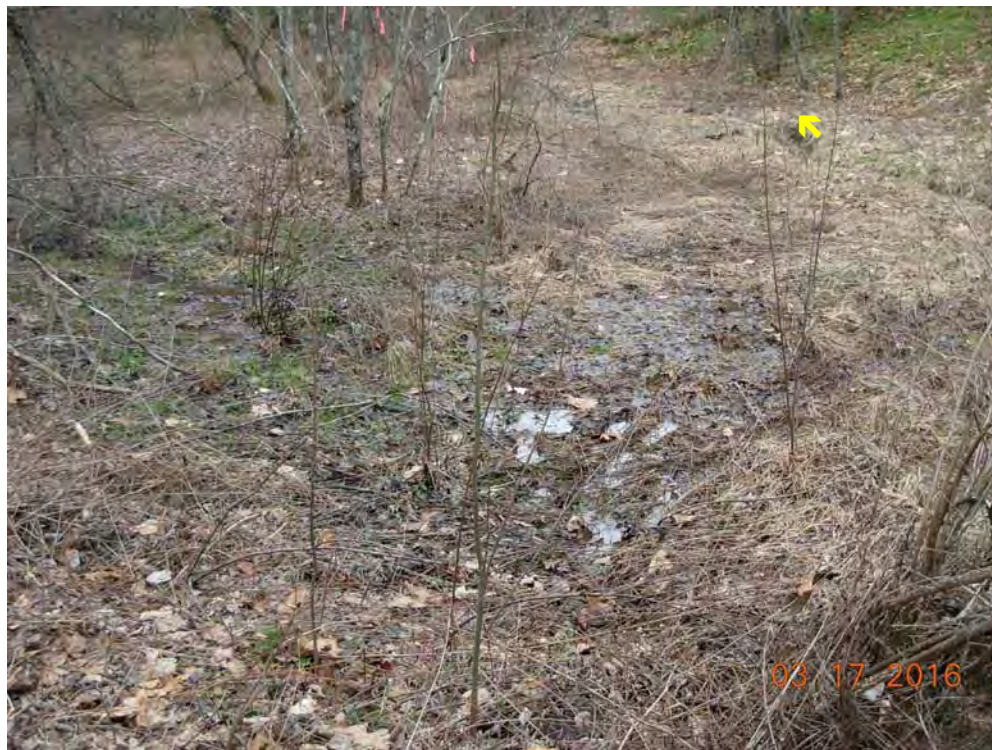
Photo 6. View eastward of a wetland not identified by the pipeline consultant at the confluence of the two main onsite streams. The incised channel of the southern stream is visible in upper right (arrow). Part of this wetland is within the proposed ATWS disturbance area.

A relatively large area of wetland exists at the confluence of the two main onsite streams just upstream from the pond (Photo 6). We left pink flags around the wetlands in this area, beginning at the upper end of the pond, extending through the confluence area, and then a short distance up each of the two watercourses. The proposed ATWS rectangle extends into this area.

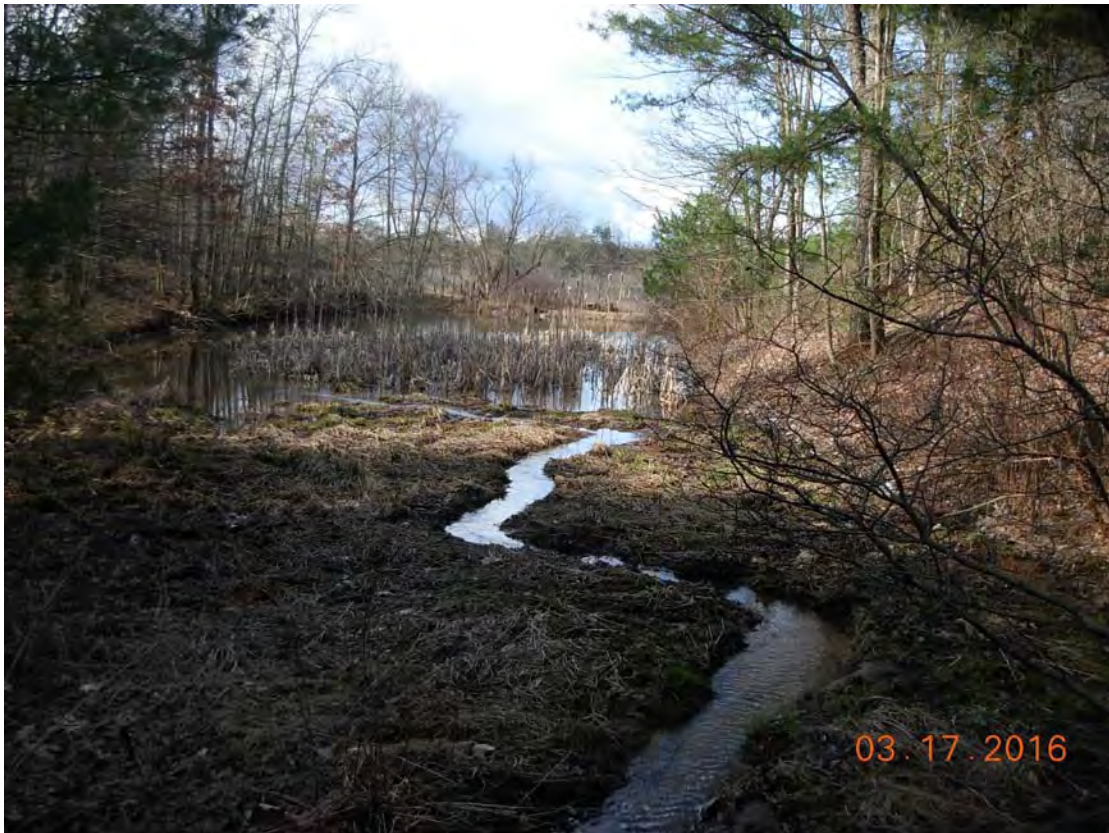
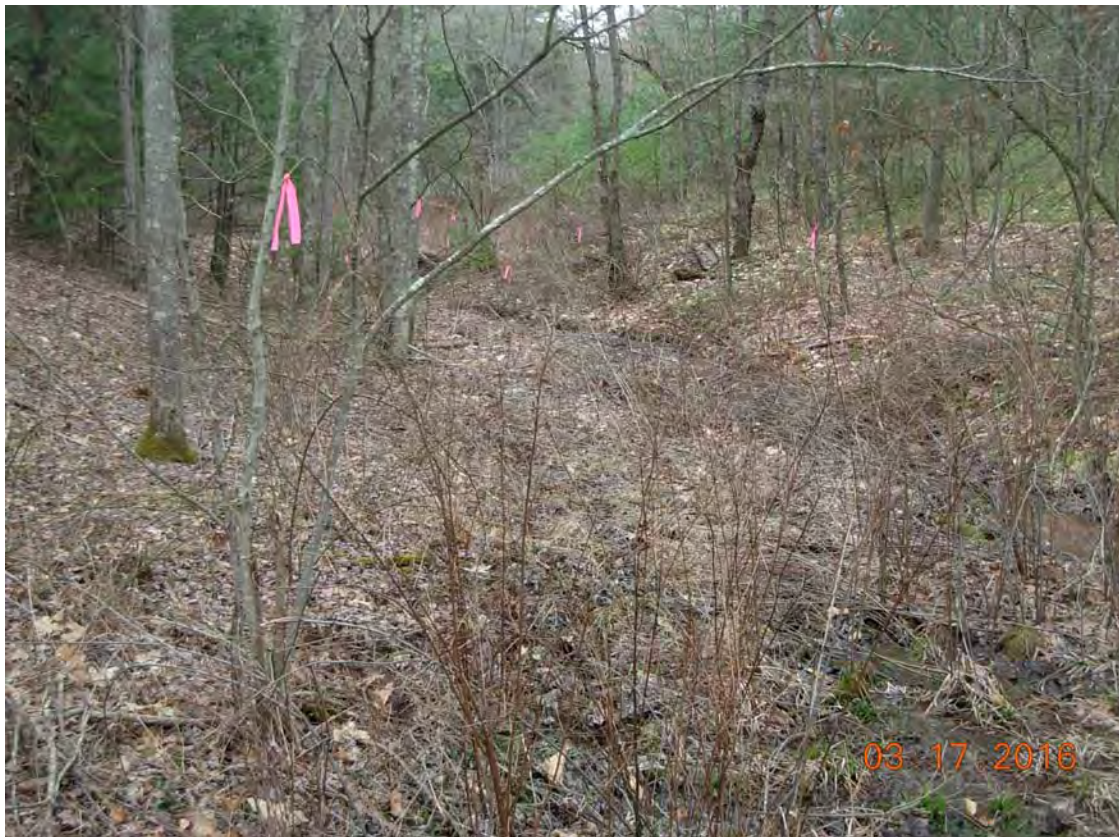
Photos 7 (looking west, above) **and 8** (looking east, below). Views are near the upper end of the onsite pond. Note in Photo 7 cattails (PEM) in the open water (POW) of the upper pond, and emergent marsh (PEM) extending an additional 75 to 100 feet upstream from the pond. Beyond that to the east (Photo 8) the wetlands along the watercourse are forested (PFO).

Emergent wetlands (PEM) dominated by cattails (*Typha latifolia*, OBL hydrophyte) occupy the upper section of the open water (POW) in the pond itself (Photo 7). Emergent wetlands dominated by reed canarygrass (*Phalaris arundinacea*, FACW hydrophyte) and other herbaceous hydrophytes occupy an area about 75 to 100 feet in length along the watercourse just upstream from the end of the pond's open water. Beyond that, the

wetlands along the onsite watercourses would be characterized as palustrine forested riparian wetlands (PFO; Photo 8) throughout the subject property.
