# Snake Creeks

## Watershed Assessment Report

January 2003

**The Snake Creeks Watershed Assn.**

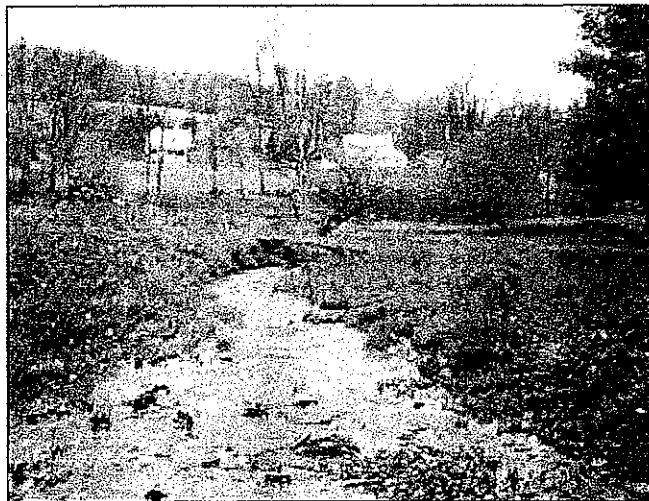
*Channel Physical Characteristics Range 0 to 20: Value 10*

Average bankfull width (ft):	3	Average bankfull depth (ft):	0.7
Pool to riffle ratio:	1:2	Erosion:	moderate
Water Temperature (°C):	10.2	Fish cover/habitat:	medium cobbles
Sedimentation:	reddish-brown silt deposits	Side slopes:	gradual to N, steep to S
Bank erosion potential:	severe	Streamside cover:	herbaceous, forested
Substrate:	60% cobble, 30% silt, 10% gravel

Facing northeast, looking downstream at sample site along Silver Creek.

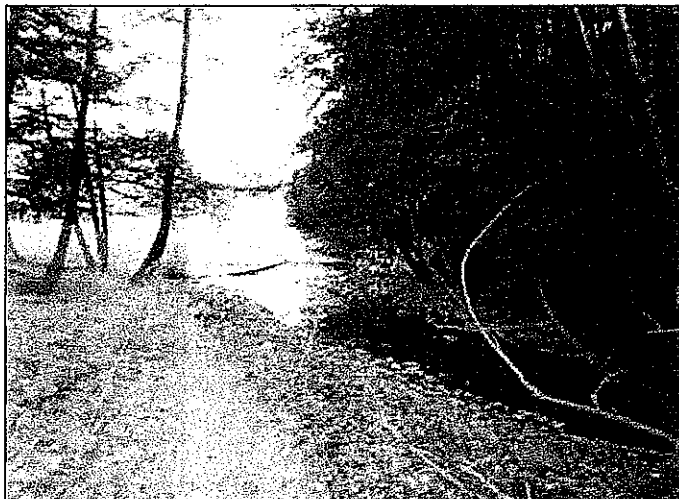
*Channel Physical Characteristics Range 0 to 20: Value 15*

Average bankfull width (ft):	25	Average bankfull depth (ft):	2.1
Pool to riffle ratio:	2:3	Erosion:	slight to S, none to N
Water Temperature (°C):	6.5	Fish cover/habitat:	root systems, undercut banks, medium-large boulders
Sedimentation:	many vegetated gravel beds	Side slopes:	gradual to N, vertical to S
Bank erosion potential:	slight	Streamside cover:	trees, herbaceous
Substrate:	50% cobble, 25% silt, 25% gravel

Facing east and looking downstream along Silver Creek.

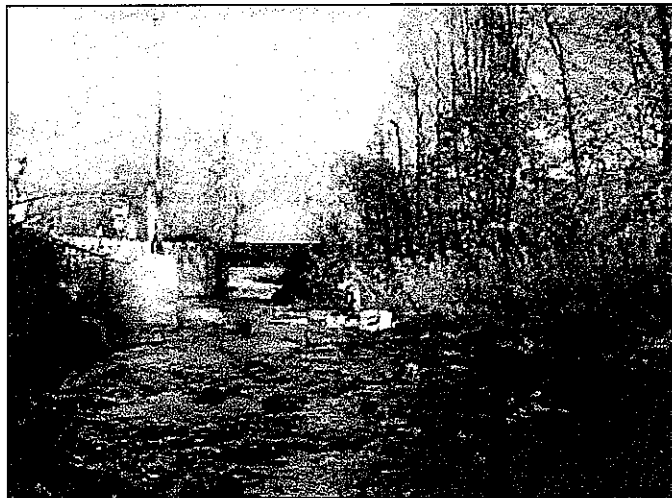
*Channel Physical Characteristics Range 0 to 20: Value 8*

Average bankfull width (ft):	26	Average bankfull depth (ft):	2.5
Pool to riffle ratio:	2:1	Erosion:	slight to S, moderate to N
Water Temperature (°C):	8.2	Fish cover/habitat:	boulders
Sedimentation:	moderate	Side slopes:	moderate
Bank erosion potential:	severe	Streamside cover:	herbaceous & soil/rock
Substrate:	25% sand, 25% gravel, 20% cobble, 30% boulder

Facing downstream and looking east at the sample location.

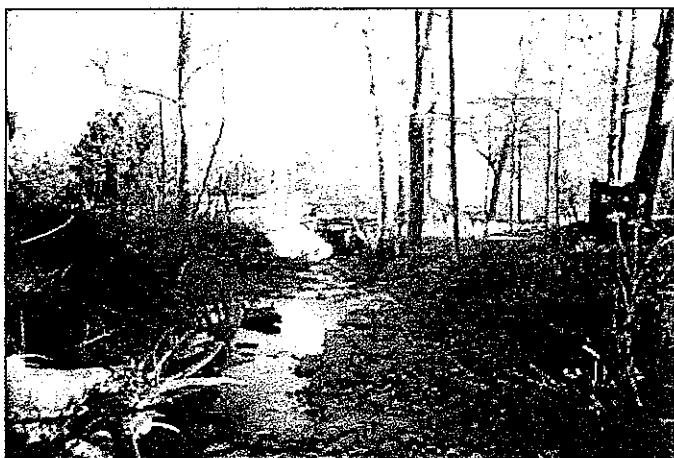
*Channel Physical Characteristics Range 0 to 20: Value 14*

Average bankfull width (ft):	15	Average bankfull depth (ft):	2
Pool to riffle ratio:	1:1	Erosion:	slight to W, moderate to E
Water Temperature (°C):	8.0	Fish cover/habitat:	undercut banks, boulders
Sedimentation:	point bars along edge of stream	Side slopes:	gradual to W, moderate to E
Bank erosion potential:	severe to E, moderate to W	Streamside cover:	trees, shrubs, herbaceous
Substrate:	50% cobble, 20% sand, 20% gravel, 10% boulder

Looking south and downstream at the unnamed tributary to Silver Creek from the sample location, which was approximately 150 feet upstream of the S.R. 4008 bridge.
