**COMMONWEALTH OF PENNSYLVANIA  
DEPARTMENT OF ENVIRONMENTAL PROTECTION  
BUREAU OF MINING PROGRAMS**

**Inspection Report**

<b>Inspection Type</b>	RTPT - Routine/Partial Inspection	<b>Permit Number</b>	19000201
<b>DEP Office</b>	EP DMO Pottsville Dstr Mng Off	<b>NPDES Number</b>	
<b>Permittee Name</b>	MID VALLEY COAL SALES INC	<b>PF Name</b>	MID VALLEY COAL SALES CONYNGHAM MINE
<b>Address 1</b>	212 W CHERRY ST	<b>Permit Type</b>	CMO - Coal Mining Operation
<b>Address 2</b>		<b>Permit Kind</b>	CRR - Refuse Reprocessing
<b>City</b>	MT CARMEL	<b>License Number</b>	5633
<b>State/ZIP Code</b>	PA 17851-1218	<b>Permit Status</b>	ACTIV - Active
<b>Arrival Date / Time</b>	06/11/2024 10:00 AM	<b>Municipality</b>	Conyngham Township
<b>Depart Date / Time</b>	06/11/2024 12:30 PM	<b>County</b>	Columbia
<b>Inspection ID</b>	3781212	<b>GP12 Permit Number</b>	
<b>Contract Operator Name</b>	FOX COAL CO INC	<b>Contract Operator License Number</b>	17977
		<b>Complaint Number</b>

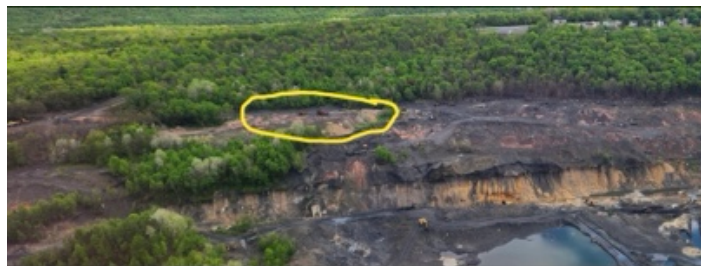
Photo # 1

1. Hot/burning material is to be moved to designated areas only, as shown in Photo #1. The operator will be sure haul truck drivers are dumping in the correct location.
2. Water cannons and tanker truck are to be utilized for dust and fire suppression.
3. Removal of hot/burning material will begin on the West end and material will be pushed/baled to the east.
4. Burning material may not be placed near coal seams or underground openings. Currently no burning material is located near an underground opening or known coal seams based on mapping reviewed on site by Mr. Jim Andrews (P.G.).
5. Operator is to report tonnage of hot/ burning bank material moved or hauled off site and ensure consistent movement of material. This information is to be submitted weekly along with the carbon monoxide readings and water used on fire suppression.

During this 6-11-2024 inspection it was determined a Notice of Violation would be issued for the SMCRA 4.2A General safety violations for coal mining operations due to a hazardous condition that pertains to public safety and well-being. The operator is to completely extinguish the existing bank fire within 60 days (8-12-2024).
