**JOINT APPLICATION FOR PENNSYLVANIA CHAPTER 105 WATER
OBSTRUCTION AND ENCROACHMENT PERMIT AND U.S. ARMY
CORPS OF ENGINEERS SECTION 404 PERMIT**

PROJECT GRAVITY

**Archbald Borough,
Lackawanna County, Pennsylvania**

October 2025

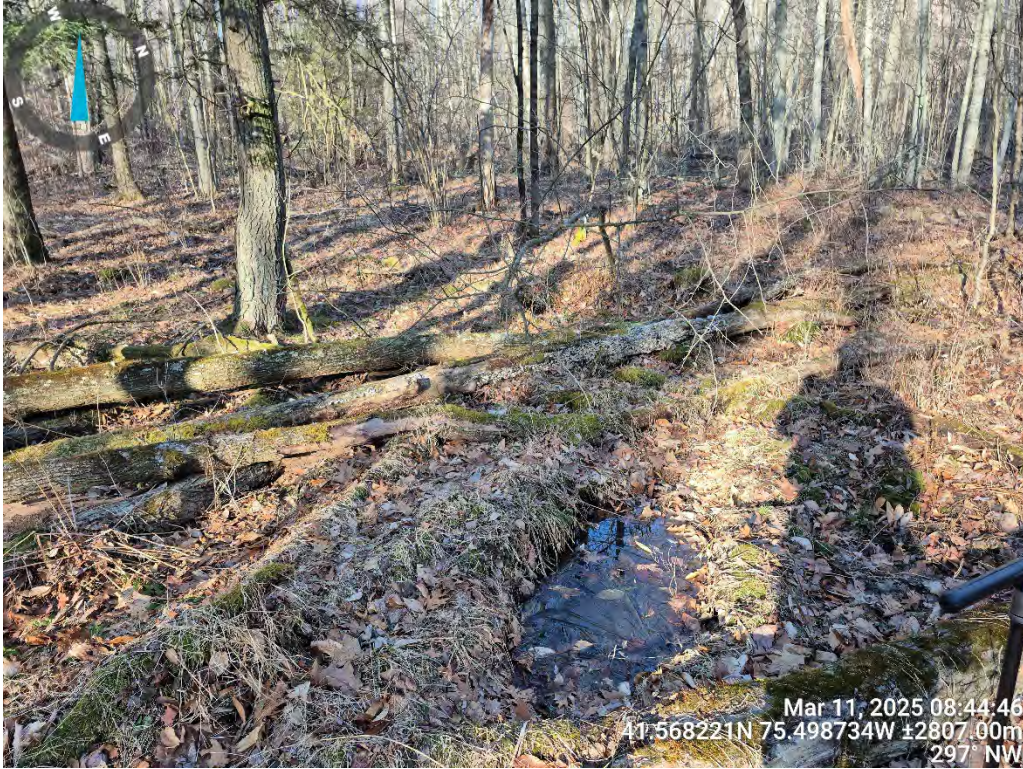
Photograph 1 illustrates an overview of Wetland 0311250835 near an old logging road which drains to UNT 1. The view is facing west-northwest.

Photograph 1 illustrates an overview of Wetland 0311250835 near an old logging road which drains to UNT 1. The view is facing west-northwest.

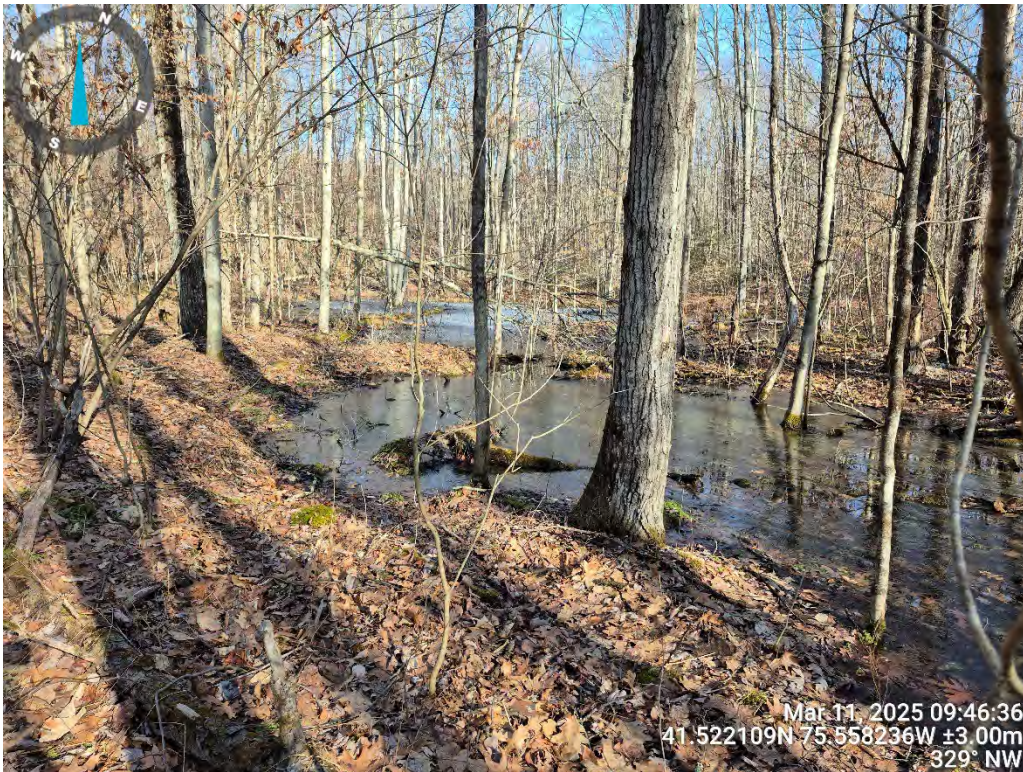
Photograph 2 illustrates an overview of Wetland 0311250854. The view is facing north-northwest.

Photograph 2 illustrates an overview of Wetland 0311250854. The view is facing north-northwest.

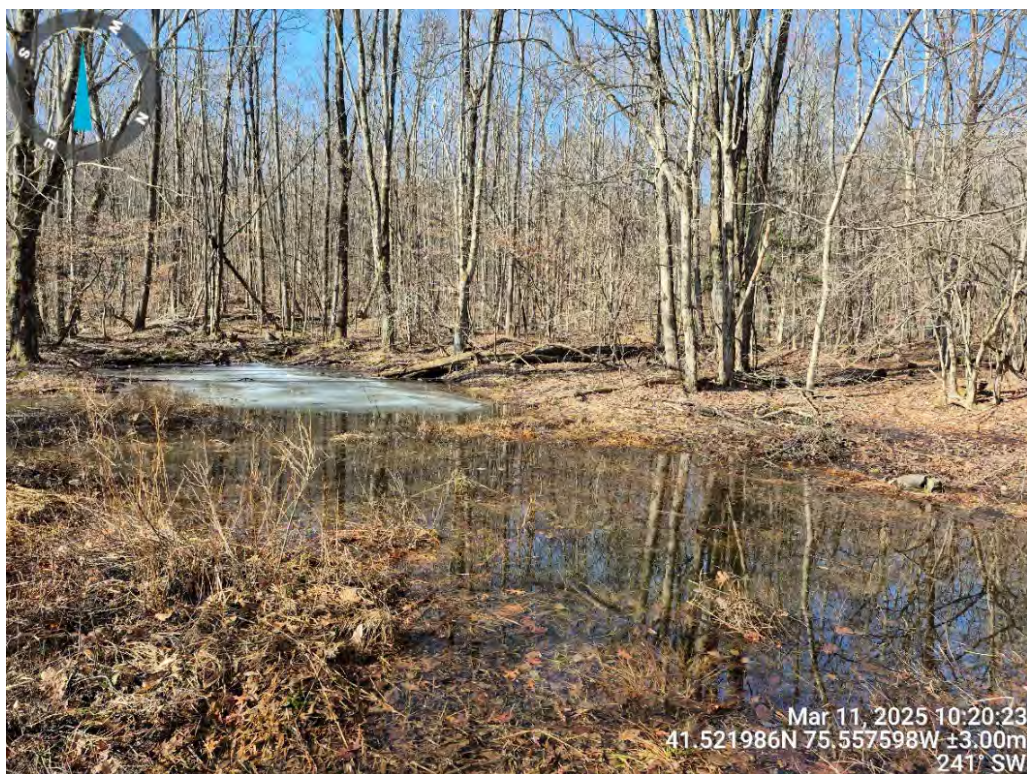
Photograph 3 illustrates an overview of Wetland 0311251010. The view is facing southwest.

Photograph 3 illustrates an overview of Wetland 0311251010. The view is facing southwest.

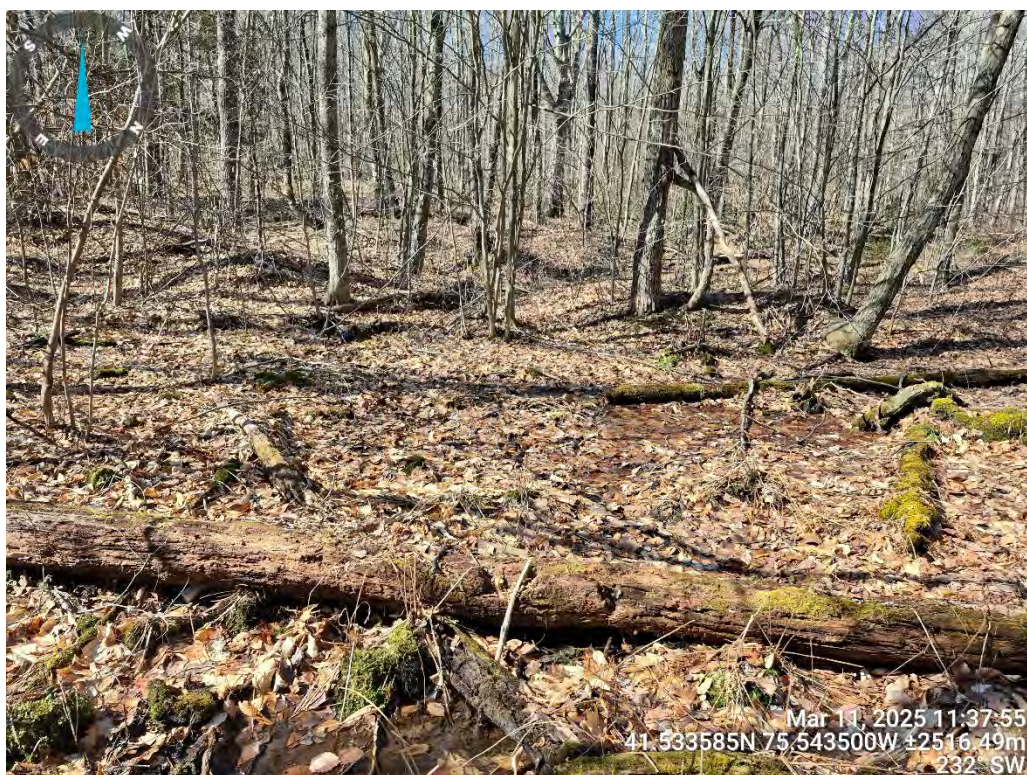
Photograph 4 illustrates the conditions within Wetland 0311251110. The view is facing southwest.

Photograph 4 illustrates the conditions within Wetland 0311251110. The view is facing southwest.

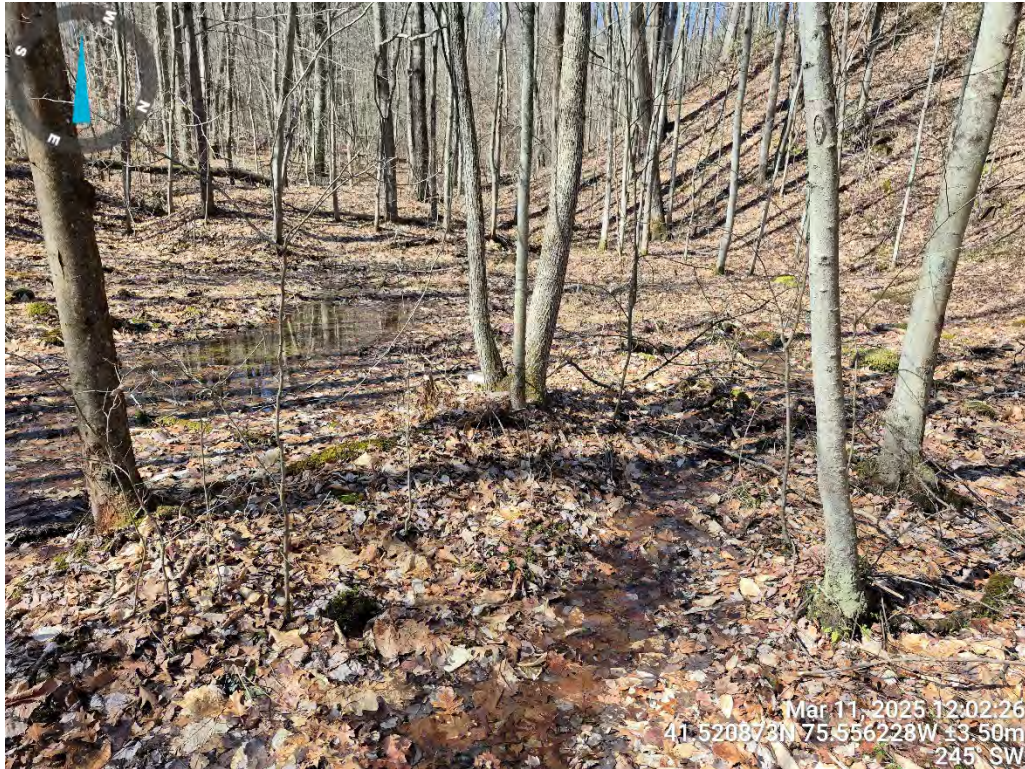
Photograph 5 illustrates an overview of the conditions within Wetland 0311251145. The view is facing southwest.

Photograph 5 illustrates an overview of the conditions within Wetland 0311251145. The view is facing southwest.

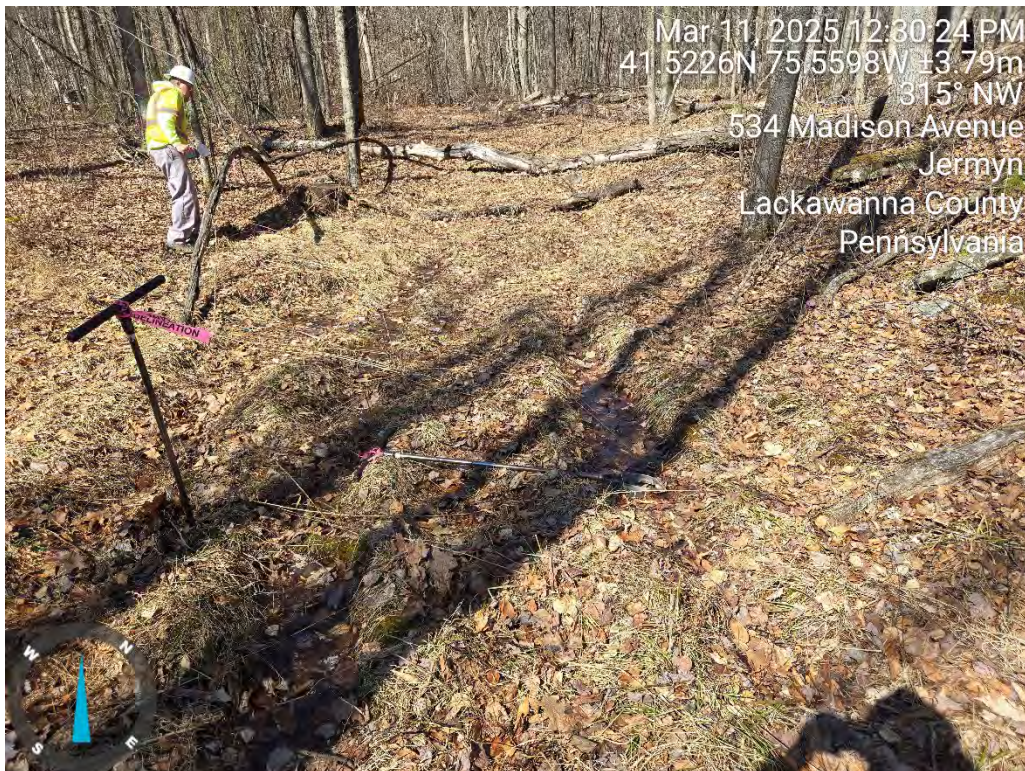
Photograph 6 illustrates Wetland 0311251226 which appeared to be on a former access road disturbance. The view is facing northwest.

Photograph 6 illustrates Wetland 0311251226 which appeared to be on a former access road disturbance. The view is facing northwest.

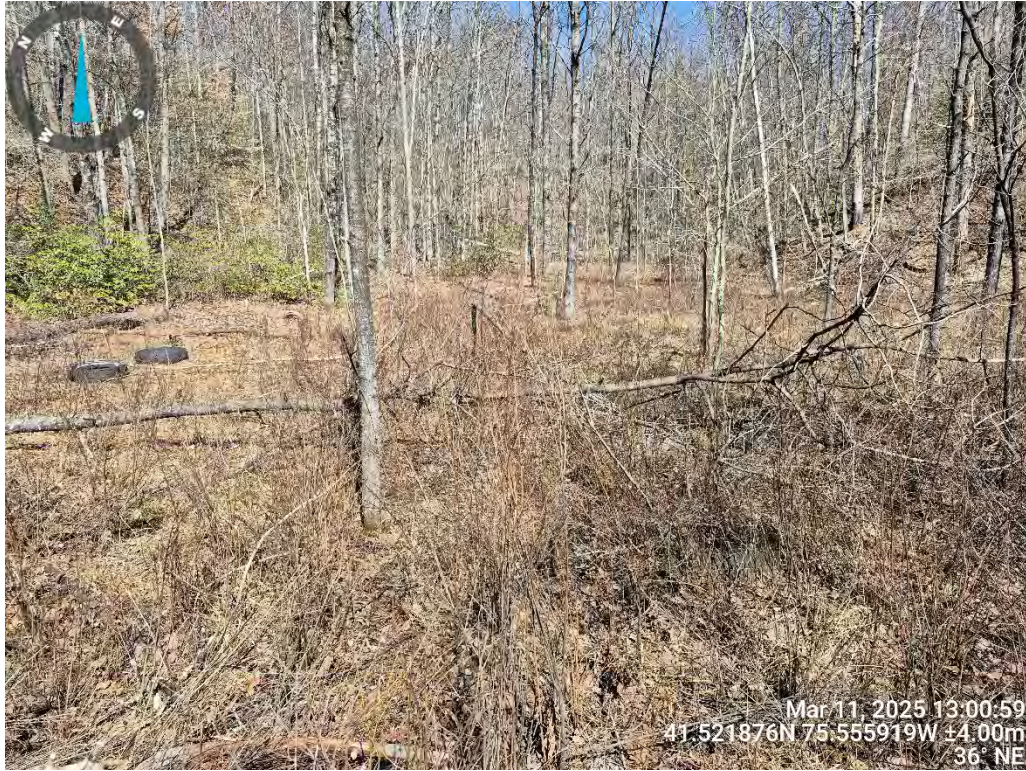
Photograph 7 illustrates the conditions of Wetland 0311251254 located at the bottom of a large topographical depression. The view is facing north-northeast.

Photograph 7 illustrates the conditions of Wetland 0311251254 located at the bottom of a large topographical depression. The view is facing north-northeast.

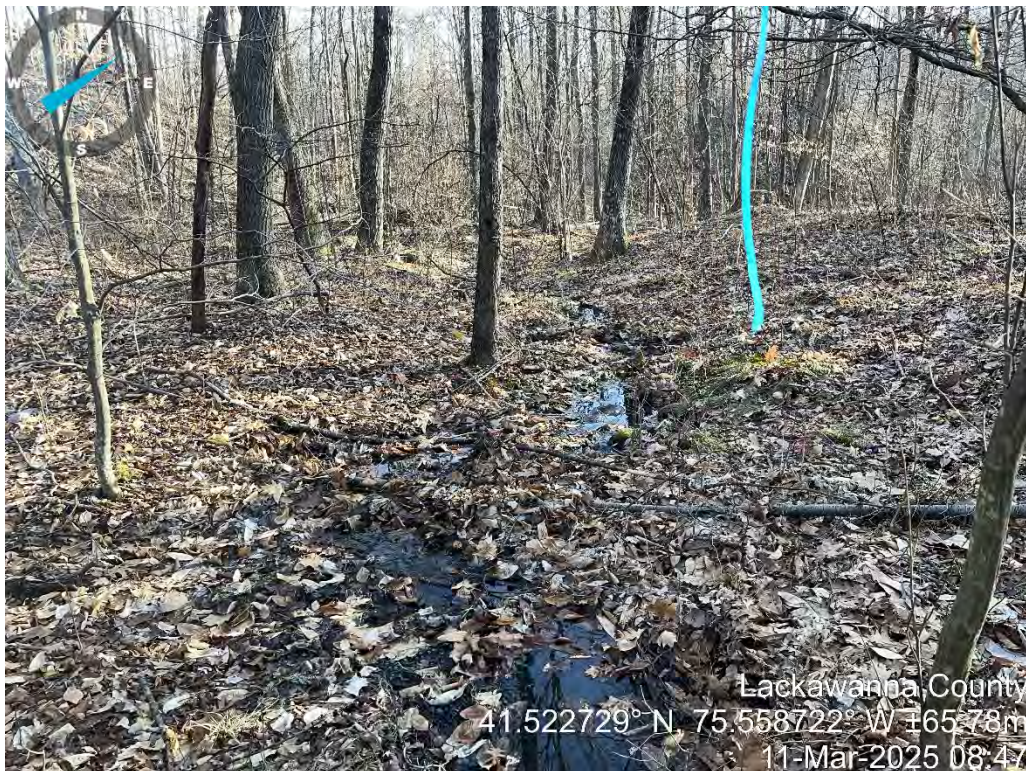
Photograph 8 illustrates the isolated UNT 1. The view is facing east.

Photograph 8 illustrates the isolated UNT 1. The view is facing east.

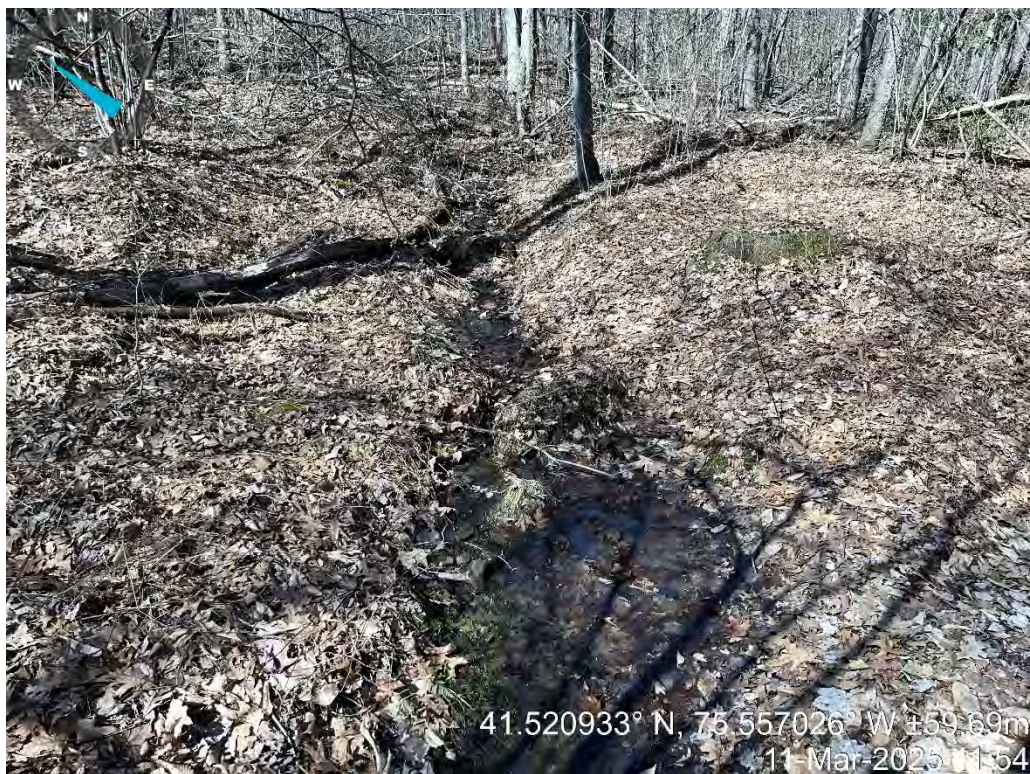
Photograph 9 illustrates the isolated UNT 1. The view is facing east.

Photograph 9 illustrates the isolated UNT 1. The view is facing east.

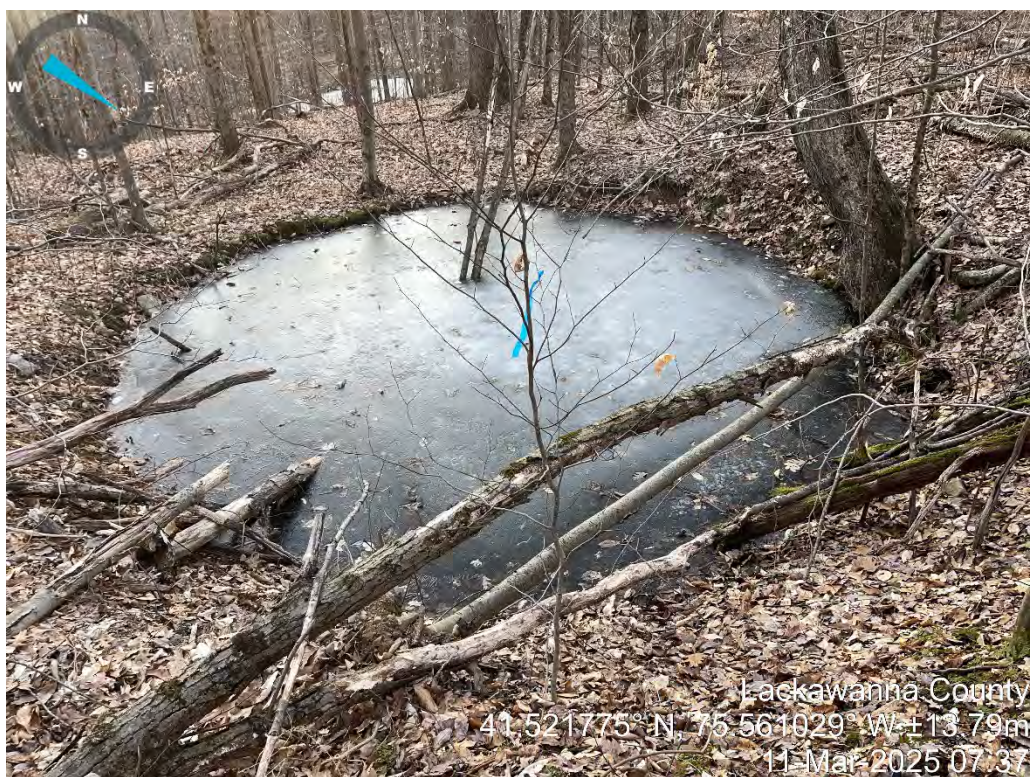
Photograph 10 illustrates a typical view of one of the excavated Open Bodies of Water. The view is facing southwest.

Photograph 10 illustrates a typical view of one of the excavated Open Bodies of Water. The view is facing southwest.

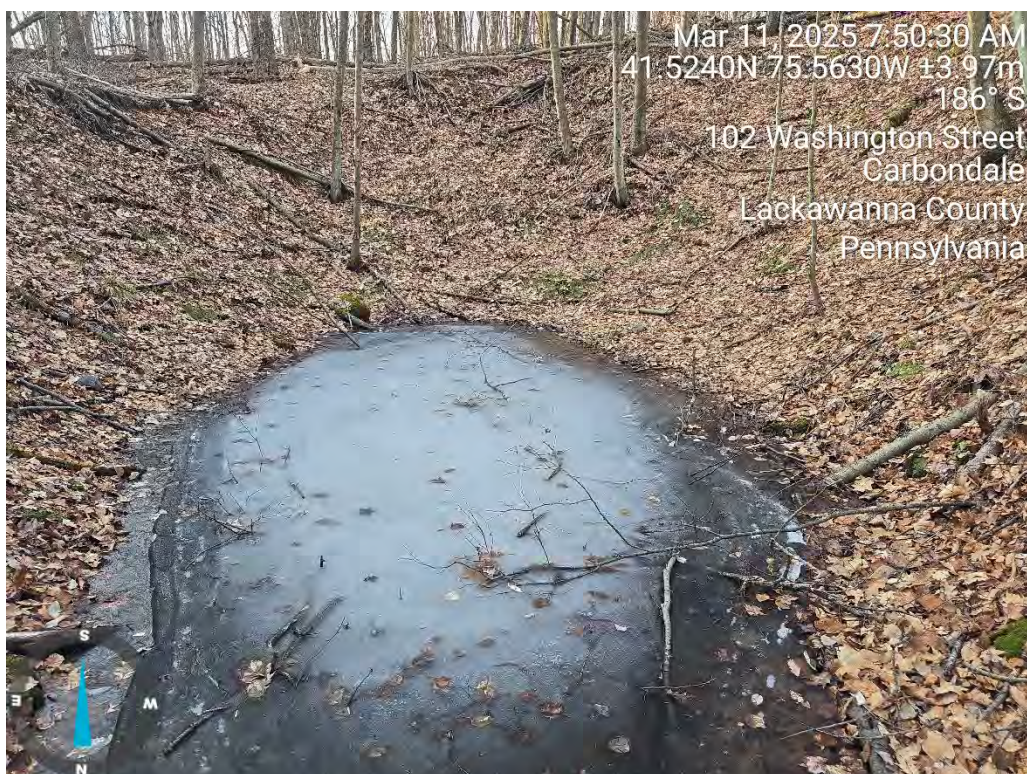
Photograph 11 illustrates another typical view of an excavated Open Body of Water. This is in the bottom of a strip mine pit. The view is facing southeast.

Photograph 11 illustrates another typical view of an excavated Open Body of Water. This is in the bottom of a strip mine pit. The view is facing southeast.

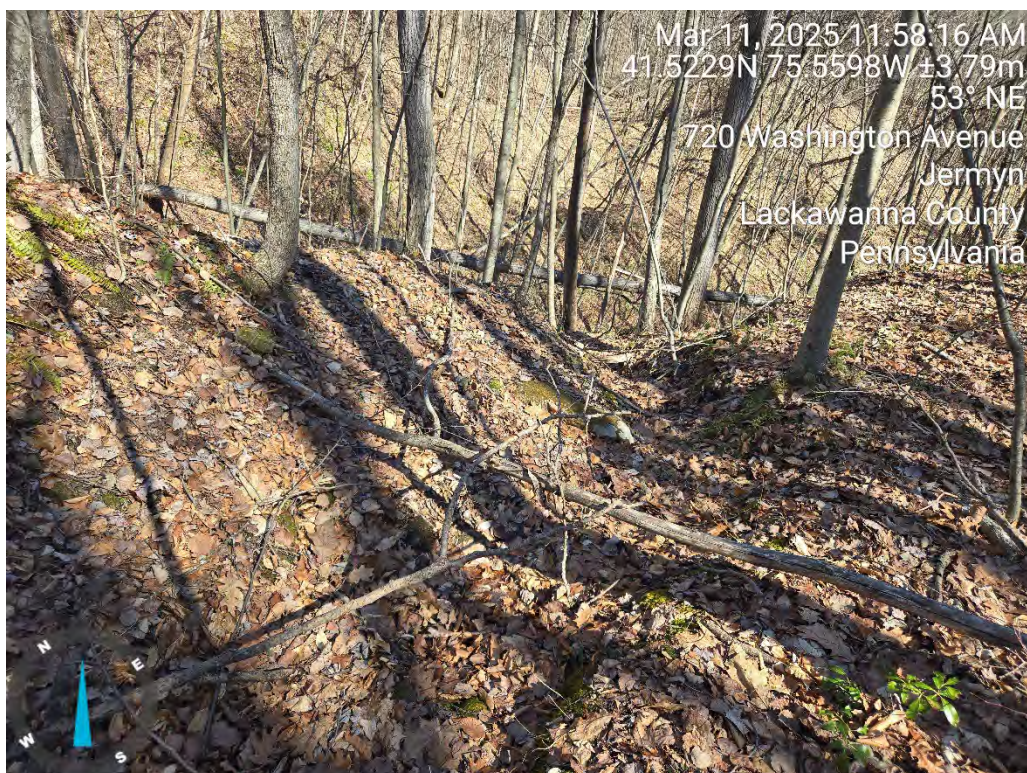
Photograph 12 illustrates a typical view of an isolated drainage feature draining into a strip mine pit. The view is facing northeast.

Photograph 12 illustrates a typical view of an isolated drainage feature draining into a strip mine pit. The view is facing northeast.

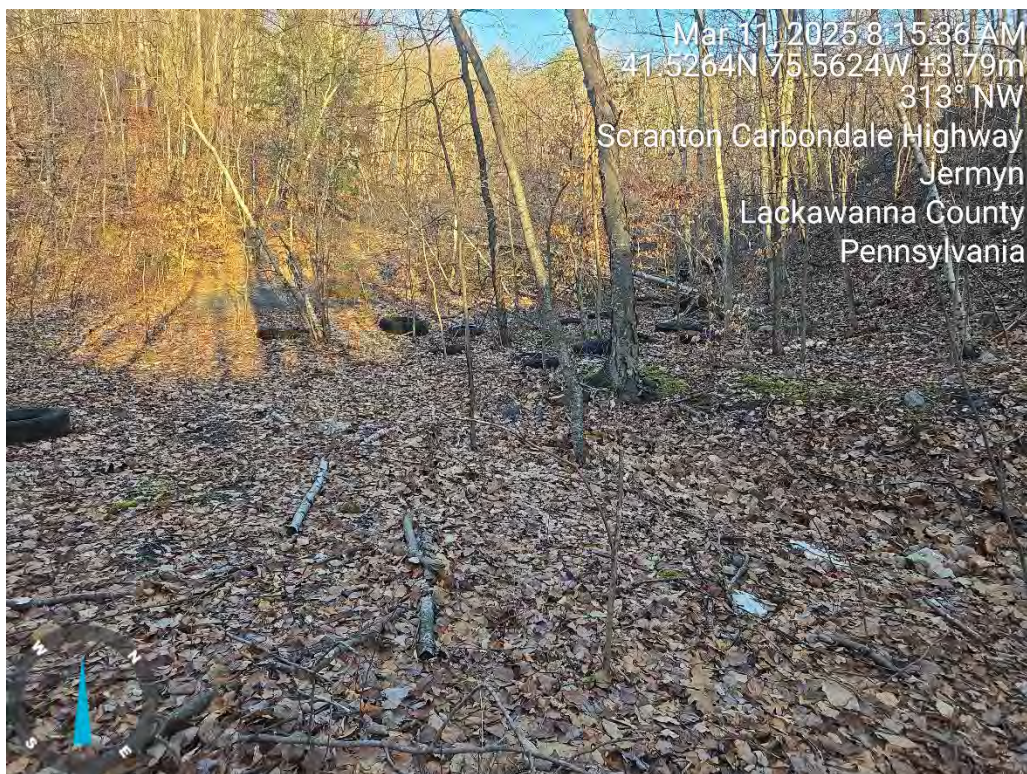
Photograph 13 illustrates a typical view of the uplands in the strip-mined portion of the AOI. The view is facing southeast.

Photograph 13 illustrates a typical view of the uplands in the strip-mined portion of the AOI. The view is facing southeast.

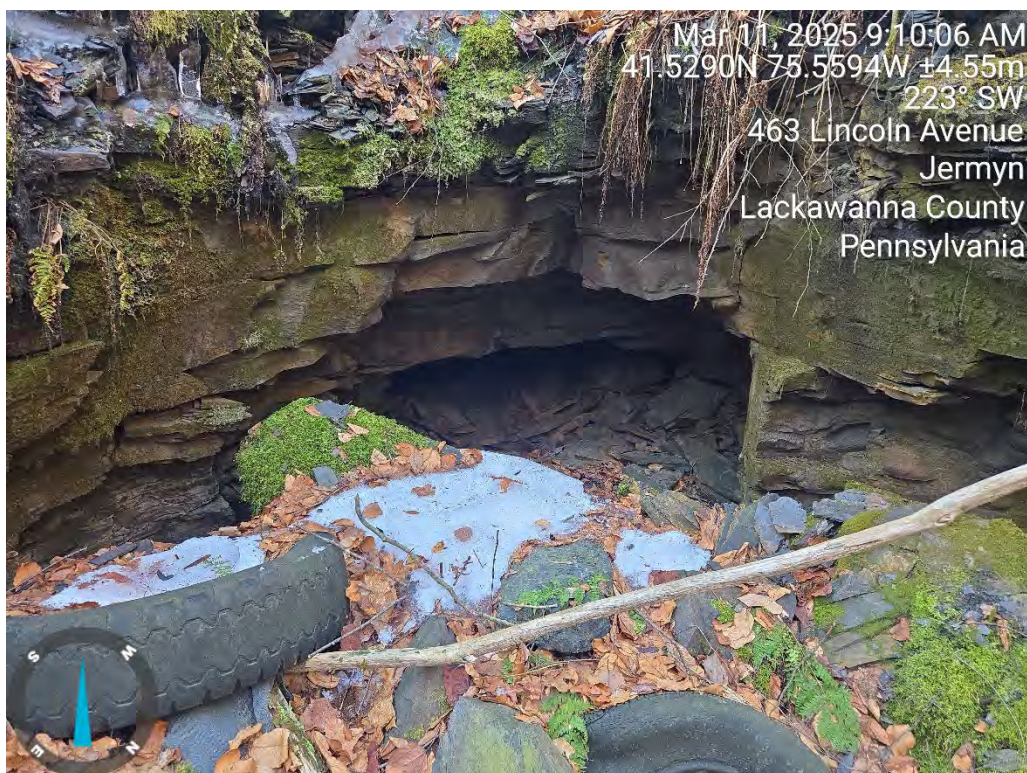
Photograph 14 illustrates a collapsed deep mine entrance. The view is facing southeast.

Photograph 14 illustrates a collapsed deep mine entrance. The view is facing southeast.

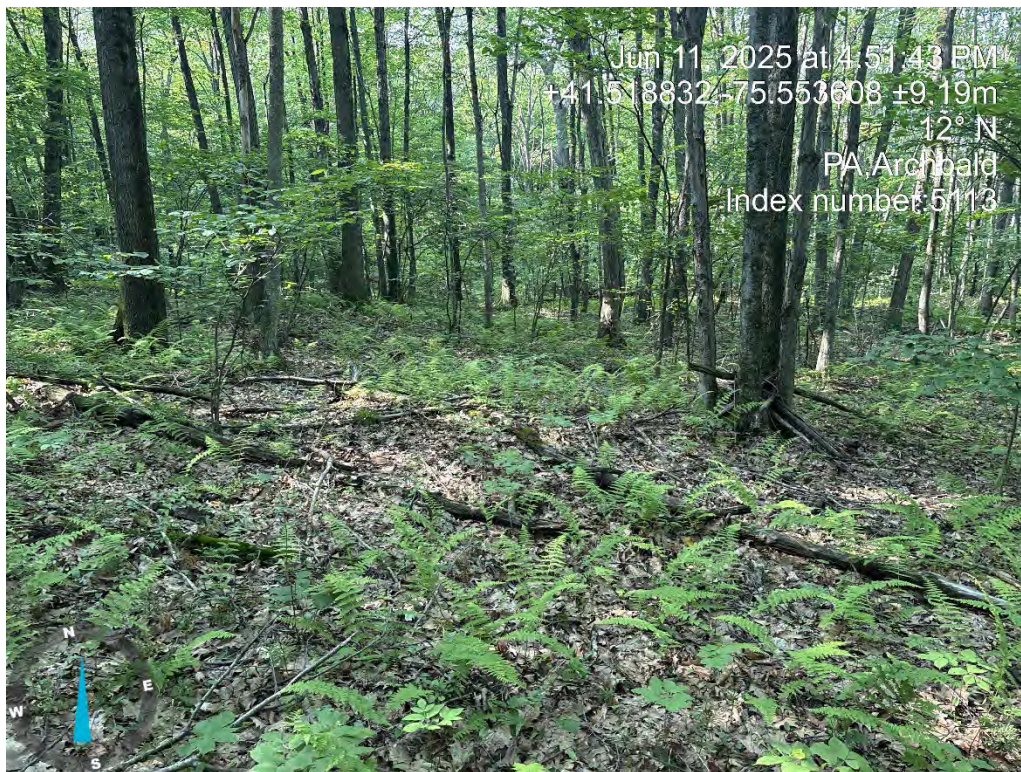
Photograph 15 illustrates a typical view of the uplands in the forested, southeastern portion of the AOI. The view is facing north/northeast.

Photograph 15 illustrates a typical view of the uplands in the forested, southeastern portion of the AOI. The view is facing north/northeast.

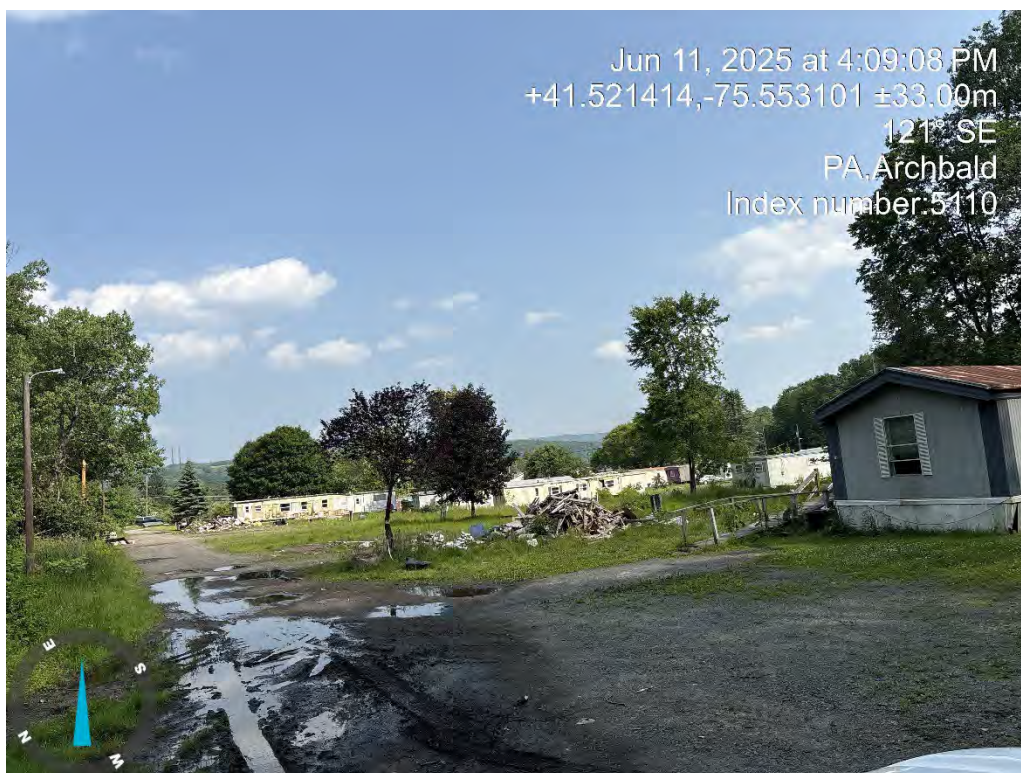
Photograph 16 illustrates a view of the existing mobile home community in the eastern portion of the AOI. The view is facing southeast.

Photograph 16 illustrates a view of the existing mobile home community in the eastern portion of the AOI. The view is facing southeast.

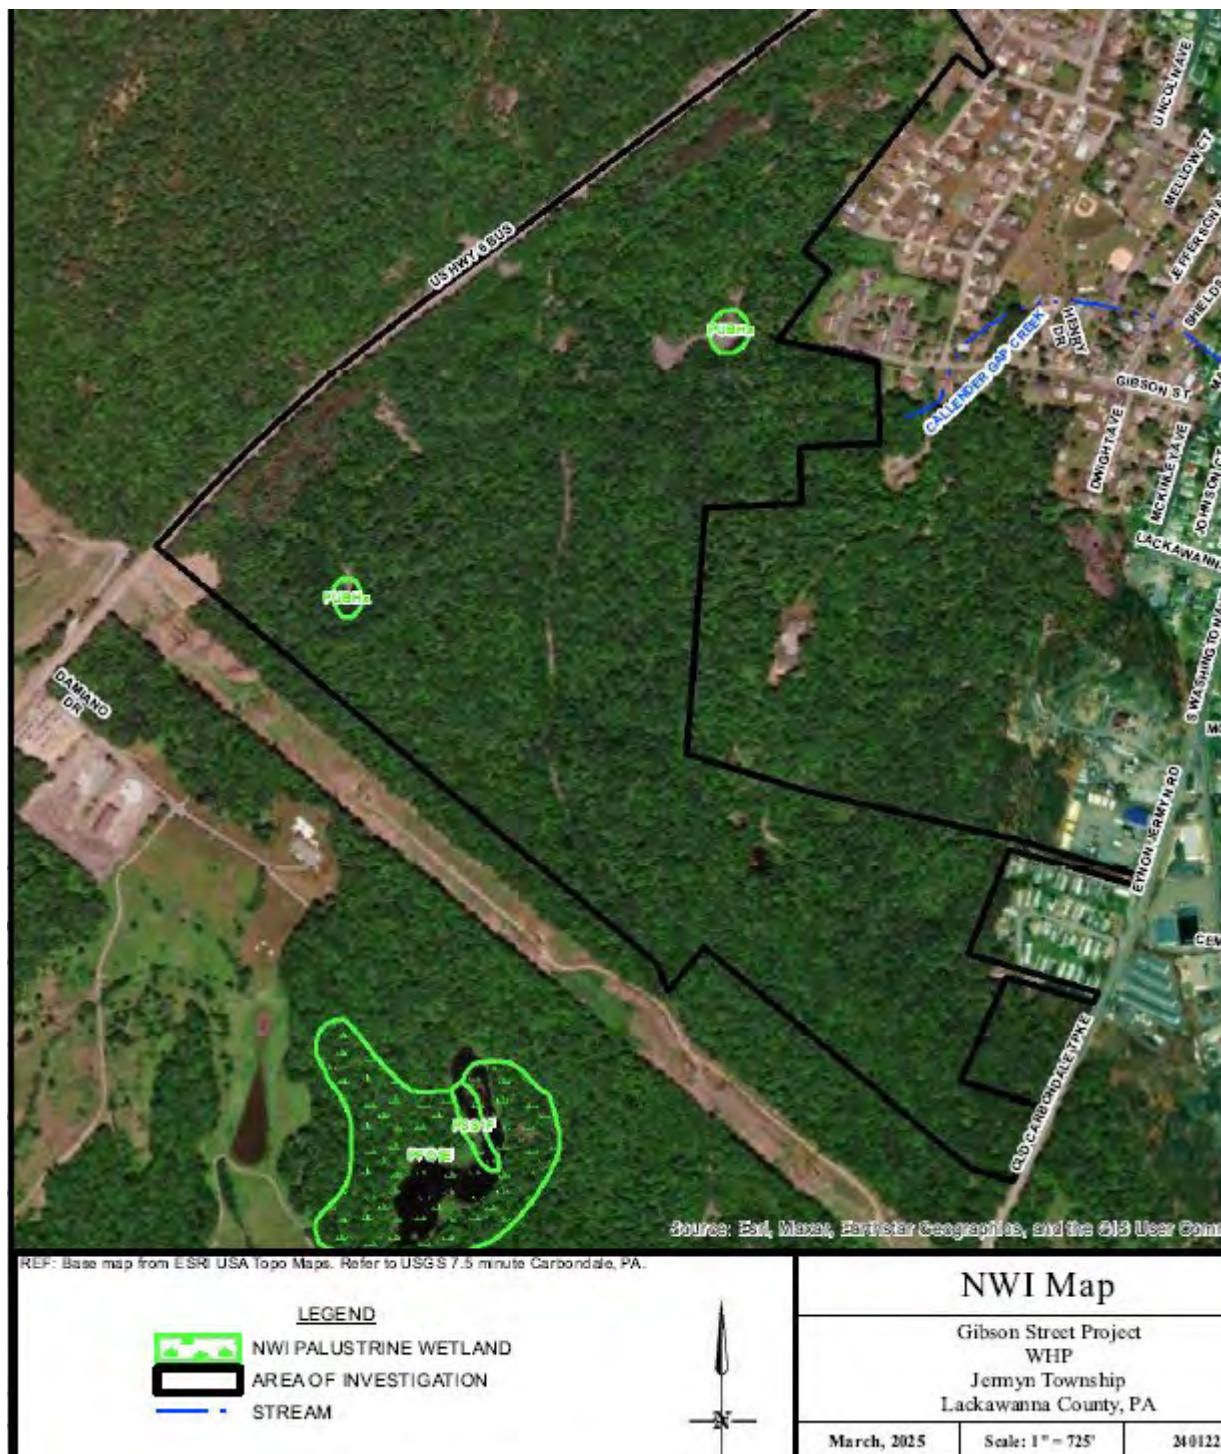
Figure 1-Project Area; area of review is a 186.2-acre area delineated in black.

The subject of this approved jurisdictional determination is a 186.2-acre site located in Archbald Borough, Lackawanna County, Pennsylvania (41.524244 N, -75.561365 W). The predominant land use of the area of review (AOR) is an abandoned strip mine that is primarily forested. The AOR drains north and east to the Lackawanna River which then flows south into the Susquehanna River (Figure 1).

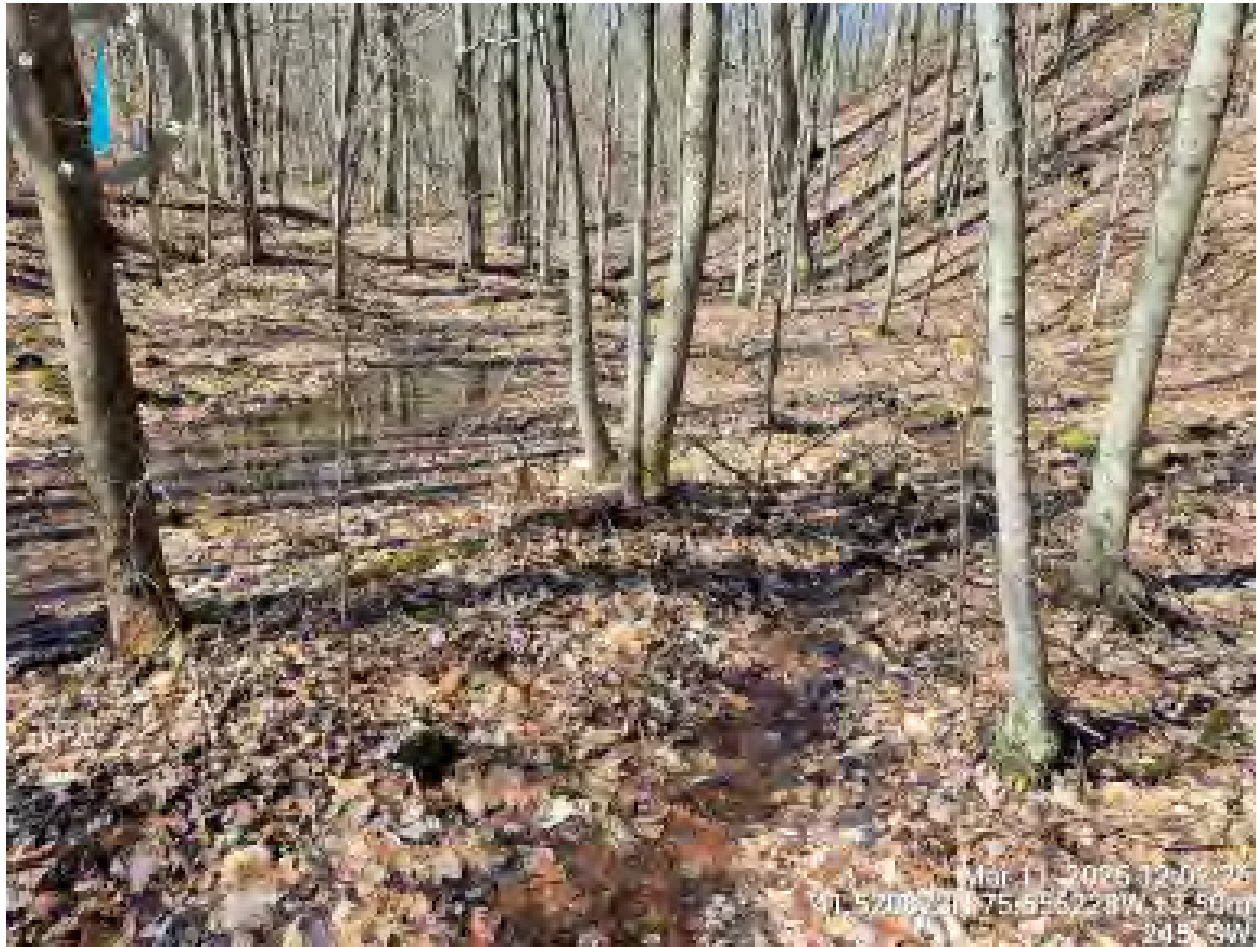
Figure 2-Wetland 0311251254 (0.12-acre) depressional area with no continuous surface connection to a jurisdictional water

The Corps received a request for a Department of the Army (DA) approved jurisdictional determination on 14 April 2025, for the subject site located in Archbald Borough, Lackawanna County, Pennsylvania. The information provided in the request package, supplied by the consultant, included a USDA Natural Resources Conservation Service Soil Survey map, USGS topographic map, aerial imagery, USFWS National Wetland Inventory Map, USGS National Hydrography Dataset, a site map, and wetland data sheets. On 21 May 2025, the Corps conducted a site visit and walked the entire 186.2-acre area of review as identified on the enclosed aerial image dated March 2025. The Corps' area of review (AOR) encompasses upland forests with depressional areas in the area that was strip mined. The project area has been heavily manipulated with prior evidence of mining. Although the USGS topographic map provided with the request package shows that Callender Gap Creek flows through the AOR from west to east, eventually flowing into the Lackawanna River, the site manipulation that occurred because of past strip mining has altered the channel to the extent that it no longer has a surface connection within the AOR to the Lackawanna River. The soils on the site are mapped as Holly Silt Loam (Hm), Atherton Loam (At), Dystrochepts and Rock Outcrop (DyD), Morris Channery Loam (MxB), Norris and Chippewa Channery Loams (NxB), Pope Soils (Po), Volusia Channery Loam (VxB), and (Wurtsboro Extremely Stoney Silt Loam Loam (WxB, WxD) (NRCS Web Soil Survey, 2024). With the exception of the Holly Silt Loam and Atherton Loam, which are hydric soil types, the remainder and their minor components are classified as non-hydric but may contain hydric inclusions. Based on field observations, supplemental information reviewed by the Corps, and in accordance with the protocol contained within the (1) Regional Supplement to the Corps of Engineers Wetland Delineation Manual: Northcentral and Northeast Regional Supplement Version 2.0, and (2) 1987 Corps Delineation Manual, the Corps determined that hydrophytic vegetation, hydric soils, and wetland hydrology indicators within the above-mentioned area of review. The Corps area of review (Figure 1) includes three (3) emergent wetlands (0.01-acre, 0.01-acre, and 0.44-acre); two scrub shrub wetlands (0.05-acre and 0.12 acre); a wetland comprised of open water, scrub shrub and emergent wetlands (0.66 acre); a wetland comprised of scrub shrub and forested wetlands (0.13-acre); two intermittent stream channels; and, 31 open water depressional areas. None of these features meet the definition of adjacent wetlands or watercourses having a continuous surface connection to a jurisdictional water and therefore, are not subject to United States Army Corps of Engineers (Corps) regulatory jurisdiction. The Corps determined that all the referenced aquatic resources do not have a surface connection to jurisdictional waters. Many of these features resulted from impacts of historic mining activity (Figures 2, 3, 4 and 5).

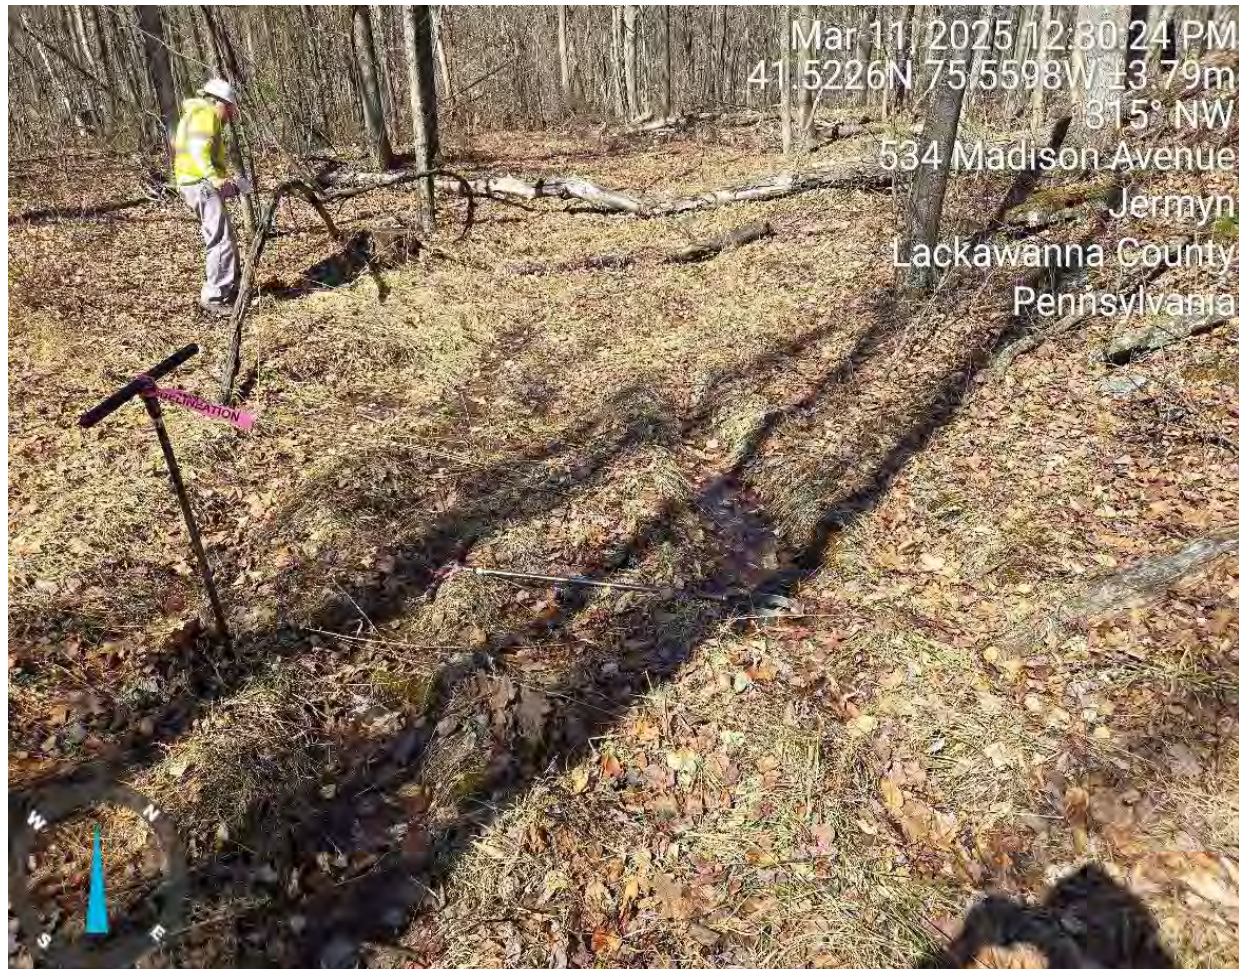
Figure 3-Wetland 0031251226 (0.01-acre) appears to be a former access road with no continuous surface connection to a jurisdictional water

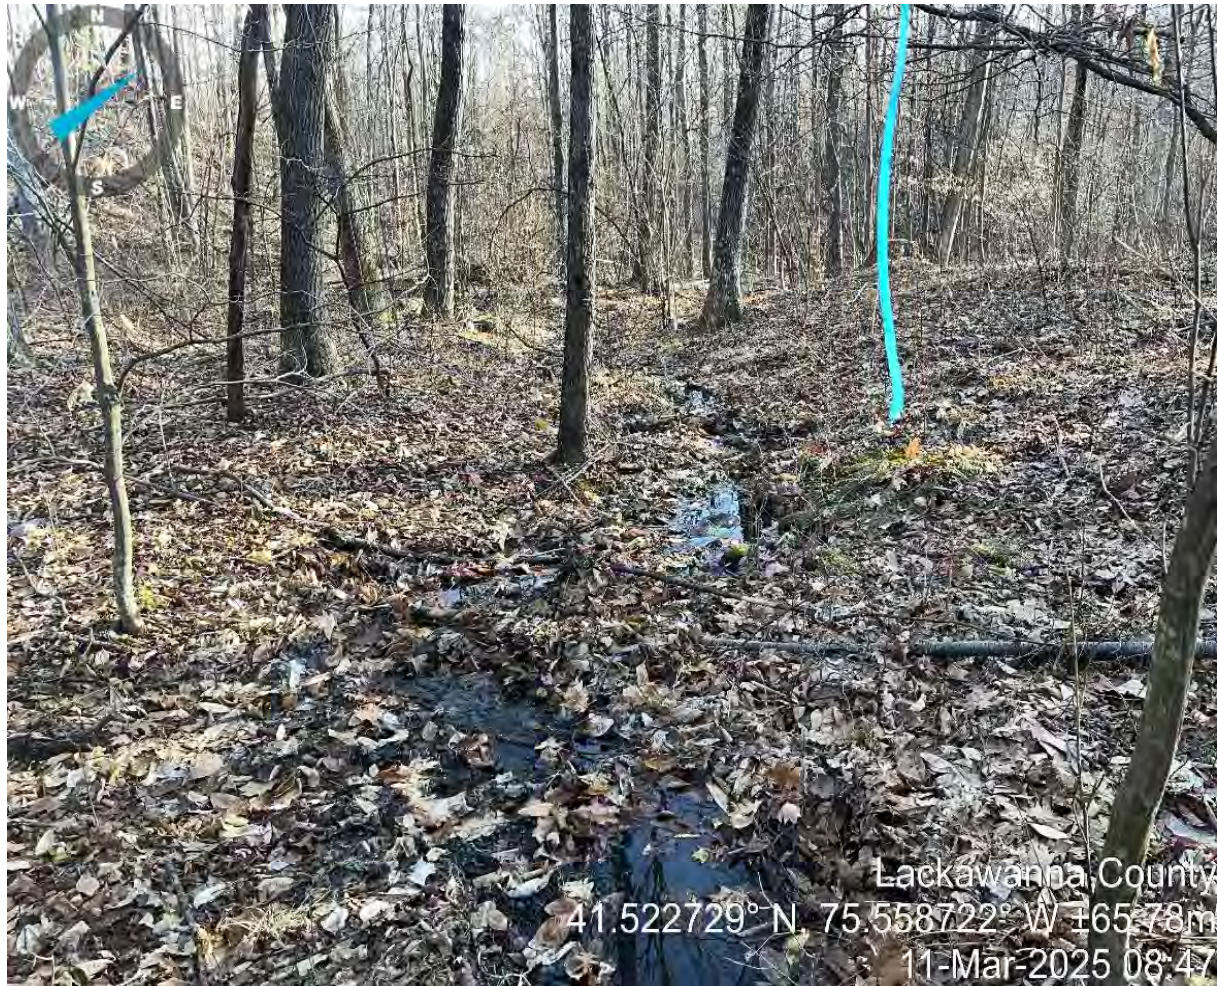
Figure 4- UNT 1 - channel has no continuous surface connection to a jurisdictional water

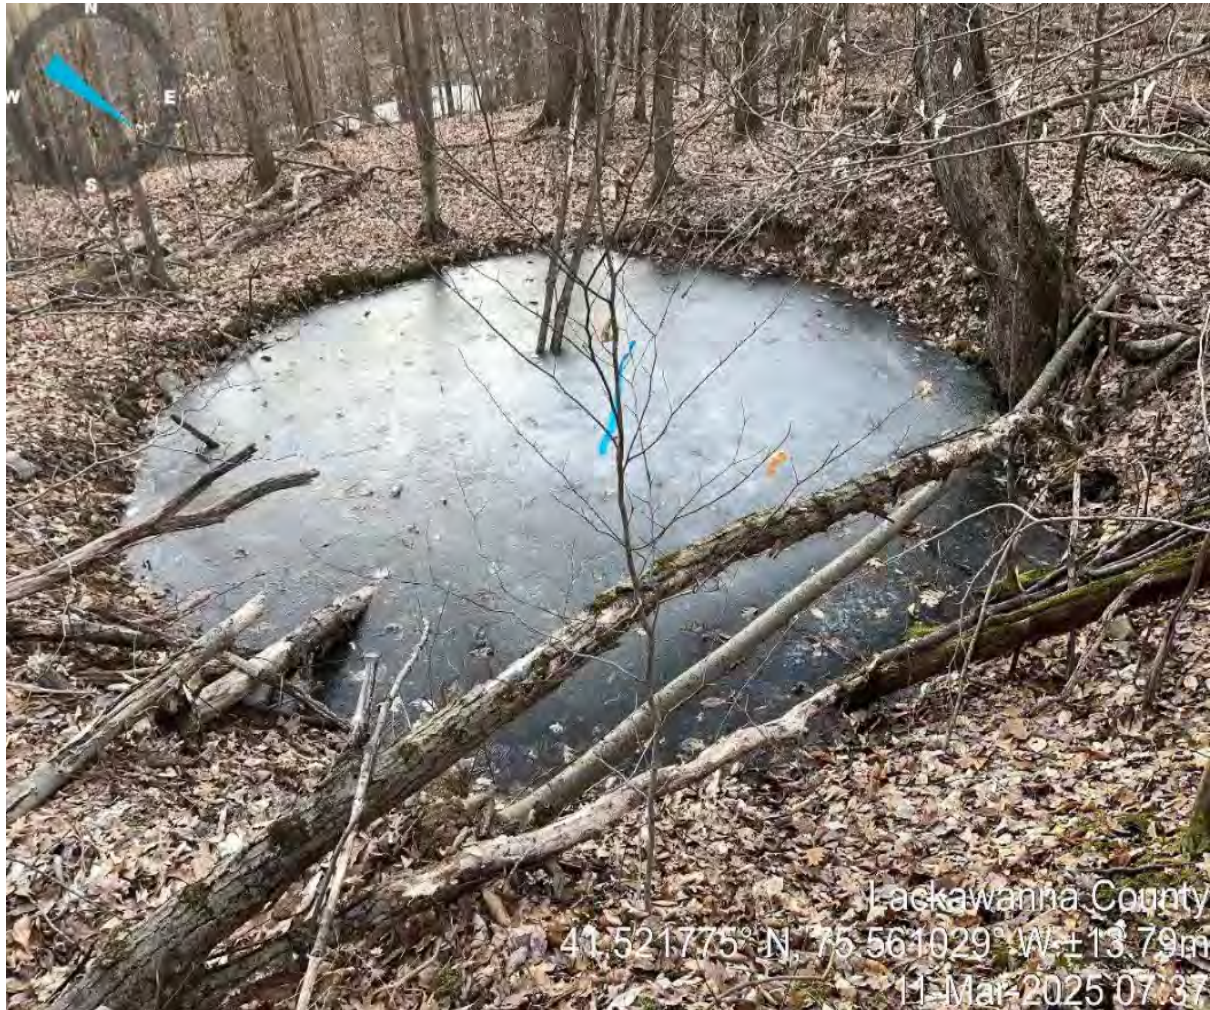
Figure 5- - Typical open water depressional area from previous strip-mining activities has no continuous surface connection to a jurisdictional water
