Wetland Delineation and Watercourse Identification Report

RURA FIELD PROJECT

BLACK LICK AND CENTER TOWNSHIPS INDIANA COUNTY, PENNSYLVANIA

November 2024

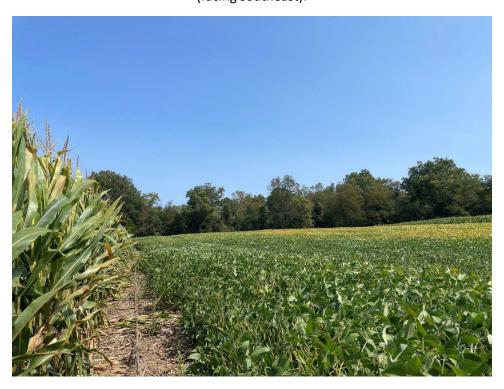
Photograph 2 – Overview of upland sample point STP-01 within agricultural field. (facing northeast).

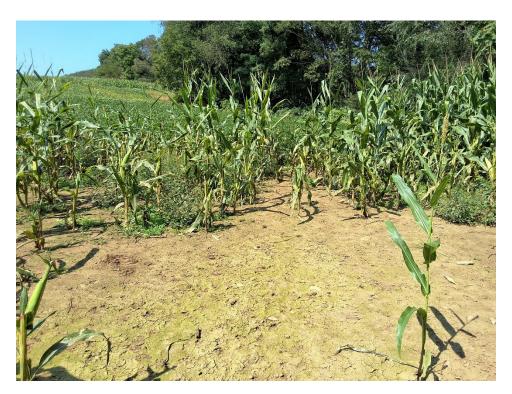
Photograph 5 – View of upland point STP-04 in the northeastern part of the study area along the edge of agricultural field, STP-04 lacked hydrophytic wetland vegetation. (facing northwest).

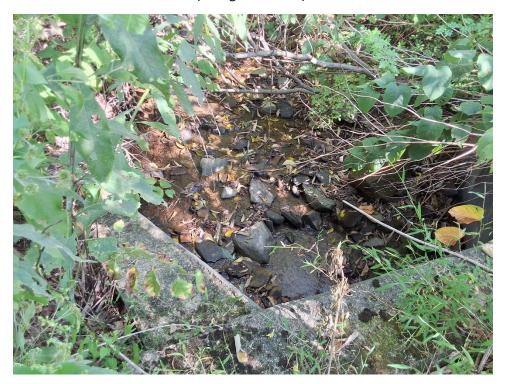
Photograph 10 –View of stream S-01 (Trib 44075 to Two Lick Creek) from an existing bridge in western portion of the study area (facing upstream).

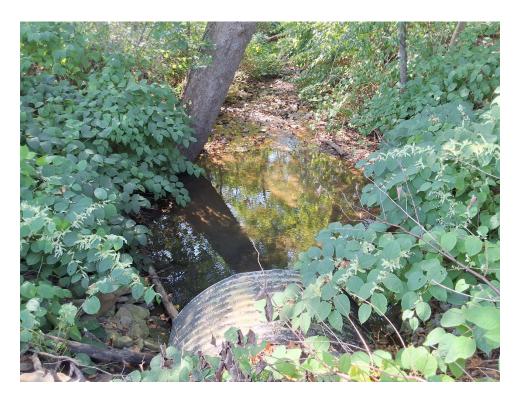
Photograph 11 – View of stream S-01 (Trib 44075 to Two Lick Creek) from existing bridge in western portion of the study area (facing downstream).

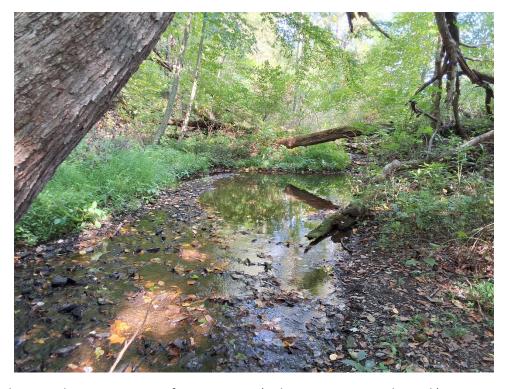
Photograph 12 – Overview of stream S-01a (Trib 44076 to Two Lick Creek) in western portion of the study area (facing upstream).

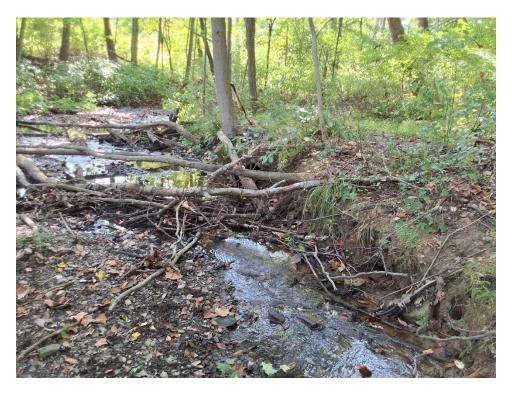
Photograph 13 – Overview of stream S-01a (Trib 44076 to Two Lick Creek) in western portion of the study area (facing downstream).

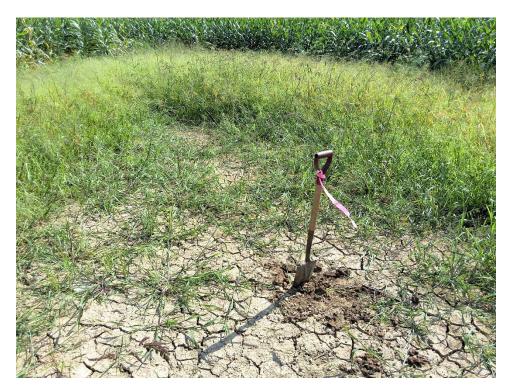
Photograph 15 – Overview of STP-03 within PEM wetland W-01. Wetland W-01 exhibited surface soil cracks and a sparsely vegetated concave surface (facing northeast).

Wetland W-01 is a 0.155-acre PEM wetland located in the southwestern portion of the study area and is in a depression within an agricultural field. The wetland's vegetation is sparse, and cracks in the surface soil were observed. Dominant wetland vegetation consists of *Panicum dichotomoflorum* (panic grass), *Echinochloa crus-galli* (barnyard grass), and *Cyperus esculentus* (yellow nutsedge). Hydrology is received from surface runoff and groundwater. Soils are compacted and disturbed, texture is silty clay loam (SiCL) with small sand inclusions from eroded sandstone. Redoximorphic concentrations in the pore linings and depletions in the matrix were observed.

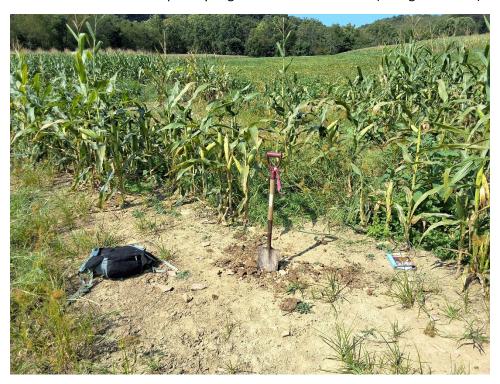
Photograph 16 – Overview of upland sample point STP-04 within western agricultural field, north of wetland W-01 (facing west).

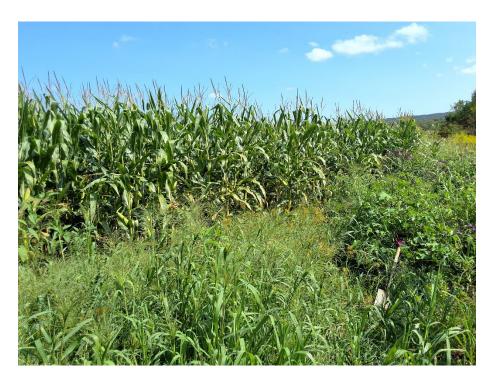
Photograph 17 – Overview of upland point STP-05 on the southern fringe of western agricultural field (facing northeast).

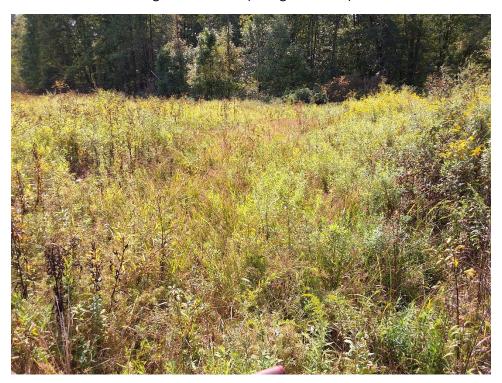
Photograph 18 – Overview of STP-06 within PEM wetland W-02a (facing southwest).

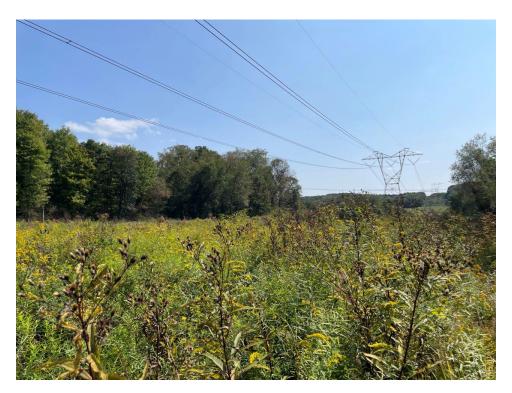
Photograph 19 – Overview of PEM wetland W-02a along utility right-of-way (facing southeast).

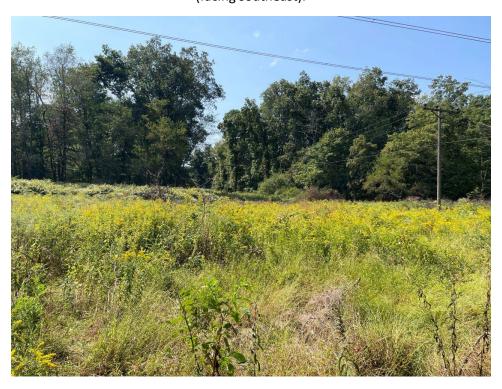
Photograph 20 – Overview of PEM wetland W-02a where it continues out of the study area towards Two Lick Creek (facing southwest).

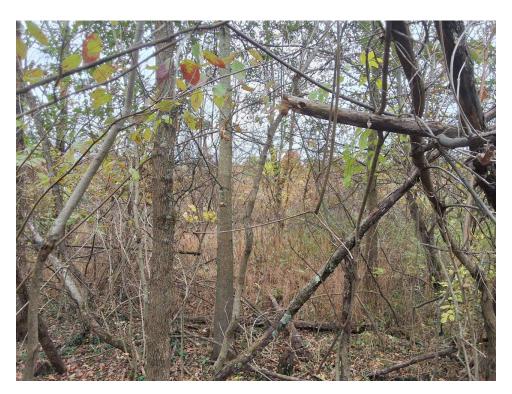
Photograph 21 – Overview of PSS wetland W-02b (facing west).

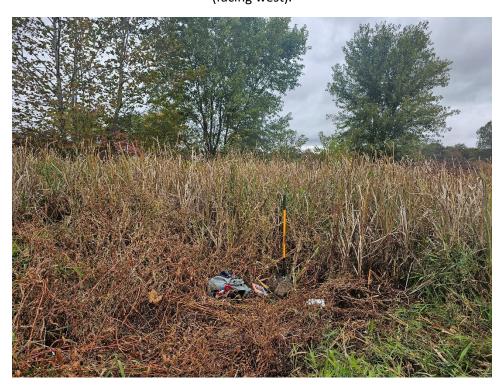
Photograph 22 – Overview of STP-08 within PEM wetland W-02c (facing northeast).

W-02c is a 0.218-acre PEM portion of wetland W-02 located in the southwestern quadrant of the study area. Vegetation within wetland W-02c is predominately grasses and forbs, with woody shrubs and trees present on its edge. Dominant vegetation consisted of *Typha angustifolia L.* (narrowleaf cattail), *Microstegium vimineum* (Japanese stiltgrass), *Acer saccharinum* (silver

maple), and *Cornus racemosa* (gray dogwood). Hydrology is received from surface runoff, groundwater, and wetland W-02b. Soil texture was silty clay loam (SiCL), redox concentrations were observed.

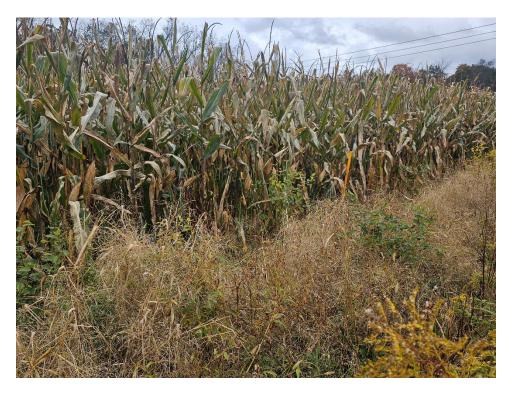
Photograph 23 – Overview of upland point STP-09 on the fringe of agricultural field (facing southwest).

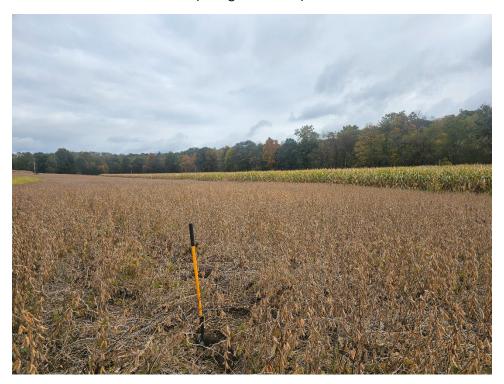
Photograph 24 – Overview of upland point STP-10 within agricultural field (facing northeast).
