CHAPTER 102 INSPECTION REPORT

Permit No.:	PAD510225

Report No.: 08

GENERAL INFORMATION						
Project/Site Name:	Alliance 51st Street, Philadelphia	Permit Issuance Date:	9/5/2023			
Site Address:	1656 S. 51 st St.	Permit Expiration Date:				
Site City, State, ZIP:	Philadelphia, PA 19143	Permit Type:	NPDES IP			
RP/Permittee Name:	Eric Carlson	Site Municipality(ies):	Philadelphia			
RP/Permittee Address:	40 Morris Ave., Suite 230	Site County(ies):	Philadelphia	<u> </u>		
RP/Permittee City, State, 2	ZIP: Bryn Mawr, PA 19010	Earth Disturbance:	11.54	acres		
RP/Permittee Email:	ecarlson@alliancehp.com	Site Latitude:	39.935278			
Surface Water(s):	Schuylkill River	Site Longitude:	75.209236			
Special Protection?	☐ Yes ⊠ No	Complaint Inspection?		☐ No		
Construction Stage:	Inactive	Activity:	Construction	า <u>></u> 1 ac.		
Operator Name	Operator Company	Operator E	mail	Approved		
n/a						
	INSPECTION INFORM	MATION				
Inspection Date:	10/01/24	Inspection Time:	10:10	АМ ПРМ

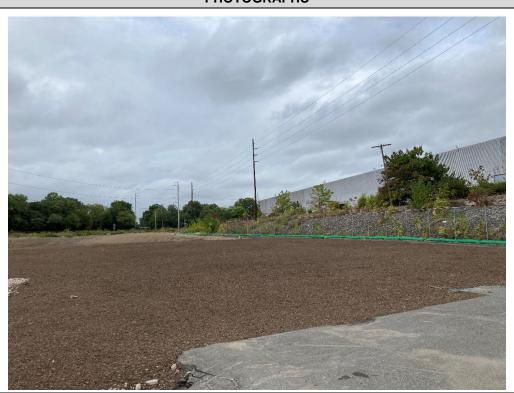
Completed mulching of upslope portion of site.

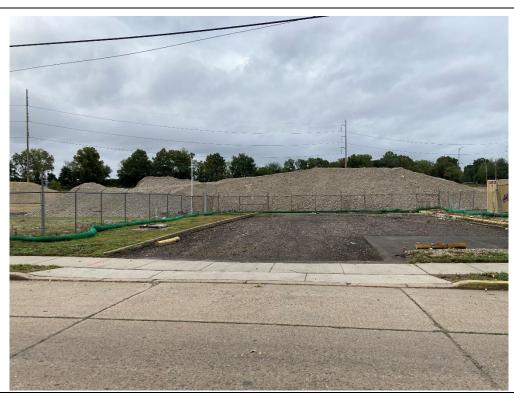
Large rock and gravel stockpile in middle section of site along 51st St.

Chapter 102 Inspection Report Report No.: 08 Failure to comply with the terms and conditions of a permit or order (CSL § 402(b)). Z. Failure to remove building materials and/or wastes from the site for recycling or disposal in accordance aa. with DEP regulations as required by the permit (CSL § 402(b)). Failure to comply with DEP regulations or the Clean Streams Law (CSL § 611). bb. Failure to take necessary measures to prevent pollutants from reaching waters of the Commonwealth (§ CC. 91.34(a)). Failure to notify DEP of new or expanded earth disturbance not identified in an NPDES permit application dd. (§ 92a.24(b)). Failure to notify and/or obtain authorization from DEP/CCD for changes to NPDES permitted activities (§ ee. 92a.41(a)(12)). ff. Other: During the inspection violations of Chapter 105 were observed and are identified in a separate Chapter 105 inspection report. E&S BMPs were evaluated and appear to be functioning as designed. PCSM BMPs were evaluated and appear to be functioning as designed. Form 3800-FM-BCW0531a was used to document the PCSM BMP evaluation. There is a need for modifications to the E&S Plan, PCSM Plan, or permit coverage. Describe: **COMPLIANCE ASSISTANCE RECOMMENDATIONS** In accordance with DEP's Erosion and Sediment Pollution Control Program Manual, Technical Guidance No. 363-2134-008 (March 2012), Page 65, inspect filter socks weekly and after each runoff event. In addition, DEP requests that damaged socks be repaired according to manufacturer's specifications or replaced within 24 hours of inspection. It is recommended the large stone stockpile observed today be spread out or surrounded by compost filter sock as soon as possible.

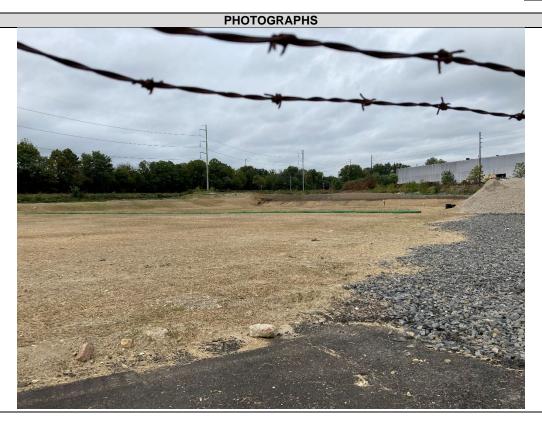
Mulching of middle and upslope portions of site, looking from 51st St.

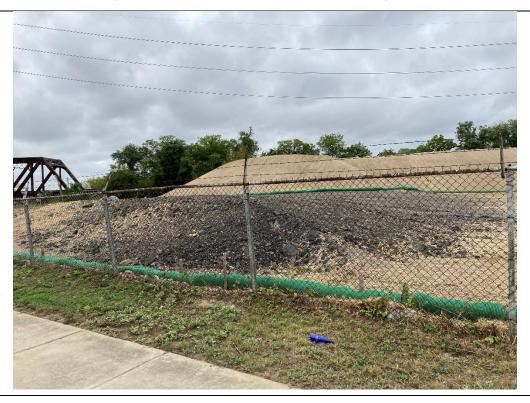
All observed filter sock at the site was in adequate condition. I noted that the mulching and matting of the large fill dirt stockpile remained in place, with a small amount of germination.						
(continued on Page 4)						
İ				ļ

Asphalt millings in foreground and stabilized large fill dirt stockpile in distance.

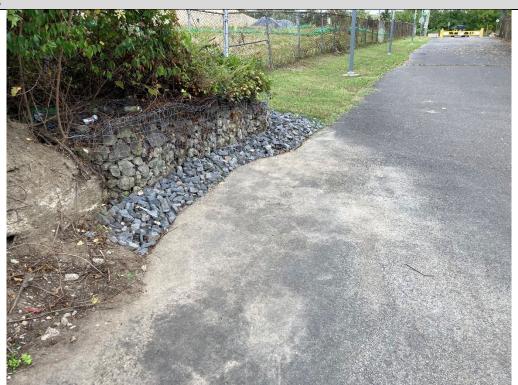
ADDITIONAL COMMENTS					
(continued from Page 1)					
·					
l observed that the affected portion of the Bartram's Garden trail had less sediment on it during this inspection than on the previous inspection (No. 07, 9/17/24). Sediment staining on the macadam trail remains.					
No violations noted during this inspection.					
NOTICE AND S	SIGNATURES				
This report is official notification that a representative of the Depinspection of your earth disturbance activity to determine complian Streams Law. This representative may be an employee of a County DEP is authorized to investigate complaints, inspect earth disturb observed by DEP/CCD have been noted in this report and constitute Law. Failure to take corrective actions to resolve the violations rassessed by DEP as as specified at Section 602 of the Clean Stready in civil penalties, up to \$10,000 in summary criminal penalties violation. This report does not constitute an Order or appealable act imply immunity from legal action for any violation noted herein. For the section of the clean stready immunity from legal action for any violation noted herein.	nce with 25 Pa. Code Chapter 102 and to Conservation District (CCD), which by delegance activities and conduct compliance of unlawful conduct as defined in Section 61 may result in administrative, civil and/or community. The Clean Streams Law provides, and up to \$25,000 in misdemeanor crinition of DEP. Nothing contained herein shalfurther information or assistance contact the content of the content of the content of the content the content of the conte	the Pennsylvania Clean legation agreement with actions. Any violations of the Clean Streams criminal penalties being less for up to \$10,000 per peninal penalties for each of the DEP/CCD inspector.

Sediment staining on Bartram's Garden trail.

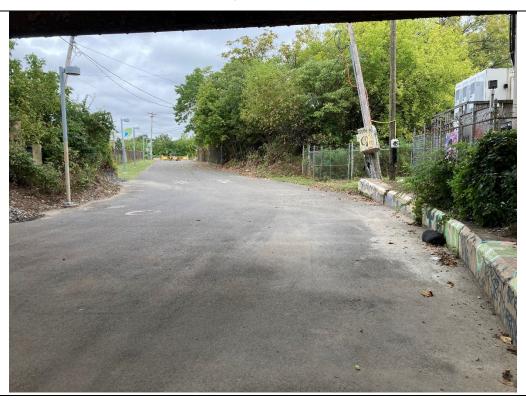
Sediment staining on Bartram's Garden trail.

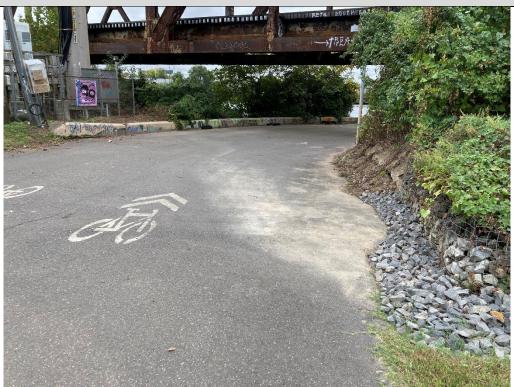
Sediment staining on Bartram's Garden trail, looking downslope towards railroad bridge.

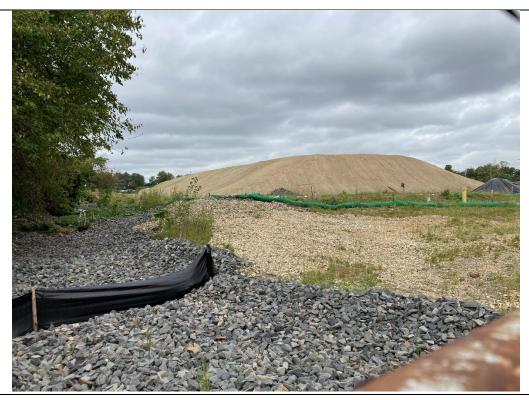
Large fill dirt stockpile with small amount of germination through mulch and matting present, looking from Bartram's Trail.
