Subject: **Revised PNDI Review**

This submittal is to notify you of a change to the proposed Adelpia Gateway Project (Project) since your agency's June 3, 2019 determination of 'No Impact Anticipated' for all Project components (**PNDI Environmental Review Receipt Numbers 638608, 638621, 648580, 648586, 648593, and 650140**). Adelpia Gateway, LLC (Adelpia) proposes to use approximately 6 acres of agricultural and residential land to the east and adjacent of the existing Quakertown Meter Station in Bucks County as additional temporary workspace (ATWS) and an associated temporary access road during Project construction. The ATWS would be used for office space parking, equipment staging, and light fabrication activities. The ATWS and access road would be returned to pre-construction conditions upon Project completion. No other Project changes are proposed at this time.

Re: Wetland Delineation  
Quakertown Compressor Station Area Site  
West Rockhill Township  
Bucks County, Pennsylvania

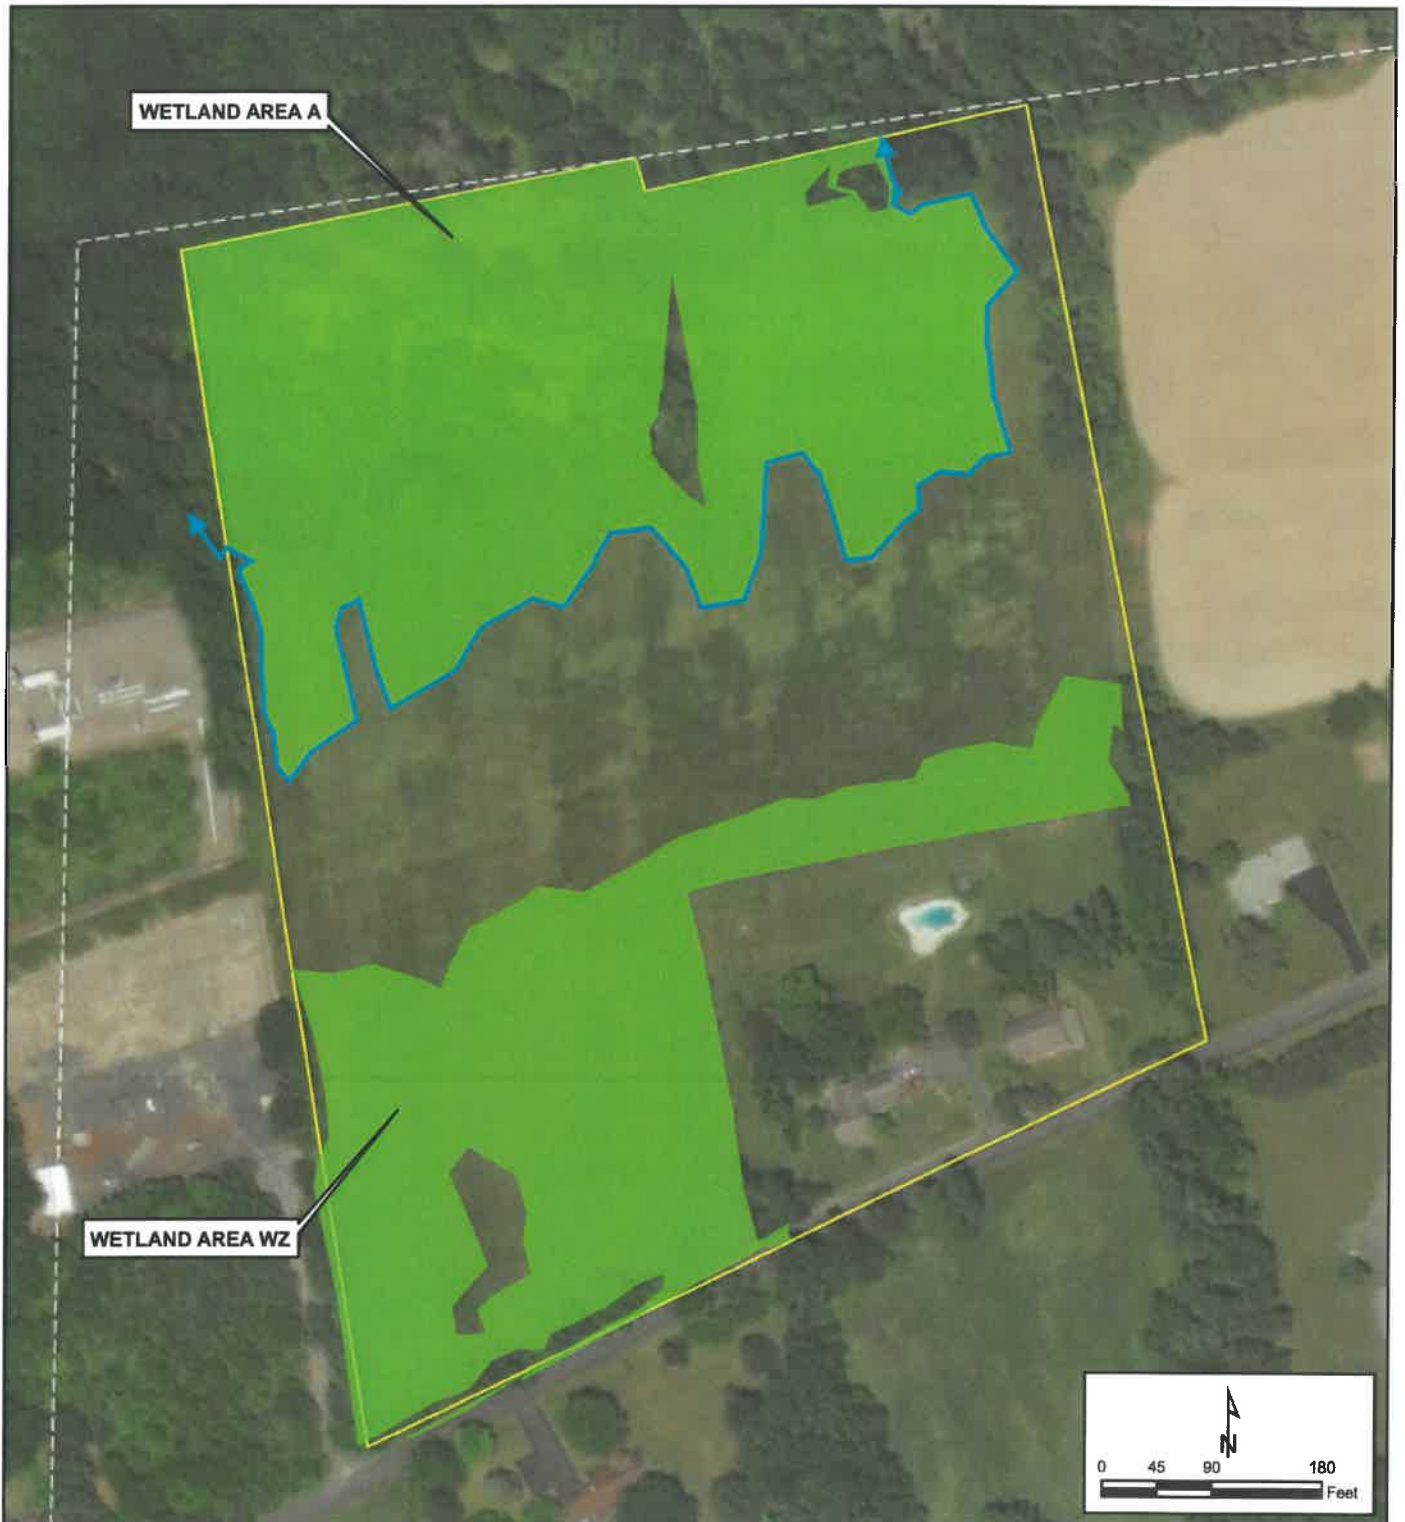
Site Map

<b>Adelphia Gateway Project Environmental Survey Area Quakertown, PA</b>		
SCALE	DRAWING NUMBER	REV
AS SHOWN	Quakertown_ENV_Map_080219	1

The wetlands are characterized by a dominance of hydrophytic vegetation, hydric soils, and presence of wetland hydrologic indicators. Upland areas lacked these characteristics. Attachment 1 includes a Map showing the wetland areas and upland inclusions at the Site.
