From: [Anthony J. Reitano](#)
To: [Brown, C David](#); [Eric Carlson](#); [Brunt, Larry](#)
Cc: [Costello, Andrea](#); [Patel, Ragesh](#); [Sabetta, Matthew](#); [McCarthy, Christine](#); [McClennen, Bonnie](#); [Suarez Rivera, Glorines](#)
Subject: RE: DRAFT response - RE: [External] FW: Alliance 51st Street PADEP Split Sample Results
Date: Thursday, September 19, 2024 11:35:03 AM
Attachments: [image001.png](#)
[Before and After cleanup photos of the three locations.pdf](#)

In follow-up to your e-mail below, Alliance retained its contractor to clean up the locations you pointed out in your e-mail below – S-3, S-5 and S-6 and S-8A. Attached in the pdf are before and after photos of the three areas. We do note that S-5 and S-6 get quite a bit of debris, most likely have the river high tide. You will see from the photo from Tuesday of this area in the pdf after the cleanup, which shows the area very clean, and then the jpg photo from yesterday, which shows debris after just 24 hours. The concern here is what could the river be depositing in the S-5/S-6 area from sources unrelated to the Alliance property.

Samples S3 and S5 exceed the standard of 37 mg/kg. Sample S6 is proximal to S

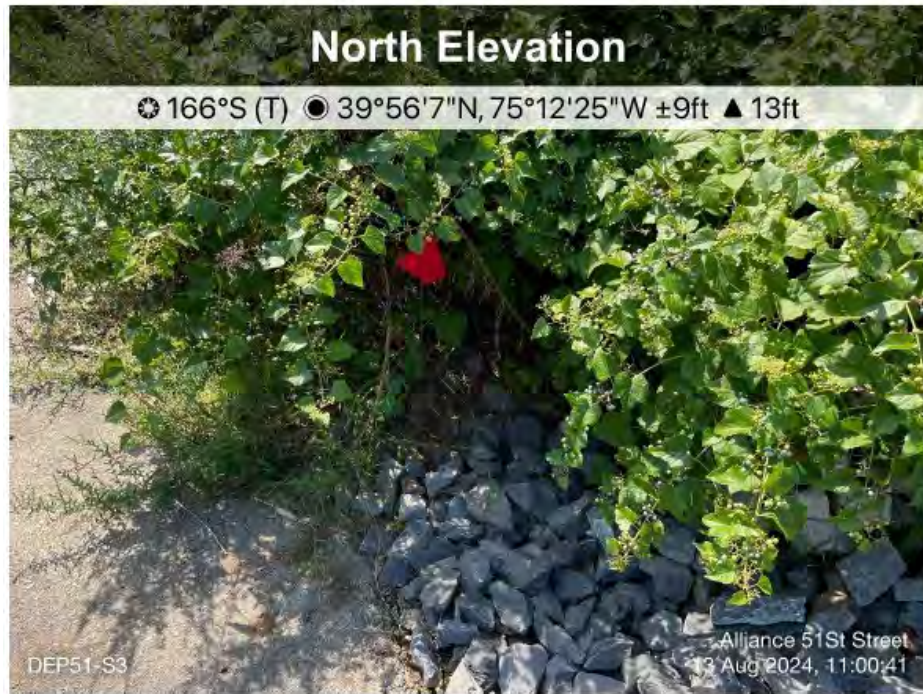
Before Cleanup

DEP51-S3 – Collected from soil next to placed stone.

Based on DEP's results, additional cleanup is needed at the S3, S5, S6, and S8A locations. The S3 soil sample was collected immediately next to the stone that was placed outside of the Alliance property fence. It is likely that not all of the contaminated soil was removed from this area during the cleanup effort in early August. Similarly, the S8A soil sample was collected from the closest accumulation of soil to the 7/22/24 S8 sample location. DEP's 7/22/24 sample results at S5 and S6 were non-detect, so no cleanup effort was completed in this area. Based on the 8/13/24 results, additional cleanup is needed.

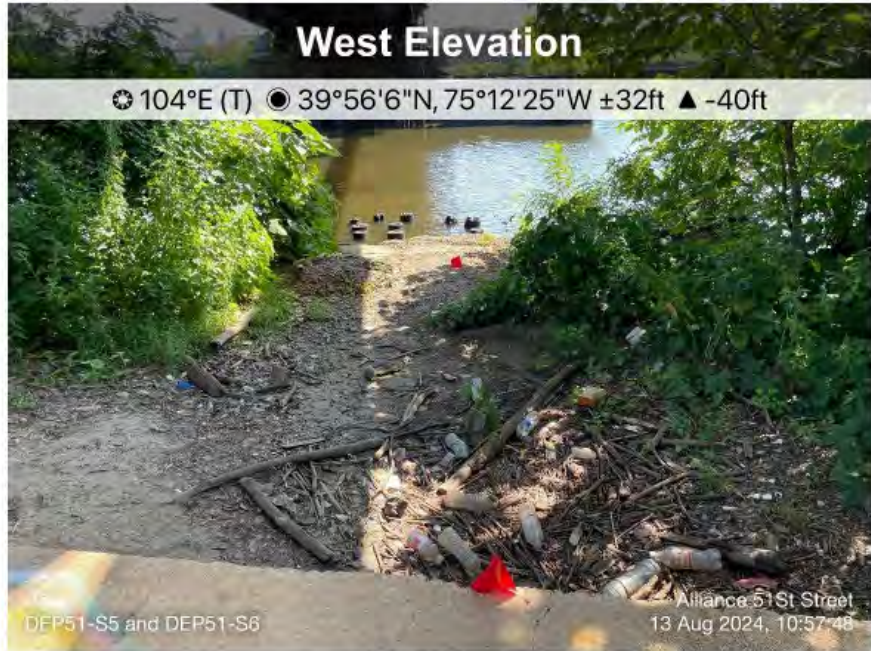
Before Cleanup

DEP51-S5 was collected from adjacent to the concrete wall and drainpipe. DEP51-S6 was collected closest to the river.

We understand your position that other sources, such as paint, may be contributing to chromium VI in soil at the trail. However, based on our observations, the area of S5 and S6 was also potentially impacted by the discharge from the Alliance property. To test the hypothesis that paint from the bridge is a dominant contributor, we'd suggest collecting additional soil samples near the bridge at a location not affected by the discharge.

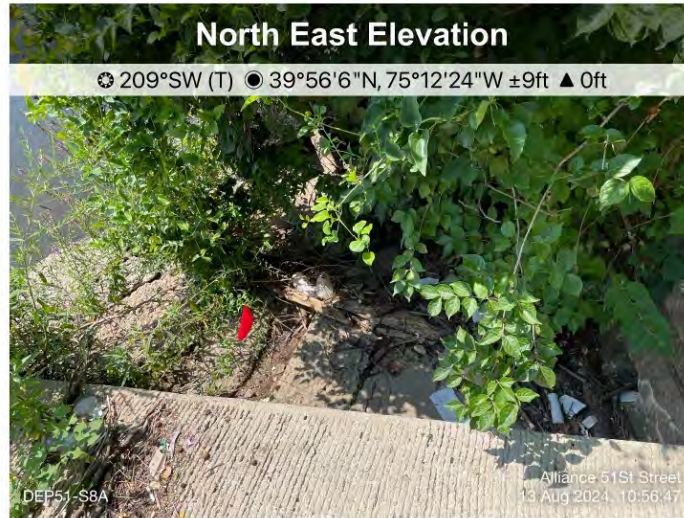
Before Cleanup

DEP51-S8A was collected from an area of accumulated soil downgradient of the original DEP51-S8 location.
