CHAPTER 102 INSPECTION REPORT

PA Department of Environmental Protection

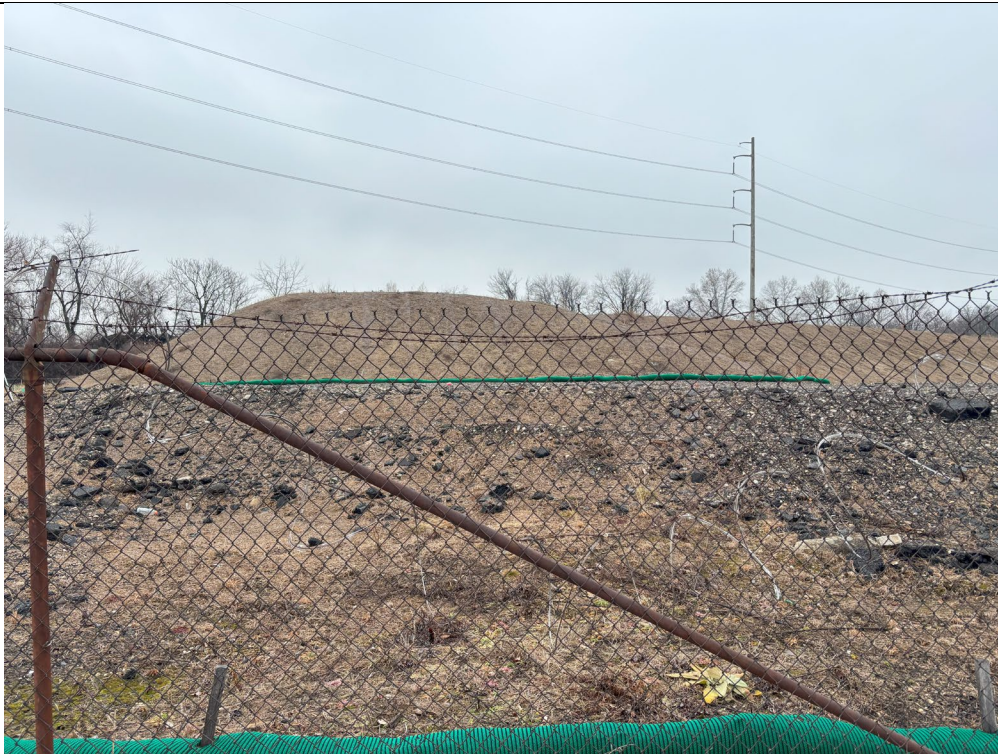
Damage to perimeter fence and concertina wire.

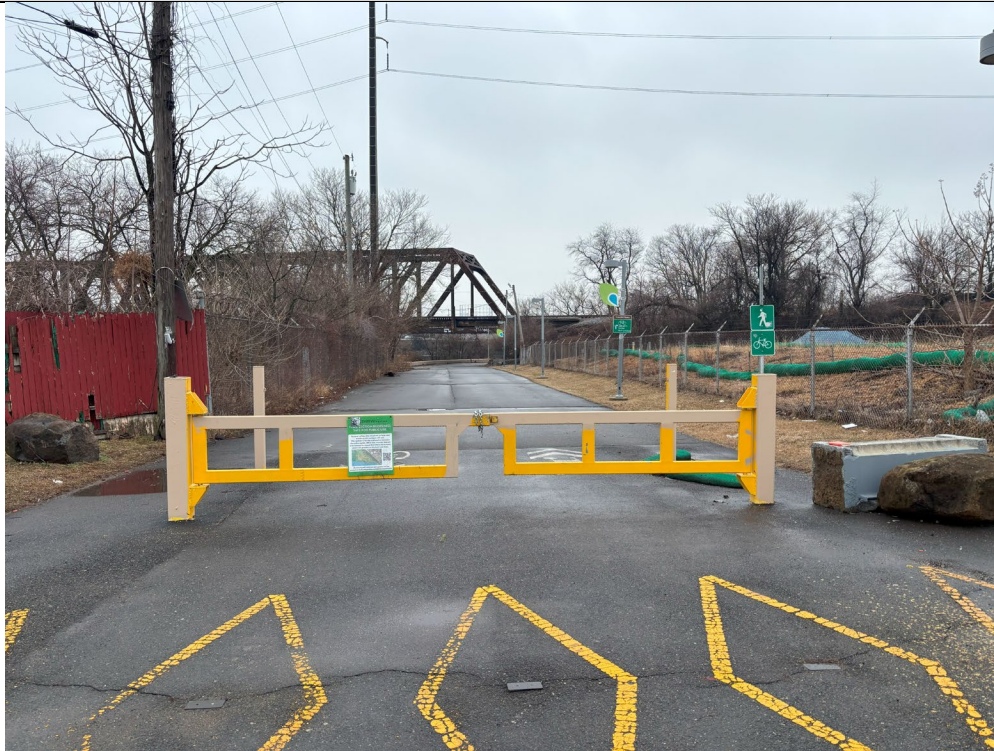
Trail gates at 51st & Botanic Sts. closed, but with signage indicating trail is open.

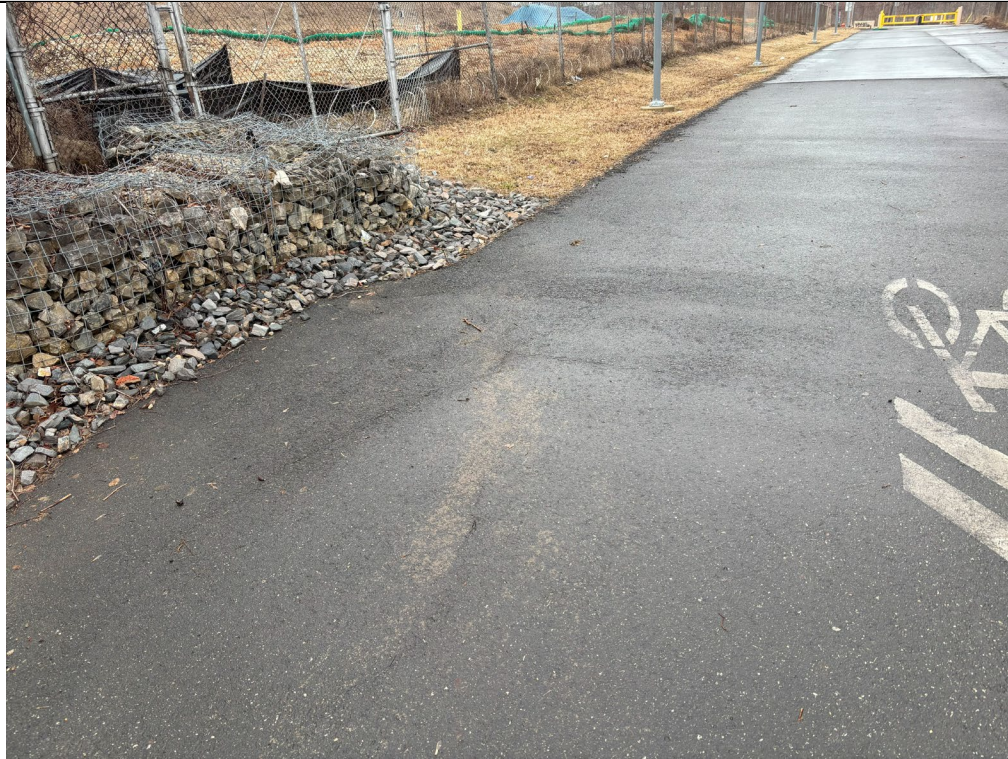
Site of previous sediment staining on Bartram's Garden trail.

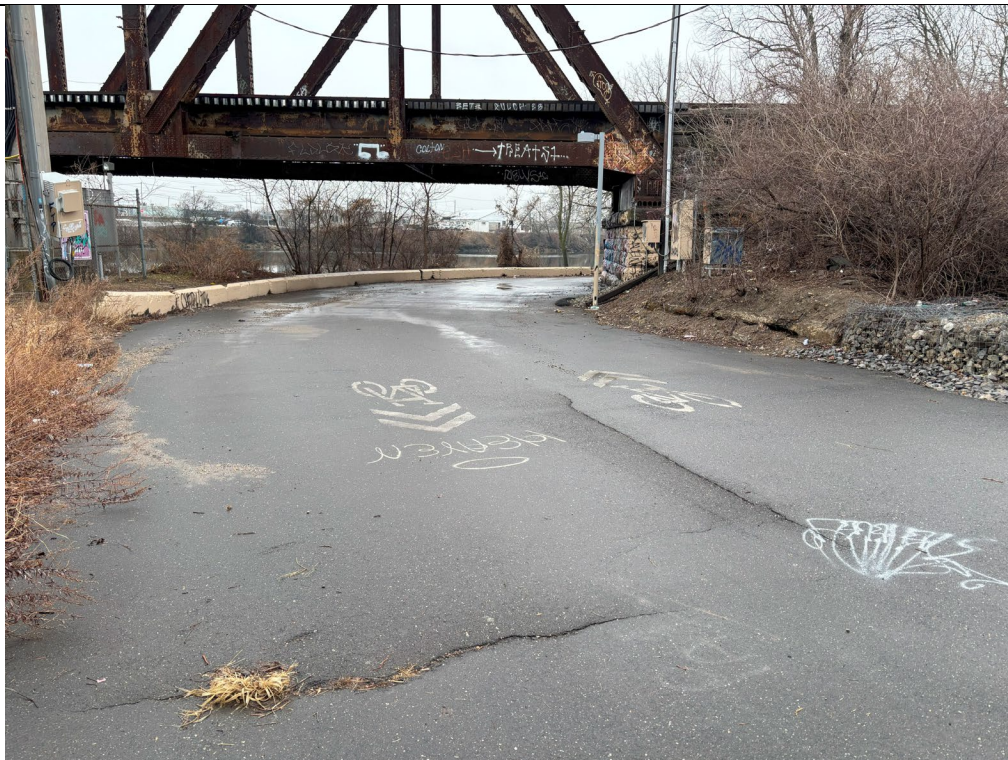
Bartram's Garden trail along Schuylkill River, looking downstream from eastern/downslope corner of site.
