**If Interim report, Subject to Change as Additional Information Becomes Available**  
**If Interim Report, this Report is cumulative, containing information from previous reports in addition to new information and may change**  
**SPLP PENNSYLVANIA PIPELINE PROJECT**  
**HORIZONTAL DIRECTIONAL DRILLING – INADVERTENT RETURN REPORT FORM**

<b>REPORT DATE:</b>	Current as of 10/19/2020	<b>HDD ALIGNMENT #</b>	PA-CH-100.0000-RD				
<b>PROJECT SITE:</b>	PPP 6 - S3-0290 - Milford Rd./Little Conestoga Rd		<b>HDD COMPANY:</b>	Michels Directional Crossing			
<b>DATE AND TIME WHEN IR WAS INITIALLY DISCOVERED</b>			<b>DATE:</b>	8/10/2020	<b>TIME:</b>	1530	
<b>LOCATION: STREET</b>	427-423 Green Valley Rd, Downingtown, PA 19335		<b>MUNICIPALITY:</b>	Upper Uwchlan	<b>COUNTY:</b>	Chester	
<b>LATITUDE:</b>	40.0794	<b>LONGITUDE:</b>	-75.7104	<b>FROM STATION:</b>	14824+00	<b>TO STATION</b>	14824+00
<b>STREAM NAME:</b>	S-H10 (UNT to Marsh Creek), S-H11 (UNT to Marsh Creek)		<b>POND / LAKE NAME:</b>	Pond H3 (Marsh Creek Reservoir)	<b>WETLAND NAME:</b>	WL-H17 (PEM, PFO)	
<b>DEP PERMIT Nos. (102 AND 105)</b>	E&S Permit # ESG0100015001, Water Obstruction Permit E15-862						
<b>CORPS PERMIT NO.</b>	PASPGP

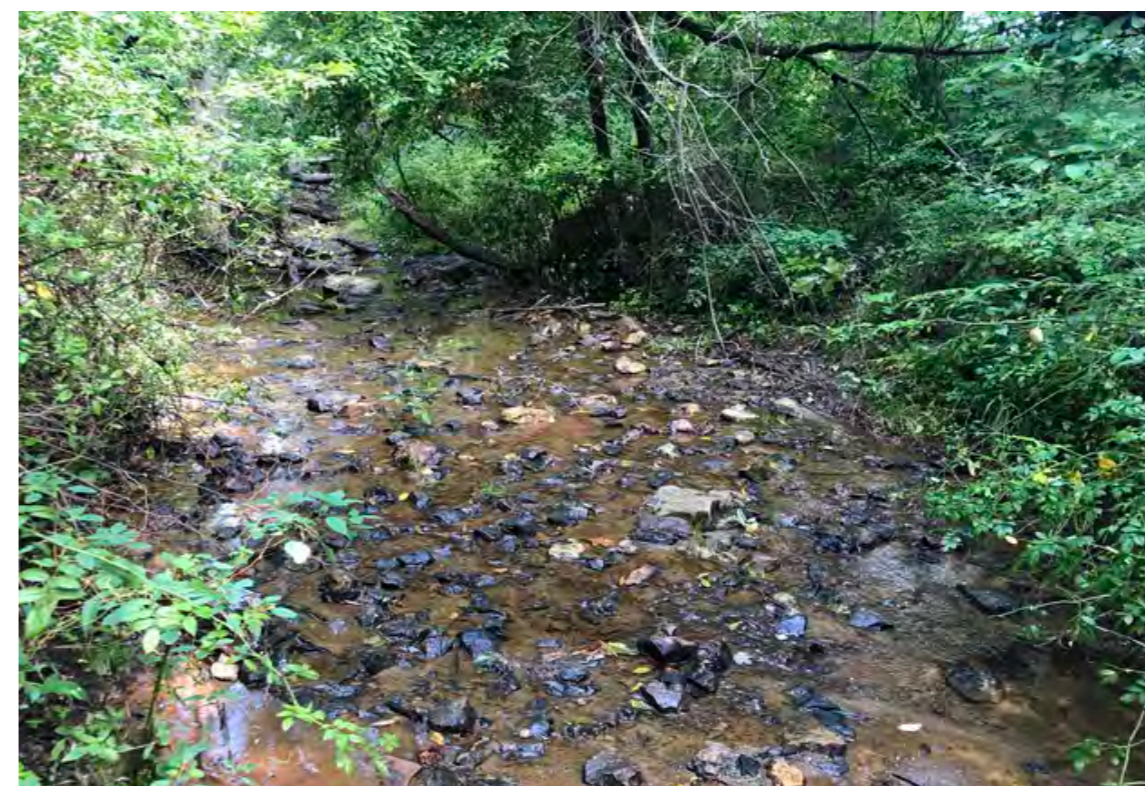
8/24/2020

View of stream S-H10 (UNT to Marsh Creek)

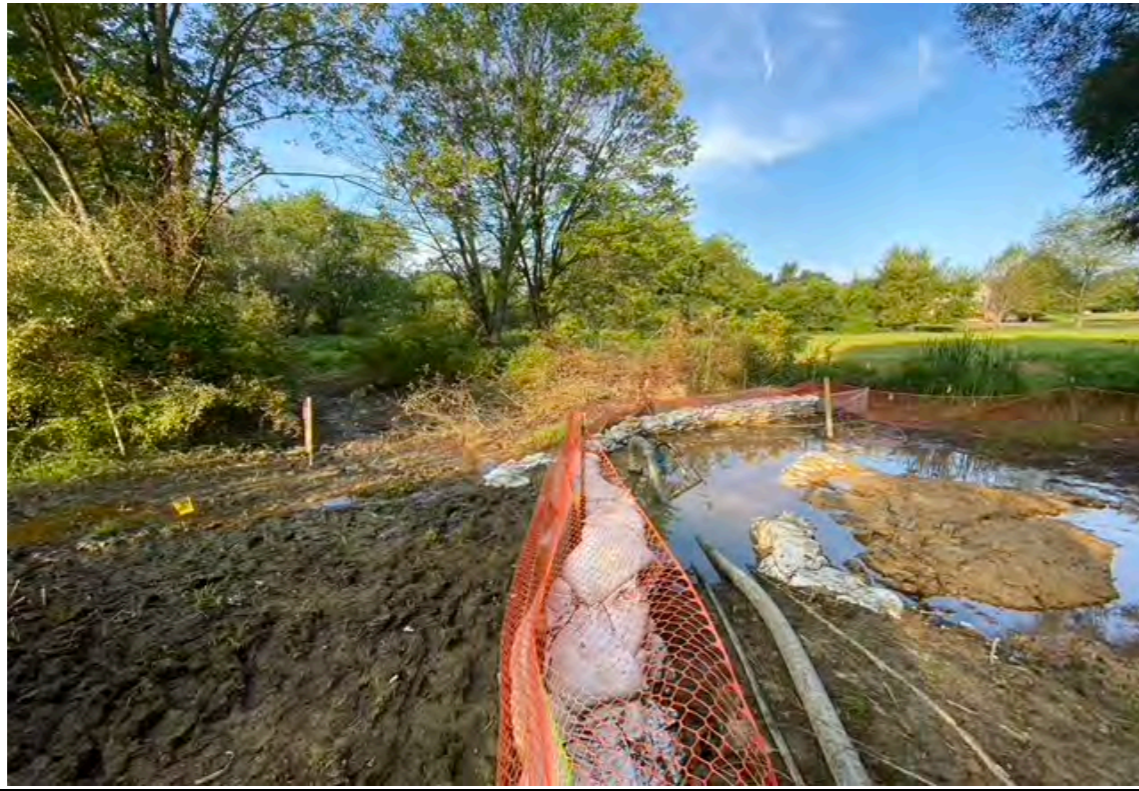
8/28/2020

View of IR release location and containment within WL-H17.

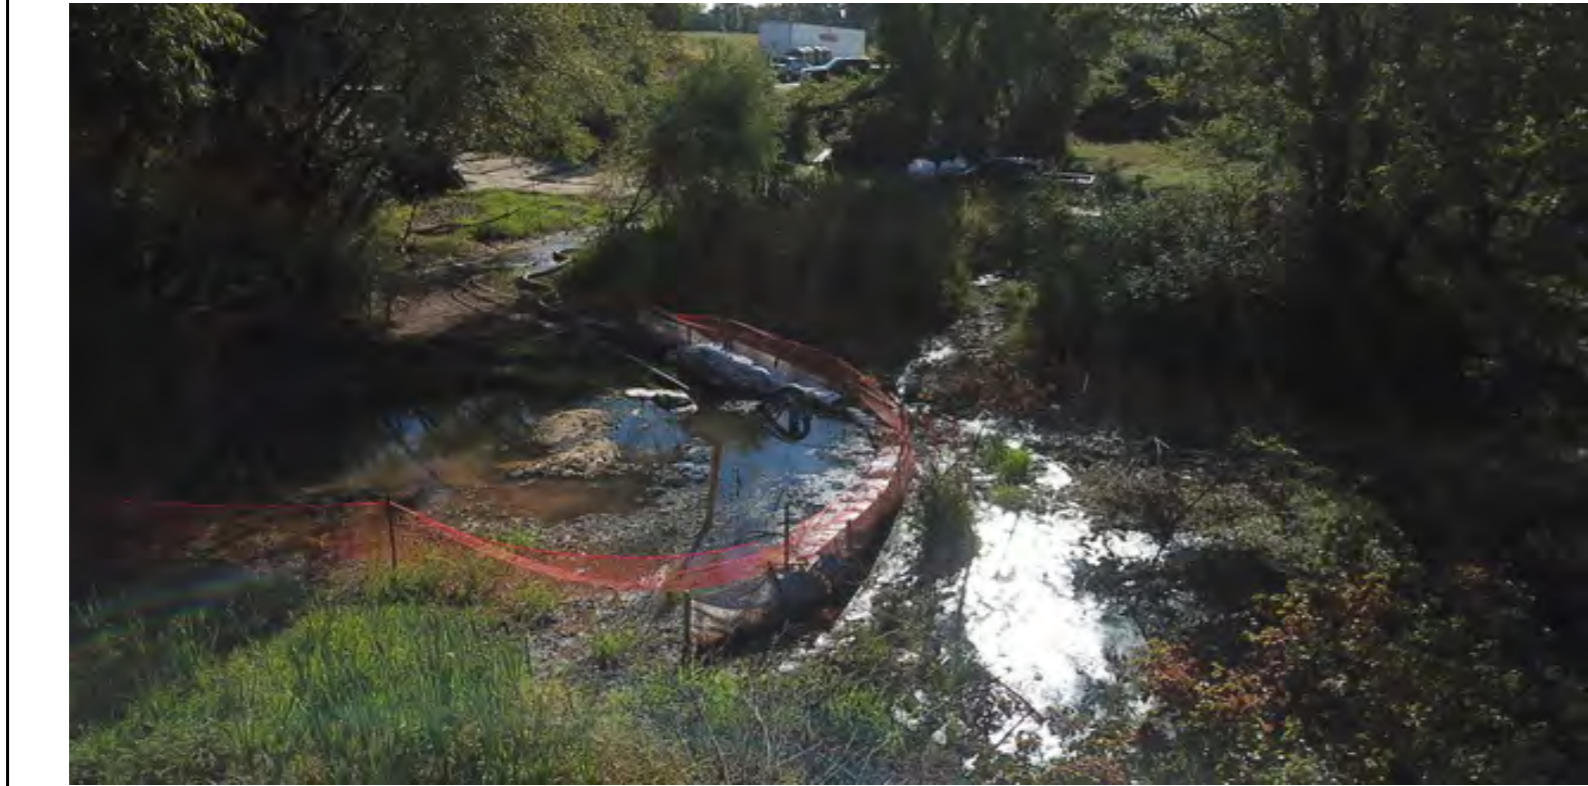
9/21/2020

View of IR release location and containment within WL-H17.

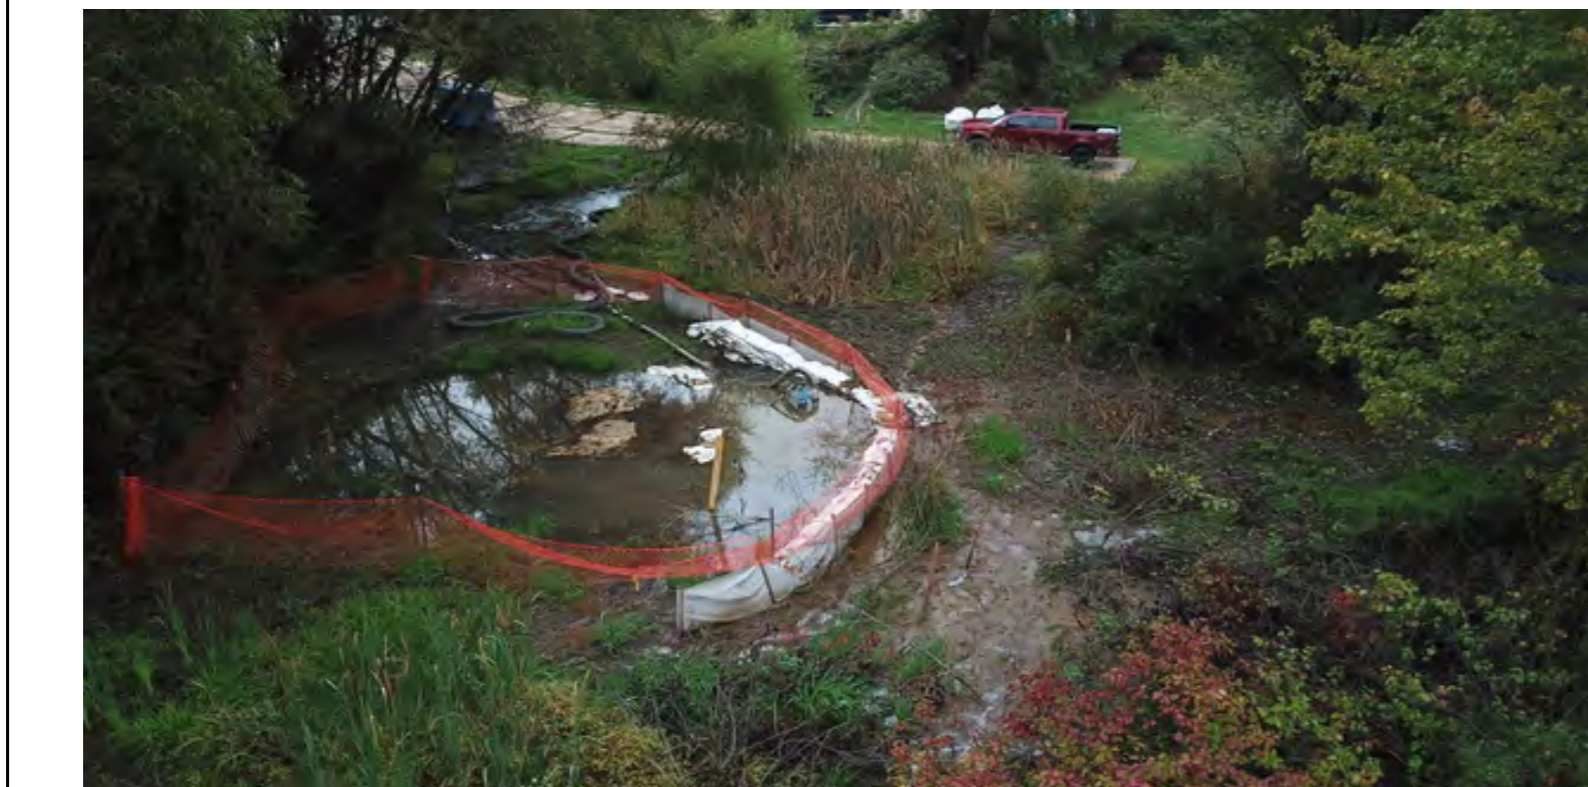
9/28/2020

View of IR release location and containment within WL-H17.

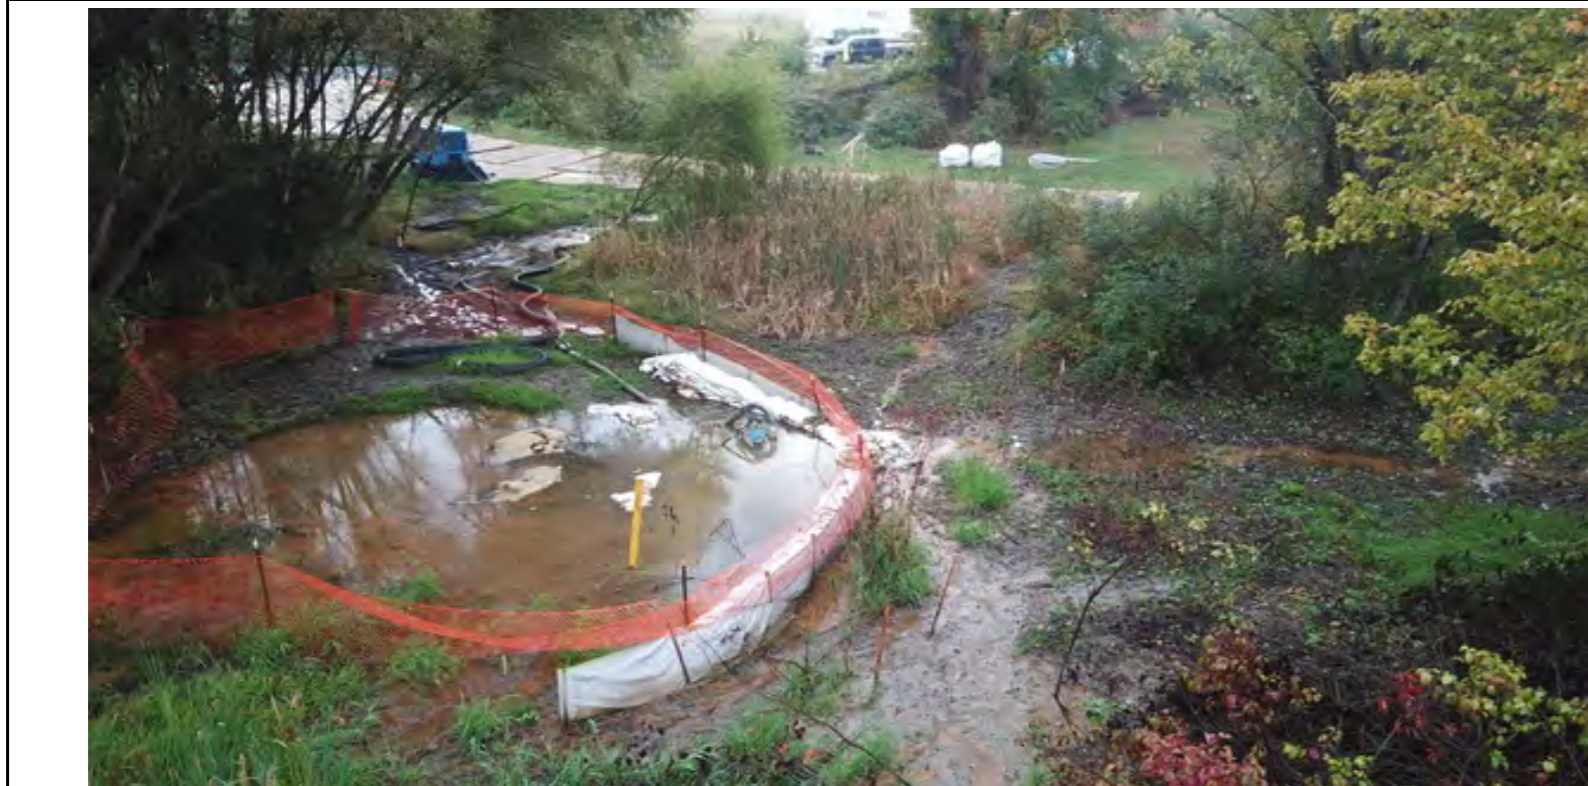
10/5/2020

View of IR release location and containment within WL-H17.

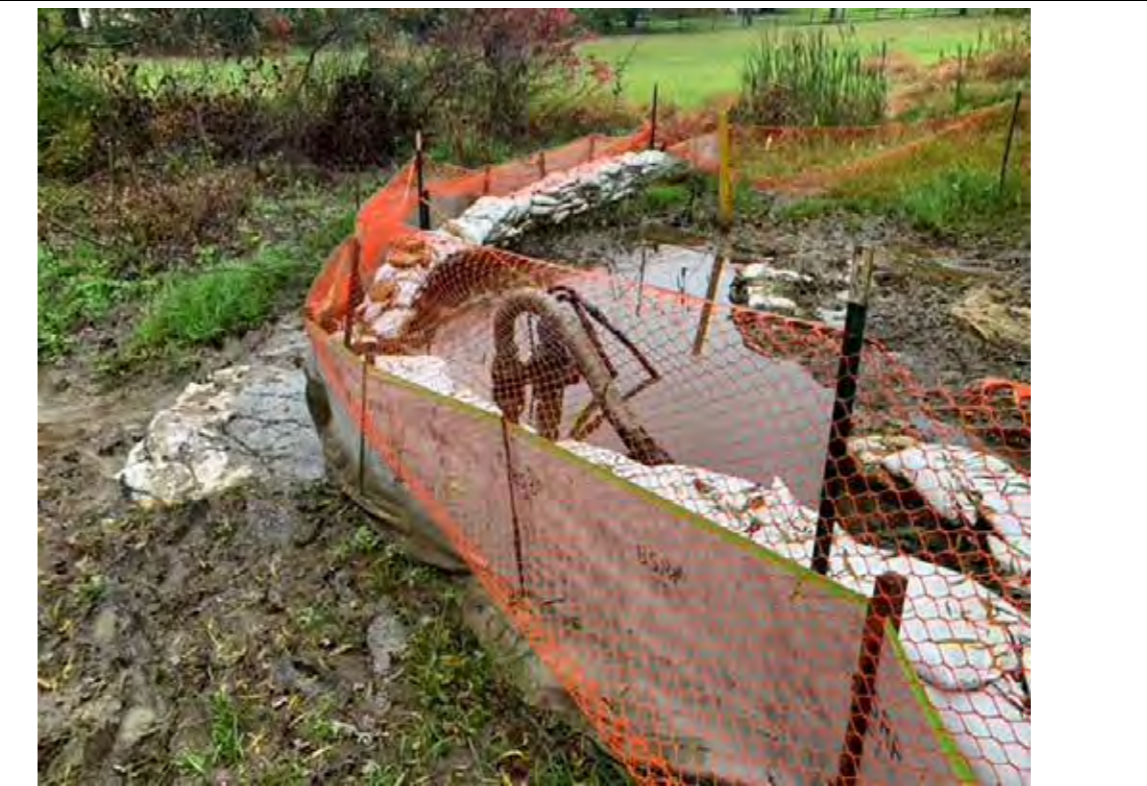
10/12/2020

View of IR release location and containment within WL-H17.

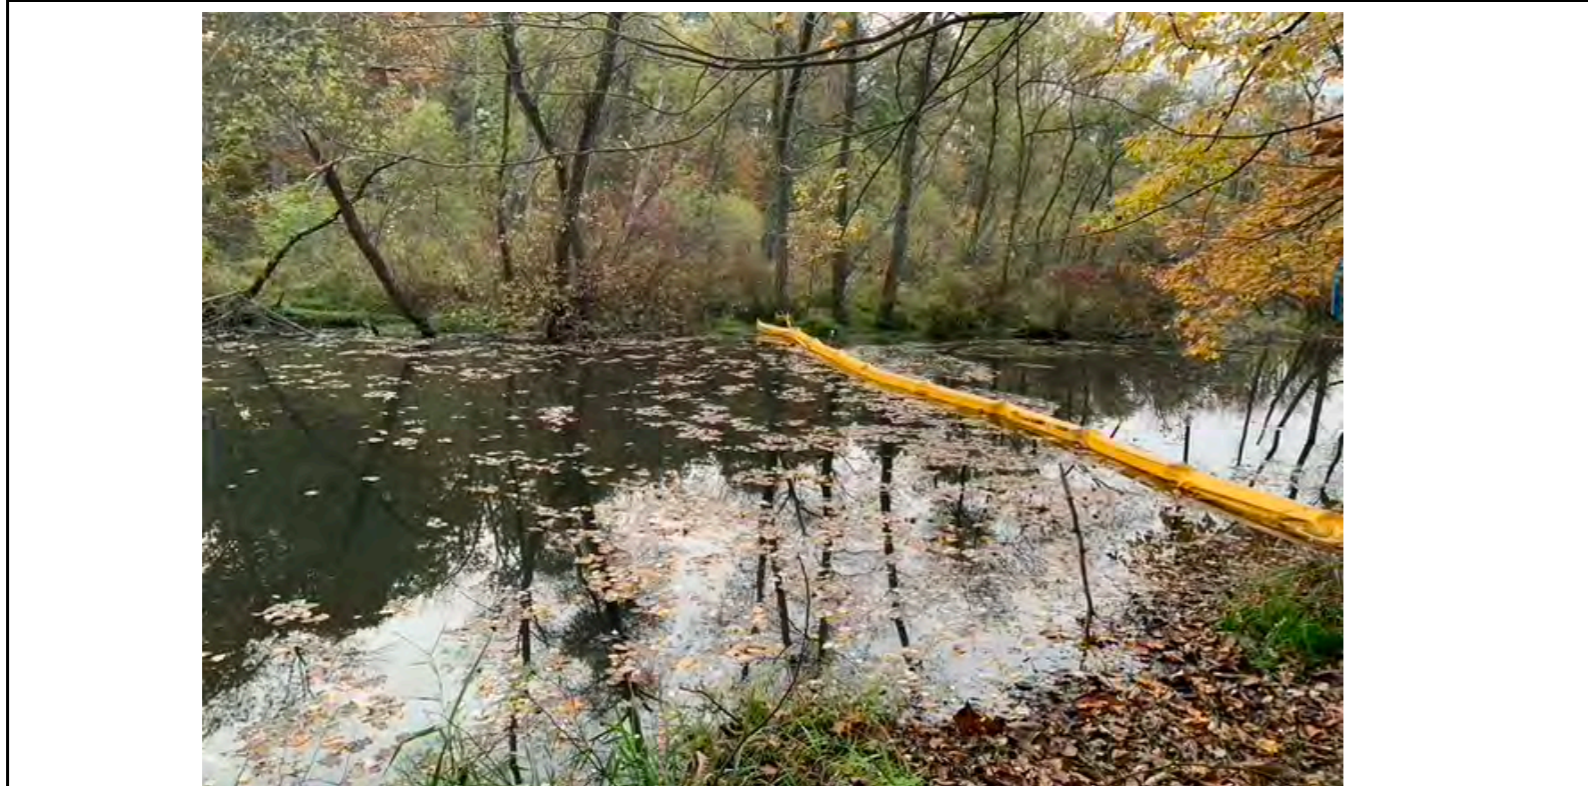
10/19/2020

View of turbidity curtain at the confluence of stream S-H10 (UNT to Marsh Creek) and pond H3 (Marsh Creek Reservoir).
