If Interim report, Subject to Change as Additional Information Becomes Available
If Interim Report, this Report is cumulative, containing information from previous reports in addition to new information and may change
SPLP PENNSYLVANIA PIPELINE PROJECT
HORIZONTAL DIRECTIONAL DRILLING – INADVERTENT RETURN REPORT FORM

REPORT DATE:	Current as of 10/26/2020	HDD ALIGNMENT #	PA-CH-100.0000-RD			
PROJECT SITE:	PPP 6 - S3-0290 - Milford Rd./Little Conestoga Rd	HDD COMPANY:	Michels Directional Crossing			
DATE AND TIME WHEN IR WAS INITIALLY DISCOVERED		DATE:	8/10/2020	TIME:	1530	
LOCATION: STREET	427-423 Green Valley Rd, Downingtown, PA 19335	MUNICIPALITY:	Upper Uwchlan	COUNTY:	Chester	
LATITUDE:	40.0794	LONGITUDE:	-75.7104	FROM STATION:	14824+00	
STREAM NAME:	S-H10 (UNT to Marsh Creek), S-H11 (UNT to Marsh Creek)	POND / LAKE NAME:	Pond H3 (Marsh Creek Reservoir)	WETLAND NAME:	WL-H17 (PEM, PFO)	
DEP PERMIT Nos. (102 AND 105)	E&S Permit # ESG0100015001, Water Obstruction Permit E15-862					
CORPS PERMIT NO.	PASPGP-5 (issued April 12, 2017)					
IR TRACKING ID:	PPP6_PA-CH-0100.0000-RD_MilfordRd_IRInterim_11_102720					
IS AUGUST 8, 2017 ORDER APPLICABLE?	YES	LISTED IN WHICH EXHIBIT?	3	DESCRI

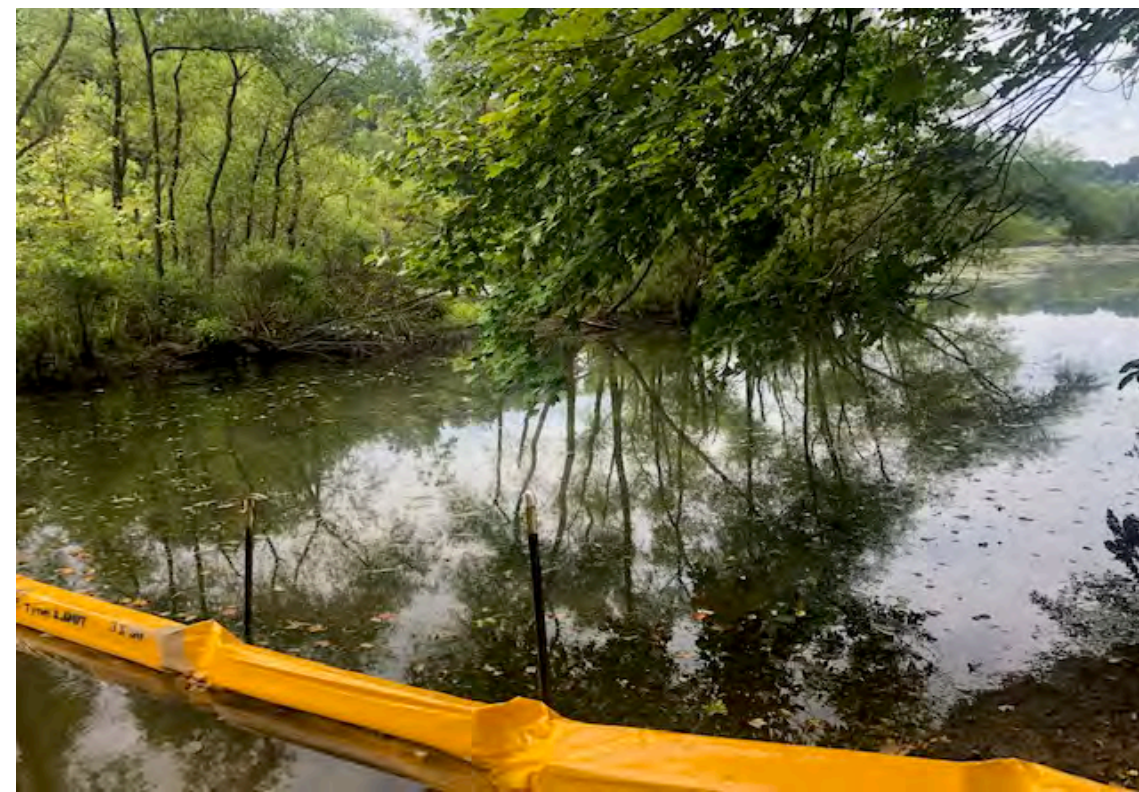
8/22/2020

View of turbidity curtain at the confluence of stream S-H10 (UNT to Marsh Creek) and pond H3 (Marsh Creek Reservoir).

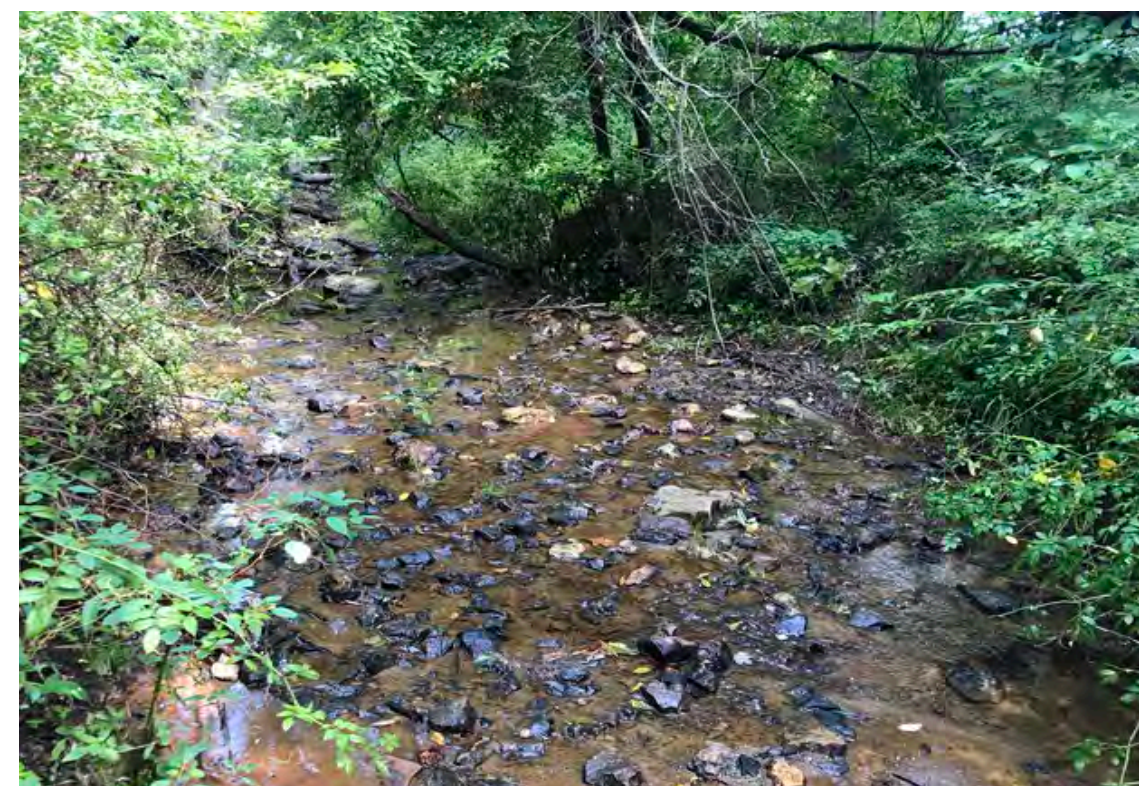
8/24/2020

View of stream S-H10 (UNT to Marsh Creek)

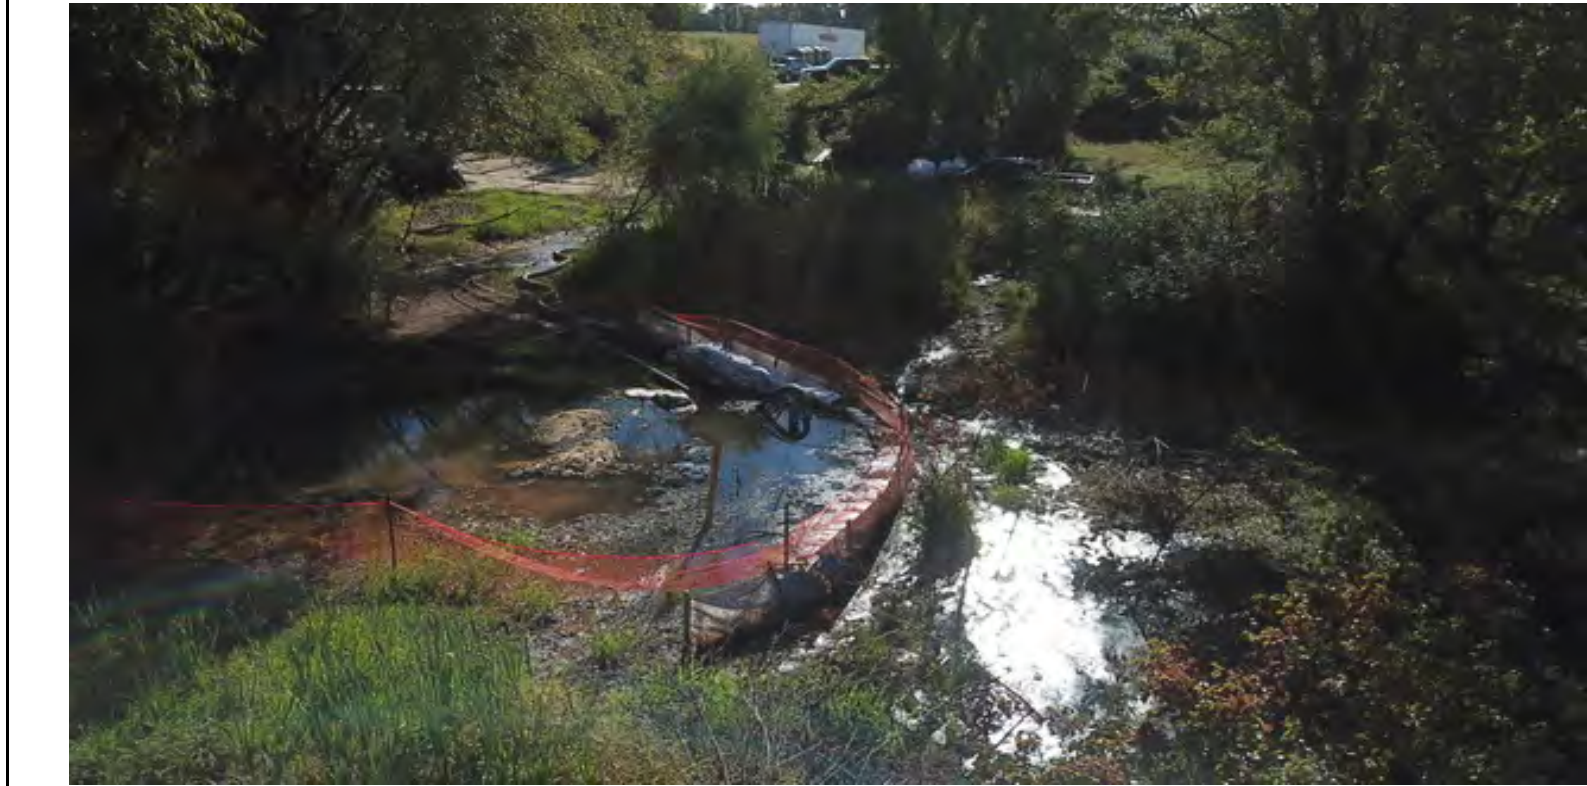
9/21/2020

View of IR release location and containment within WL-H17.

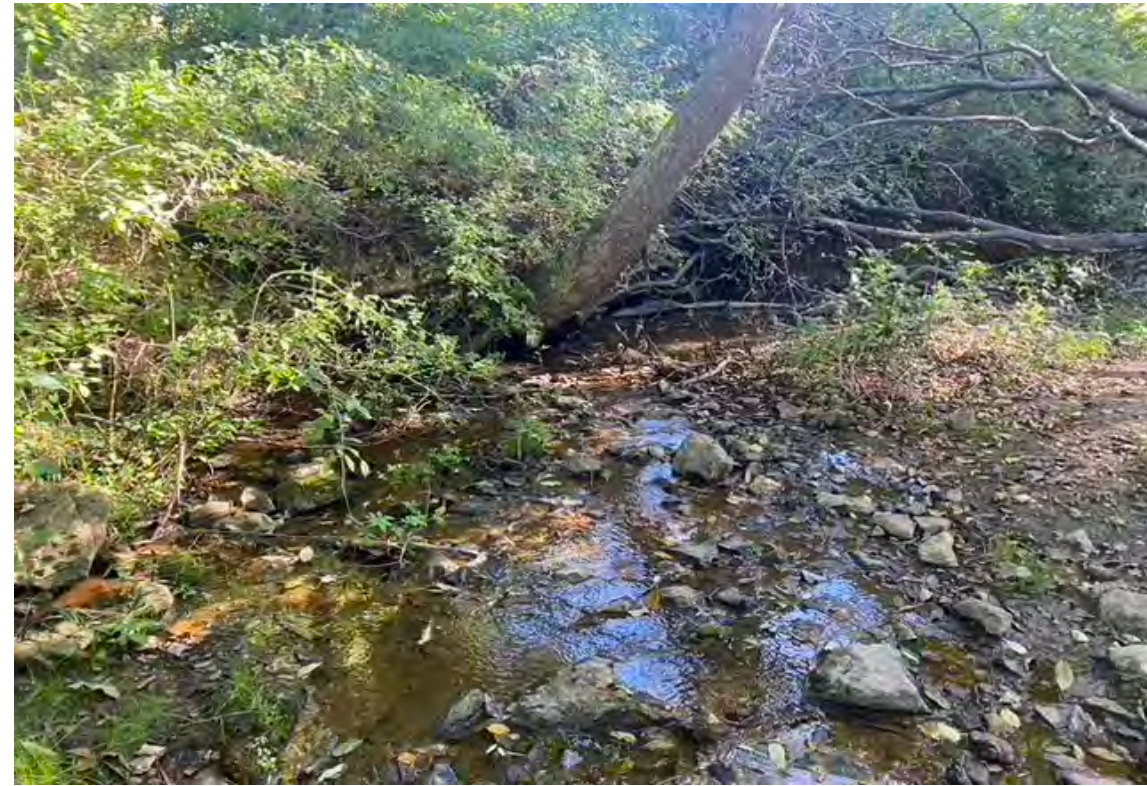
9/21/2020

View of stream S-H10 (UNT to Marsh Creek)

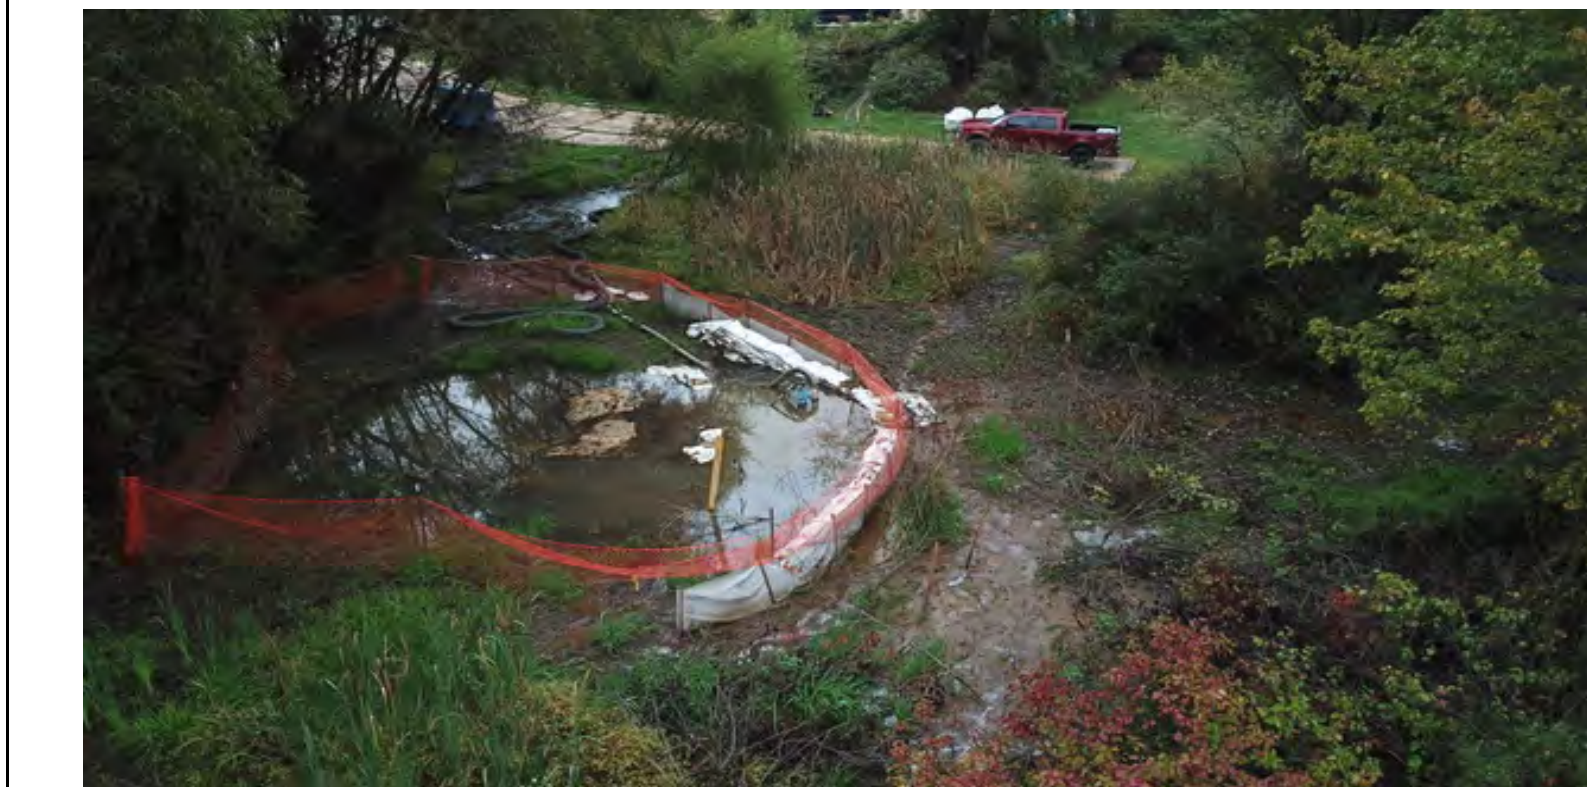
9/28/2020

View of IR release location and containment within WL-H17.

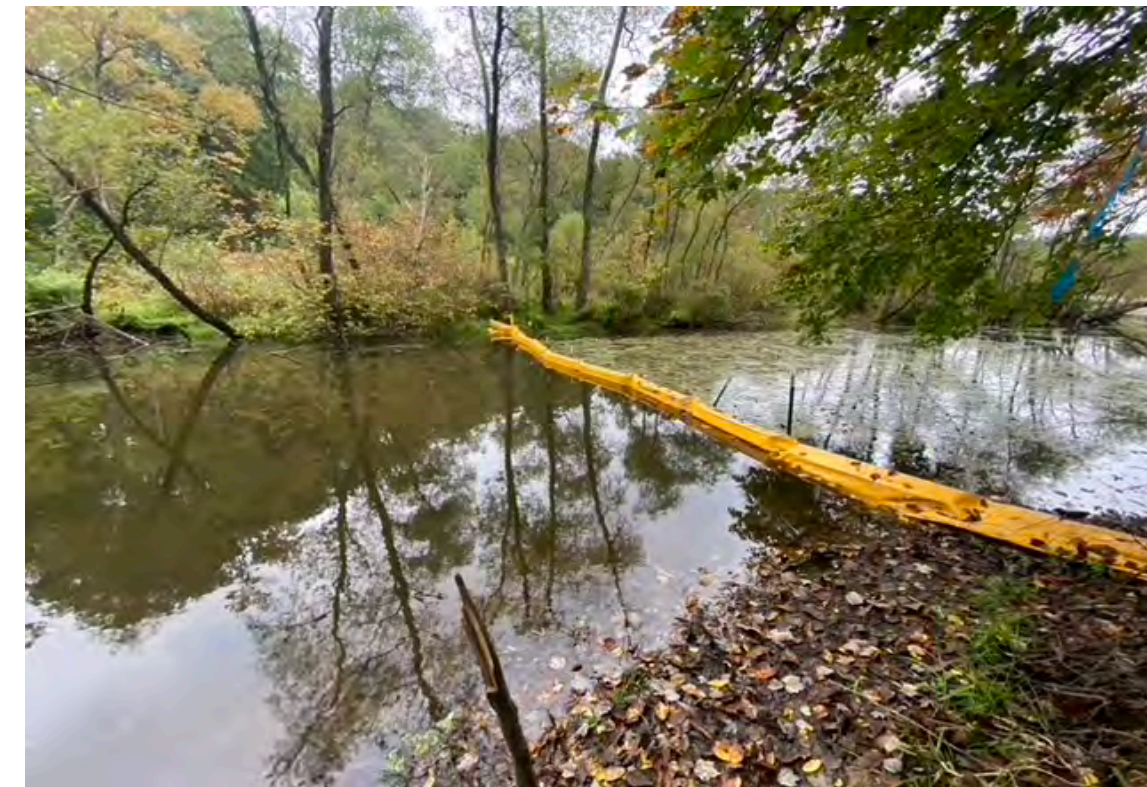
9/28/2020

View of turbidity curtain at the confluence of stream S-H10 (UNT to Marsh Creek) and pond H3 (Marsh Creek Reservoir).

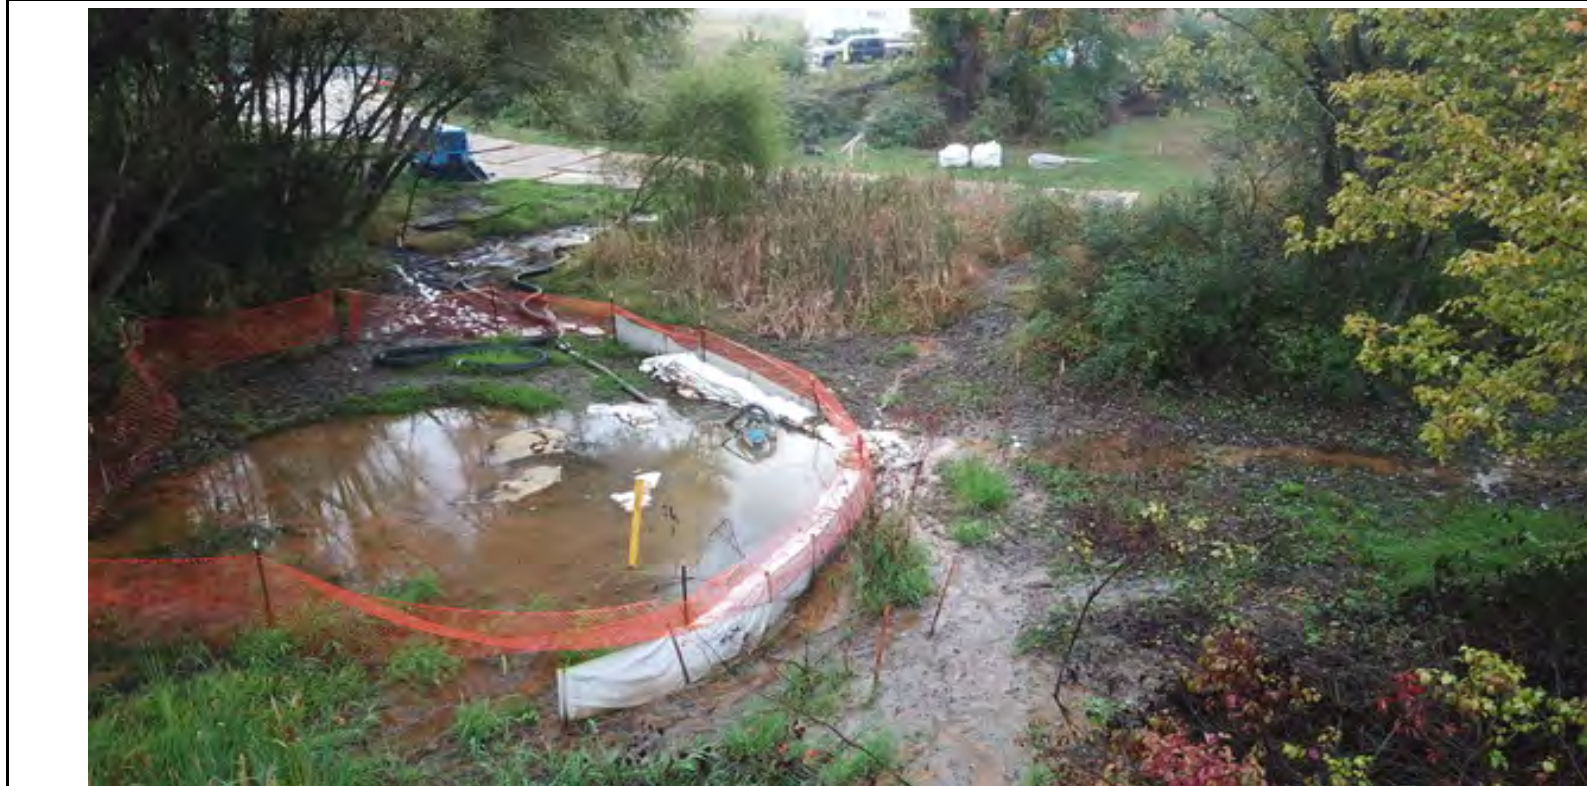
10/5/2020

View of IR release location and containment within WL-H17.

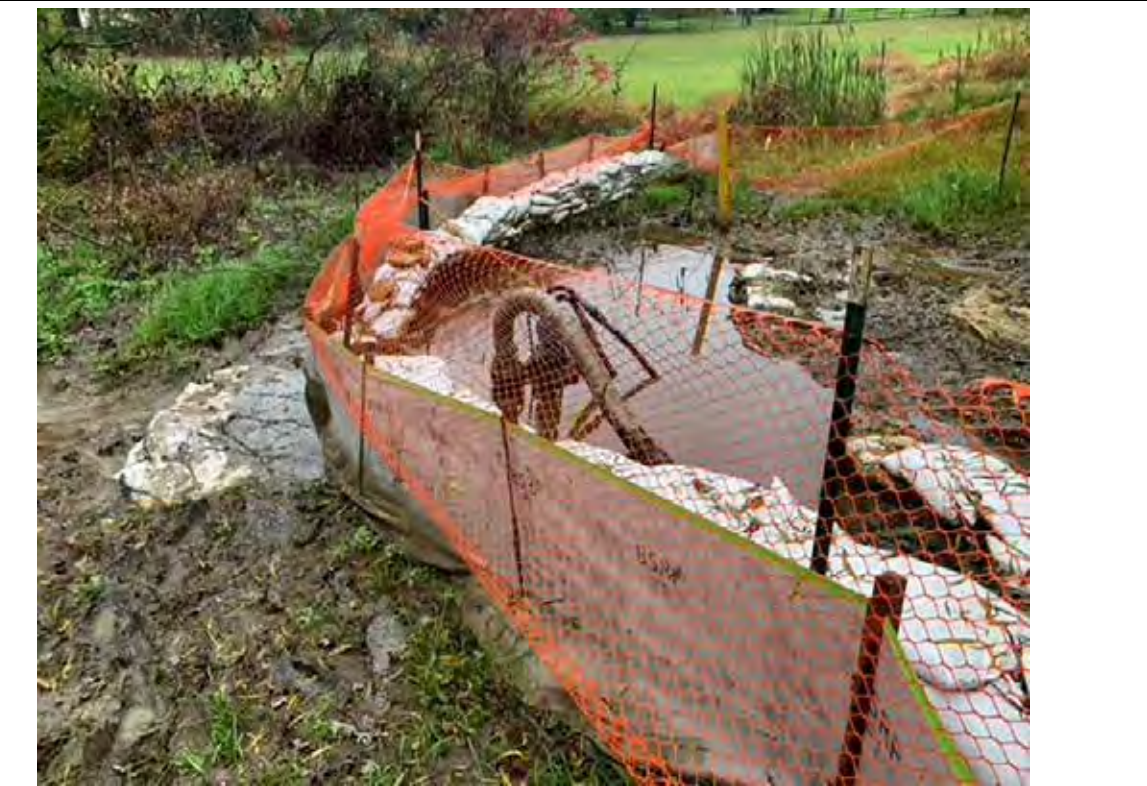
10/12/2020

View of IR release location and containment within WL-H17.

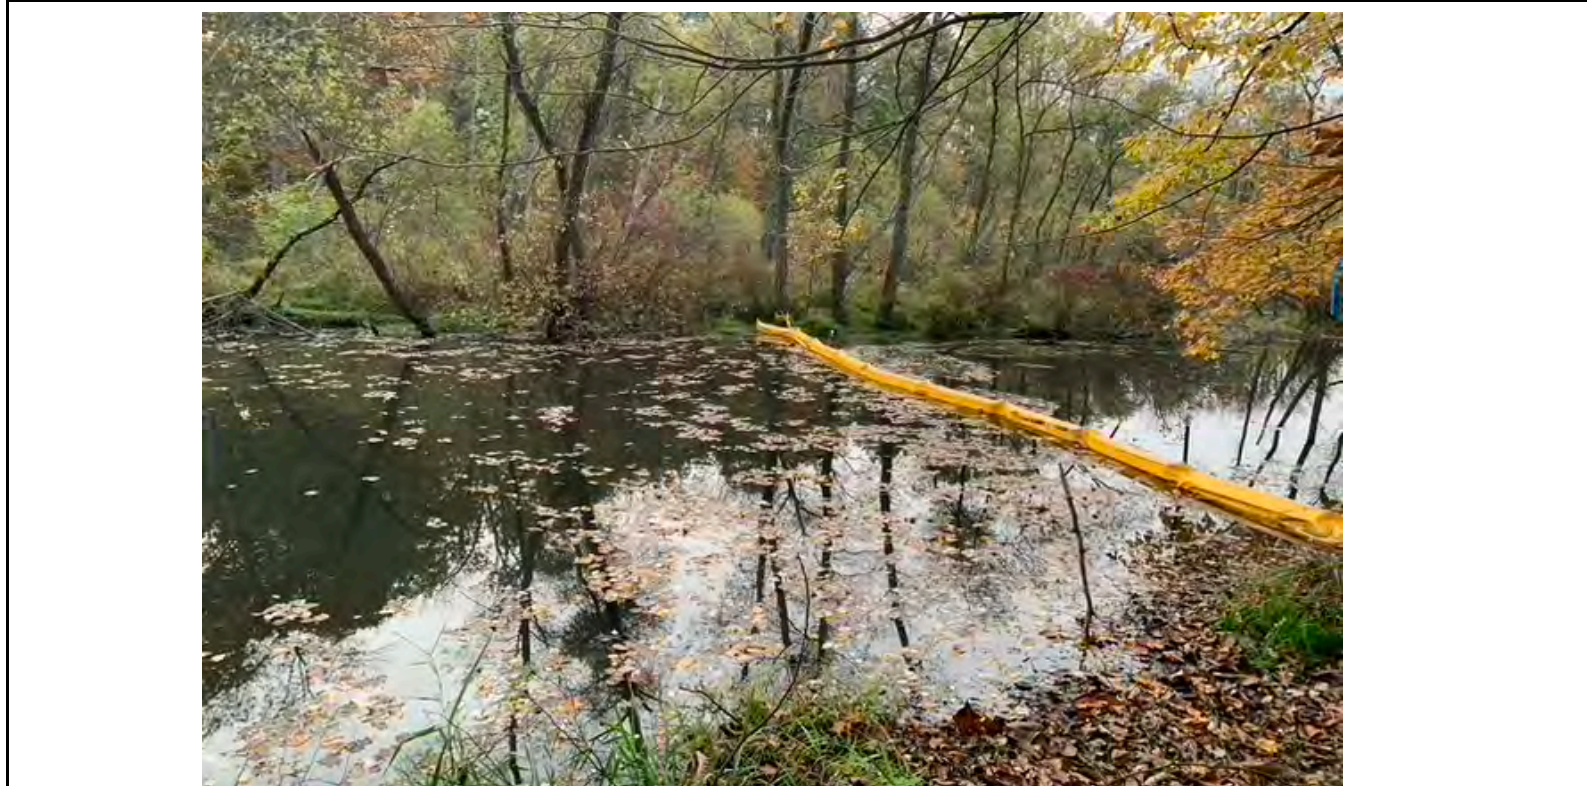
10/19/2020

View of turbidity curtain at the confluence of stream S-H10 (UNT to Marsh Creek) and pond H3 (Marsh Creek Reservoir).

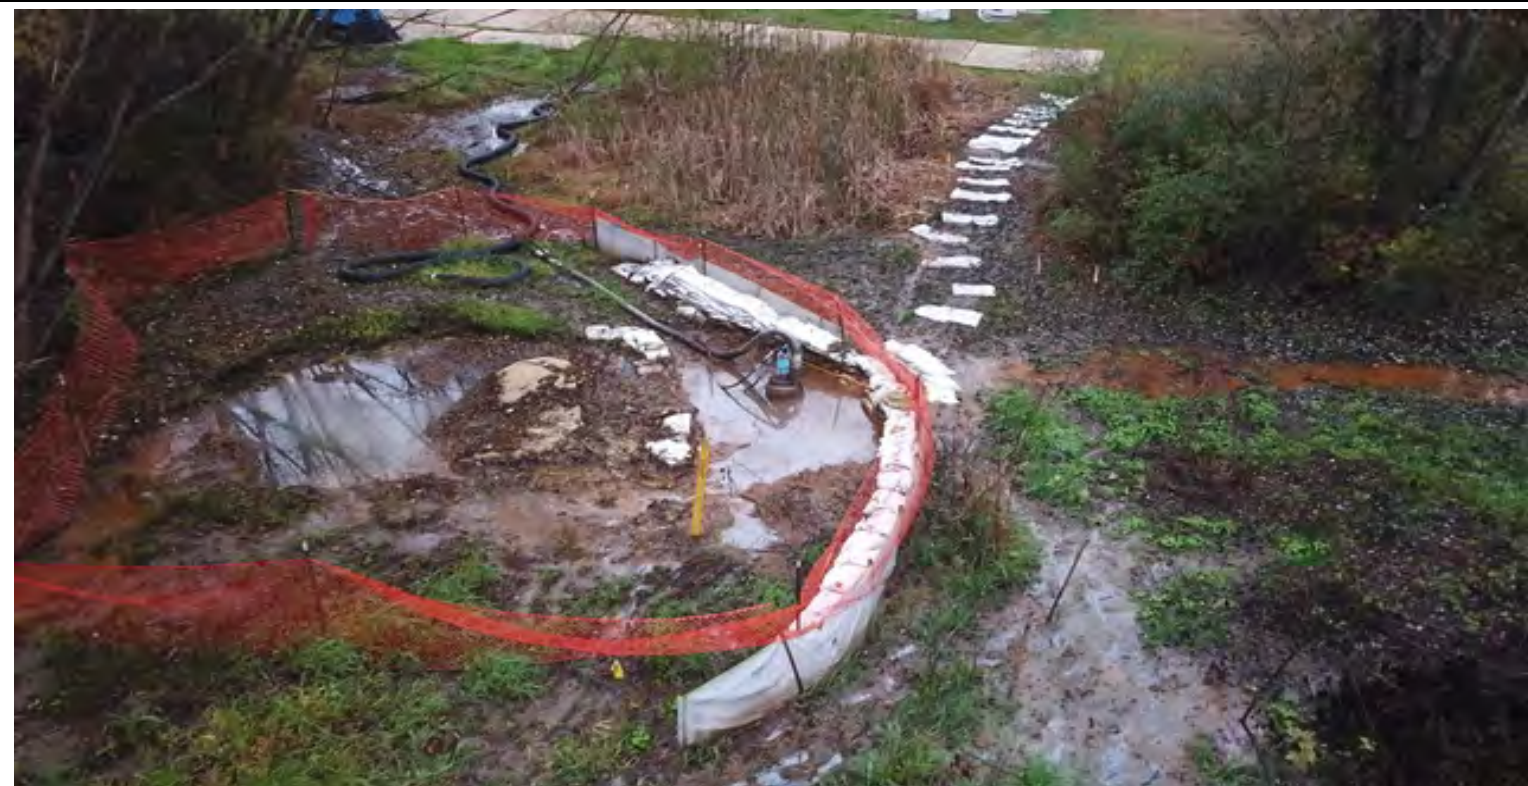
10/26/2020

View of IR release location and containment within WL-H17.
