**If Interim report, Subject to Change as Additional Information Becomes Available**  
**If Interim Report, this Report is cumulative, containing information from previous reports in addition to new information and may change**  
**SPLP PENNSYLVANIA PIPELINE PROJECT**  
**HORIZONTAL DIRECTIONAL DRILLING – INADVERTENT RETURN REPORT FORM**

<b>REPORT DATE:</b>	Current as of 11/23/2020	<b>HDD ALIGNMENT #</b>	PA-CH-100.0000-RD			
<b>PROJECT SITE:</b>	PPP 6 - S3-0290 - Milford Rd./Little Conestoga Rd	<b>HDD COMPANY:</b>	Michels Directional Crossing			
<b>DATE AND TIME WHEN IR WAS INITIALLY DISCOVERED</b>		<b>DATE:</b>	8/10/2020	<b>TIME:</b>	1530	
<b>LOCATION: STREET</b>	427-423 Green Valley Rd, Downingtown, PA 19335	<b>MUNICIPALITY:</b>	Upper Uwchlan	<b>COUNTY:</b>	Chester	
<b>LATITUDE:</b>	40.0794	<b>LONGITUDE:</b>	-75.7104	<b>FROM STATION:</b>	14824+00	
<b>STREAM NAME:</b>	S-H10 (UNT to Marsh Creek), S-H11 (UNT to Marsh Creek)	<b>POND / LAKE NAME:</b>	Pond H3 (Marsh Creek Reservoir)	<b>WETLAND NAME:</b>	WL-H17 (PEM, PFO)	
<b>DEP PERMIT Nos. (102 AND 105)</b>	E&S Permit # ESG0100015001, Water Obstruction Permit E15-862					
<b>CORPS PERMIT NO.</b>	PASPGP-5 (issued April 12, 2017)

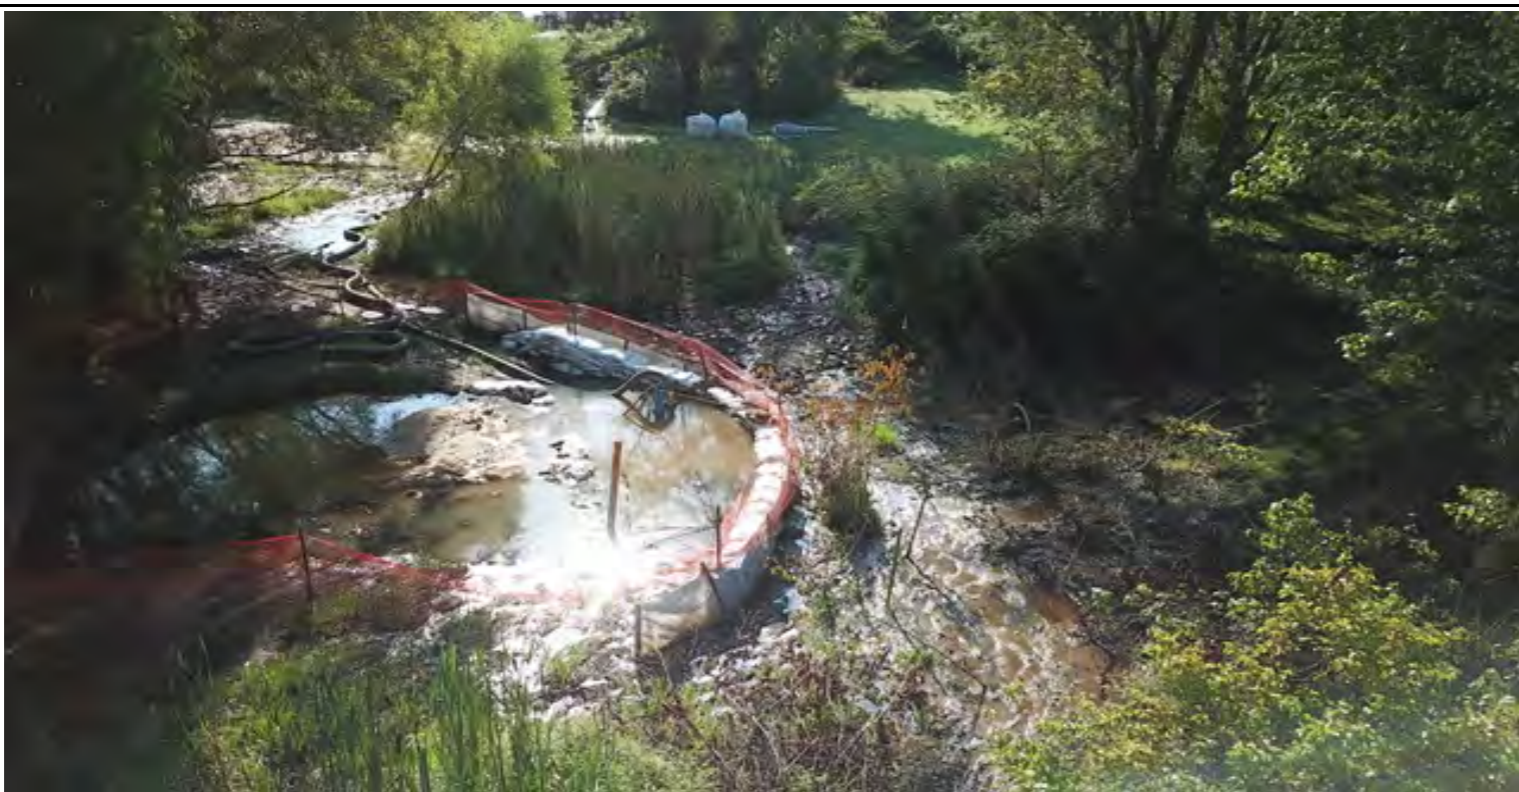
9/4/2020

View of IR release location and containment within WL-H17.

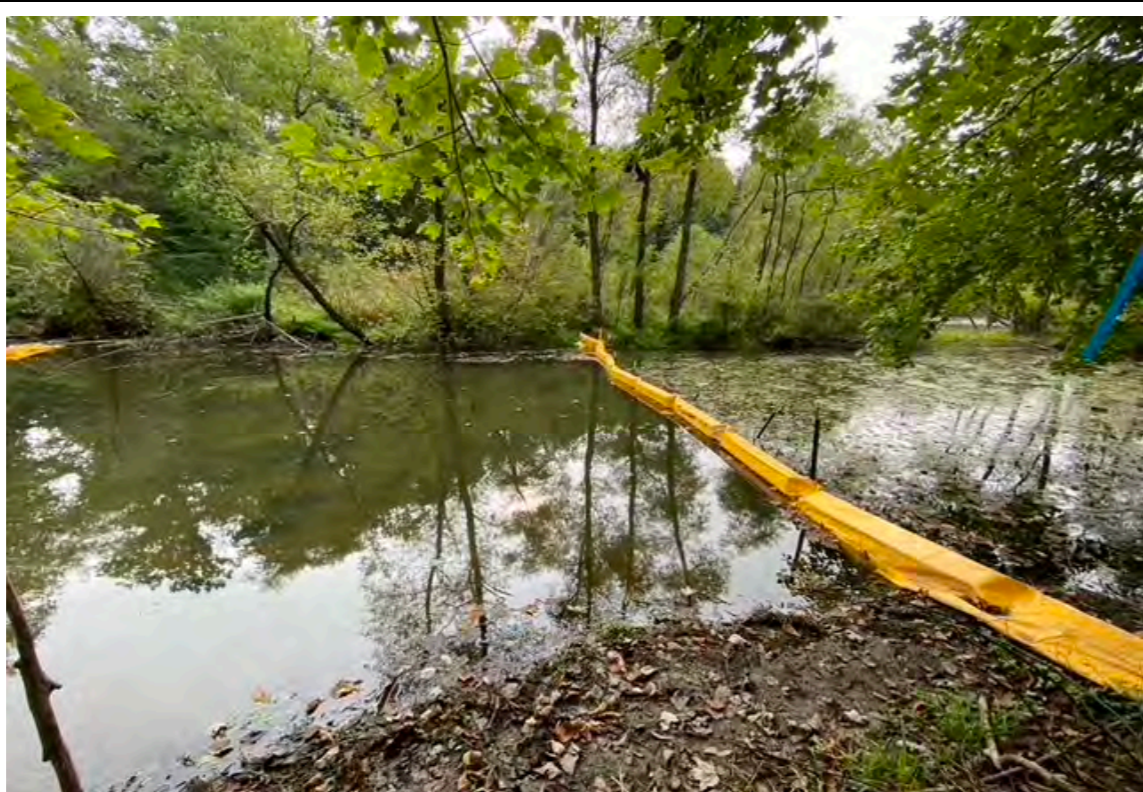
9/14/2020

View of turbidity curtain at the confluence of stream S-H10 (UNT to Marsh Creek) and pond H3 (Marsh Creek Reservoir).

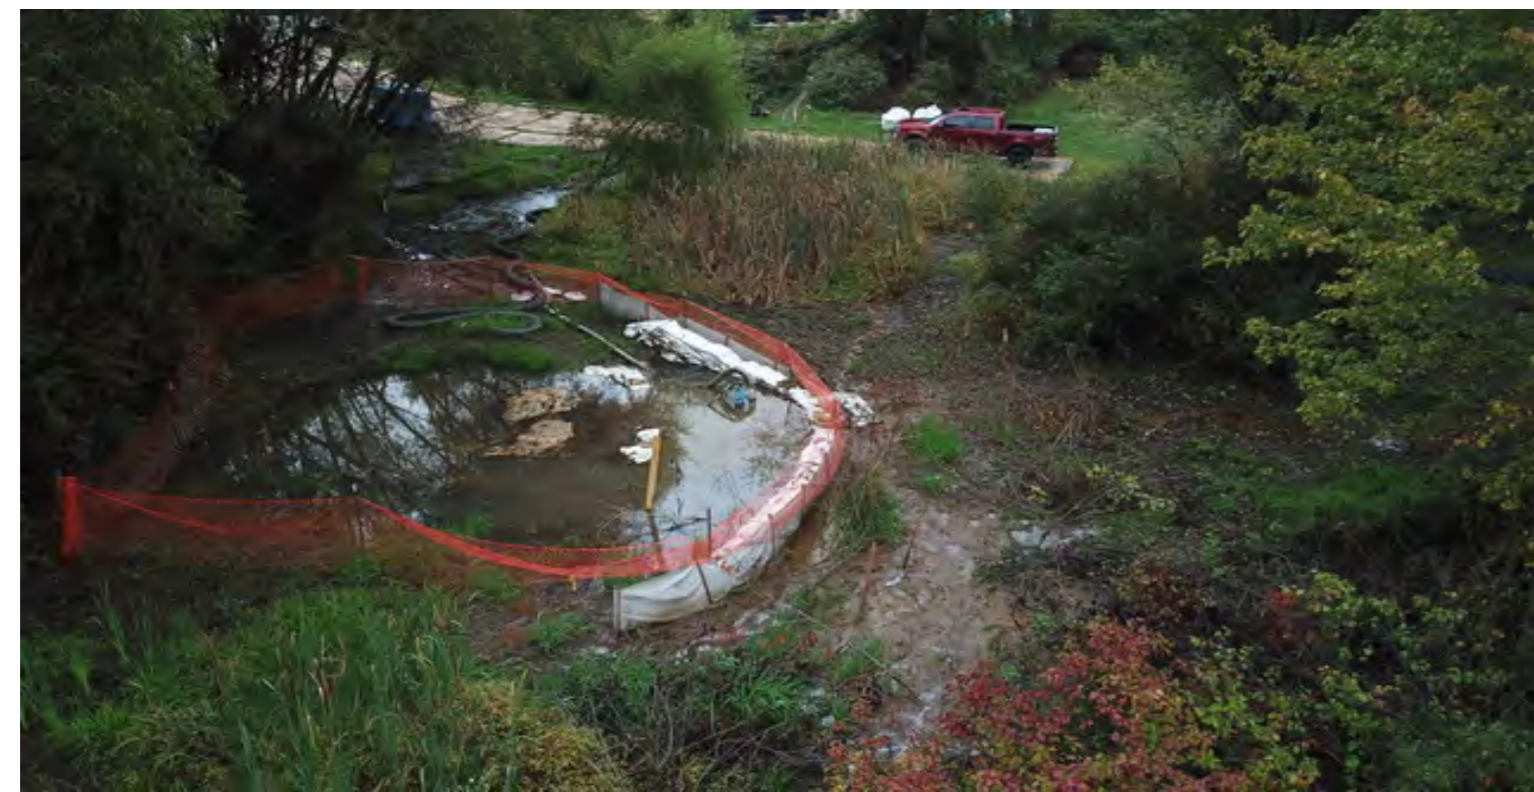
9/28/2020

View of IR release location and containment within WL-H17.

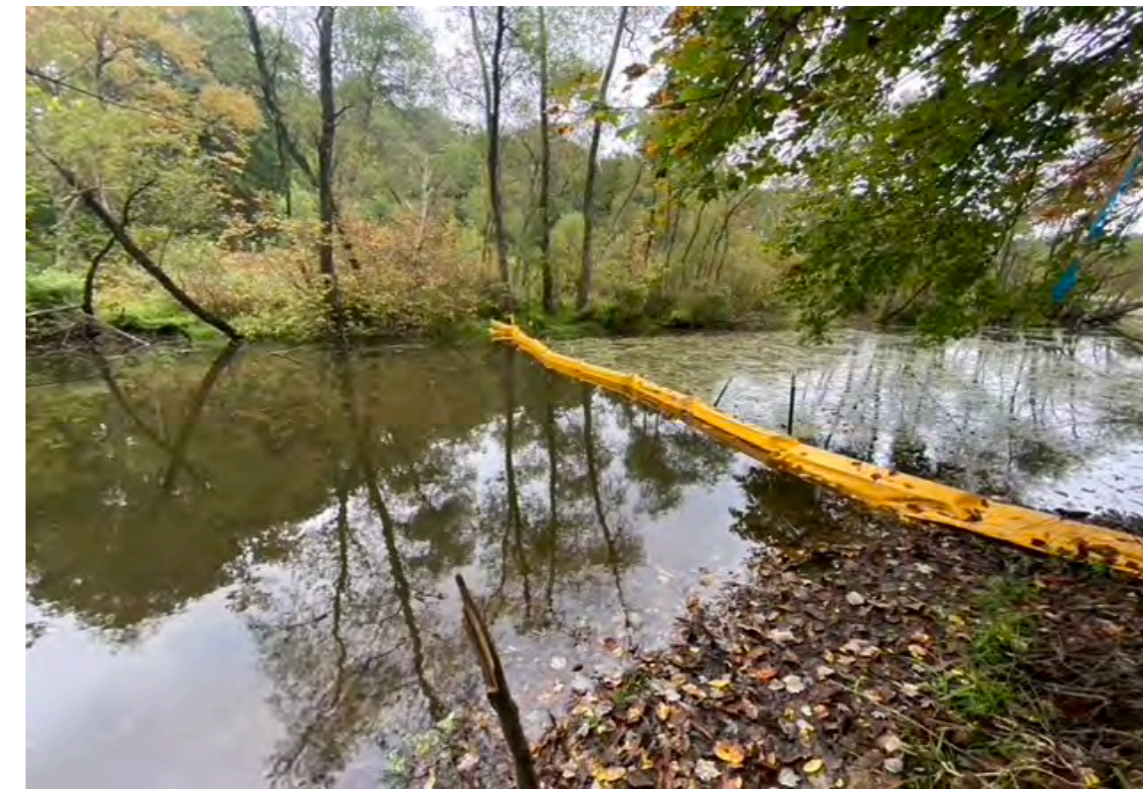
9/28/2020

View of turbidity curtain at the confluence of stream S-H10 (UNT to Marsh Creek) and pond H3 (Marsh Creek Reservoir).
