If Interim report, Subject to Change as Additional Information Becomes Available
If Interim Report, this Report is cumulative, containing information from previous reports in addition to new information and may change
SPLP PENNSYLVANIA PIPELINE PROJECT
HORIZONTAL DIRECTIONAL DRILLING – INADVERTENT RETURN REPORT FORM

REPORT DATE:	Current as of 12/8/2020	HDD ALIGNMENT #	PA-CH-100.0000-RD				
PROJECT SITE:	PPP 6 - S3-0290 - Milford Rd./Little Conestoga Rd		HDD COMPANY:	Michels Directional Crossing			
DATE AND TIME WHEN IR WAS INITIALLY DISCOVERED			DATE:	8/10/2020	TIME:	1530	
LOCATION: STREET	427-423 Green Valley Rd, Downingtown, PA 19335		MUNICIPALITY:	Upper Uwchlan	COUNTY:	Chester	
LATITUDE:	40.0794	LONGITUDE:	-75.7104	FROM STATION:	14824+00	TO STATION	14824+00
STREAM NAME:	S-H10 (UNT to Marsh Creek), S-H11 (UNT to Marsh Creek)		POND / LAKE NAME:	Pond H3 (Marsh Creek Reservoir)	WETLAND NAME:	WL-H17 (PEM, PFO)	
DEP PERMIT Nos. (102 AND 105)	E&S Permit # ESG0100015001, Water Obstruction Permit E15-862						
CORPS PERMIT NO.	PASPGP-5 (issued April 12, 2017)						
IR TRACKING ID:	PPP6_PA-CH-0100.0000-RD_MilfordRd_IRInterim_17_120920						
IS AUGUST 8, 2017 ORDER APPLICABLE?	YES	LISTED

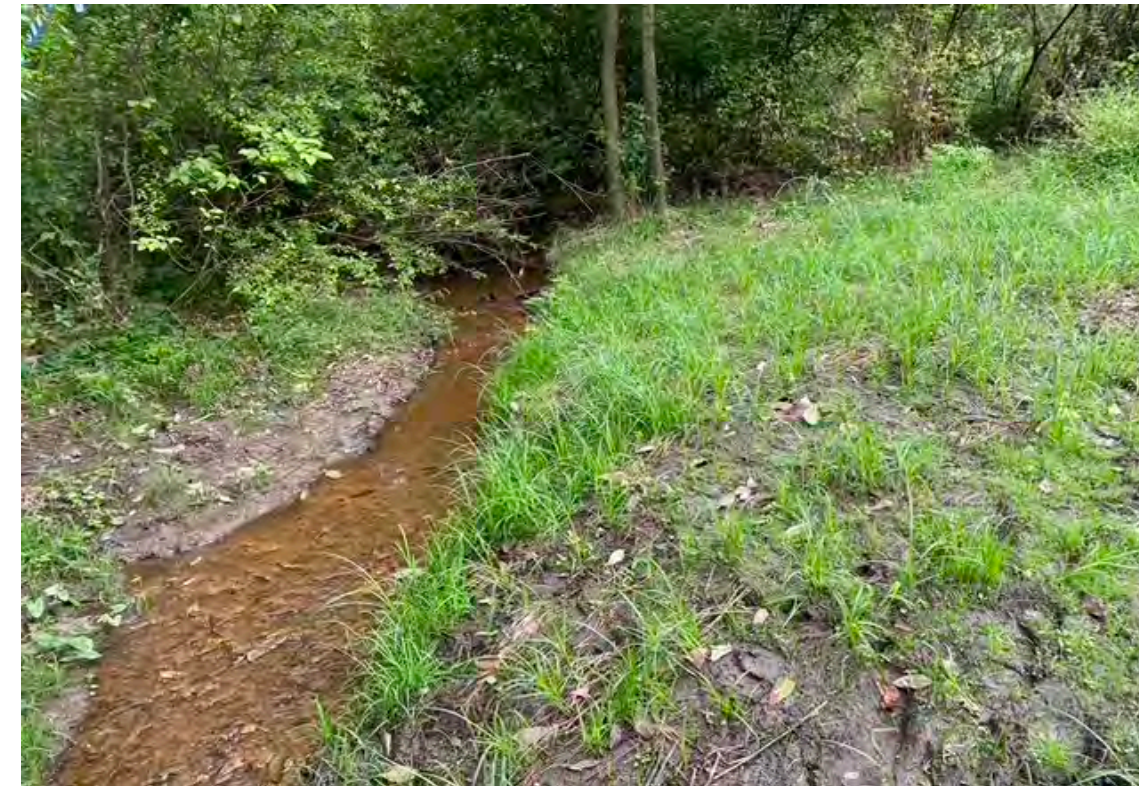
9/14/2020

View of stream S-H10 (UNT to Marsh Creek)

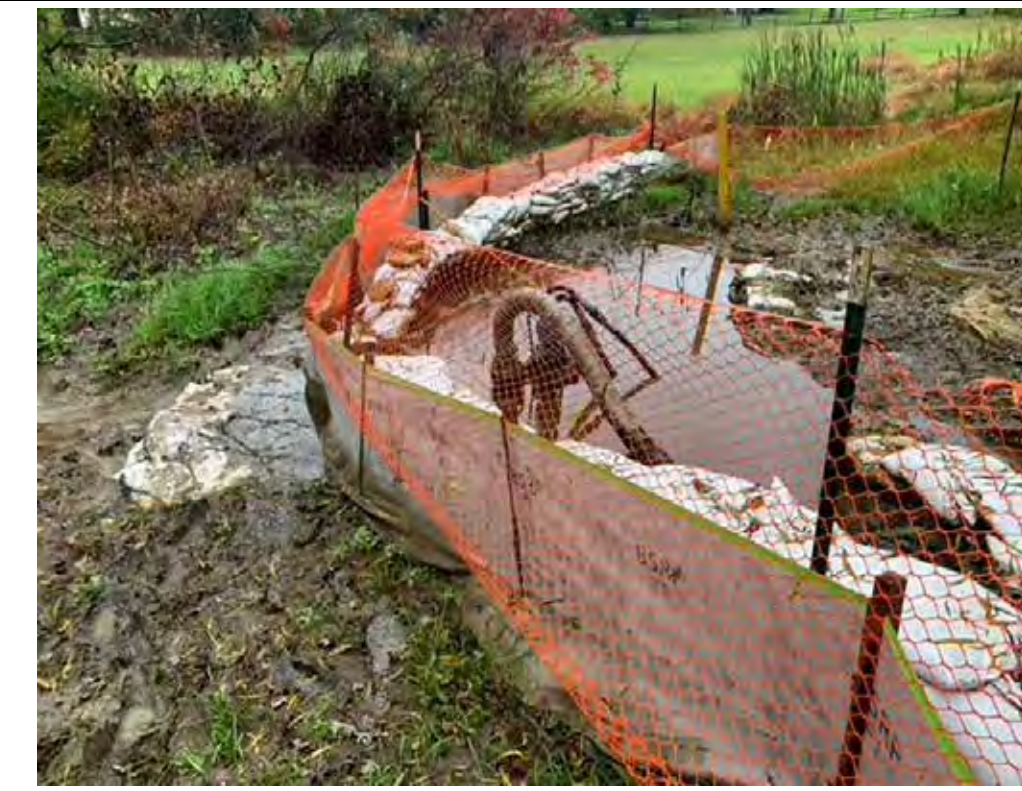
10/12/2020

View of IR release location and containment within WL-H17.

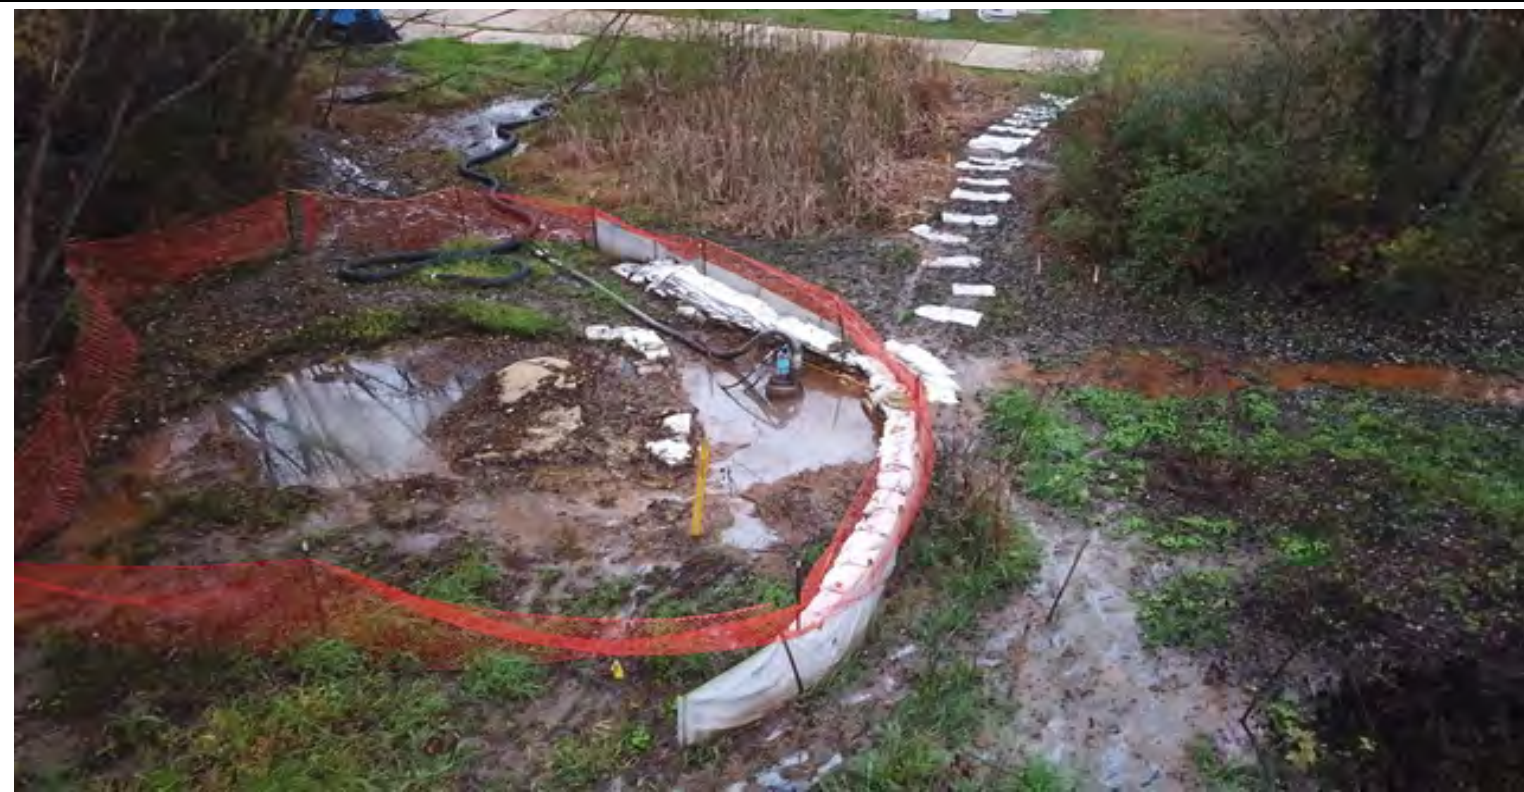
10/26/2020

View of IR release location and containment within WL-H17.

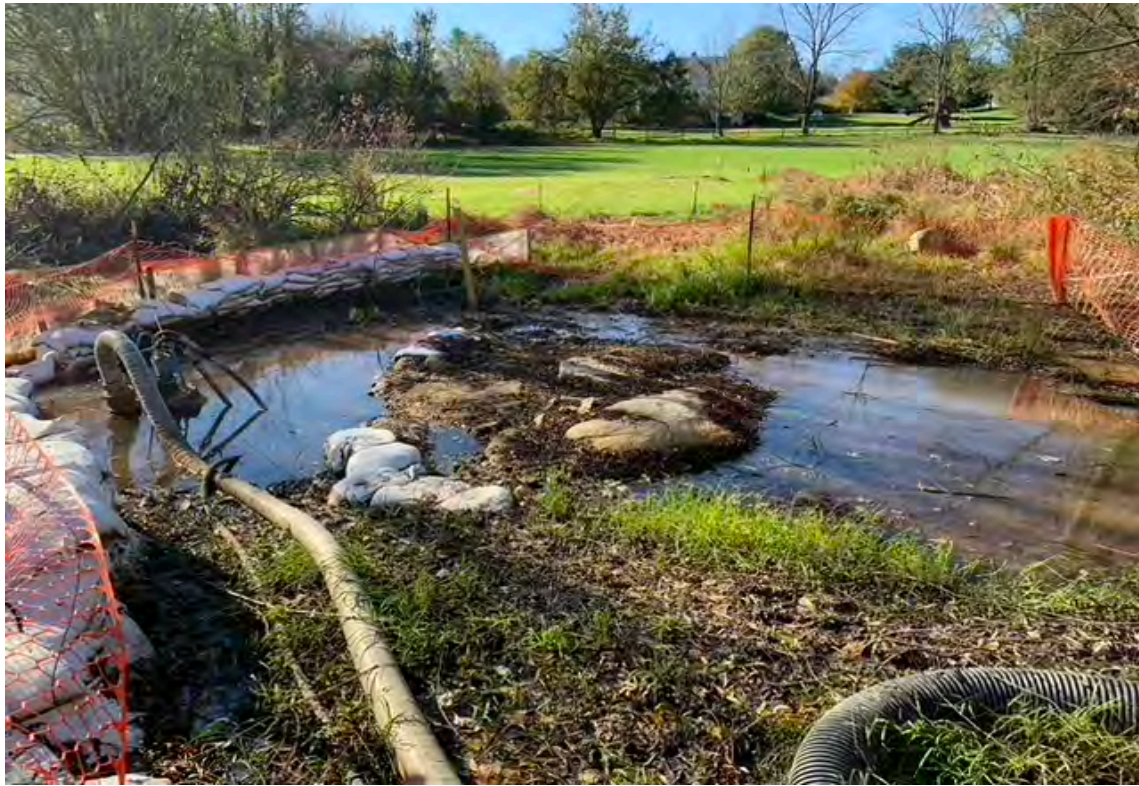
11/2/2020

View of IR release location and containment within WL-H17.

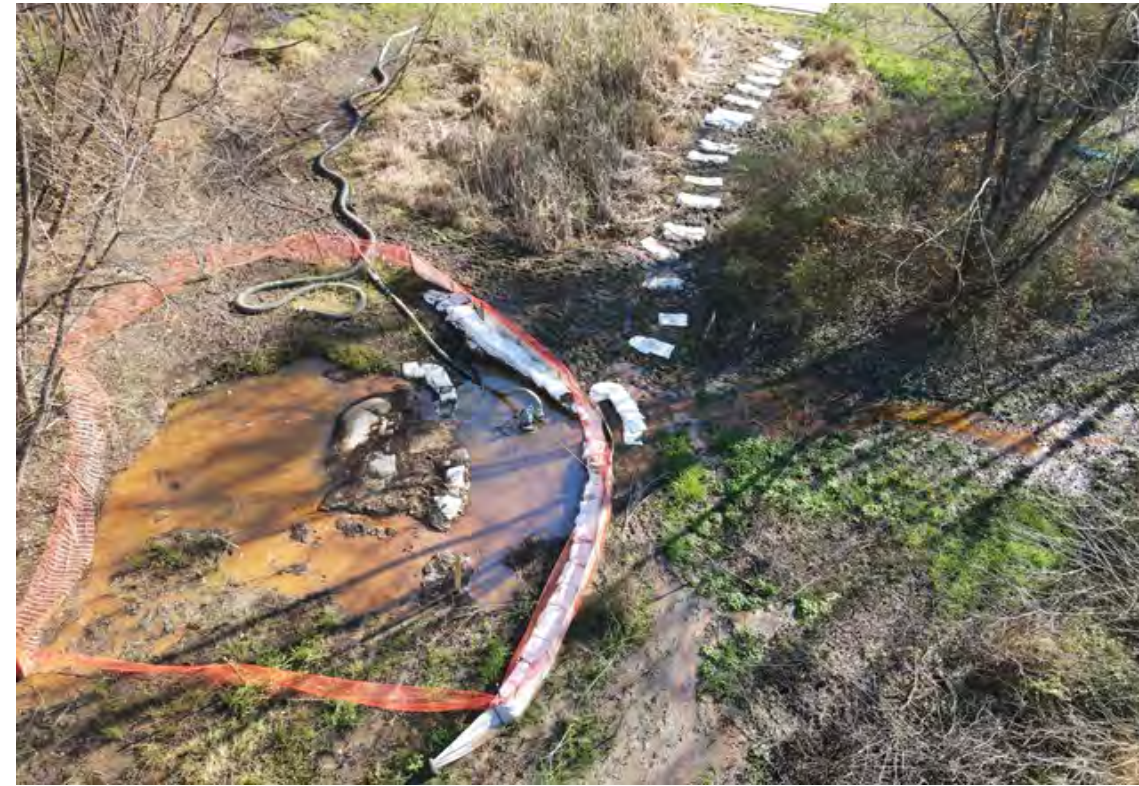
11/9/2020

View of IR release location and containment within WL-H17.

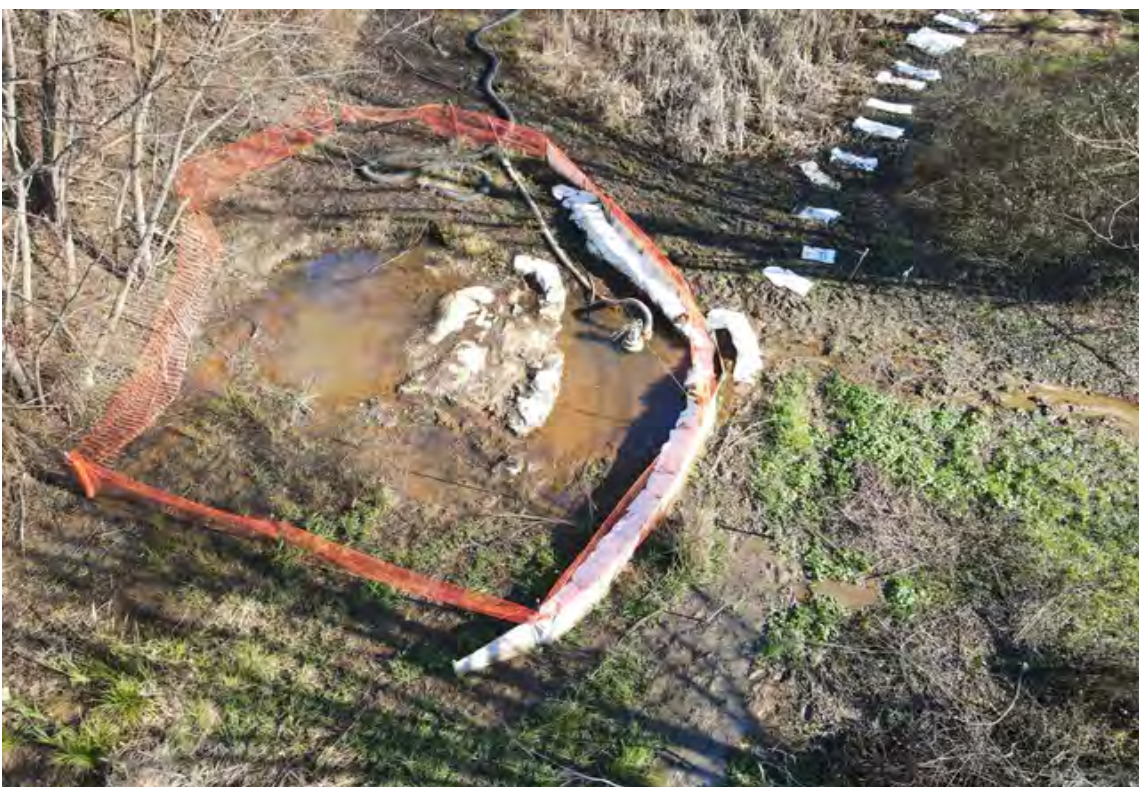
11/16/2020

View of IR release location and containment within WL-H17.

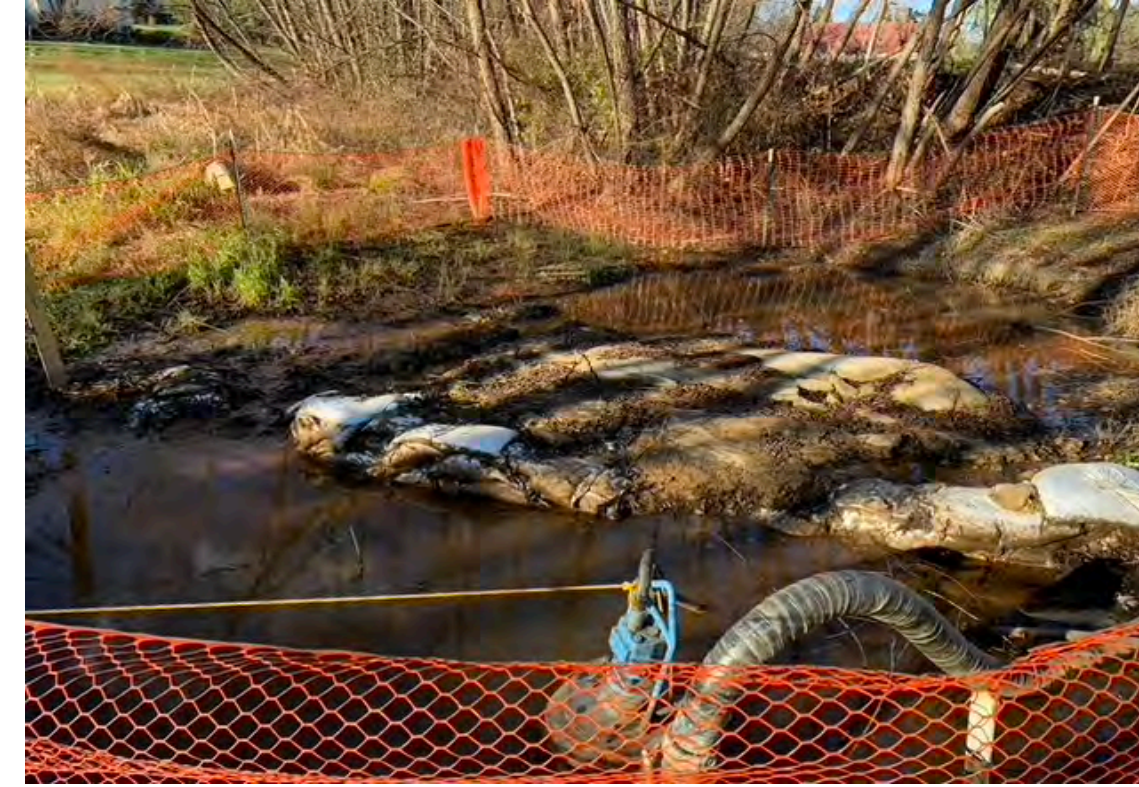
11/23/2020

View of IR release location and containment within WL-H17.

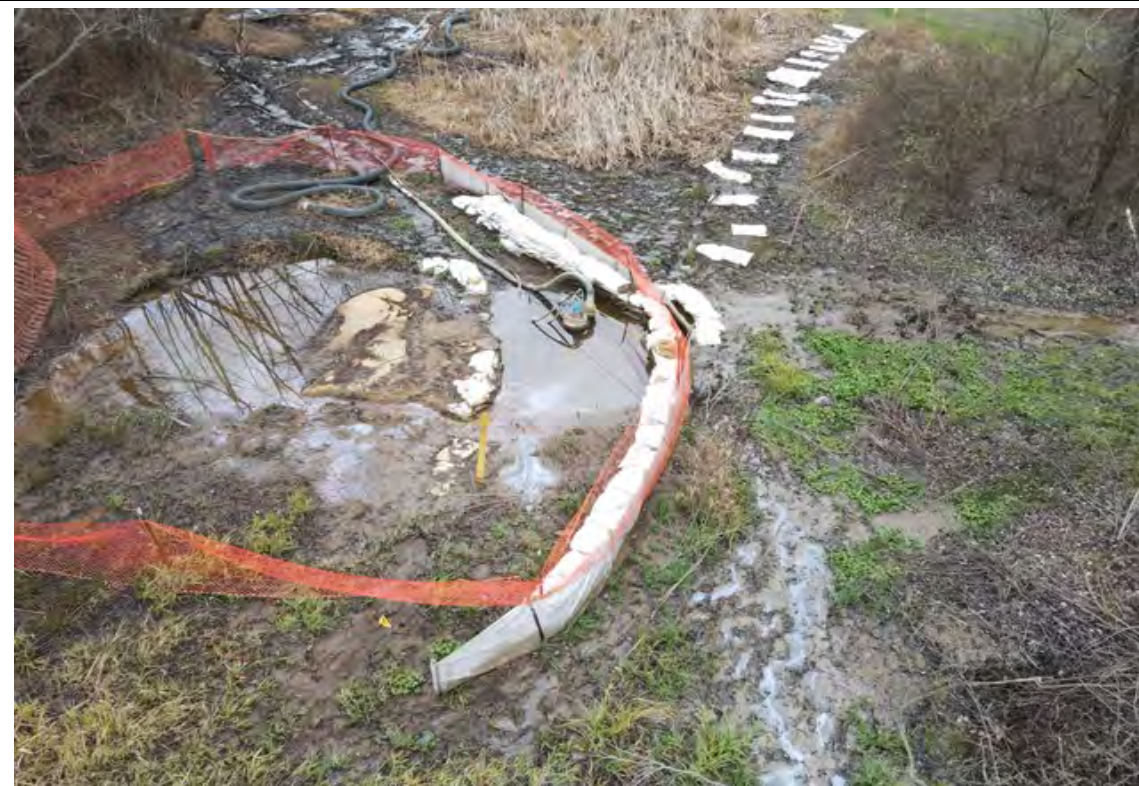
12/1/2020

View of IR release location and containment within WL-H17.

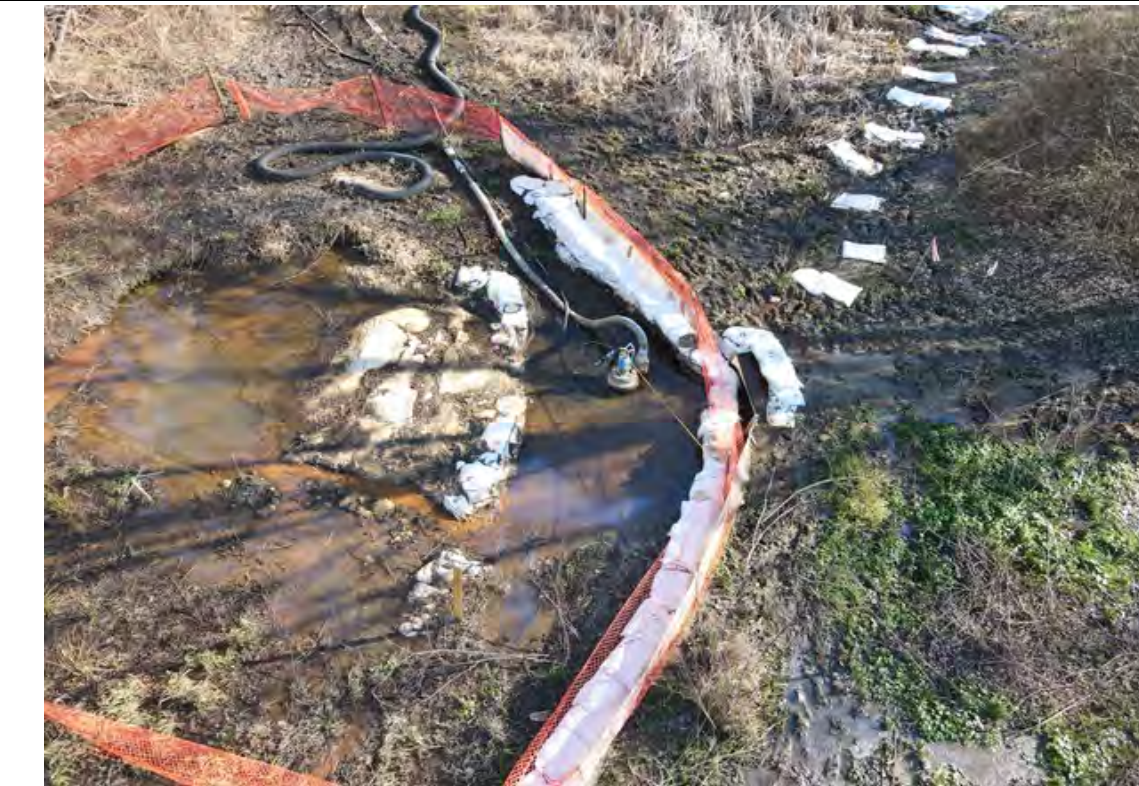
12/8/2020

View of IR release location and containment within WL-H17.
