**If Interim report, Subject to Change as Additional Information Becomes Available**  
**If Interim Report, this Report is cumulative, containing information from previous reports in addition to new information and may change**  
**SPLP PENNSYLVANIA PIPELINE PROJECT**  
**HORIZONTAL DIRECTIONAL DRILLING – INADVERTENT RETURN REPORT FORM**

<b>REPORT DATE:</b>	Current as of 1/12/2021		<b>HDD ALIGNMENT #</b>	PA-CH-100.0000-RD			
<b>PROJECT SITE:</b>	PPP 6 - S3-0290 - Milford Rd./Little Conestoga Rd		<b>HDD COMPANY:</b>	Michels Directional Crossing			
<b>DATE AND TIME WHEN IR WAS INITIALLY DISCOVERED</b>			<b>DATE:</b>	8/10/2020	<b>TIME:</b>	1530	
<b>LOCATION: STREET</b>	427-423 Green Valley Rd, Downingtown, PA 19335		<b>MUNICIPALITY:</b>	Upper Uwchlan	<b>COUNTY:</b>	Chester	
<b>LATITUDE:</b>	40.0794	<b>LONGITUDE:</b>	-75.7104	<b>FROM STATION:</b>	14824+00	<b>TO STATION</b>	14824+00
<b>STREAM NAME:</b>	S-H10 (UNT to Marsh Creek), S-H11 (UNT to Marsh Creek)		<b>POND / LAKE NAME:</b>	Pond H3 (Marsh Creek Reservoir)	<b>WETLAND NAME:</b>	WL-H17 (PEM, PFO)	
<b>DEP PERMIT Nos. (102 AND 105)</b>	E&S Permit # ESG0100015001, Water Obstruction Permit E15-862						
<b>CORPS PERMIT NO.</b>	PASPGP-

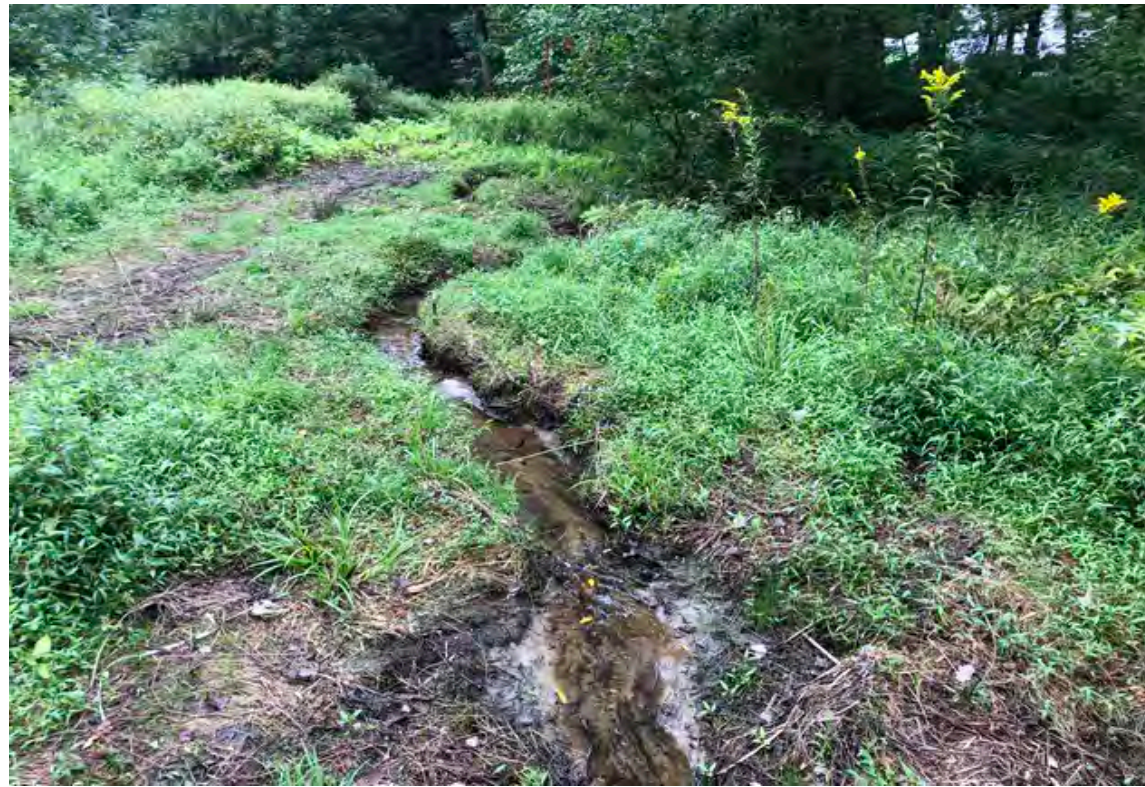
8/31/2020

View of stream S-H10 (UNT to Marsh Creek)

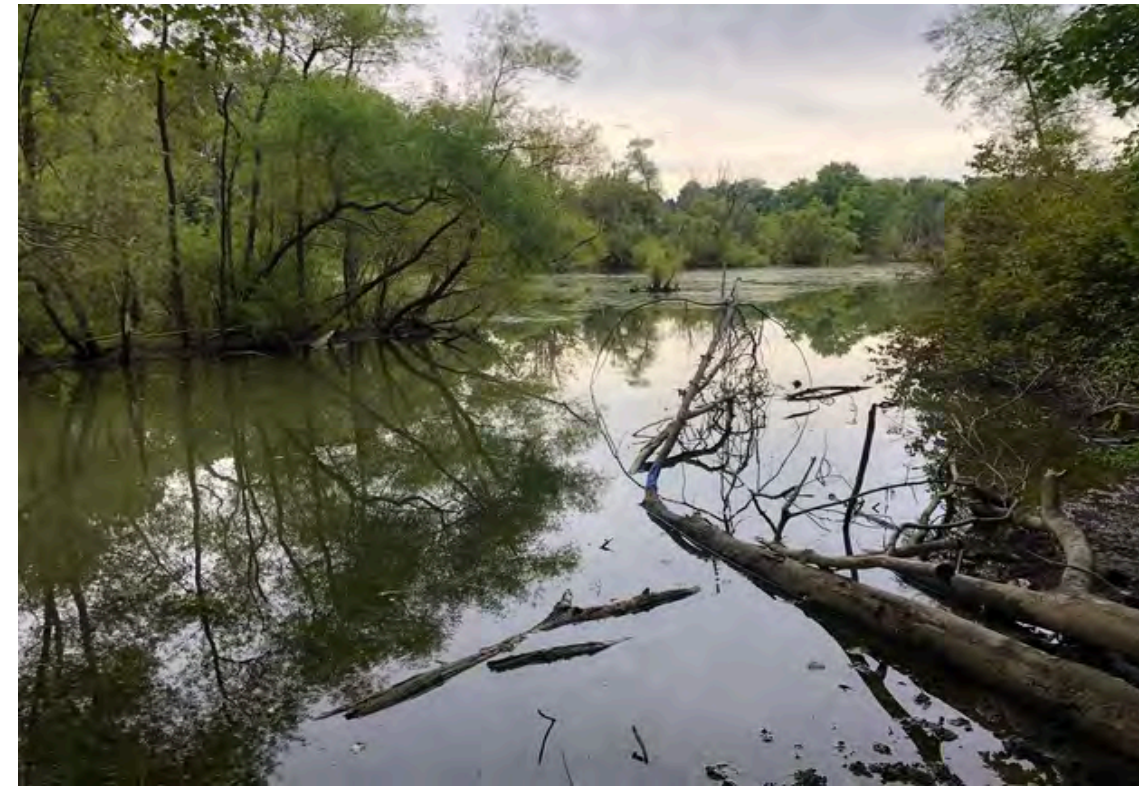
8/31/2020

View of pond H3 (Marsh Creek Reservoir).

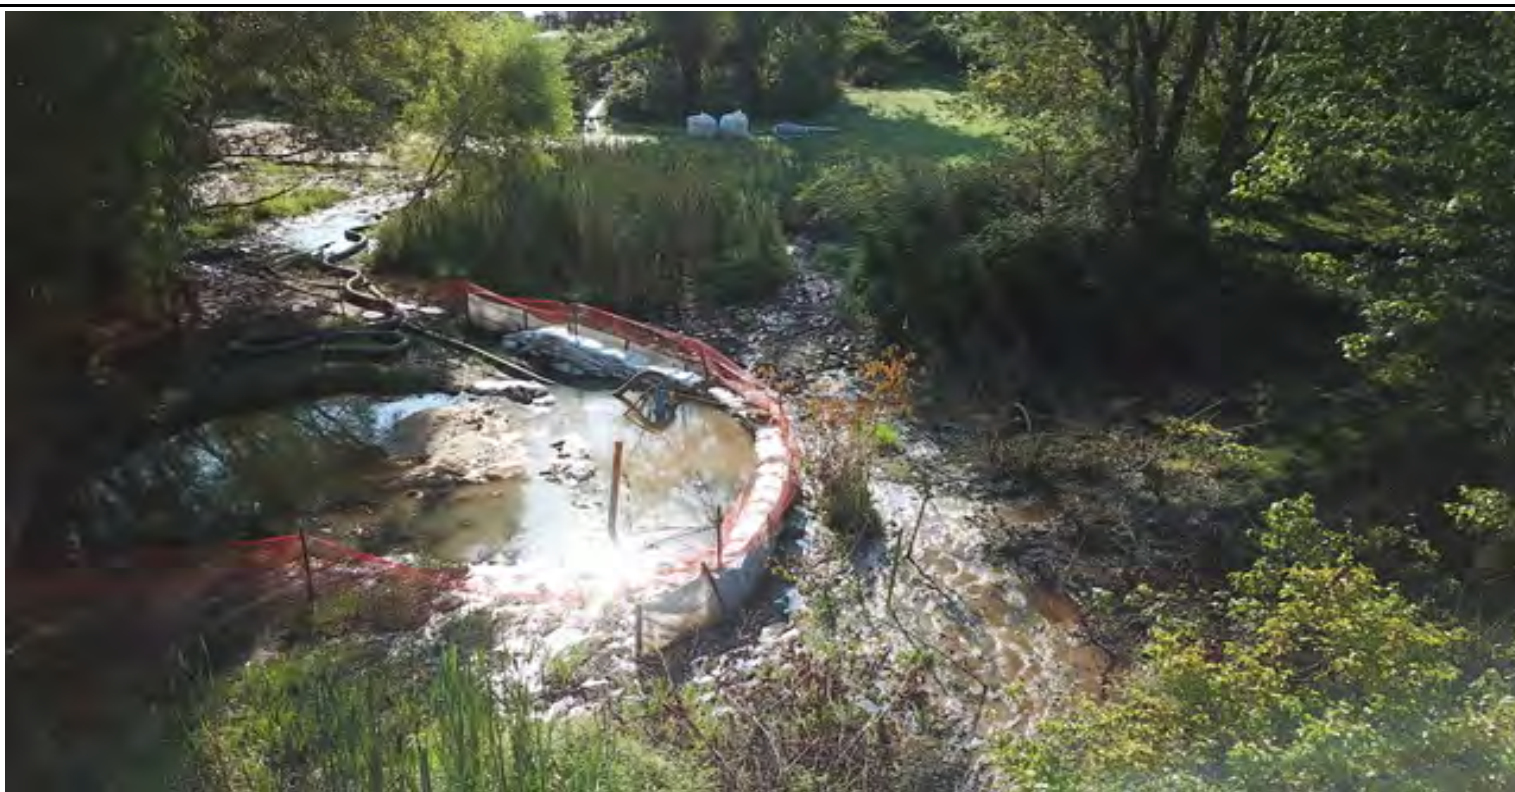
9/4/2020

View of IR release location and containment within WL-H17.

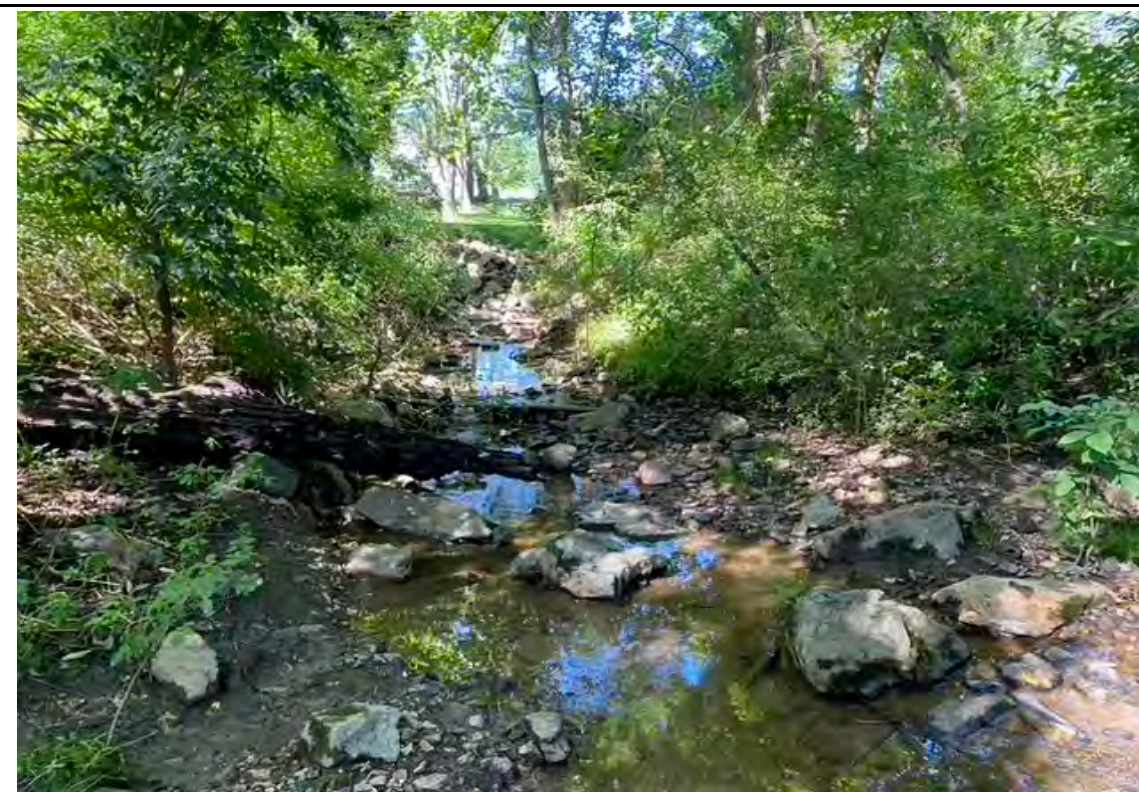
9/5/2020

View of stream S-H10 (UNT to Marsh Creek)

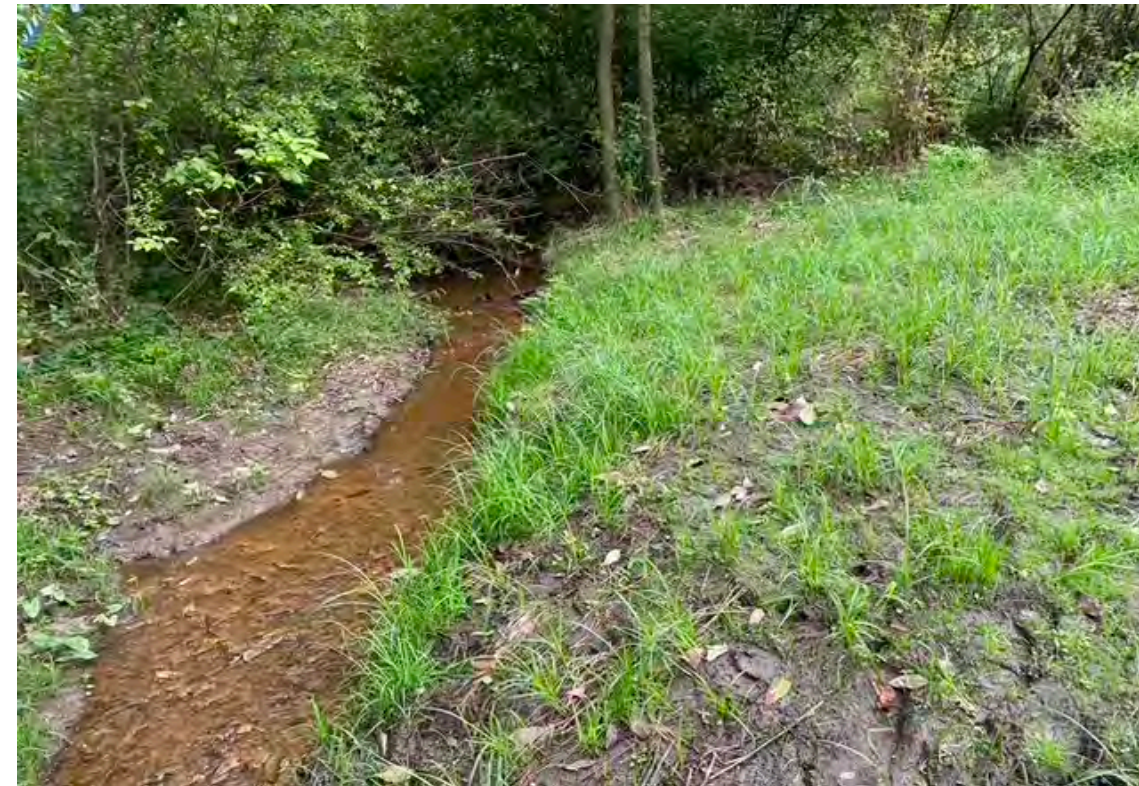
9/14/2020

View of stream S-H10 (UNT to Marsh Creek)

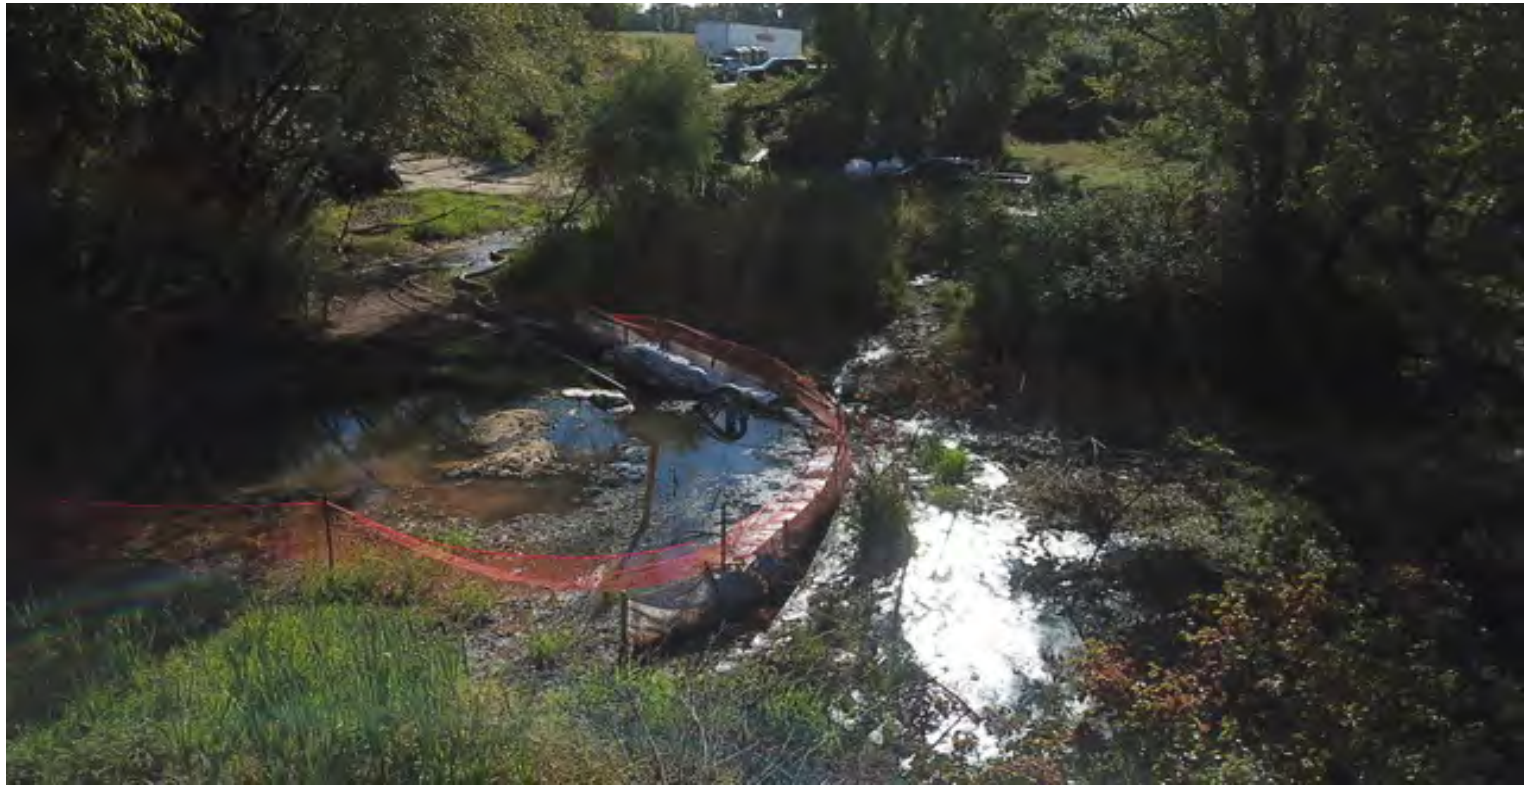
9/21/2020

View of IR release location and containment within WL-H17.

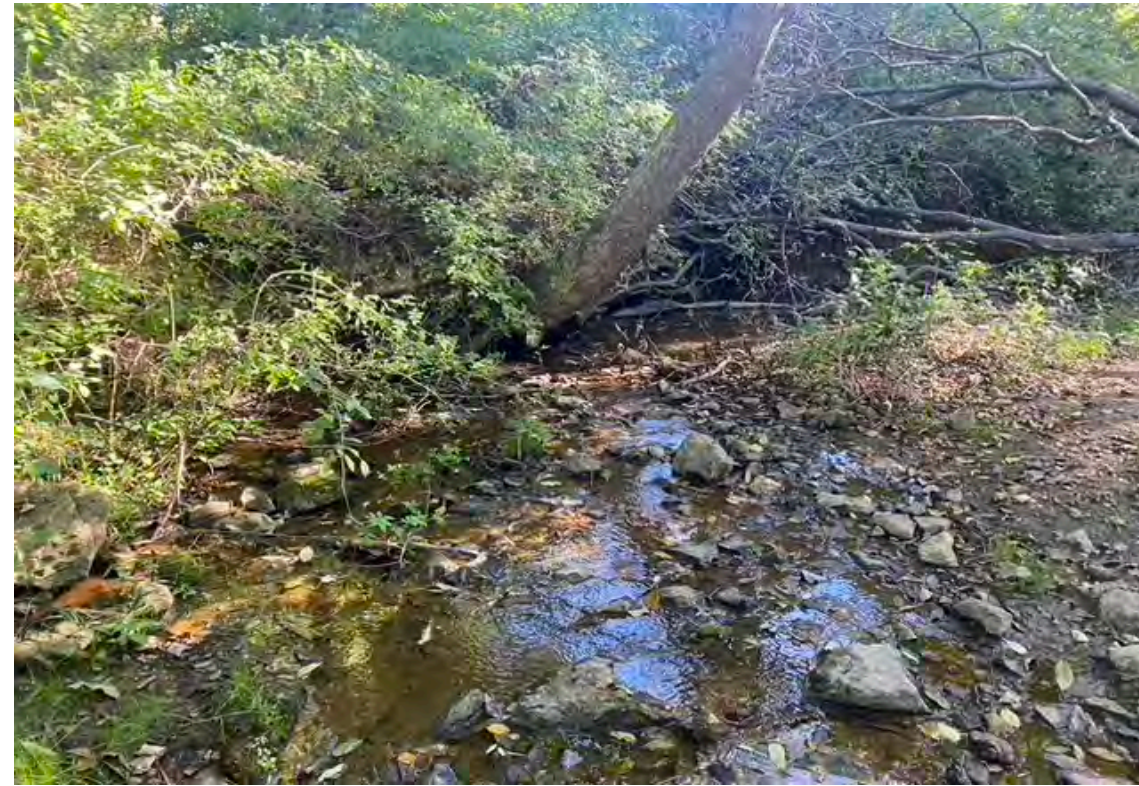
9/21/2020

View of stream S-H10 (UNT to Marsh Creek)

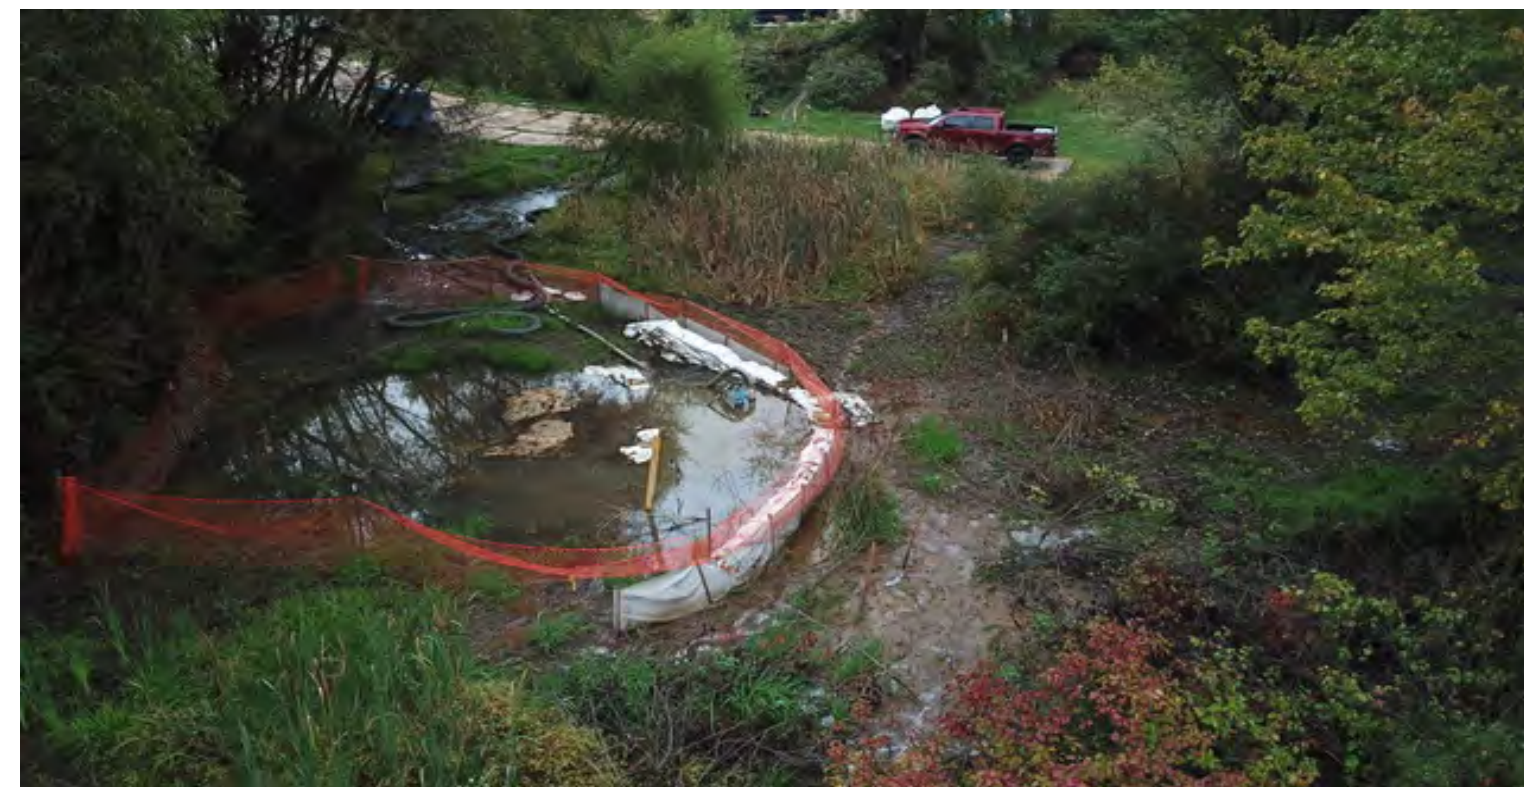
9/28/2020

View of IR release location and containment within WL-H17.

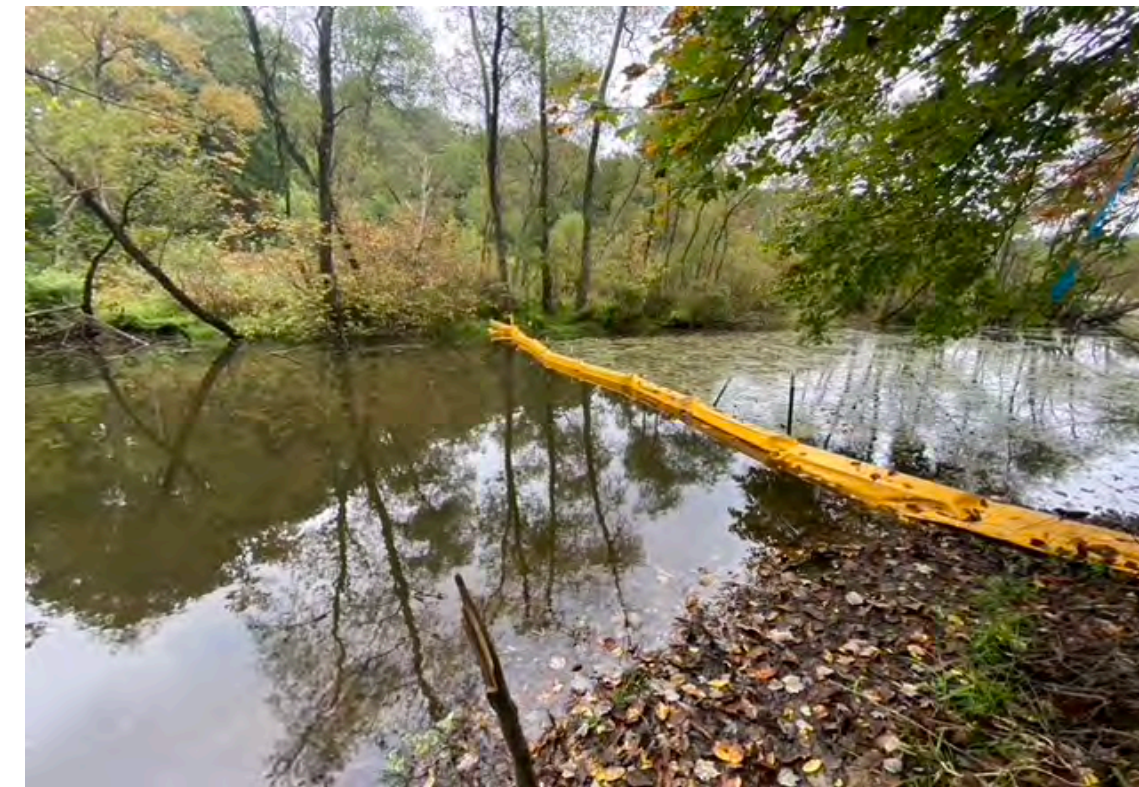
9/28/2020

View of turbidity curtain at the confluence of stream S-H10 (UNT to Marsh Creek) and pond H3 (Marsh Creek Reservoir).

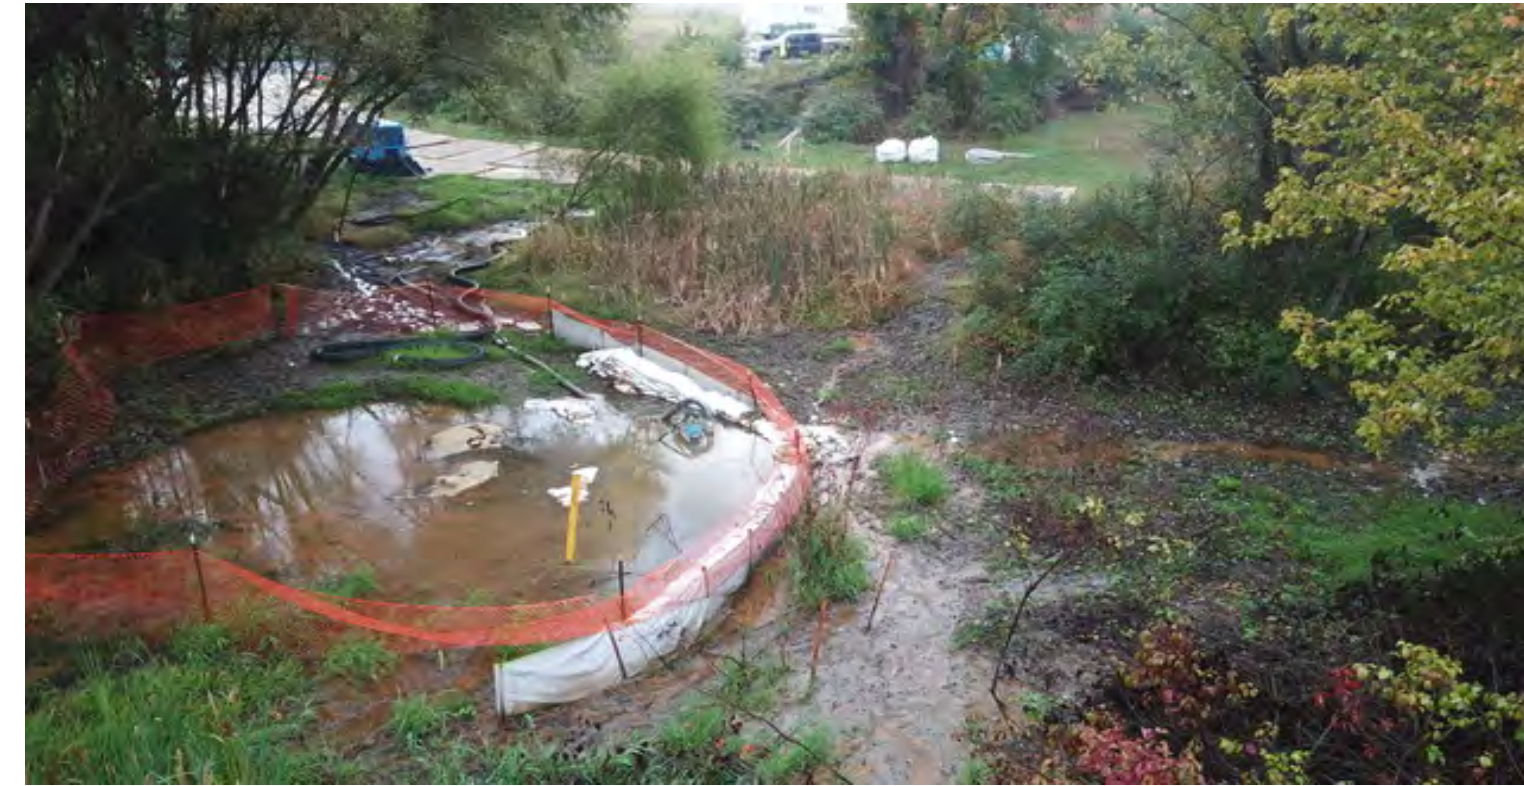
10/5/2020

View of IR release location and containment within WL-H17.

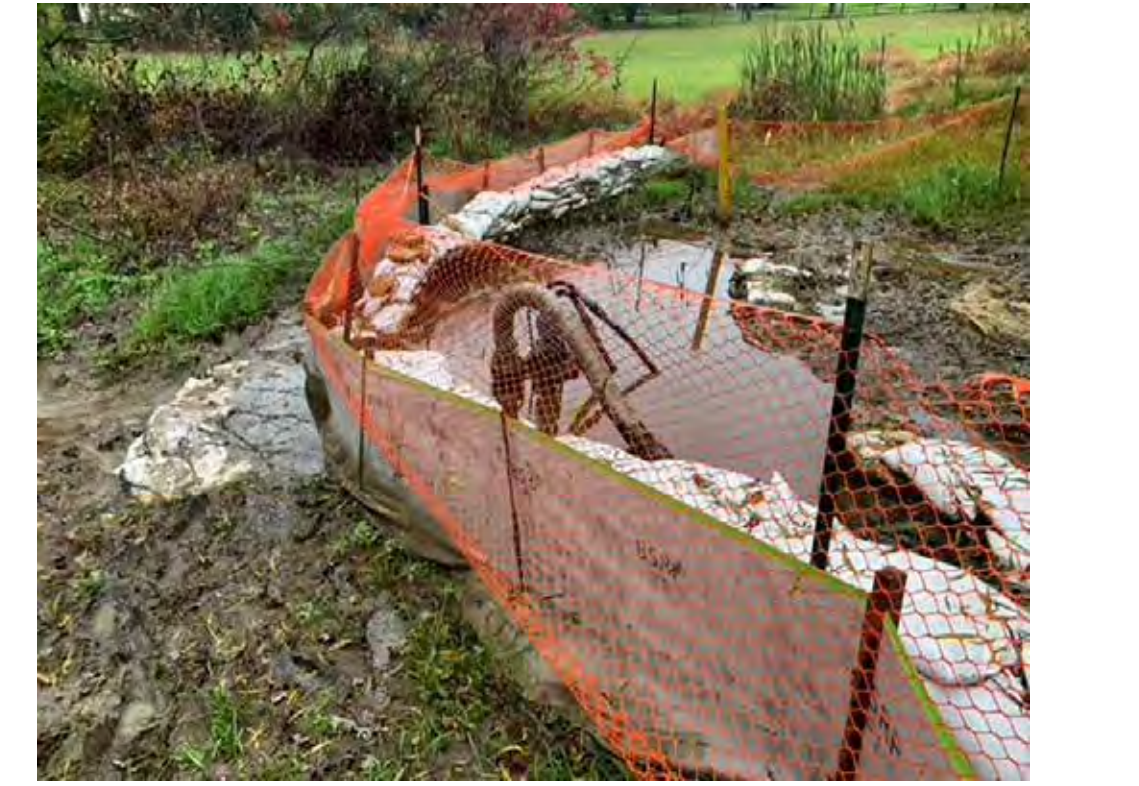
10/12/2020

View of IR release location and containment within WL-H17.

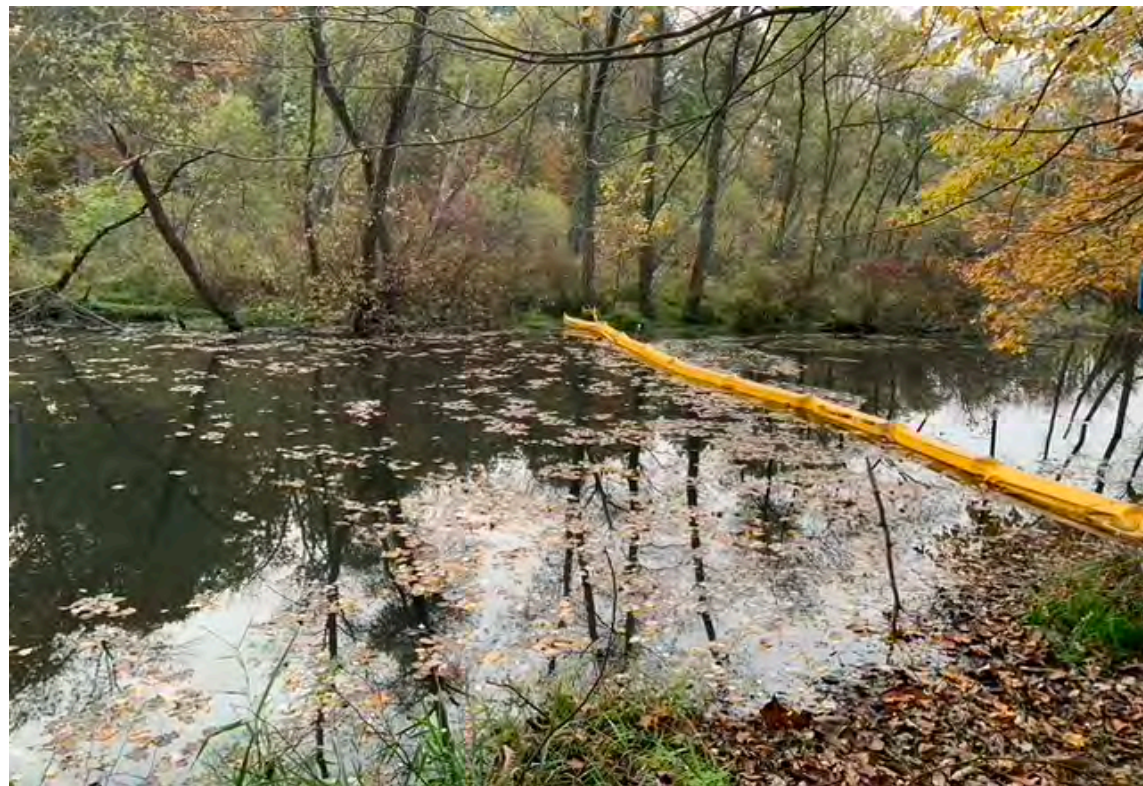
10/19/2020

View of turbidity curtain at the confluence of stream S-H10 (UNT to Marsh Creek) and pond H3 (Marsh Creek Reservoir).

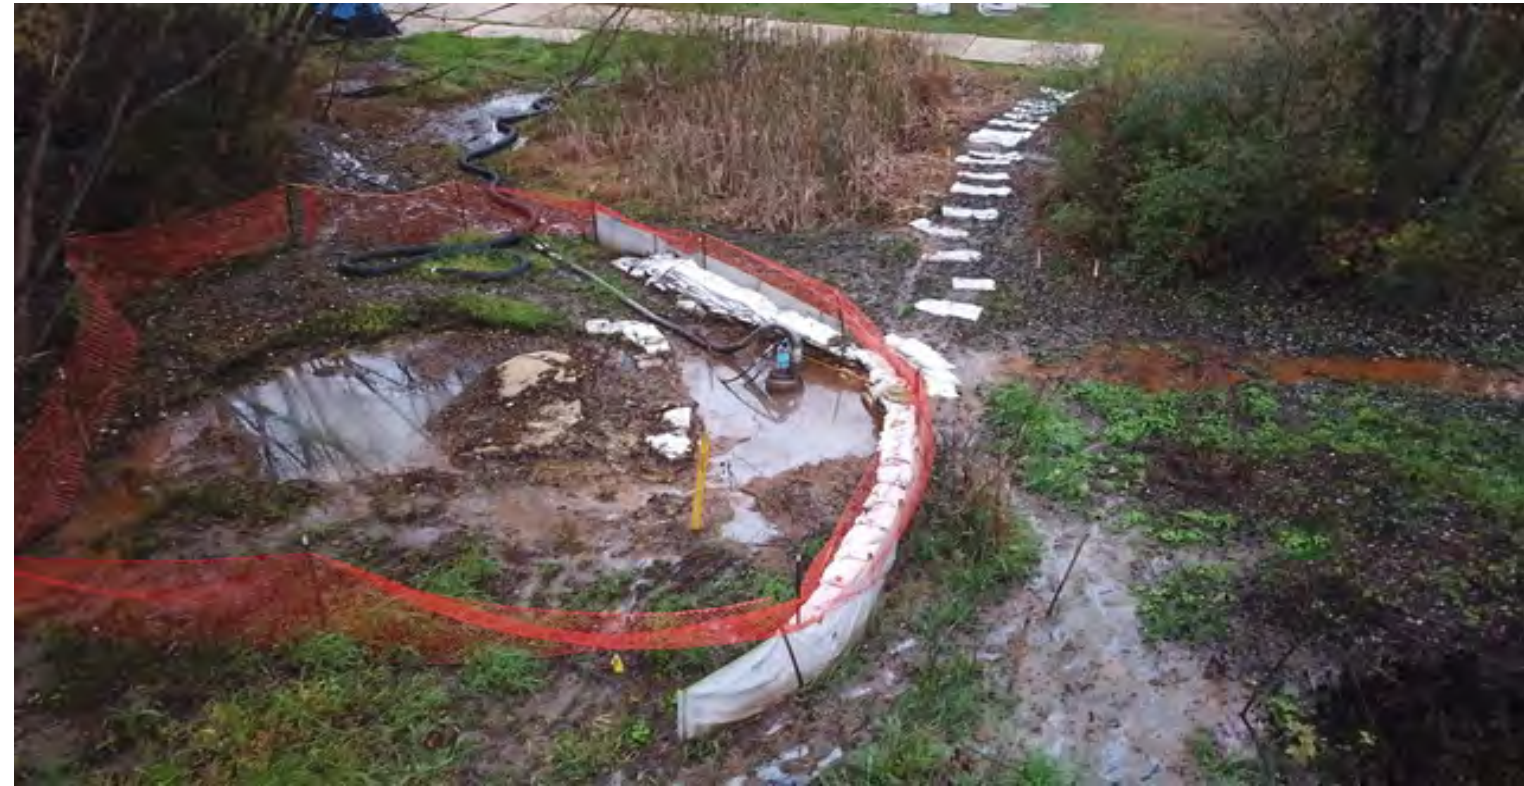
10/26/2020

View of IR release location and containment within WL-H17.

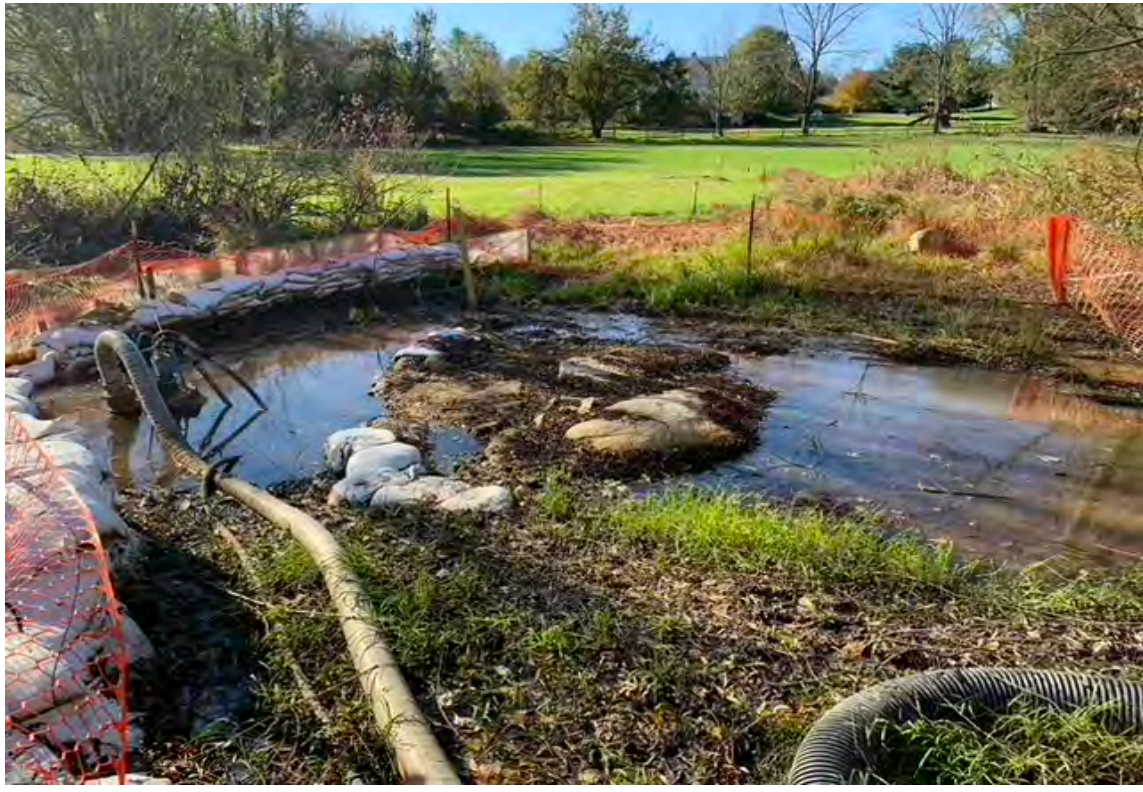
11/2/2020

View of IR release location and containment within WL-H17.

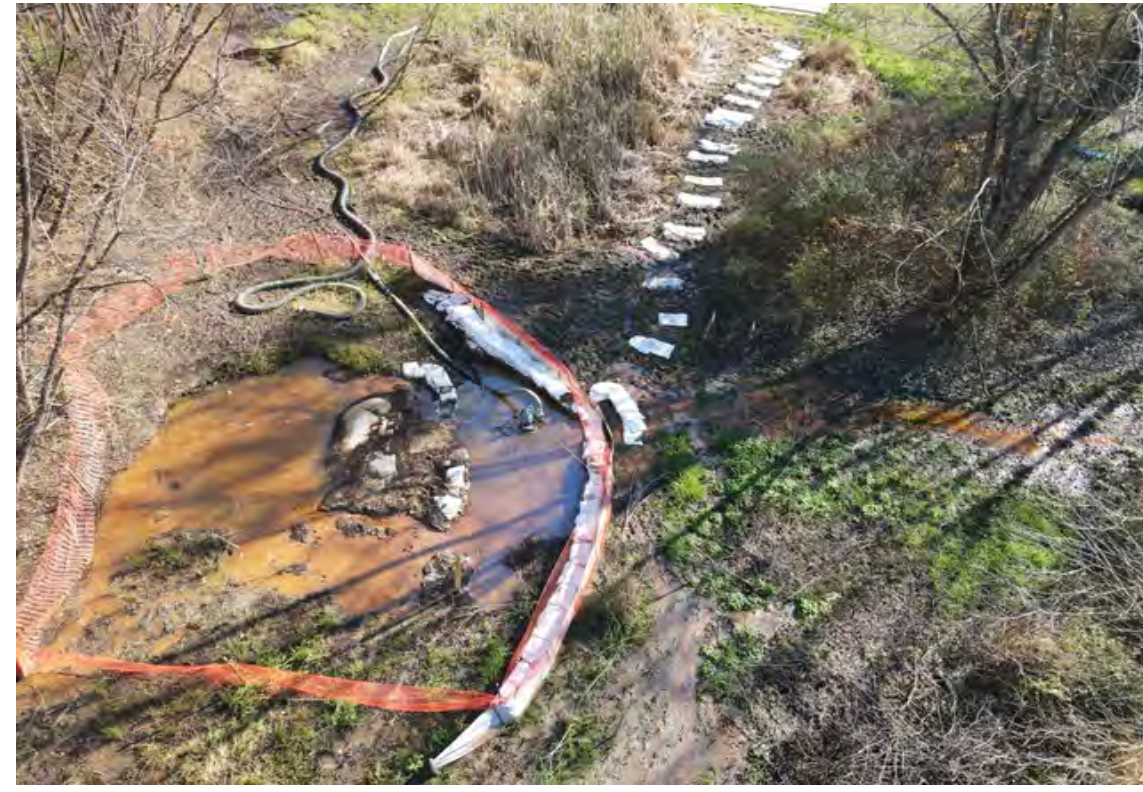
11/9/2020

View of IR release location and containment within WL-H17.

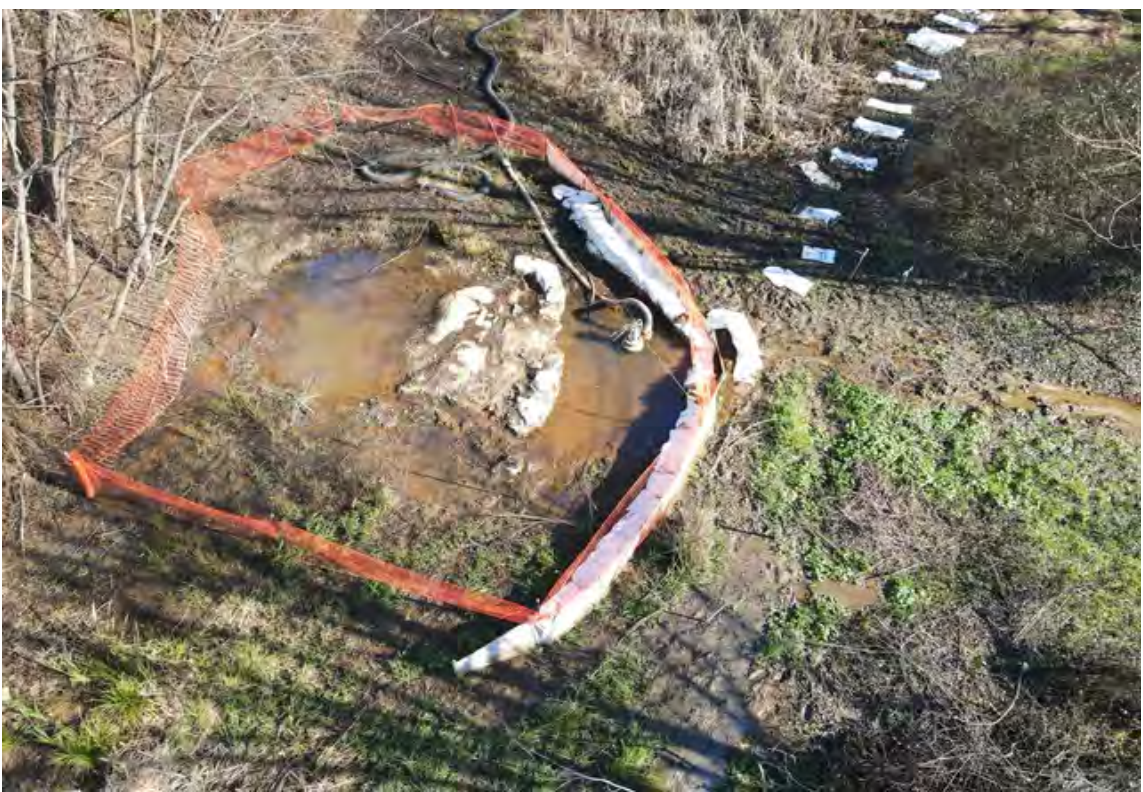
11/16/2020

View of IR release location and containment within WL-H17.

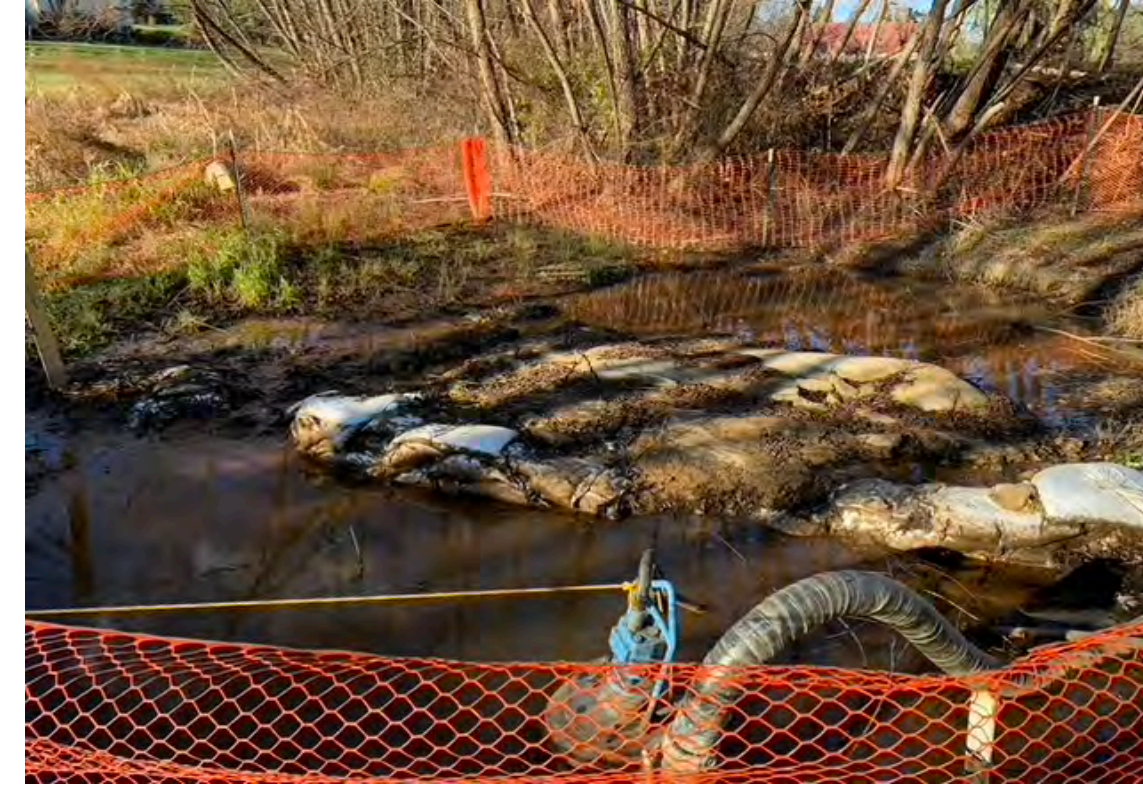
11/23/2020

View of IR release location and containment within WL-H17.

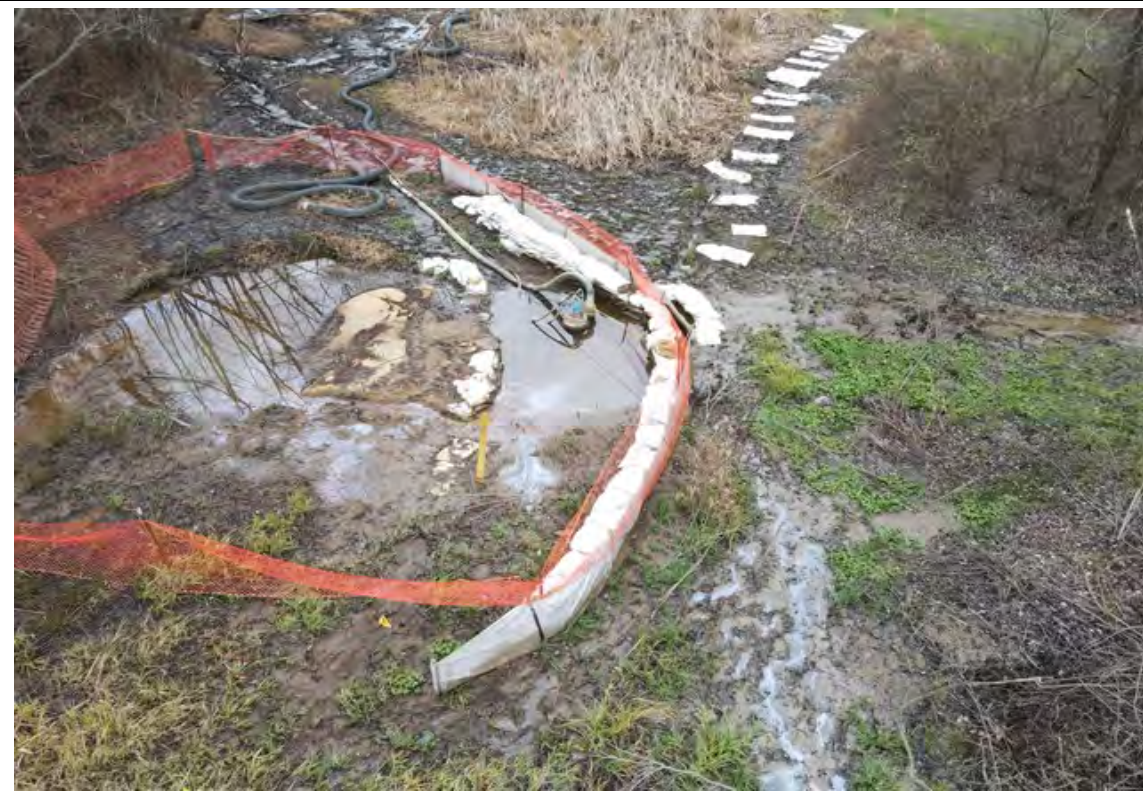
12/1/2020

View of IR release location and containment within WL-H17.

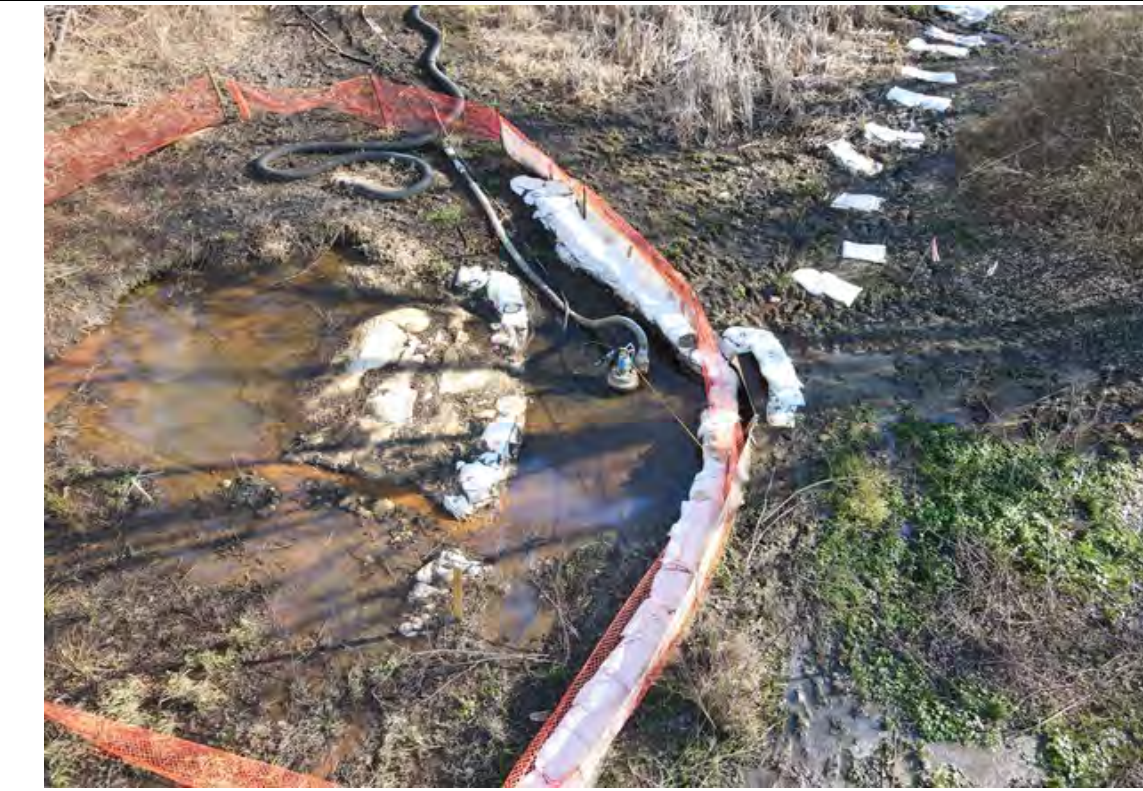
12/8/2020

View of IR release location and containment within WL-H17.

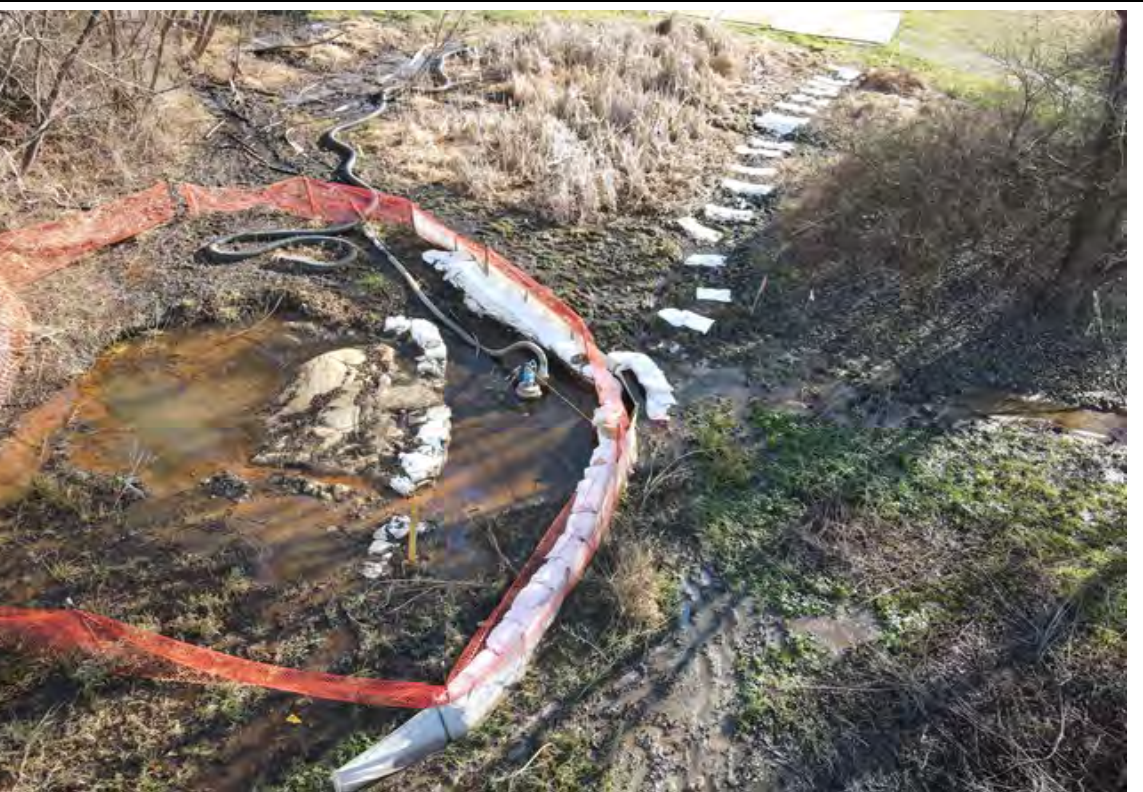
12/15/2020

View of IR release location and containment within WL-H17.

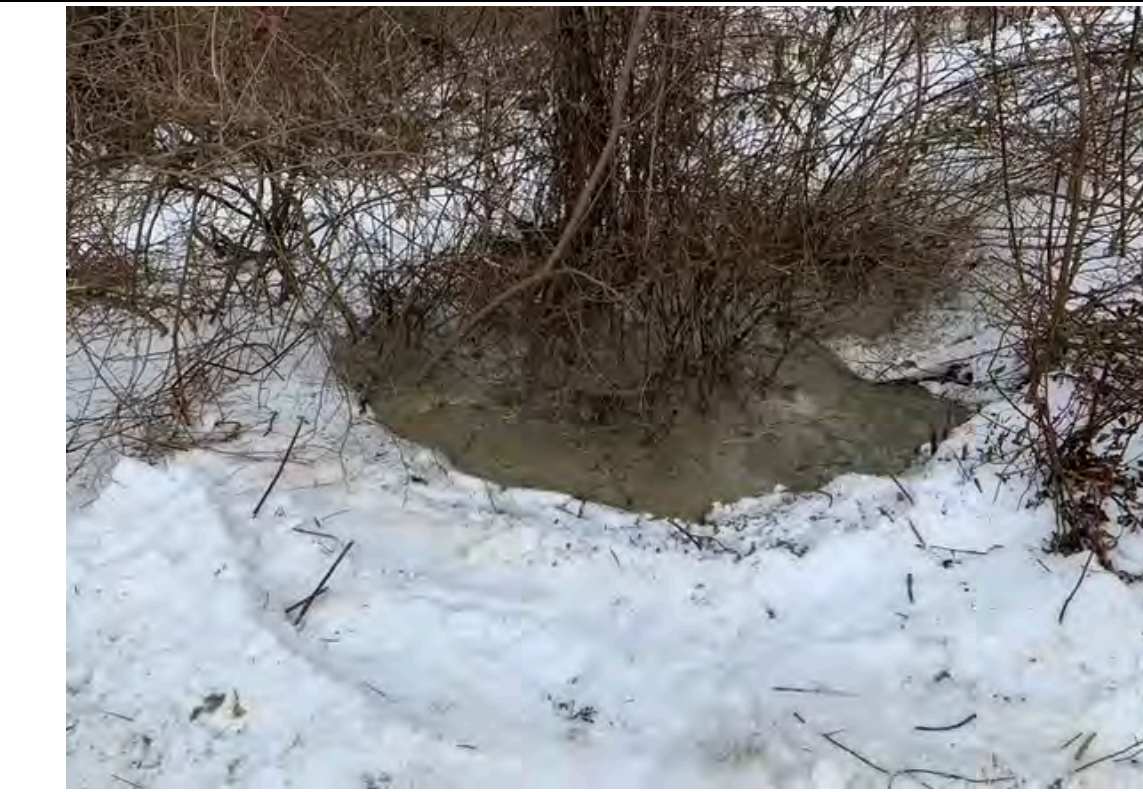
12/19/2020

View of earth feature one filled with 13 cubic yards of flowable fill.

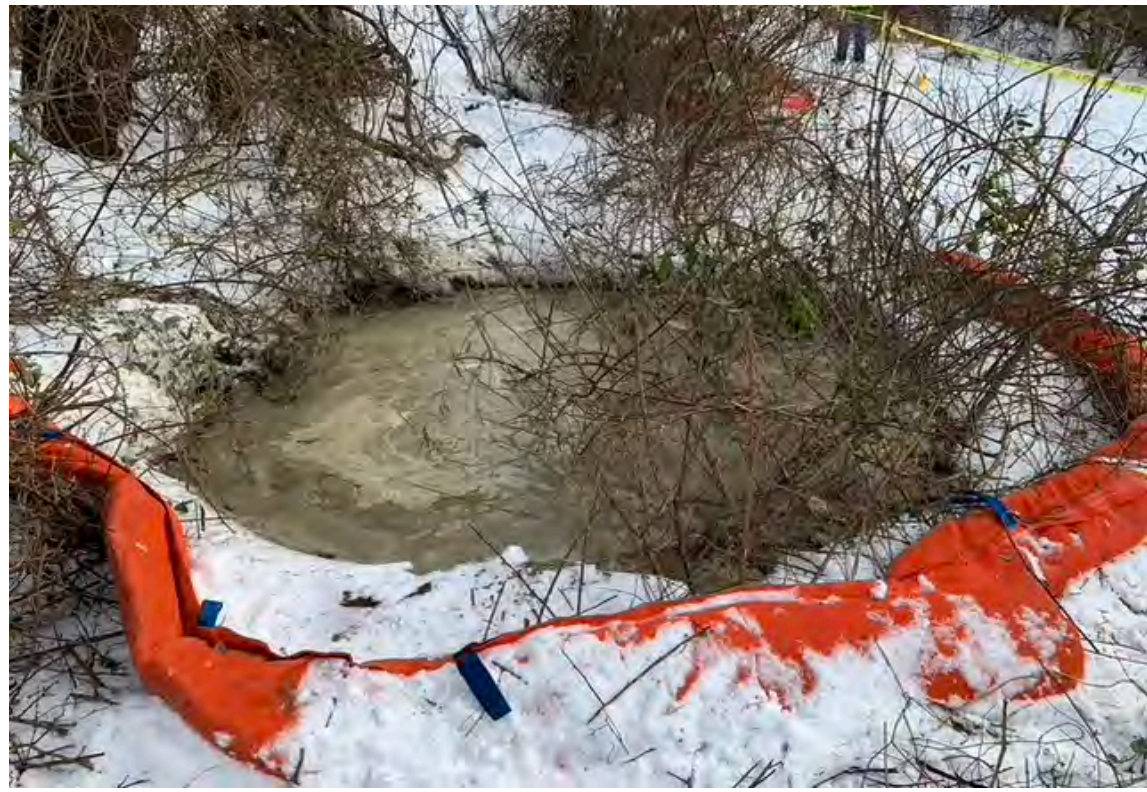
12/19/2020

View of earth feature two filled with 28 cubic yards of flowable fill.

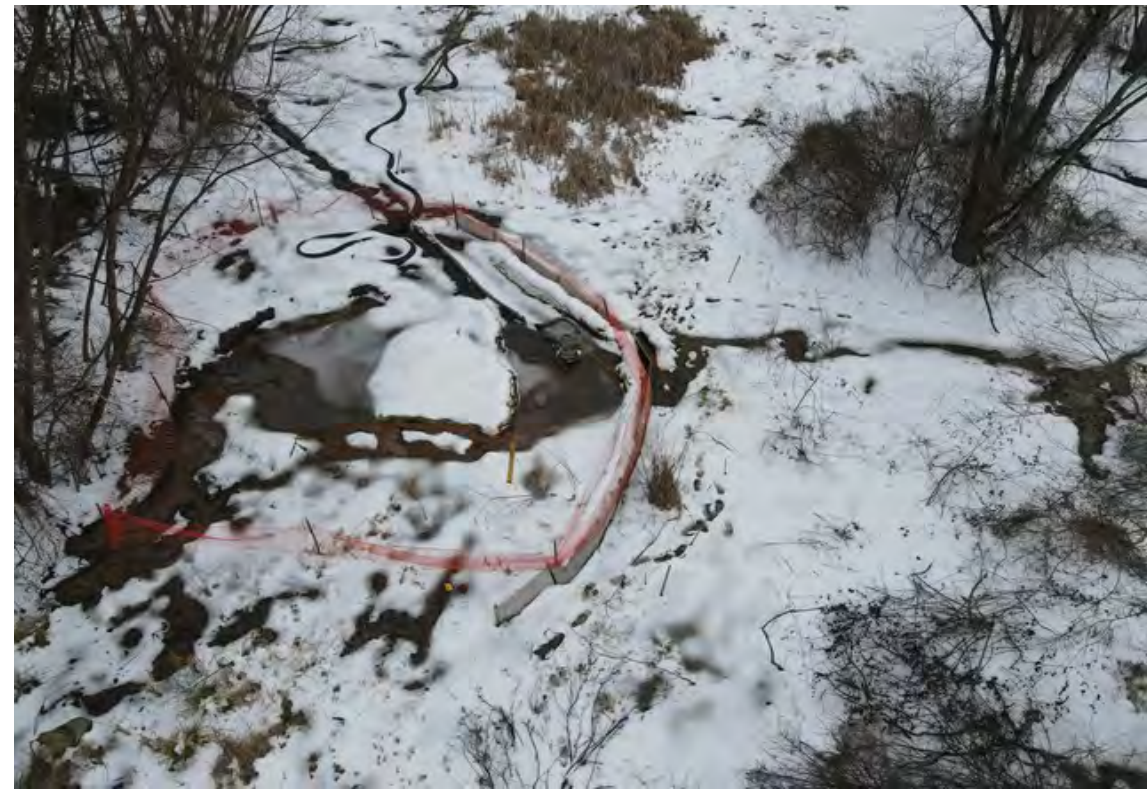
12/21/2020

View of IR release location and containment within WL-H17.
