**If Interim report, Subject to Change as Additional Information Becomes Available**  
**If Interim Report, this Report is cumulative, containing information from previous reports in addition to new information and may change**  
**SPLP PENNSYLVANIA PIPELINE PROJECT**  
**HORIZONTAL DIRECTIONAL DRILLING – INADVERTENT RETURN REPORT FORM**

<b>REPORT DATE:</b>	Current as of 1/12/2021		<b>HDD ALIGNMENT #</b>	PA-CH-100.0000-RD			
<b>PROJECT SITE:</b>	PPP 6 - S3-0290 - Milford Rd./Little Conestoga Rd		<b>HDD COMPANY:</b>	Michels Directional Crossing			
<b>DATE AND TIME WHEN IR WAS INITIALLY DISCOVERED</b>			<b>DATE:</b>	8/10/2020	<b>TIME:</b>	1530	
<b>LOCATION: STREET</b>	427-423 Green Valley Rd, Downingtown, PA 19335		<b>MUNICIPALITY:</b>	Upper Uwchlan	<b>COUNTY:</b>	Chester	
<b>LATITUDE:</b>	40.0794	<b>LONGITUDE:</b>	-75.7104	<b>FROM STATION:</b>	14824+00	<b>TO STATION</b>	14824+00
<b>STREAM NAME:</b>	S-H10 (UNT to Marsh Creek), S-H11 (UNT to Marsh Creek)		<b>POND / LAKE NAME:</b>	Pond H3 (Marsh Creek Reservoir)	<b>WETLAND NAME:</b>	WL-H17 (PEM, PFO)	
<b>DEP PERMIT Nos. (102 AND 105)</b>	E&S Permit # ESG0100015001, Water Obstruction Permit E15-862						
<b>CORPS PERMIT NO.</b>	PASPGP-

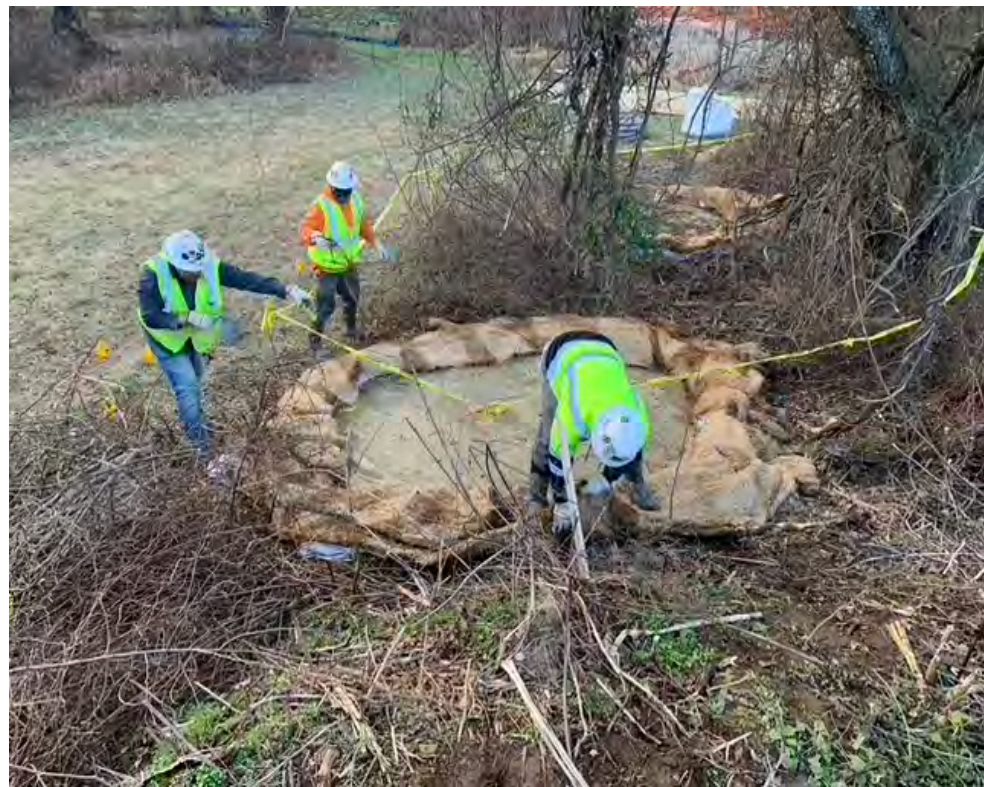
12/28/2020

View of contractor crew members installing erosion control blanket to stabilize earth feature locations.

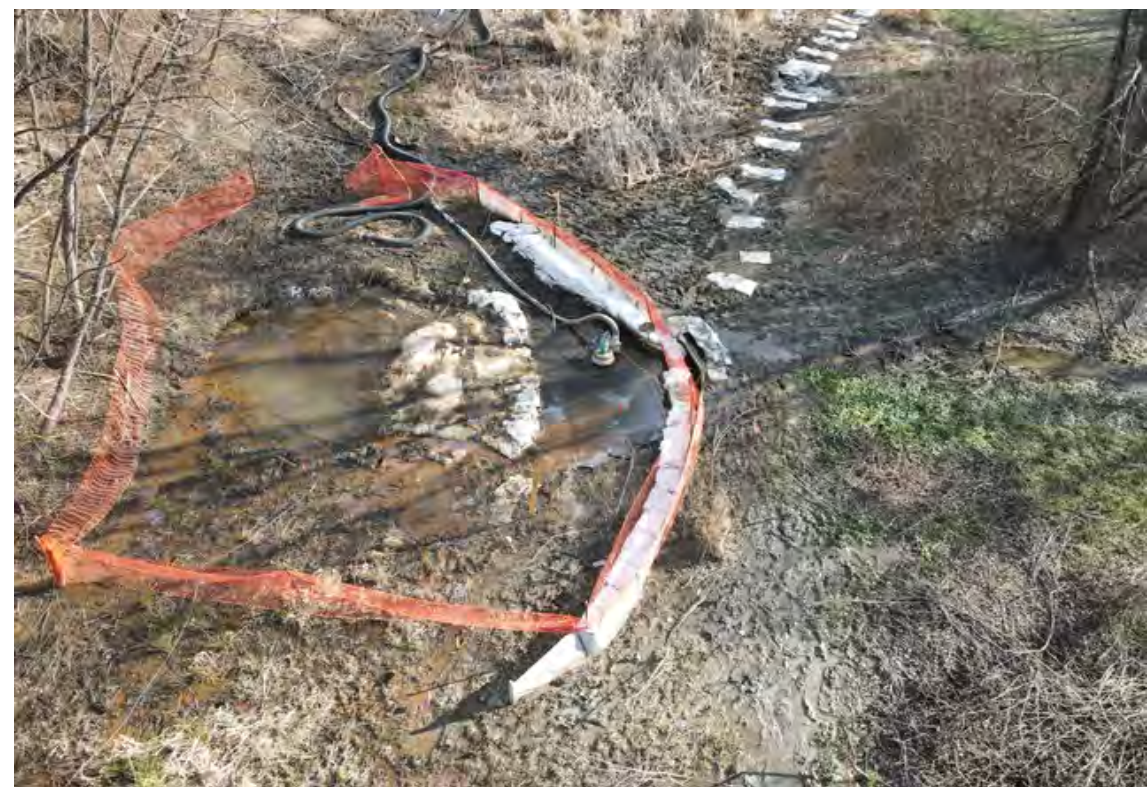
12/29/2020

View of IR release location and containment within WL-H17.

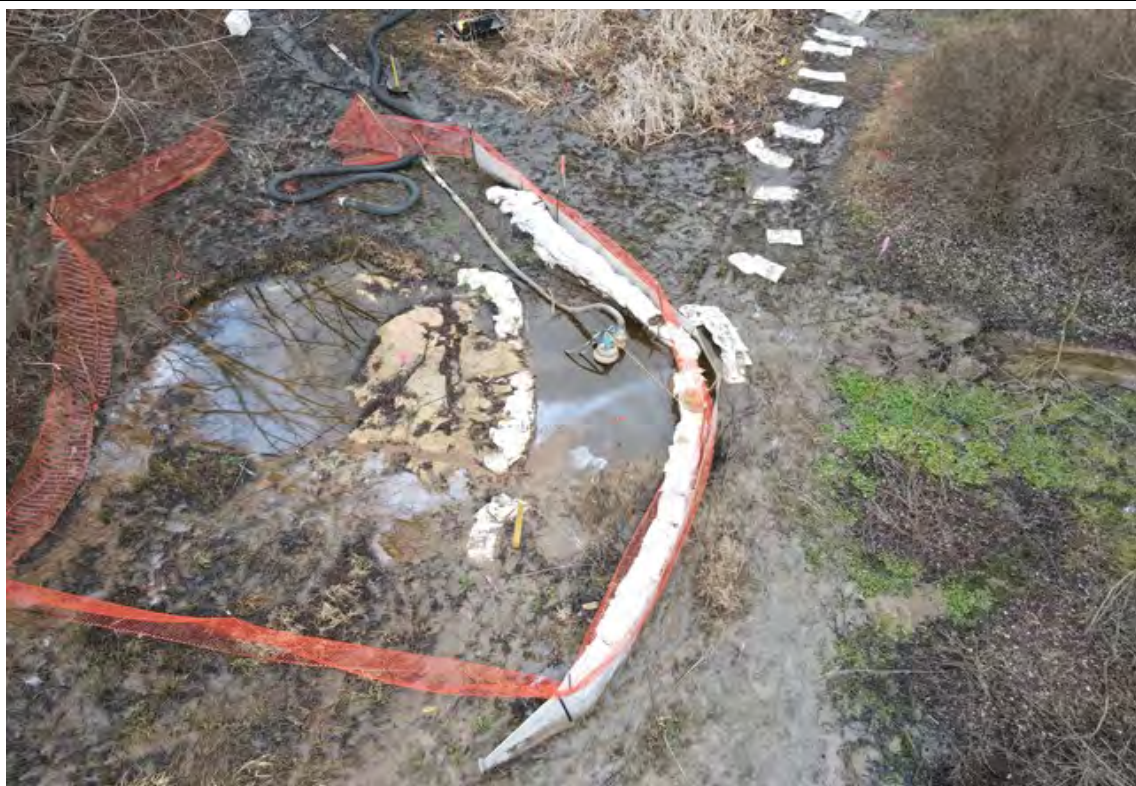
1/5/2021

View of IR release location and containment within WL-H17.

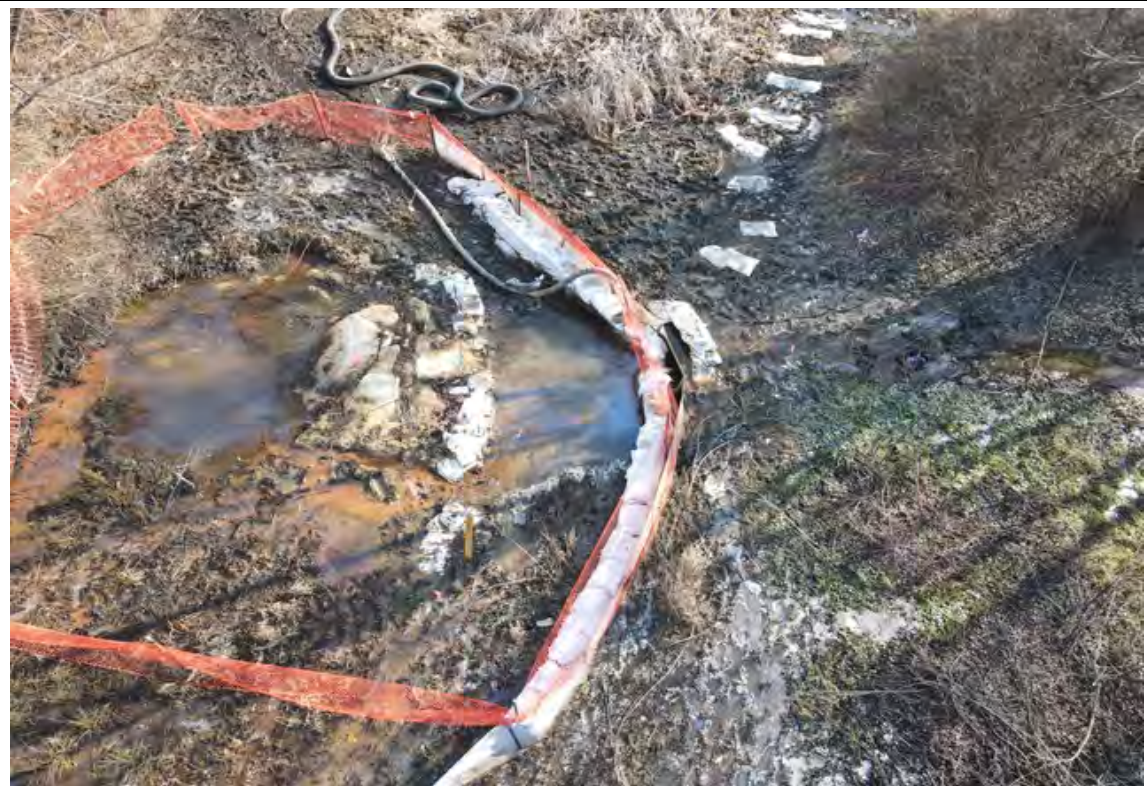
1/12/2021

View of IR release location and containment within WL-H17.
