**If Interim report, Subject to Change as Additional Information Becomes Available**  
**If Interim Report, this Report is cumulative, containing information from previous reports in addition to new information and may change**  
**SPLP PENNSYLVANIA PIPELINE PROJECT**  
**HORIZONTAL DIRECTIONAL DRILLING – INADVERTENT RETURN REPORT FORM**

<b>REPORT DATE:</b>	Current as of 1/19/2021		<b>HDD ALIGNMENT #</b>	PA-CH-100.0000-RD			
<b>PROJECT SITE:</b>	PPP 6 - S3-0290 - Milford Rd./Little Conestoga Rd		<b>HDD COMPANY:</b>	Michels Directional Crossing			
<b>DATE AND TIME WHEN IR WAS INITIALLY DISCOVERED</b>			<b>DATE:</b>	8/10/2020	<b>TIME:</b>	1530	
<b>LOCATION: STREET</b>	427-423 Green Valley Rd, Downingtown, PA 19335		<b>MUNICIPALITY:</b>	Upper Uwchlan	<b>COUNTY:</b>	Chester	
<b>LATITUDE:</b>	40.0794	<b>LONGITUDE:</b>	-75.7104	<b>FROM STATION:</b>	14824+00	<b>TO STATION</b>	14824+00
<b>STREAM NAME:</b>	S-H10 (UNT to Marsh Creek), S-H11 (UNT to Marsh Creek)		<b>POND / LAKE NAME:</b>	Pond H3 (Marsh Creek Reservoir)	<b>WETLAND NAME:</b>	WL-H17 (PEM, PFO)	
<b>DEP PERMIT Nos. (102 AND 105)</b>	E&S Permit # ESG0100015001, Water Obstruction Permit E15-862						
<b>CORPS PERMIT NO.</b>	PASPGP-

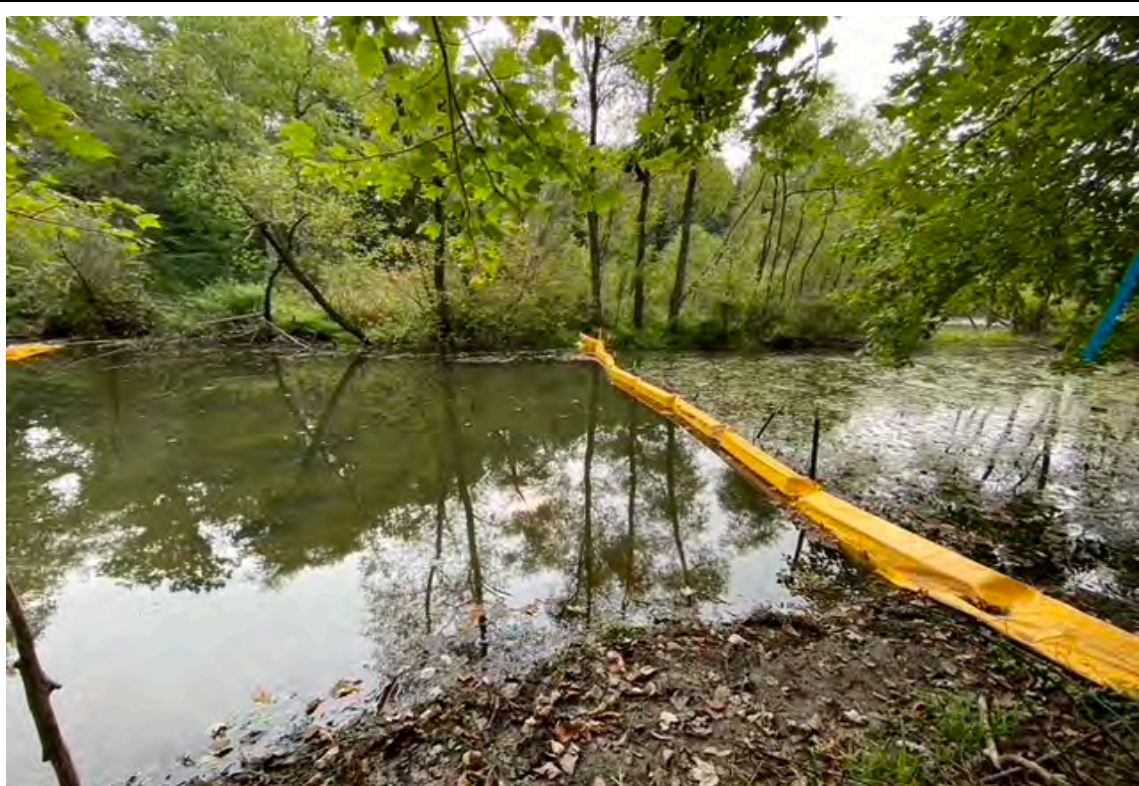
View of turbidity curtain at the confluence of stream S-H10 (UNT to Marsh Creek) and pond H3 (Marsh Creek Reservoir).
