If Interim report, Subject to Change as Additional Information Becomes Available
If Interim Report, this Report is cumulative, containing information from previous reports in addition to new information and may change
SPLP PENNSYLVANIA PIPELINE PROJECT
HORIZONTAL DIRECTIONAL DRILLING – INADVERTENT RETURN REPORT FORM

REPORT DATE:	Current as of 1/26/2021		HDD ALIGNMENT #	PA-CH-100.0000-RD			
PROJECT SITE:	PPP 6 - S3-0290 - Milford Rd./Little Conestoga Rd		HDD COMPANY:	Michels Directional Crossing			
DATE AND TIME WHEN IR WAS INITIALLY DISCOVERED			DATE:	8/10/2020	TIME:	1530	
LOCATION: STREET	427-423 Green Valley Rd, Downingtown, PA 19335		MUNICIPALITY:	Upper Uwchlan	COUNTY:	Chester	
LATITUDE:	40.0794	LONGITUDE:	-75.7104	FROM STATION:	14824+00	TO STATION	14824+00
STREAM NAME:	S-H10 (UNT to Marsh Creek), S-H11 (UNT to Marsh Creek)		POND / LAKE NAME:	Pond H3 (Marsh Creek Reservoir)	WETLAND NAME:	WL-H17 (PEM, PFO)	
DEP PERMIT Nos. (102 AND 105)	E&S Permit # ESG0100015001, Water Obstruction Permit E15-862						
CORPS PERMIT NO.	PASPGP-5 (issued April 12, 2017)						
IR TRACKING ID:	PPP6_PA-CH-0100.0000-RD_MilfordRd_IRInterim_24_012721						
IS AUGUST 8, 2017 ORDER APPLICABLE?	YES	LISTED

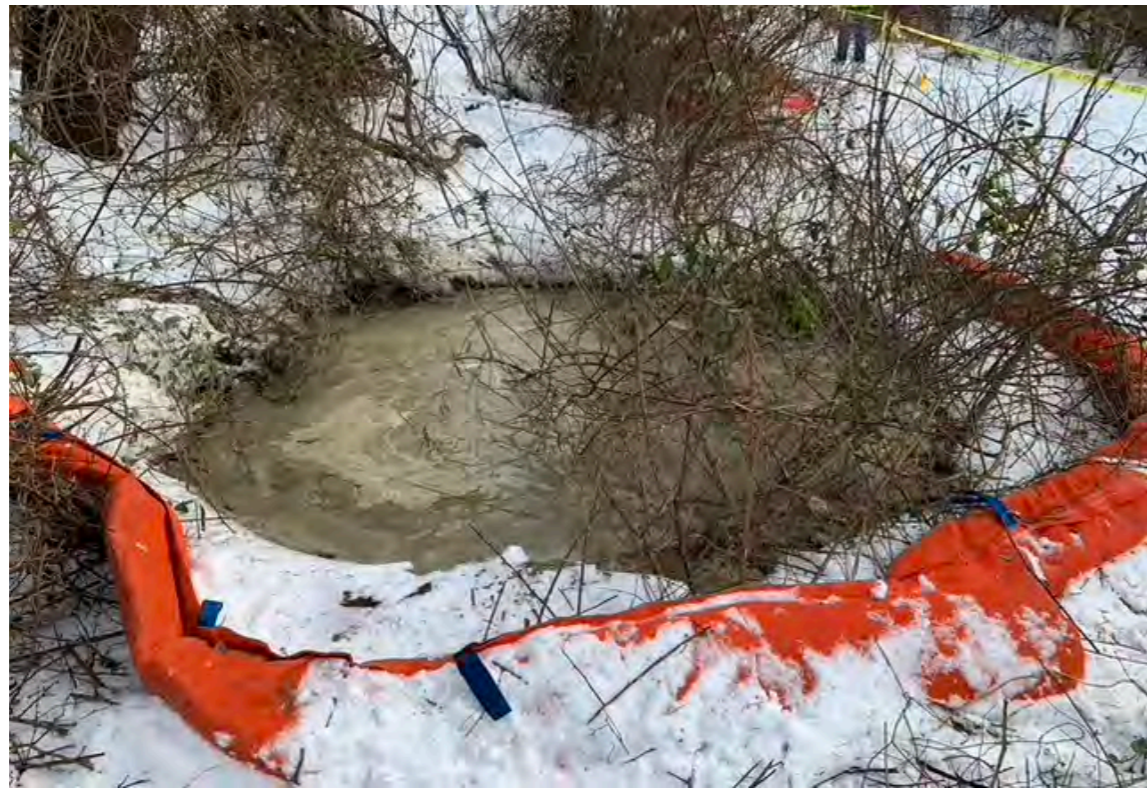
12/19/2020

View of earth feature two filled with 28 cubic yards of flowable fill.
