REPORT DATE:	Current as of 2/9/2021	HDD ALIGNMENT #	PA-CH-100.0000-RD				
PROJECT SITE:	PPP 6 - S3-0290 - Milford Rd./Little Conestoga Rd		HDD COMPANY:	Michels Directional Crossing			
DATE AND TIME WHEN IR WAS INITIALLY DISCOVERED			DATE:	8/10/2020	TIME:	1530	
LOCATION: STREET	427-423 Green Valley Rd, Downingtown, PA 19335		MUNICIPALITY:	Upper Uwchlan	COUNTY:	Chester	
LATITUDE:	40.0794	LONGITUDE:	-75.7104	FROM STATION:	14824+00	TO STATION	14824+00
STREAM NAME:	S-H10 (UNT to Marsh Creek), S-H11 (UNT to Marsh Creek)		POND / LAKE NAME:	Pond H3 (Marsh Creek Reservoir)	WETLAND NAME:	WL-H17 (PEM, PFO)	
DEP PERMIT Nos. (102 AND 105)	E&S Permit # ESG0100015001, Water Obstruction Permit E15-862						
CORPS PERMIT NO.	PASPGP-5 (issued April 12, 2017)						
IR TRACKING ID:	PPP6_PA-CH-0100.0000-RD_MilfordRd_IRInterim_26_021021						
IS AUGUST 8, 2017 ORDER APPLICABLE?	YES	LISTED IN WHICH EXHIBIT?	3	DESCRIPTION IN EXHIBIT	HDDs for Reevaluation

**SPLP PENNSYLVANIA PIPELINE PROJECT
HORIZONTAL DIRECTIONAL DRILLING – INADVERTENT RETURN REPORT FORM**

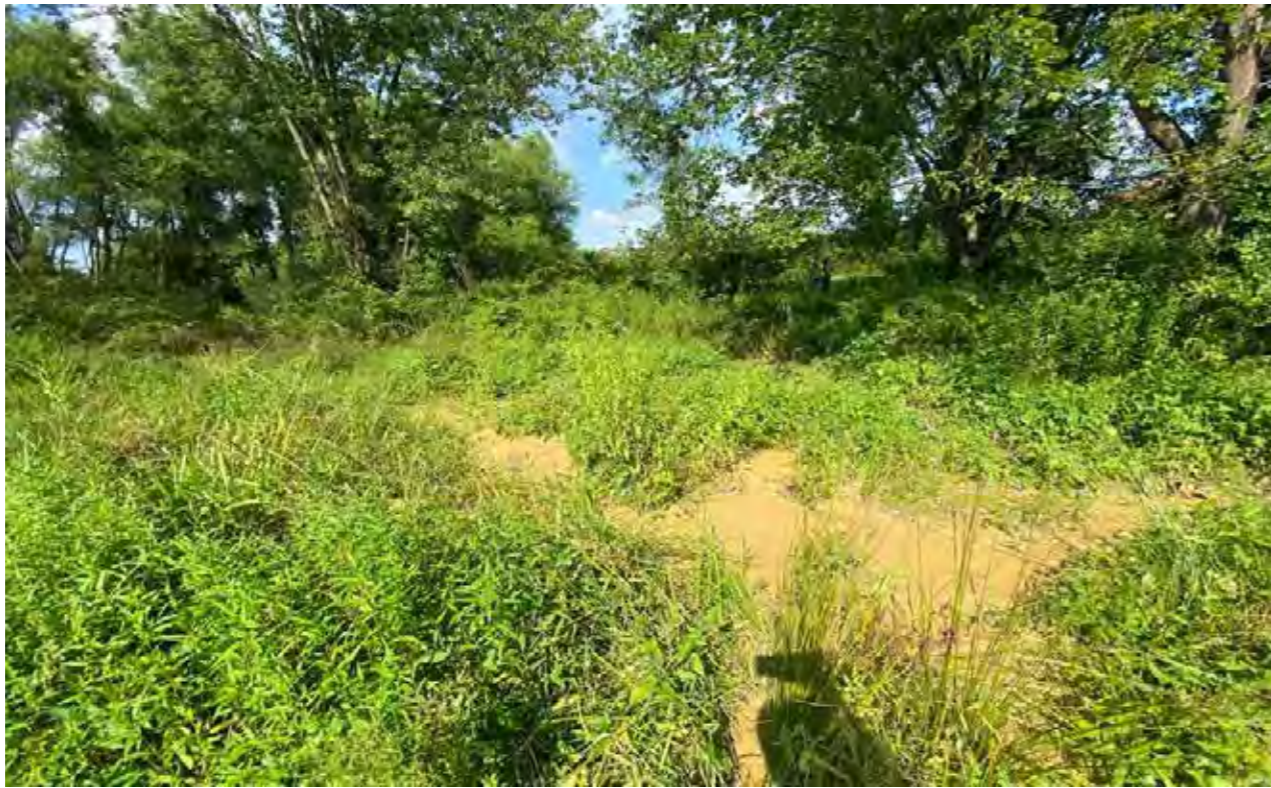
View of drilling fluid within WL-H17 at location of IR release point.
