**If Interim report, Subject to Change as Additional Information Becomes Available**  
**If Interim Report, this Report is cumulative, containing information from previous reports in addition to new information and may change**  
**SPLP PENNSYLVANIA PIPELINE PROJECT**  
**HORIZONTAL DIRECTIONAL DRILLING – INADVERTENT RETURN REPORT FORM**

<b>REPORT DATE:</b>	Current as of 2/16/2021		<b>HDD ALIGNMENT #</b>	PA-CH-100.0000-RD			
<b>PROJECT SITE:</b>	PPP 6 - S3-0290 - Milford Rd./Little Conestoga Rd		<b>HDD COMPANY:</b>	Michels Directional Crossing			
<b>DATE AND TIME WHEN IR WAS INITIALLY DISCOVERED</b>			<b>DATE:</b>	8/10/2020	<b>TIME:</b>	1530	
<b>LOCATION: STREET</b>	427-423 Green Valley Rd, Downingtown, PA 19335		<b>MUNICIPALITY:</b>	Upper Uwchlan	<b>COUNTY:</b>	Chester	
<b>LATITUDE:</b>	40.0794	<b>LONGITUDE:</b>	-75.7104	<b>FROM STATION:</b>	14824+00	<b>TO STATION</b>	14824+00
<b>STREAM NAME:</b>	S-H10 (UNT to Marsh Creek), S-H11 (UNT to Marsh Creek)		<b>POND / LAKE NAME:</b>	Pond H3 (Marsh Creek Reservoir)	<b>WETLAND NAME:</b>	WL-H17 (PEM, PFO)	
<b>DEP PERMIT Nos. (102 AND 105)</b>	E&S Permit # ESG0100015001, Water Obstruction Permit E15-862						
<b>CORPS PERMIT NO.</b>	PASPGP-

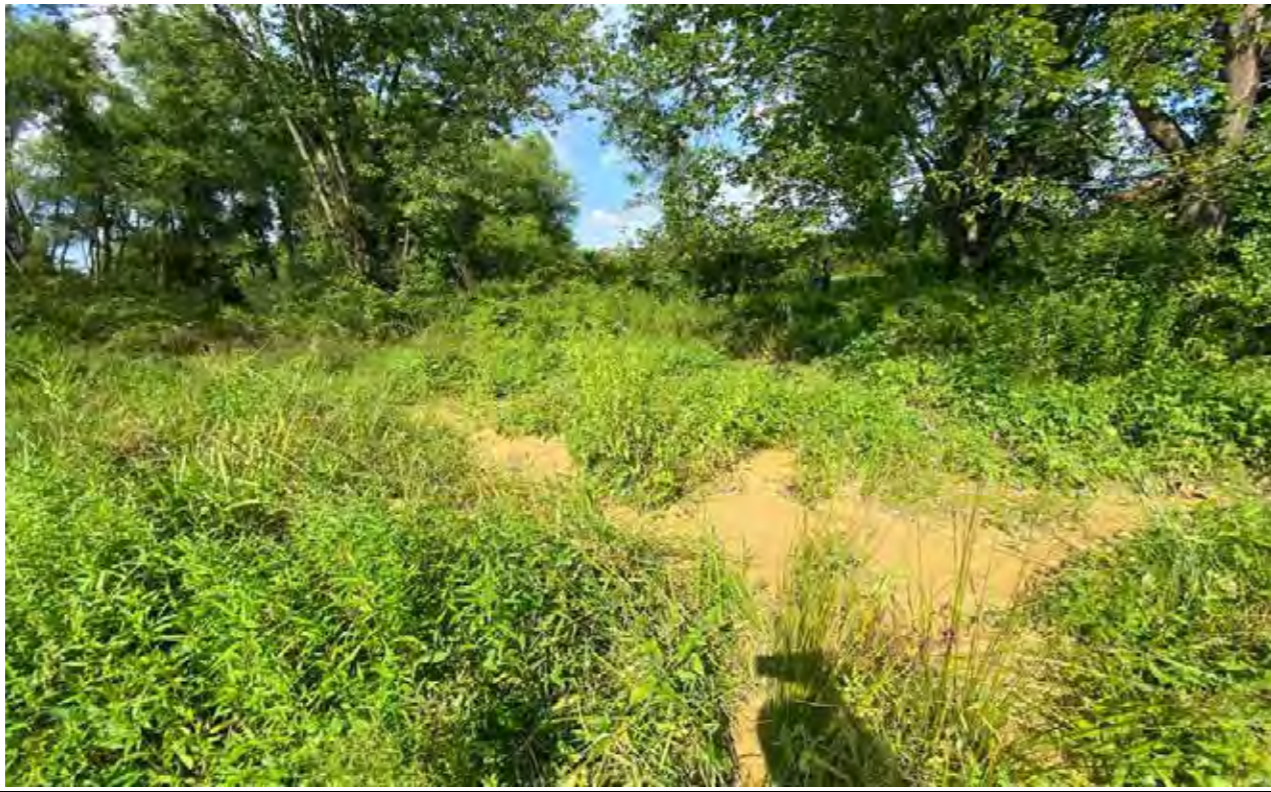
View of drilling fluid within WL-H17 at location of IR release point.

NAME:		PHONE:		EMAIL:		TITLE:			
NAME:		PHONE:		EMAIL:		TITLE:			
NAME:		PHONE:		EMAIL:		TITLE:			
IMPACTED RESOURCE(S)									
RESOURCE:	WETLAND WL-H17	SURFACE WATER CLASSIFICATION OR WETLAND TYPE:	PEM/PFO	WHAT STEPS HAVE BEEN TAKEN TO ELIMINATE OR MITIGATE THE IMPACTS?	Sandbag and silt fence containment constructed at release point. Drilling fluid recovered using hand tools and pumps.				
RESOURCE:	STREAM S-H10	SURFACE WATER CLASSIFICATION OR WETLAND TYPE:	DRAINS TO HQ-TSF	WHAT STEPS HAVE BEEN TAKEN TO ELIMINATE OR MITIGATE THE IMPACTS?	Sandbag and silt fence containments constructed within stream. Drilling fluid recovered using hand tools and pumps.				
RESOURCE:	STREAM S-H11	SURFACE WATER CLASSIFICATION OR WETLAND TYPE:	DRAINS TO HQ-TSF	WHAT STEPS HAVE BEEN TAKEN TO ELIMINATE OR MITIGATE THE IMPACTS?	Sandbag and silt fence containments constructed within stream. Drilling fluid recovered using hand tools and pumps.

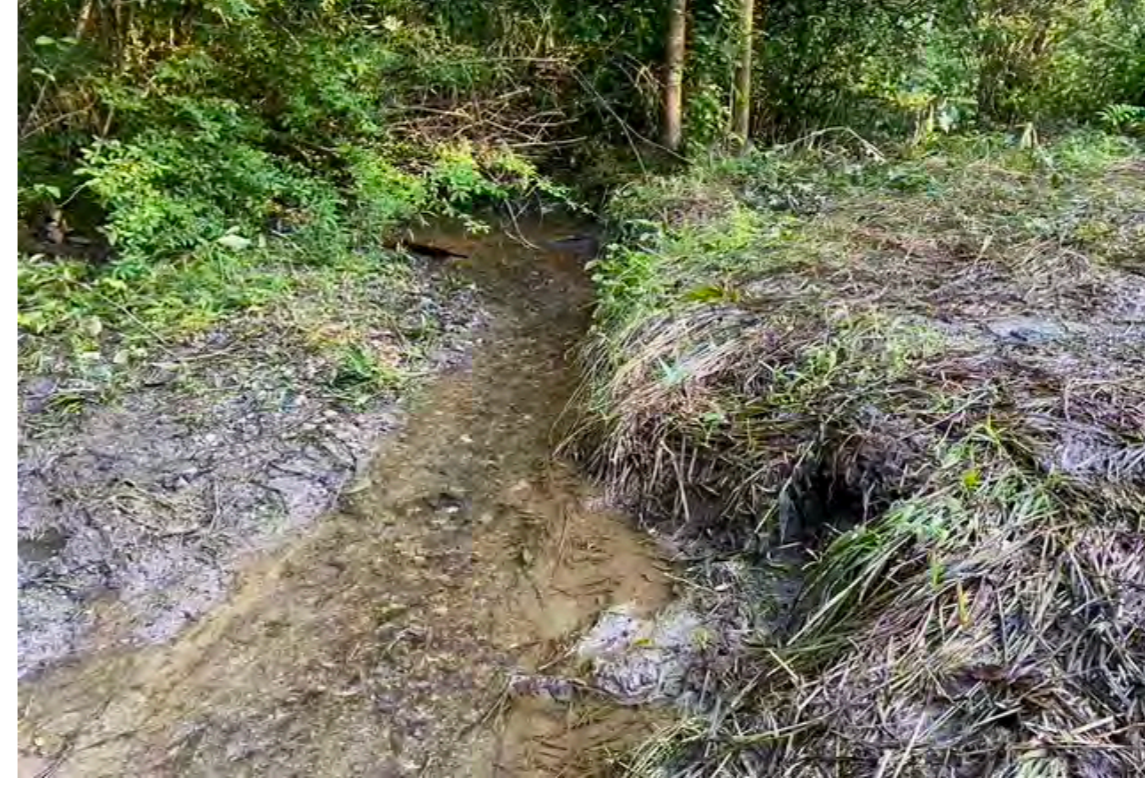
View of stream S-H10 (UNT to Marsh Creek) following cleanup.

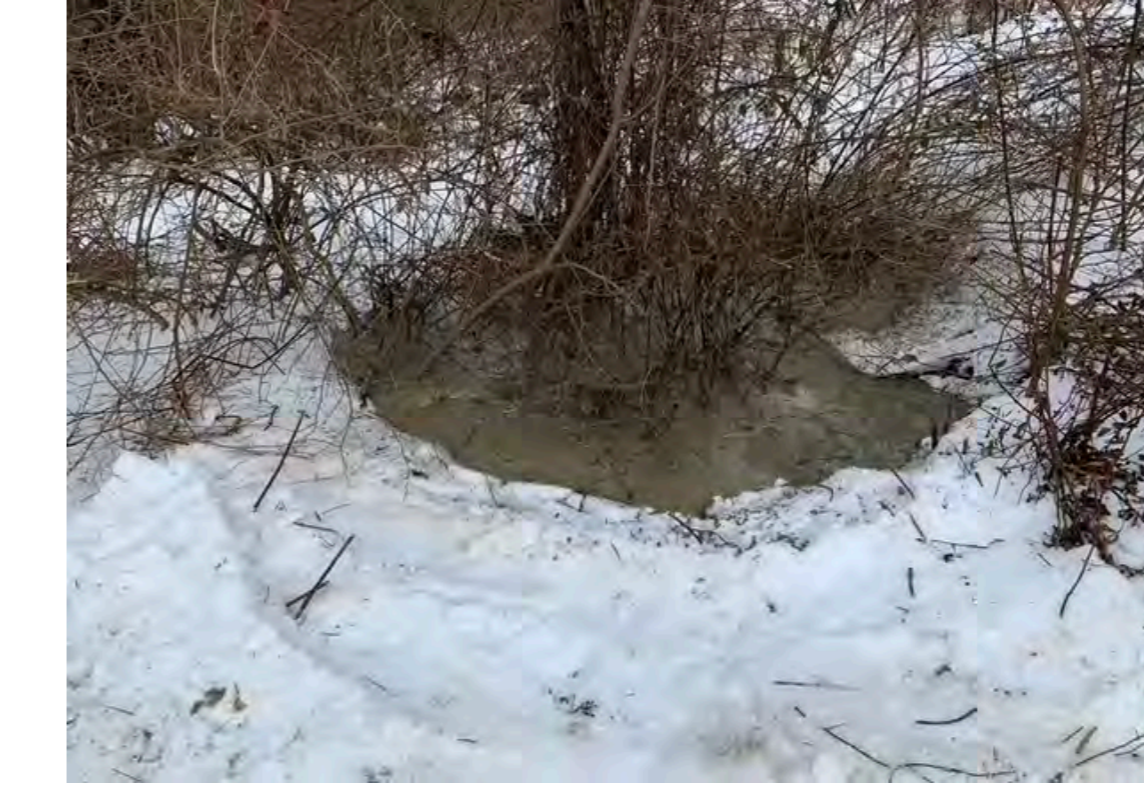
View of earth feature one filled with 13 cubic yards of flowable fill.
