If Interim report, Subject to Change as Additional Information Becomes Available
If Interim Report, this Report is cumulative, containing information from previous reports in addition to new information and may change
SPLP PENNSYLVANIA PIPELINE PROJECT
HORIZONTAL DIRECTIONAL DRILLING – INADVERTENT RETURN REPORT FORM

REPORT DATE:	Current as of 4/6/2021	HDD ALIGNMENT #	PA-CH-100.0000-RD				
PROJECT SITE:	PPP 6 - S3-0290 - Milford Rd./Little Conestoga Rd		HDD COMPANY:	Michels Directional Crossing			
DATE AND TIME WHEN IR WAS INITIALLY DISCOVERED			DATE:	8/10/2020	TIME:	1530	
LOCATION: STREET	427-423 Green Valley Rd, Downingtown, PA 19335		MUNICIPALITY:	Upper Uwchlan	COUNTY:	Chester	
LATITUDE:	40.0794	LONGITUDE:	-75.7104	FROM STATION:	14824+00	TO STATION	14824+00
STREAM NAME:	S-H10 (UNT to Marsh Creek), S-H11 (UNT to Marsh Creek)		POND / LAKE NAME:	Pond H3 (Marsh Creek Reservoir)	WETLAND NAME:	WL-H17 (PEM, PFO)	
DEP PERMIT Nos. (102 AND 105)	E&S Permit # ESG0100015001, Water Obstruction Permit E15-862						
CORPS PERMIT NO.	PASPGP-5 (issued April 12, 2017)						
IR TRACKING ID:	PPP6_PA-CH-0100.0000-RD_MilfordRd_IRInterim_34_040721						
IS AUGUST 8, 2017 ORDER APPLICABLE?	YES	LISTED I

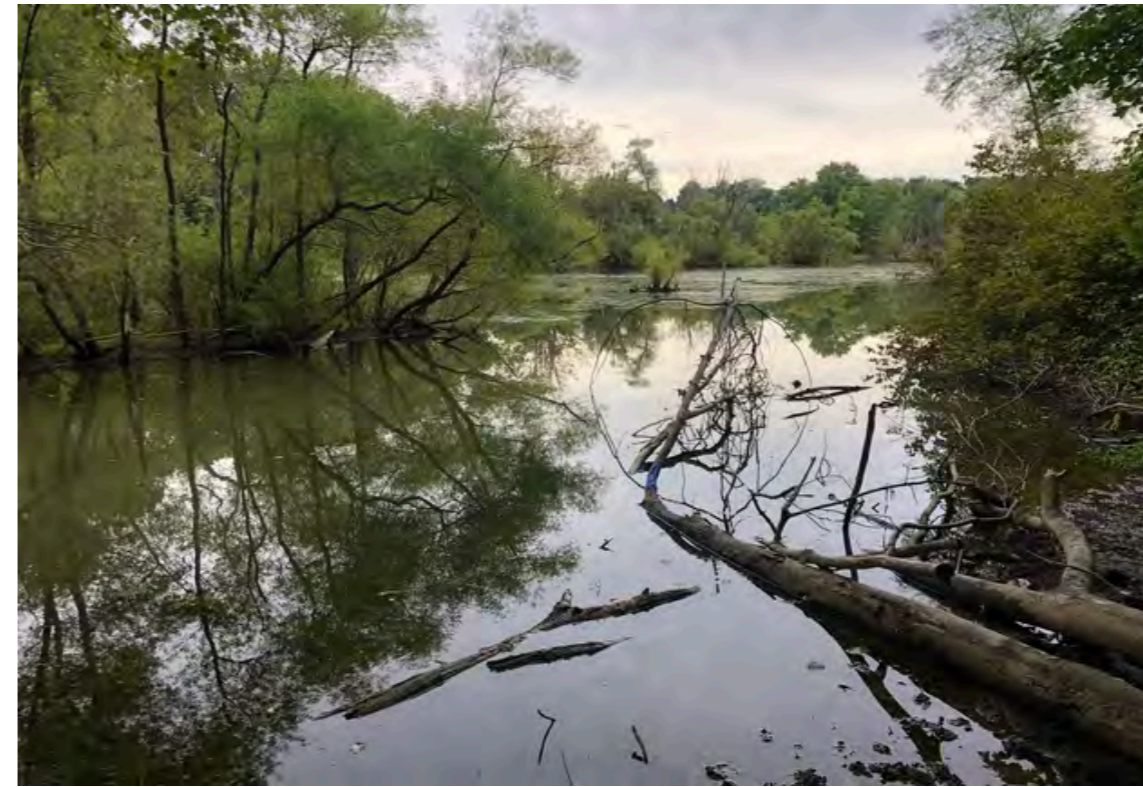
8/31/2020

View of pond H3 (Marsh Creek Reservoir).

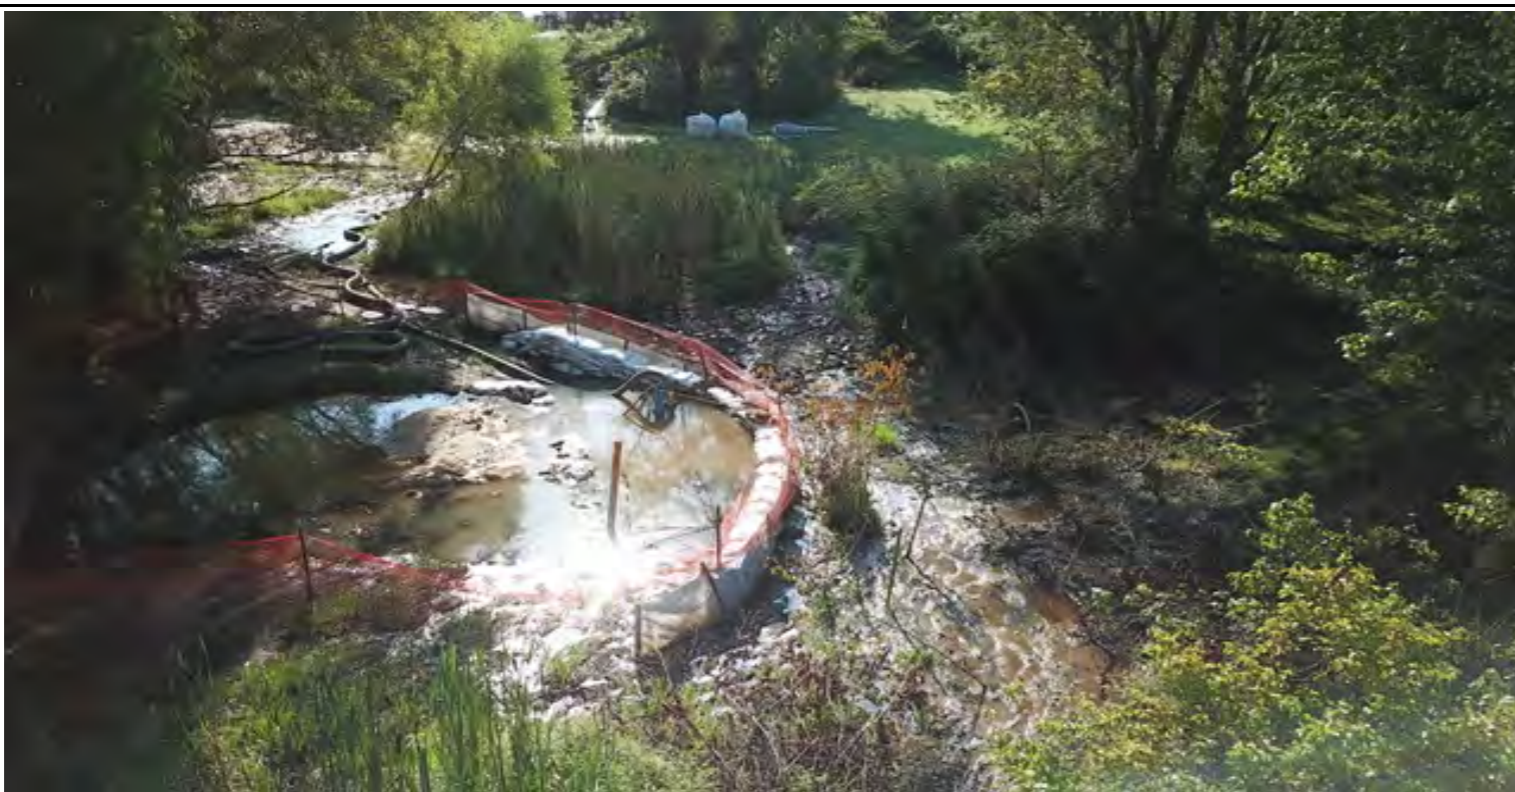
9/4/2020

View of IR release location and containment within WL-H17.

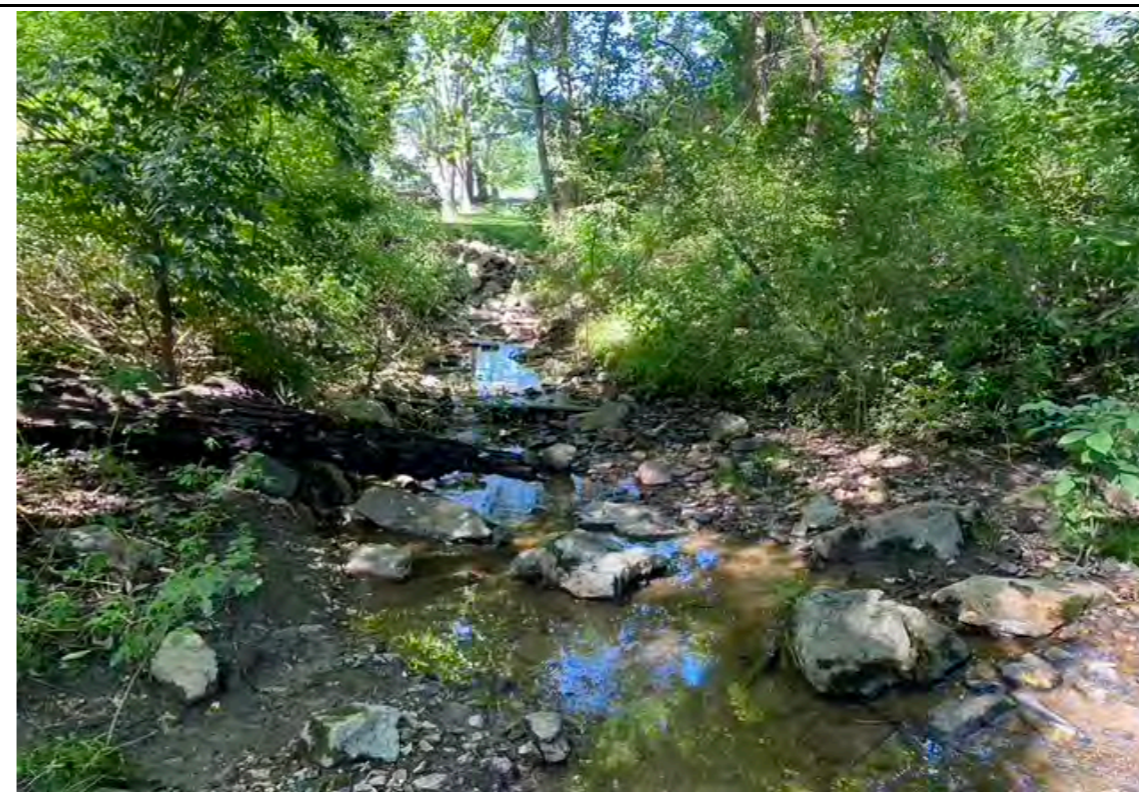
9/5/2020

View of stream S-H10 (UNT to Marsh Creek)

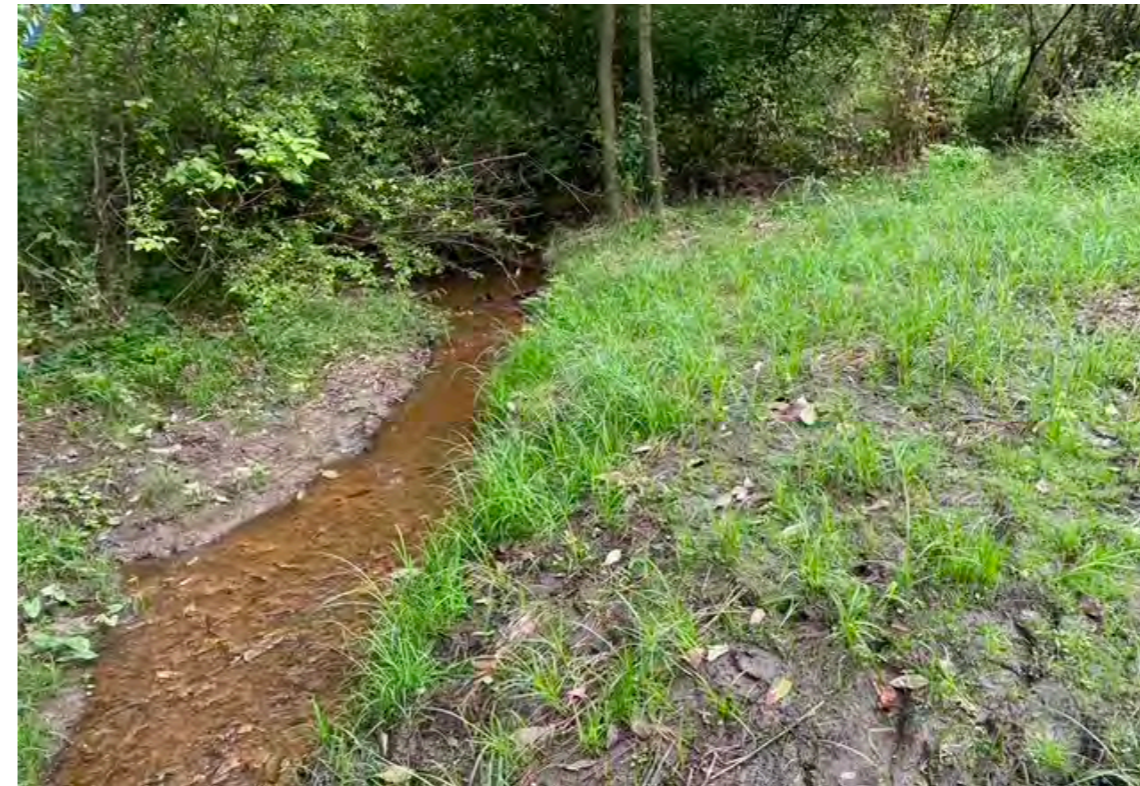
9/14/2020

View of stream S-H10 (UNT to Marsh Creek)

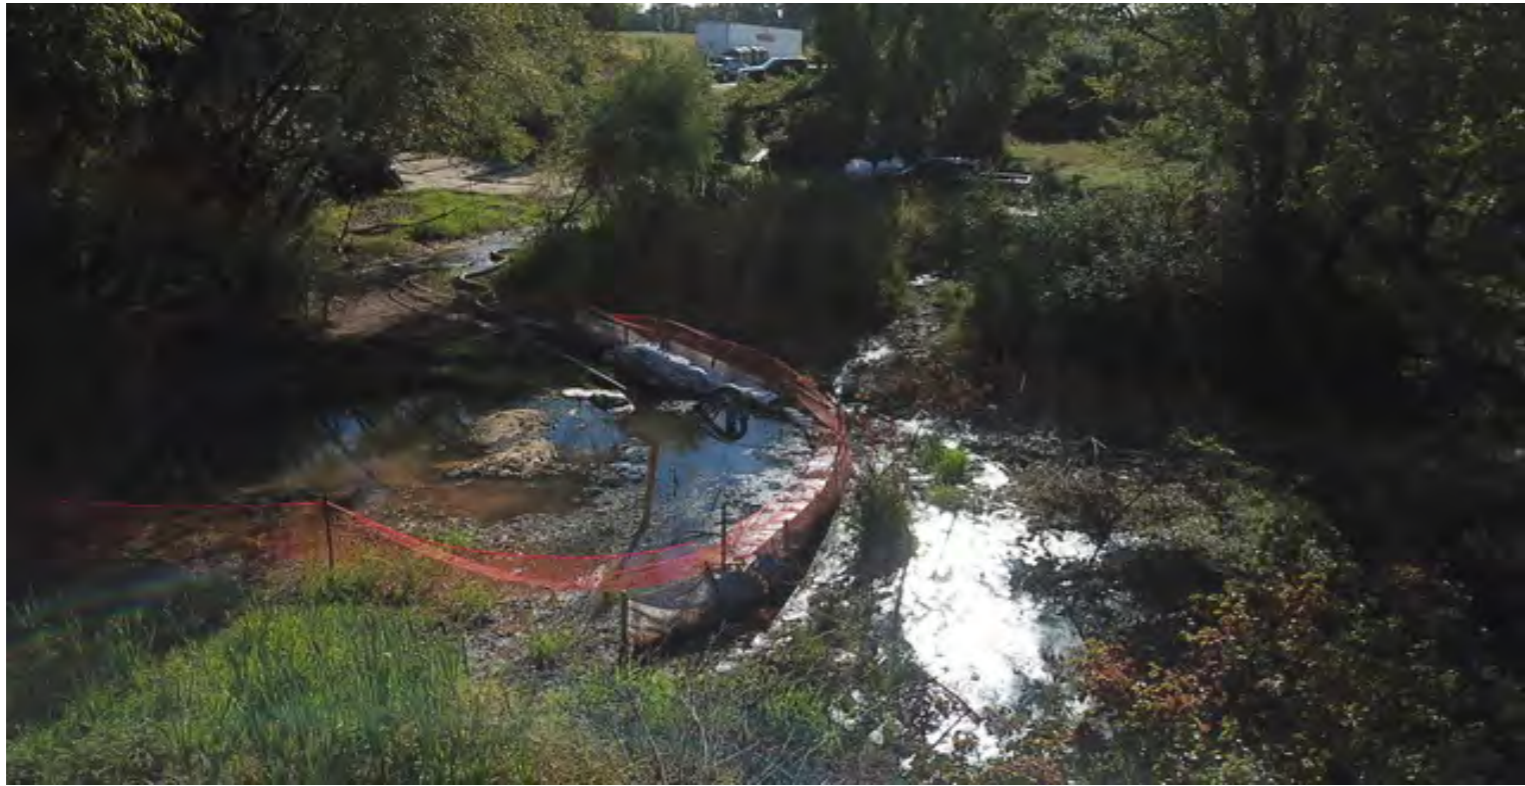
9/21/2020

View of IR release location and containment within WL-H17.

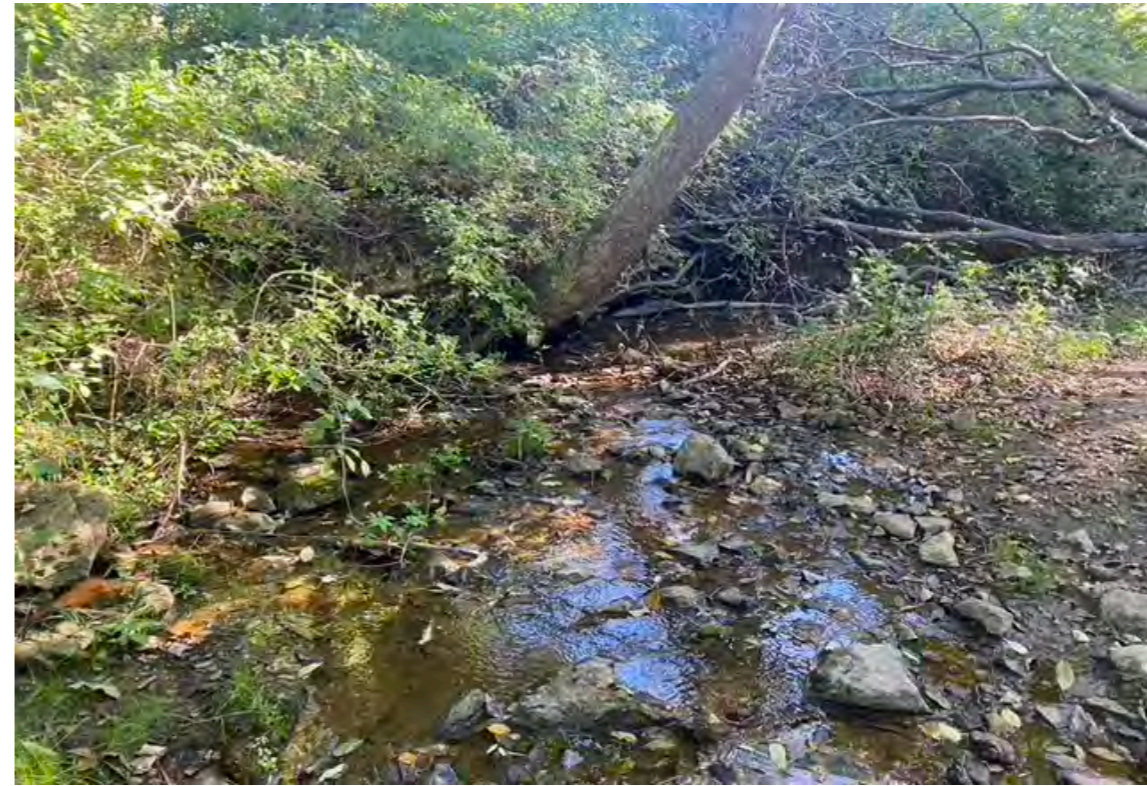
9/21/2020

View of stream S-H10 (UNT to Marsh Creek)

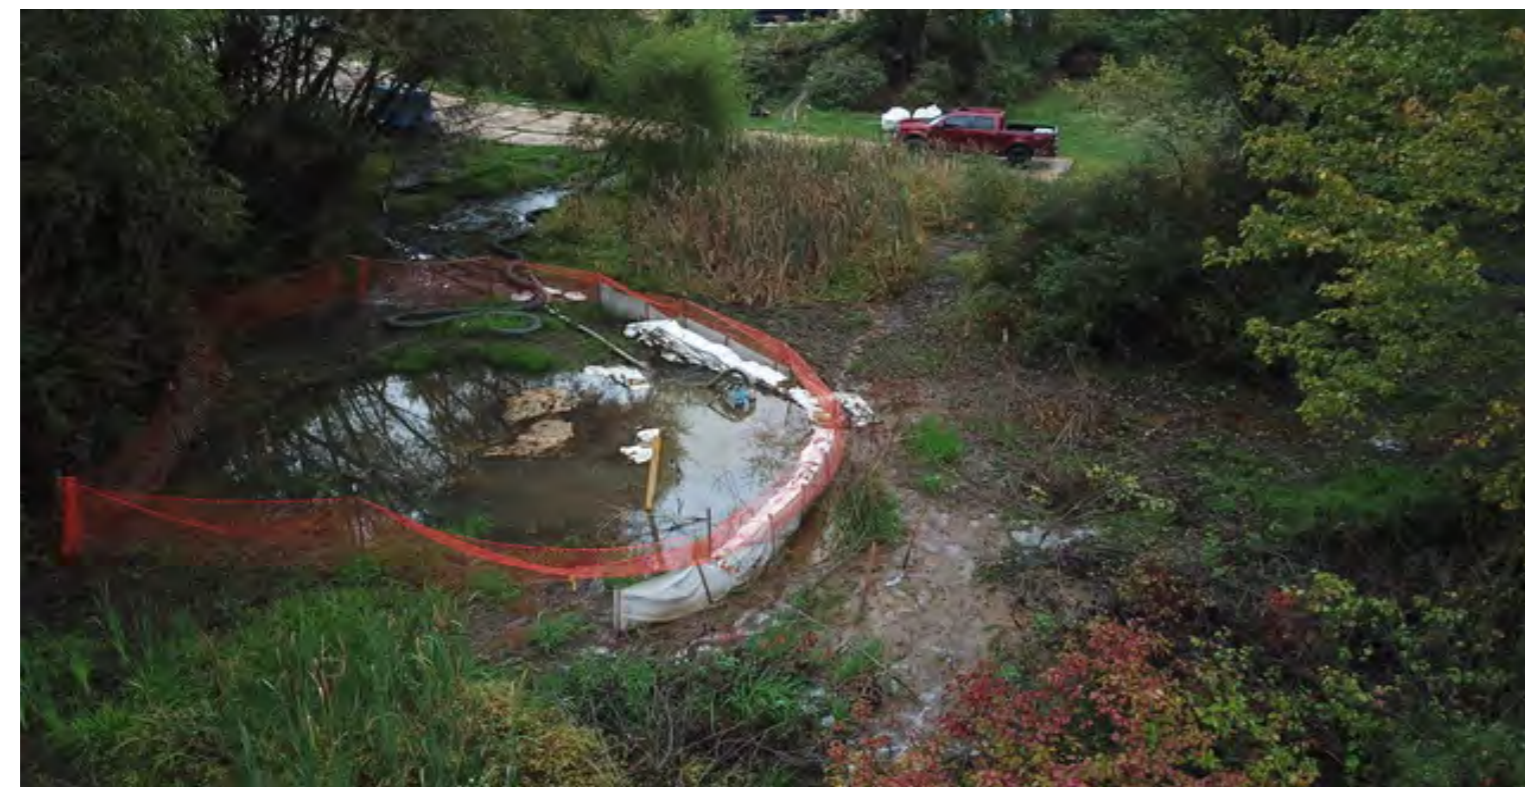
9/28/2020

View of IR release location and containment within WL-H17.
