If Interim report, Subject to Change as Additional Information Becomes Available
If Interim Report, this Report is cumulative, containing information from previous reports in addition to new information and may change
SPLP PENNSYLVANIA PIPELINE PROJECT
HORIZONTAL DIRECTIONAL DRILLING – INADVERTENT RETURN REPORT FORM

REPORT DATE:	Current as of 4/6/2021	HDD ALIGNMENT #	PA-CH-100.0000-RD				
PROJECT SITE:	PPP 6 - S3-0290 - Milford Rd./Little Conestoga Rd		HDD COMPANY:	Michels Directional Crossing			
DATE AND TIME WHEN IR WAS INITIALLY DISCOVERED			DATE:	8/10/2020	TIME:	1530	
LOCATION: STREET	427-423 Green Valley Rd, Downingtown, PA 19335		MUNICIPALITY:	Upper Uwchlan	COUNTY:	Chester	
LATITUDE:	40.0794	LONGITUDE:	-75.7104	FROM STATION:	14824+00	TO STATION	14824+00
STREAM NAME:	S-H10 (UNT to Marsh Creek), S-H11 (UNT to Marsh Creek)		POND / LAKE NAME:	Pond H3 (Marsh Creek Reservoir)	WETLAND NAME:	WL-H17 (PEM, PFO)	
DEP PERMIT Nos. (102 AND 105)	E&S Permit # ESG0100015001, Water Obstruction Permit E15-862						
CORPS PERMIT NO.	PASPGP-5 (issued April 12, 2017)						
IR TRACKING ID:	PPP6_PA-CH-0100.0000-RD_MilfordRd_IRInterim_34_040721						
IS AUGUST 8, 2017 ORDER APPLICABLE?	YES	LISTED I

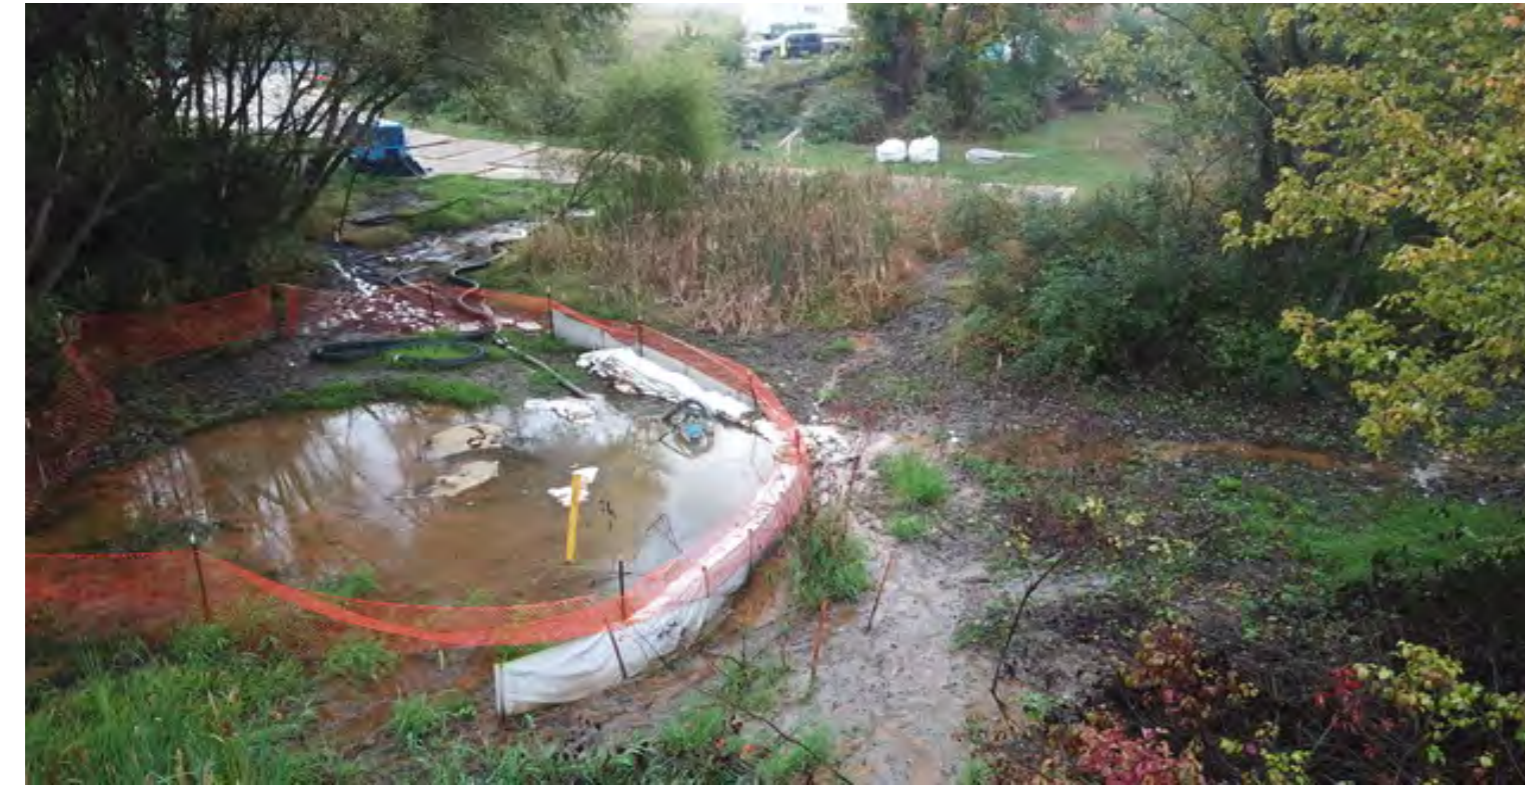
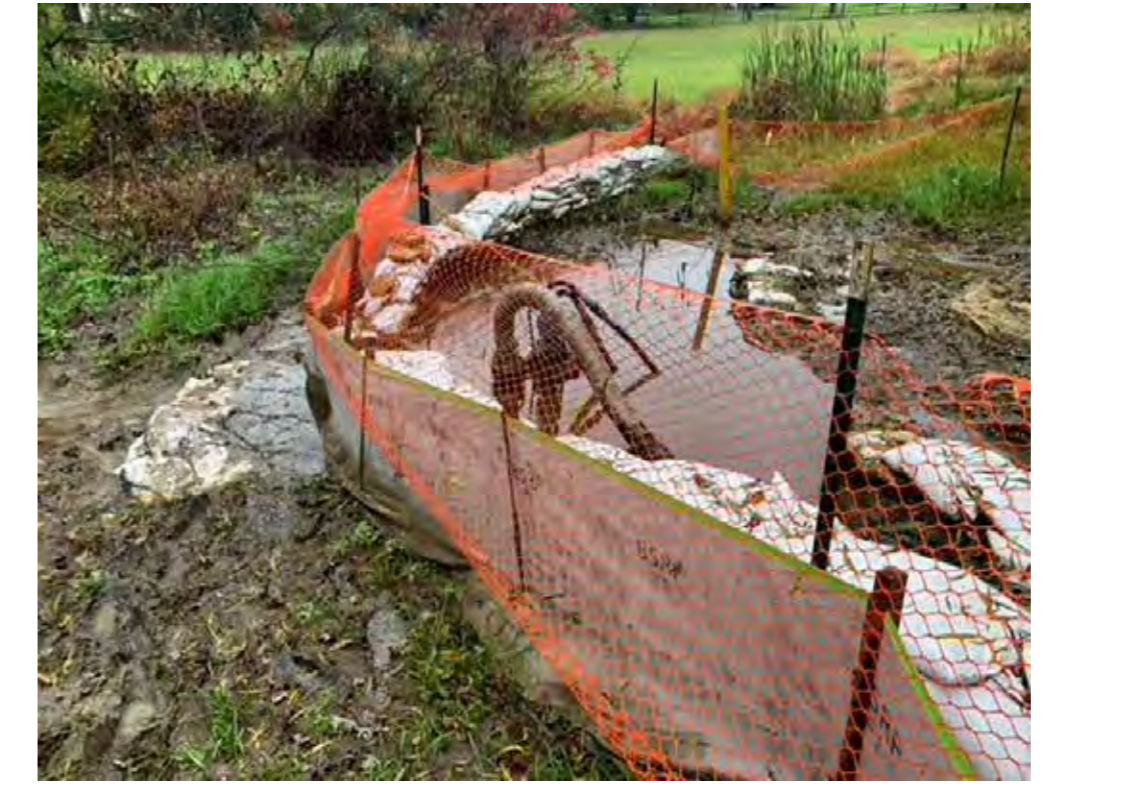
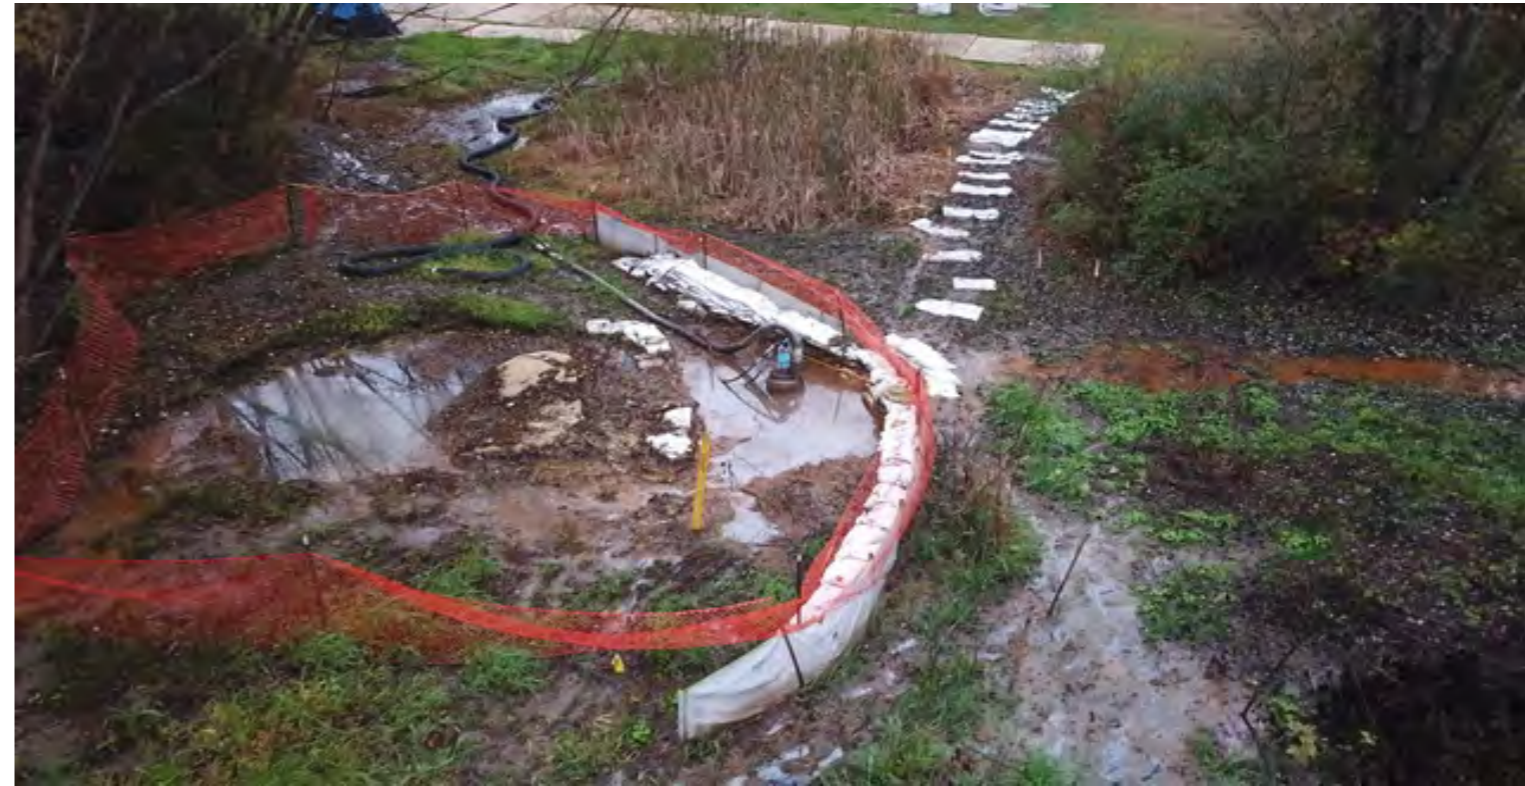
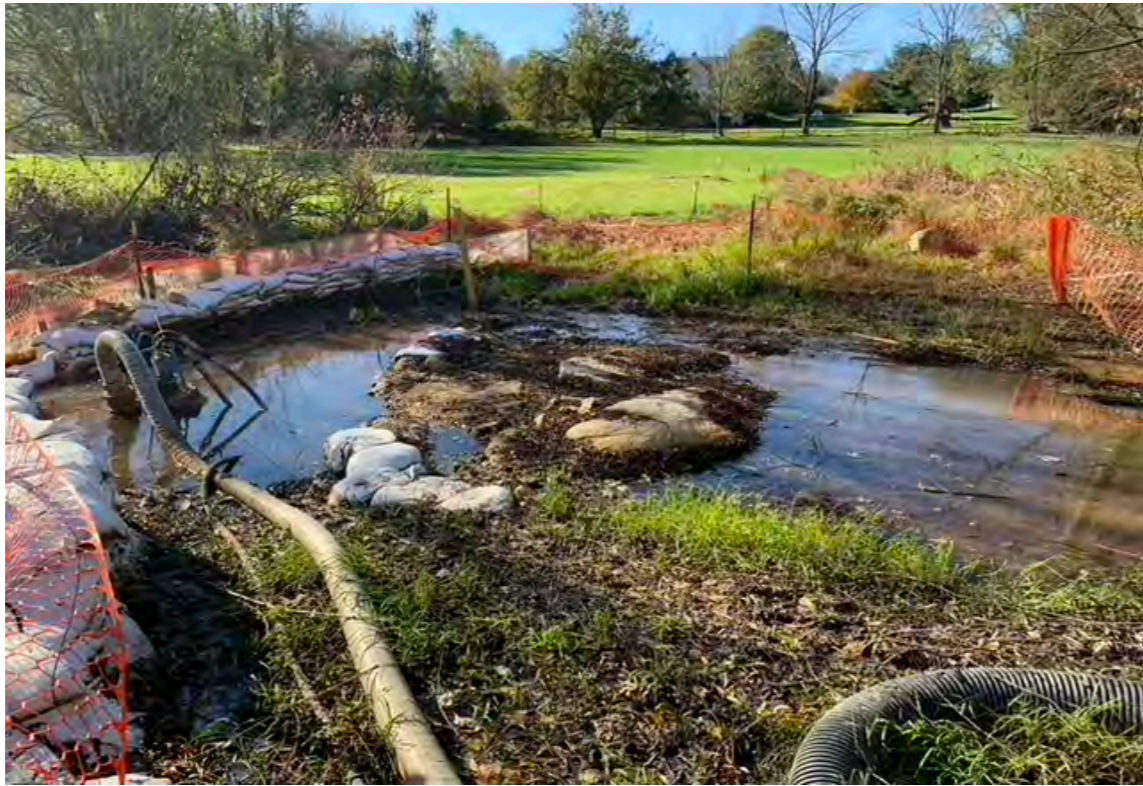
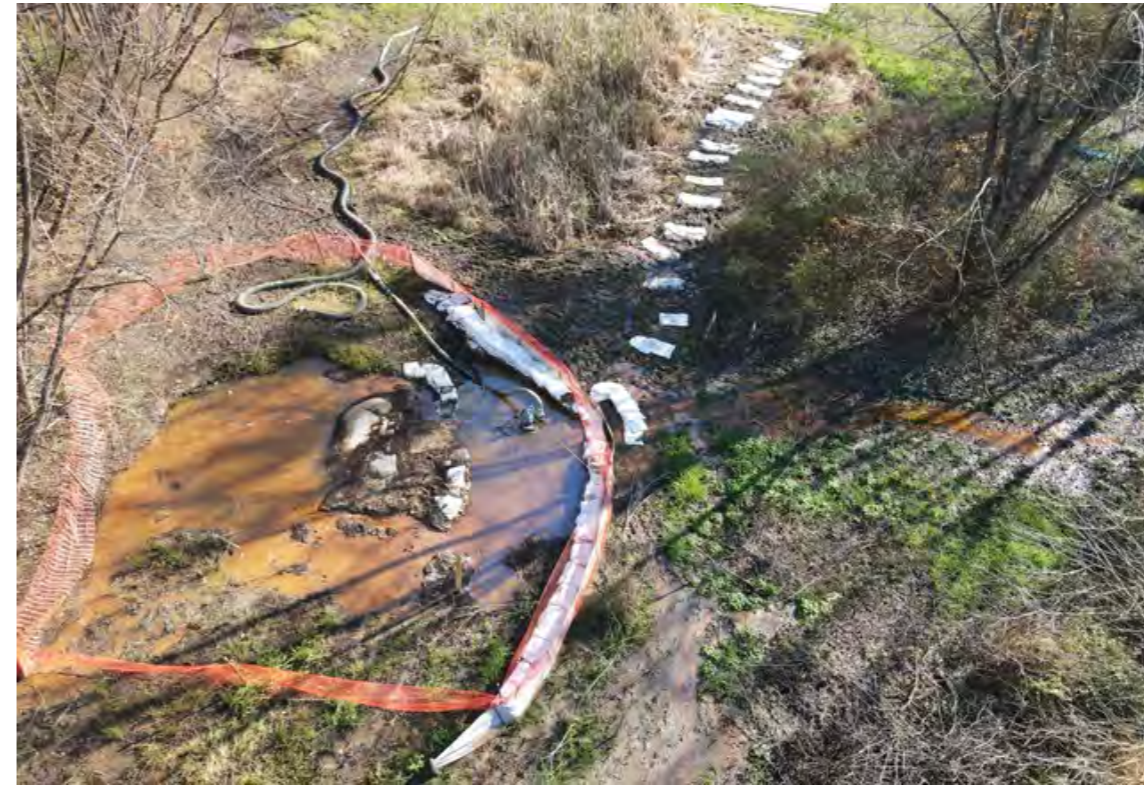
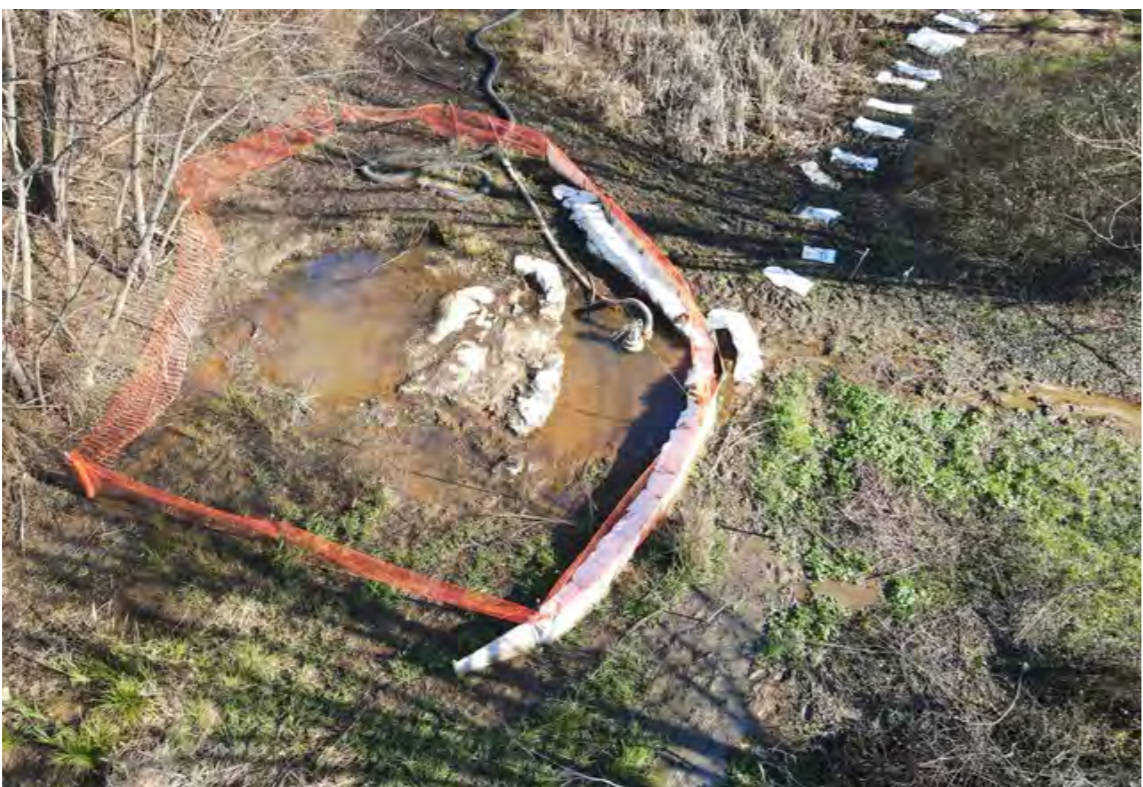
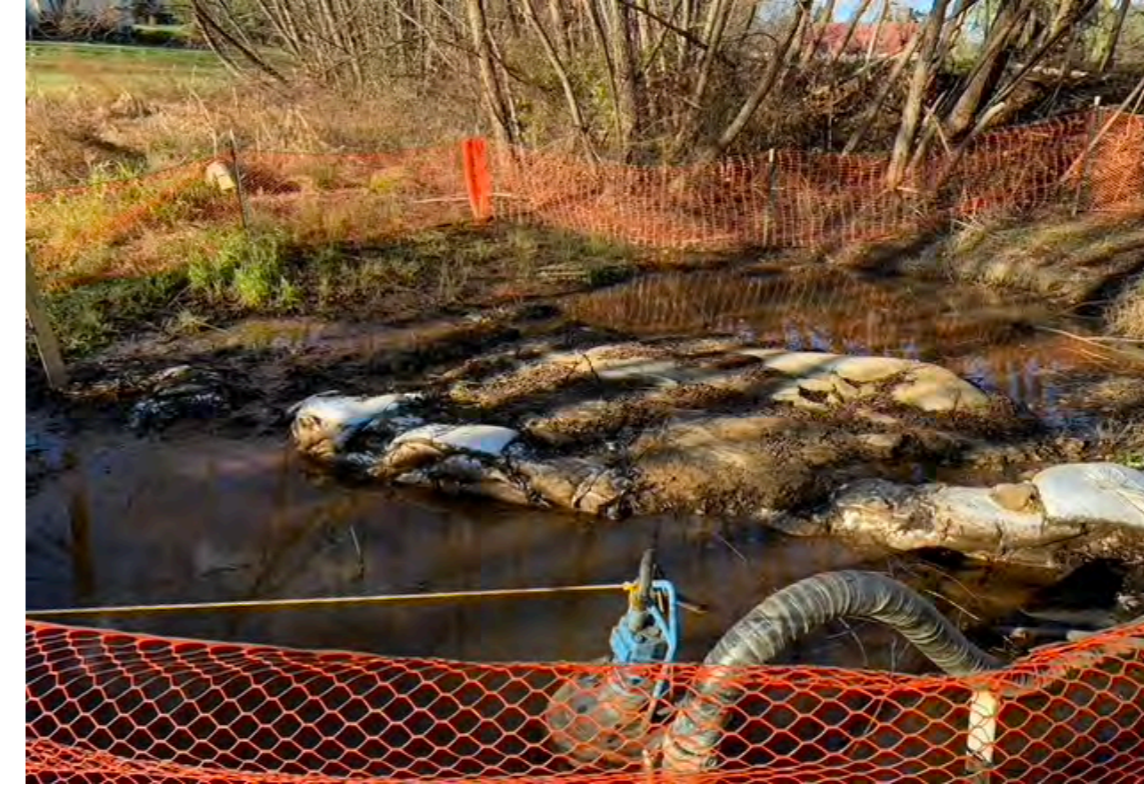
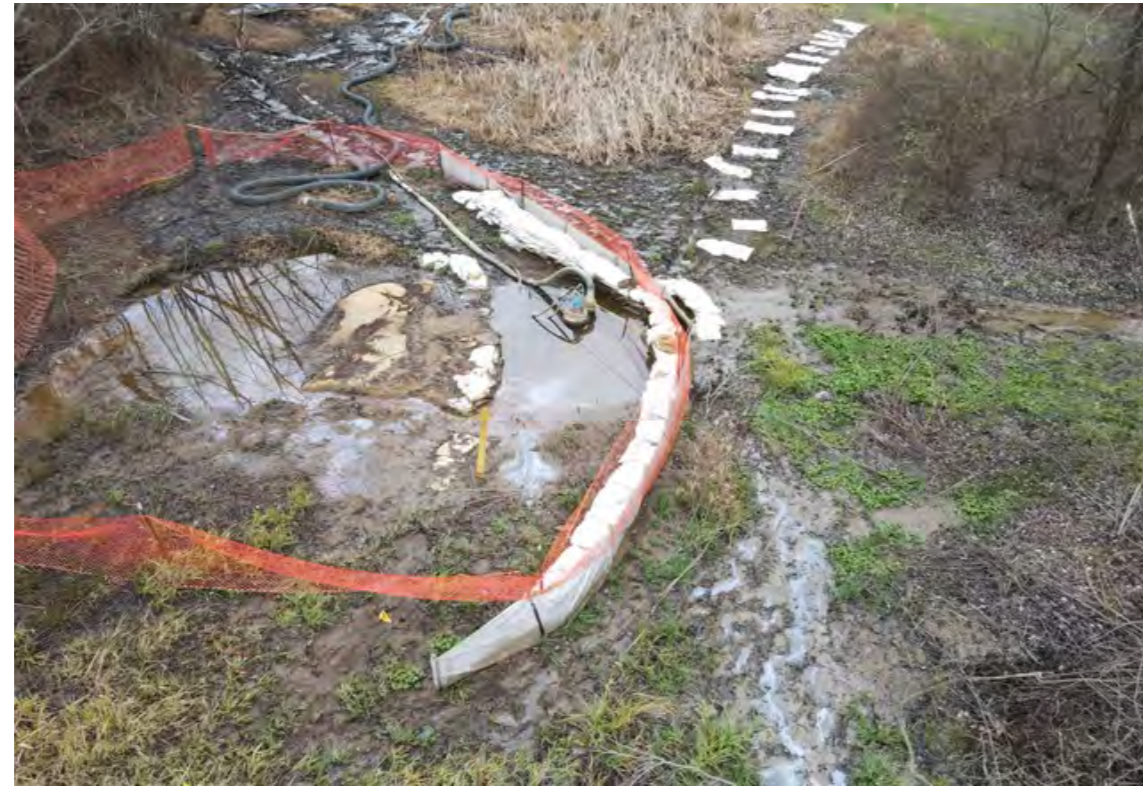
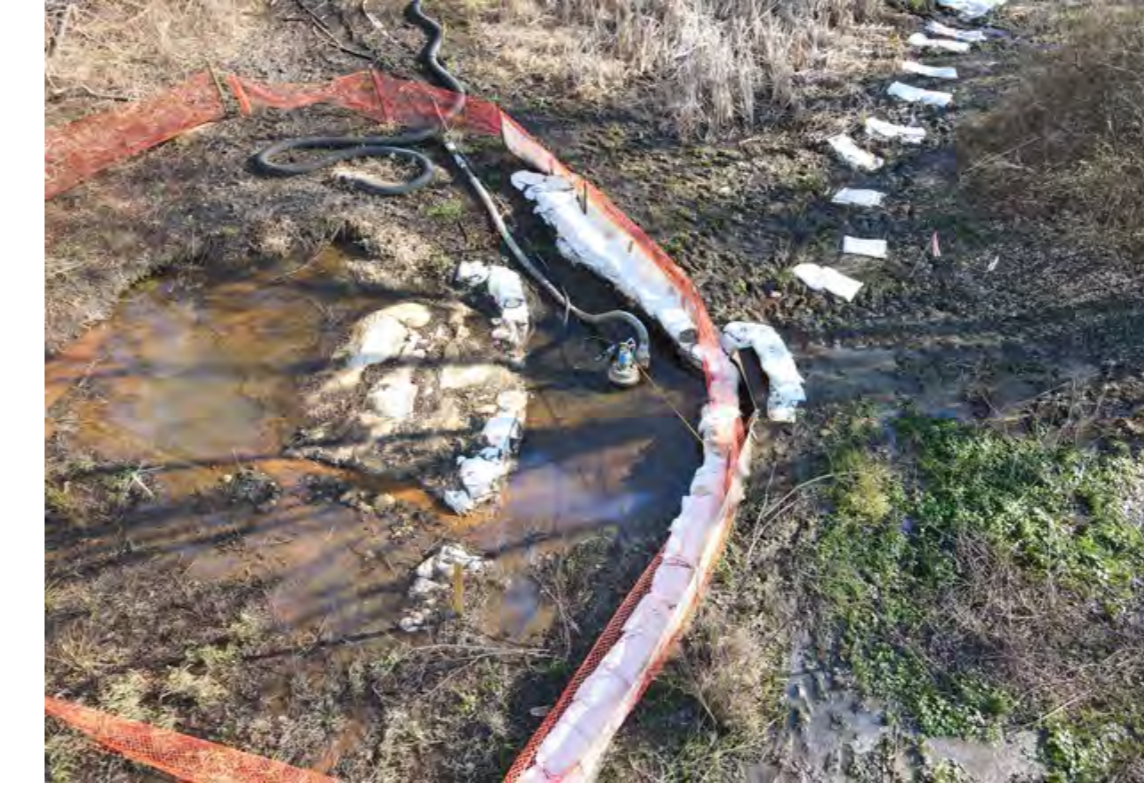
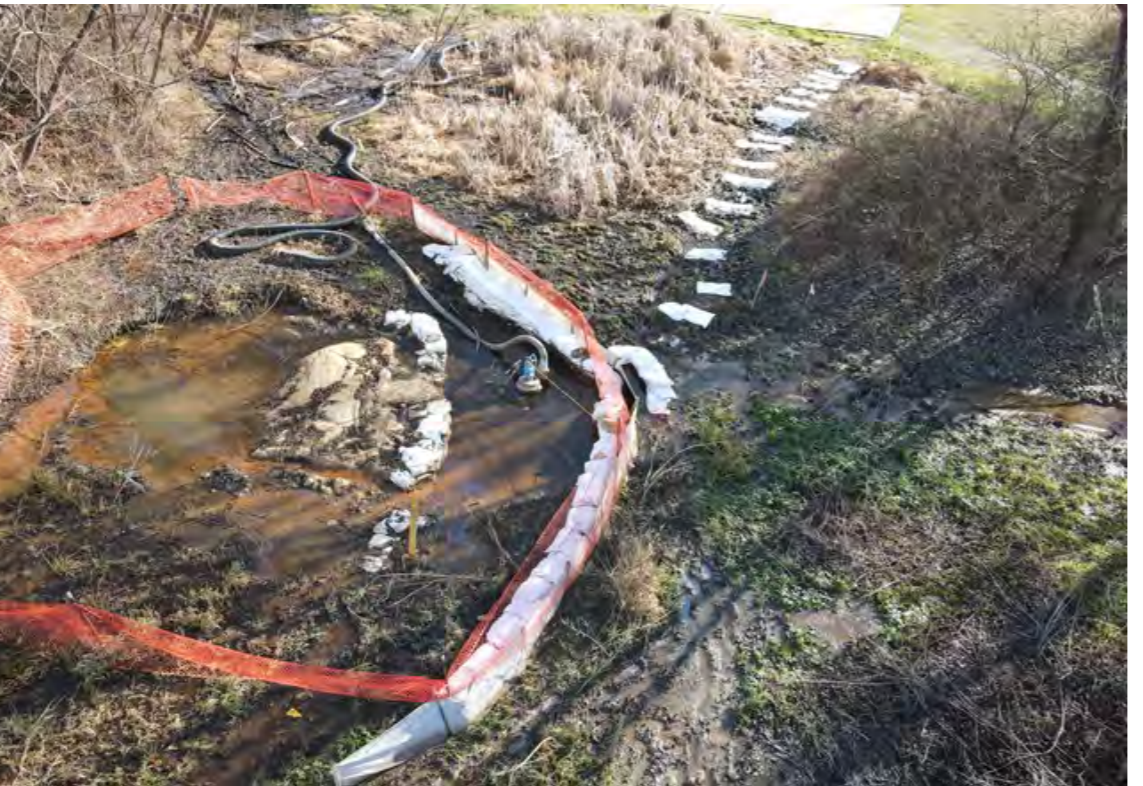
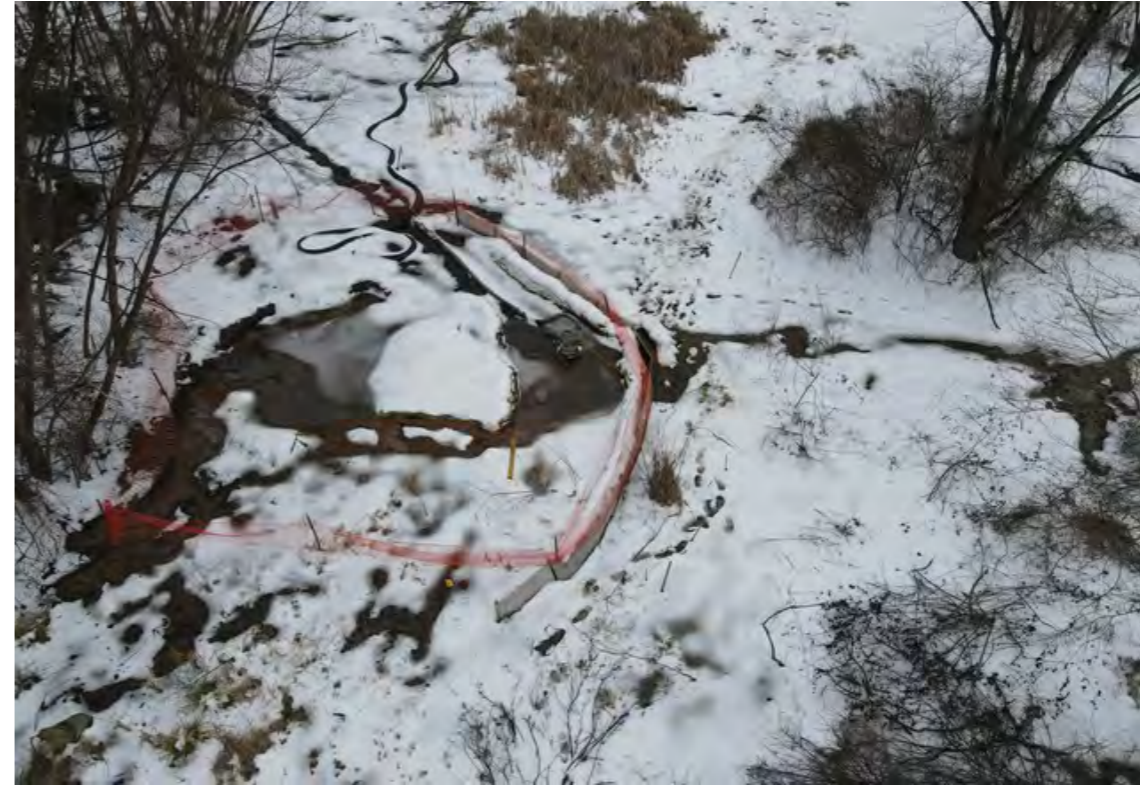
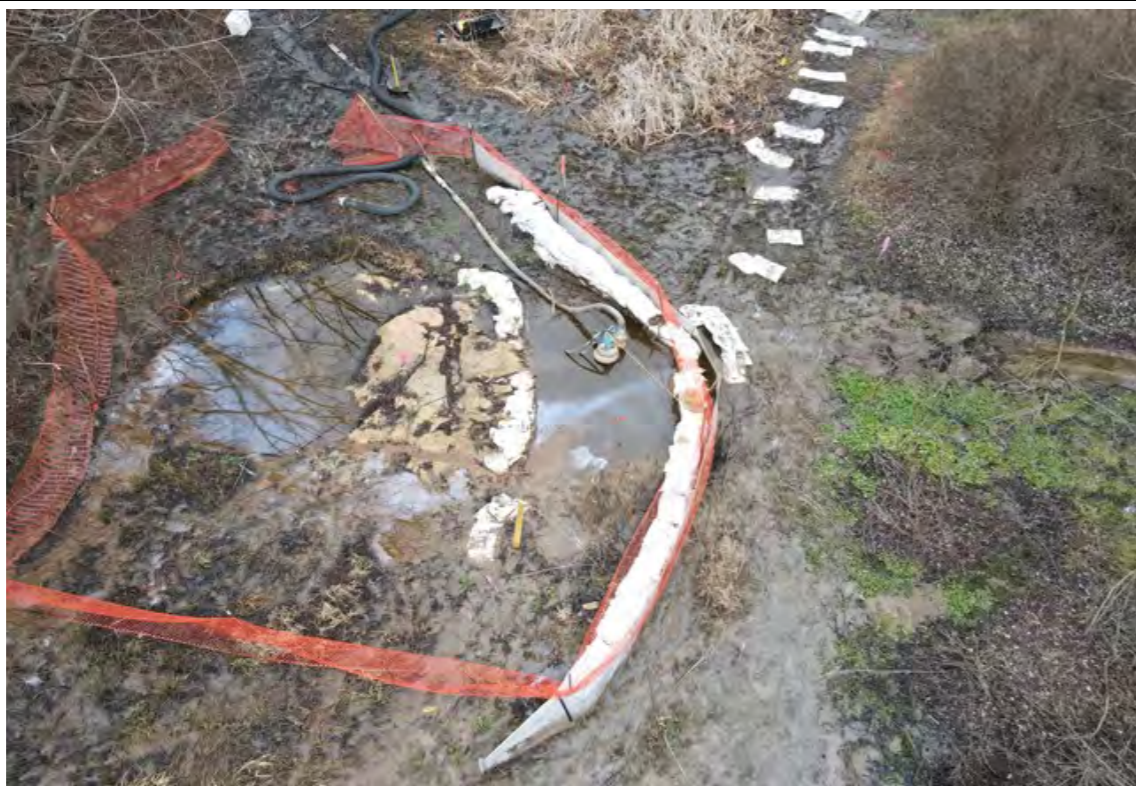
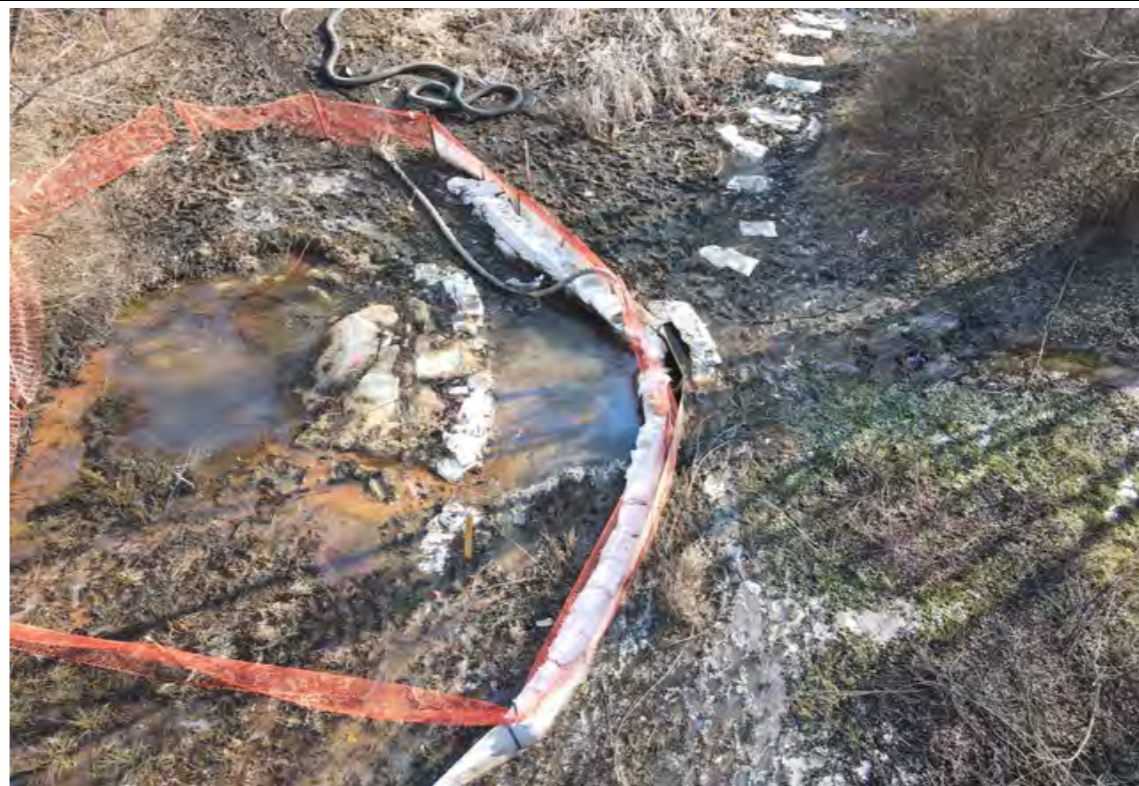
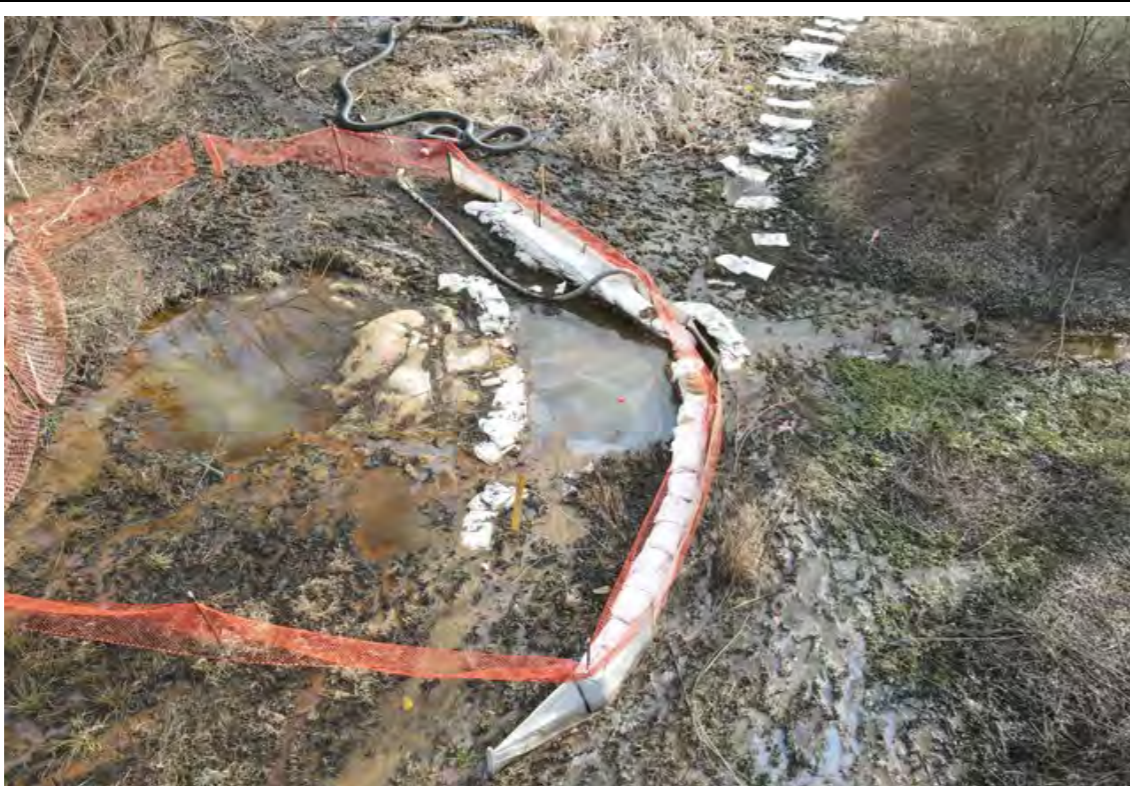
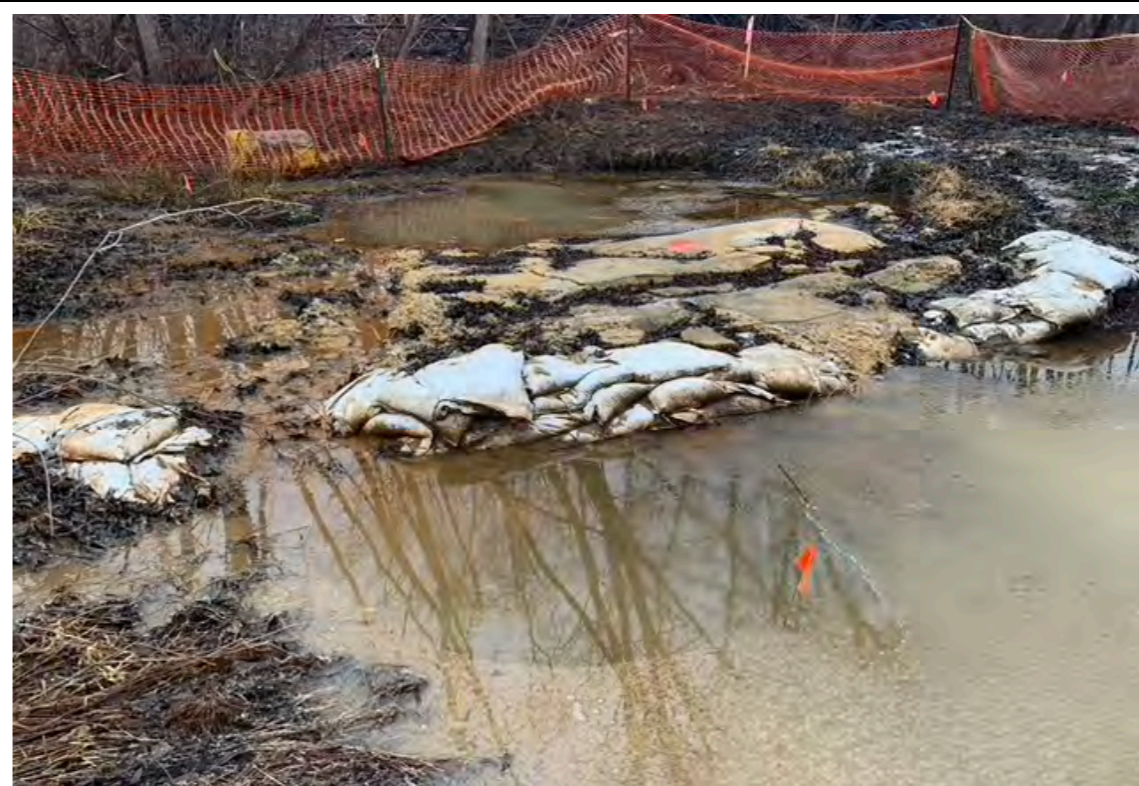
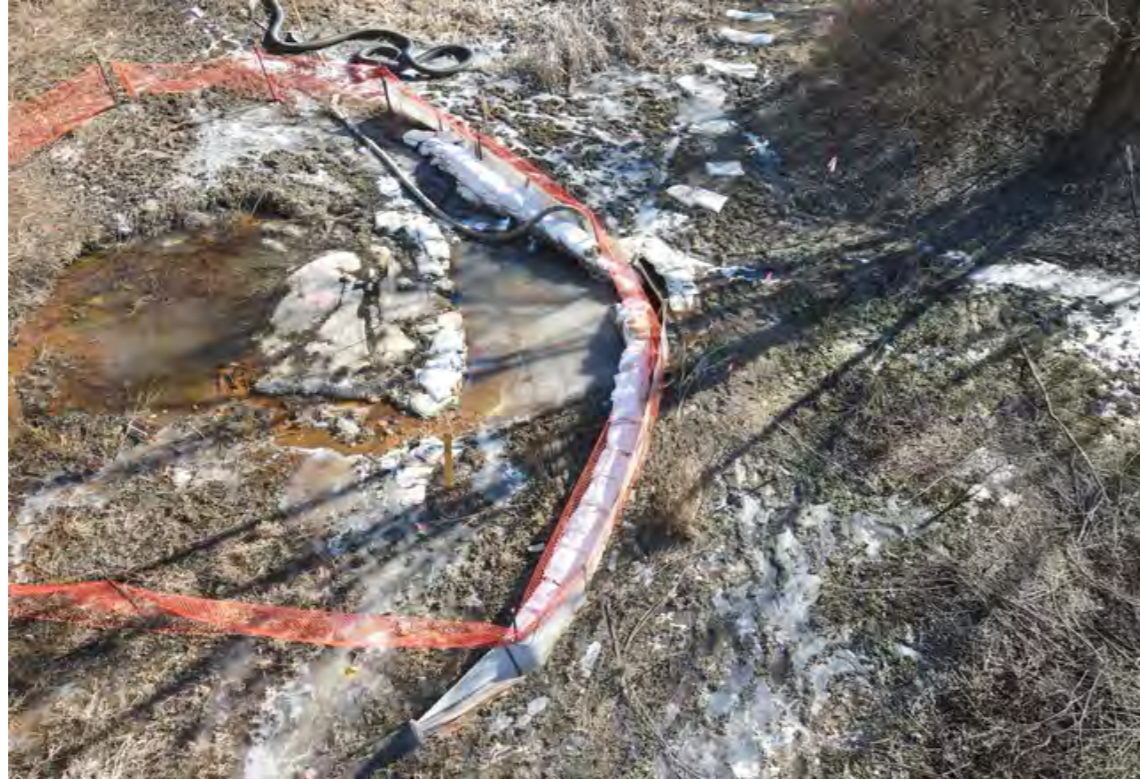
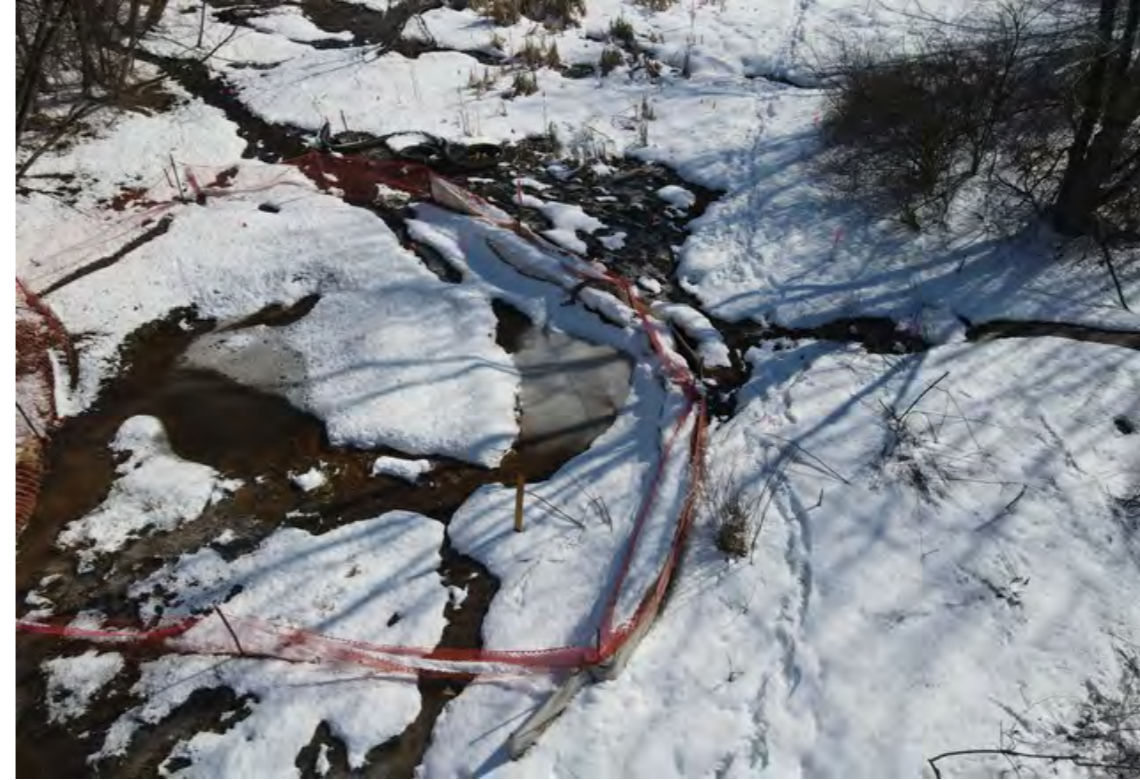
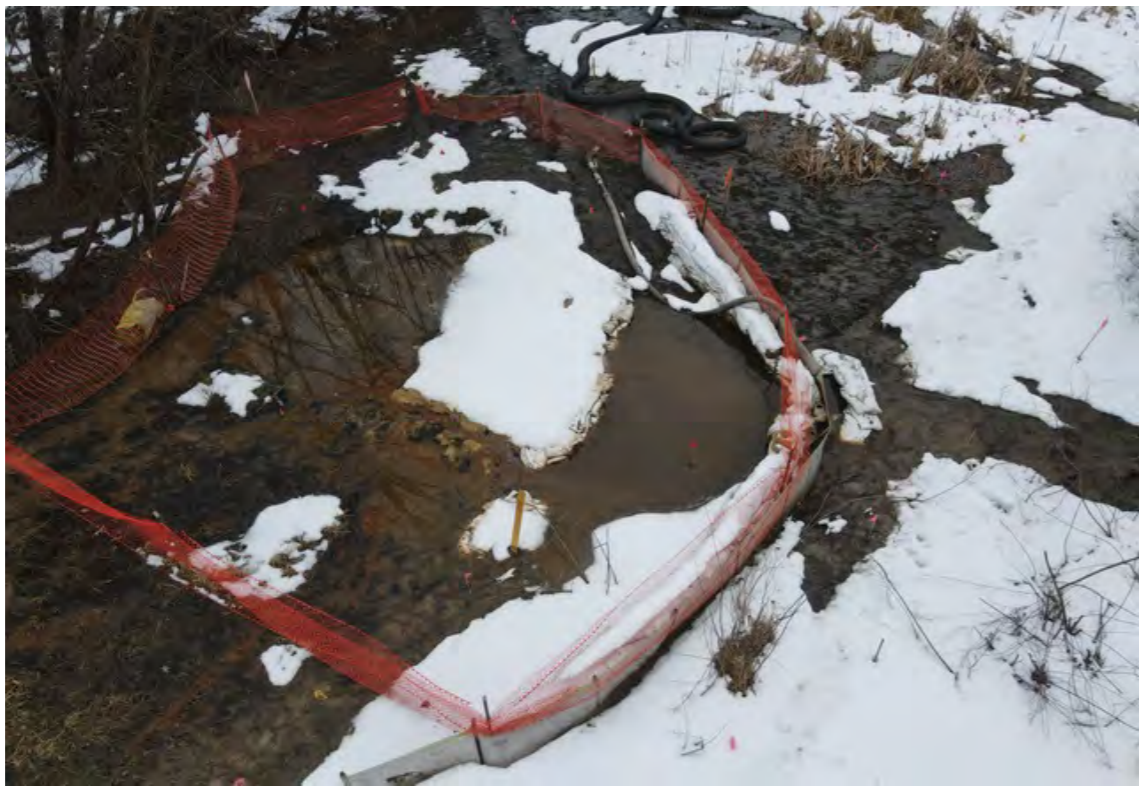
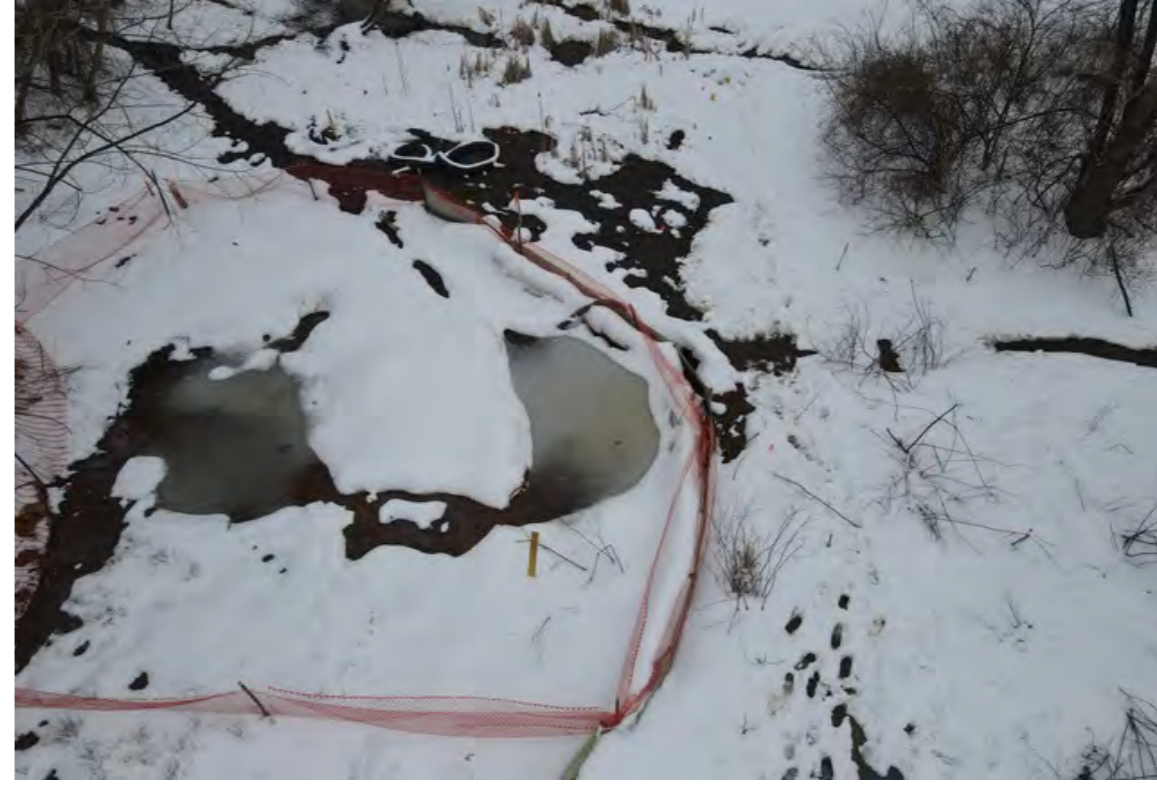
View of IR release location and containment within WL-H17.

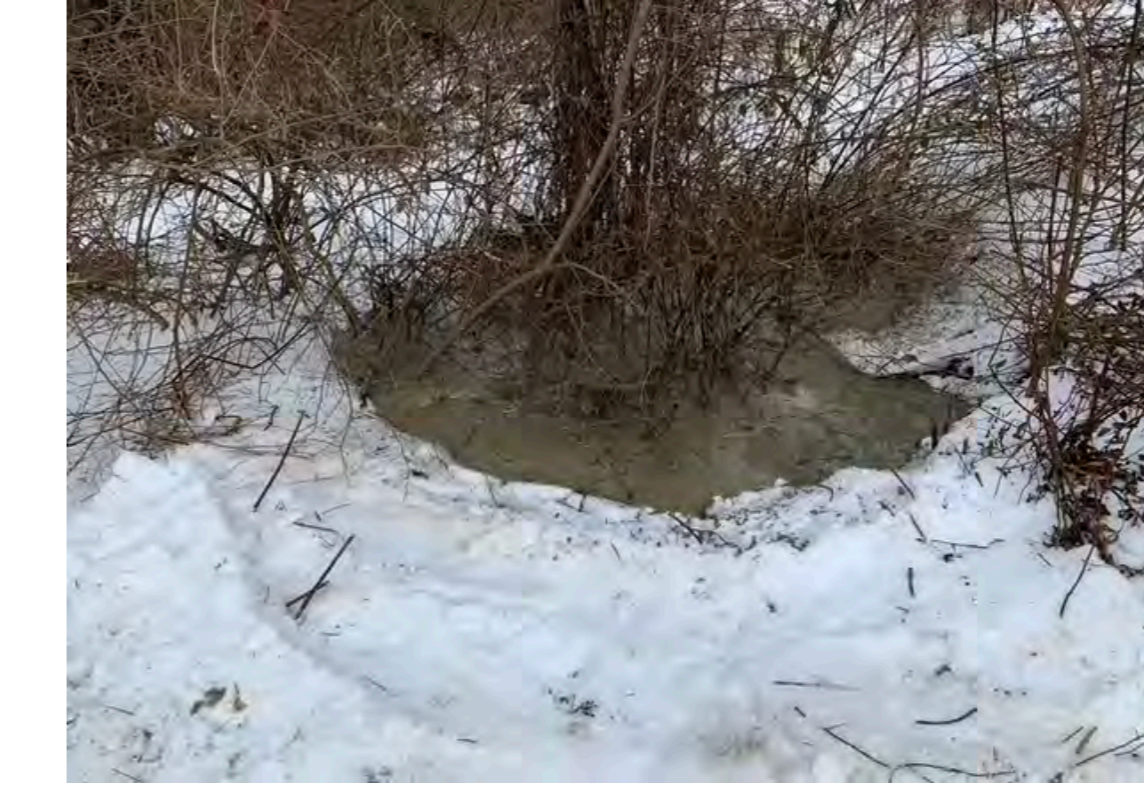
12/19/2020

View of earth feature one filled with 13 cubic yards of flowable fill.
