If Interim report, Subject to Change as Additional Information Becomes Available
If Interim Report, this Report is cumulative, containing information from previous reports in addition to new information and may change
SPLP PENNSYLVANIA PIPELINE PROJECT
HORIZONTAL DIRECTIONAL DRILLING – INADVERTENT RETURN REPORT FORM

REPORT DATE:	Current as of 5/4/2021		HDD ALIGNMENT #	PA-CH-100.0000-RD			
PROJECT SITE:	PPP 6 - S3-0290 - Milford Rd./Little Conestoga Rd		HDD COMPANY:	Michels Directional Crossing			
DATE AND TIME WHEN IR WAS INITIALLY DISCOVERED			DATE:	8/10/2020	TIME:	1530	
LOCATION: STREET	427-423 Green Valley Rd, Downingtown, PA 19335		MUNICIPALITY:	Upper Uwchlan	COUNTY:	Chester	
LATITUDE:	40.0794	LONGITUDE:	-75.7104	FROM STATION:	14824+00	TO STATION	14824+00
STREAM NAME:	S-H10 (UNT to Marsh Creek), S-H11 (UNT to Marsh Creek)		POND / LAKE NAME:	Pond H3 (Marsh Creek Reservoir)	WETLAND NAME:	WL-H17 (PEM, PFO)	
DEP PERMIT Nos. (102 AND 105)	E&S Permit # ESG0100015001, Water Obstruction Permit E15-862						
CORPS PERMIT NO.	PASPGP-5 (issued April 12, 2017)						
IR TRACKING ID:	PPP6_PA-CH-0100.0000-RD_MilfordRd_IRInterim_38_050521						
IS AUGUST 8, 2017 ORDER APPLICABLE?	YES	LISTED I

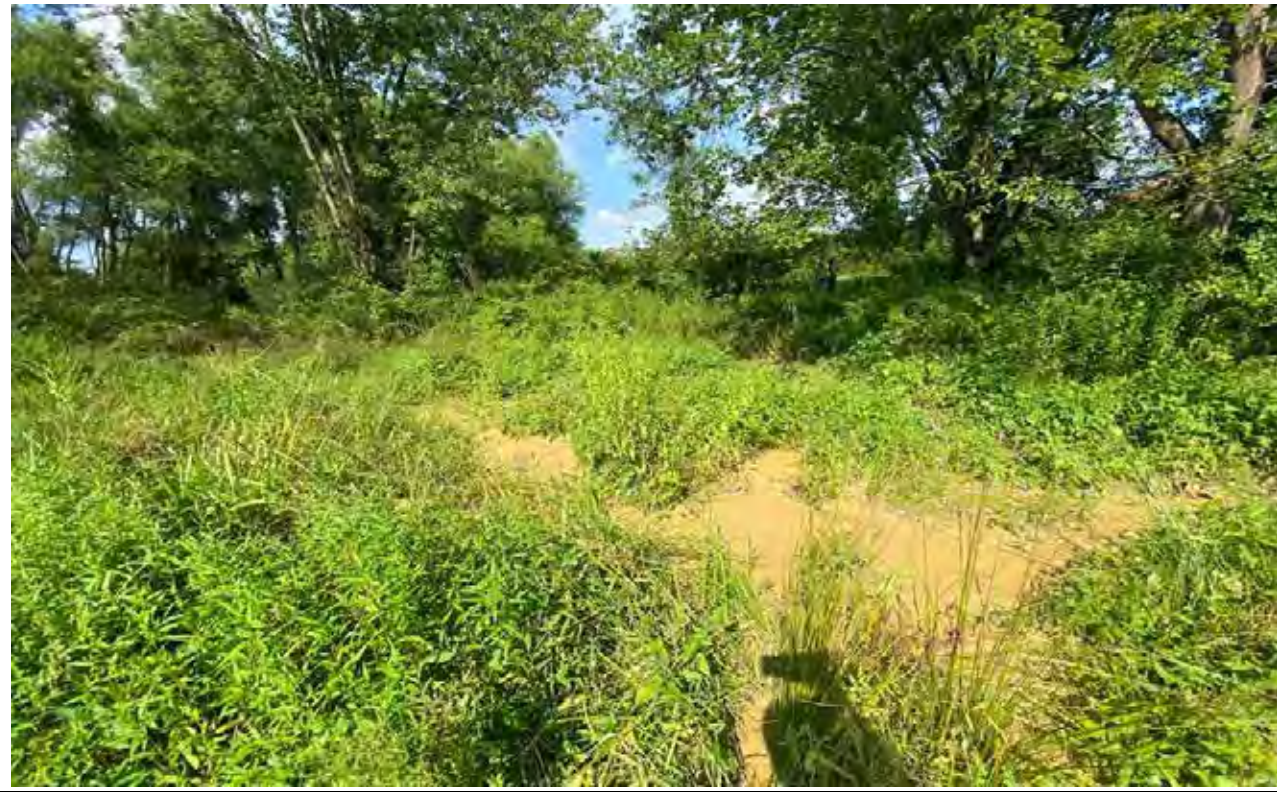
8/10/2020

View of drilling fluid within WL-H17 at location of IR release point.

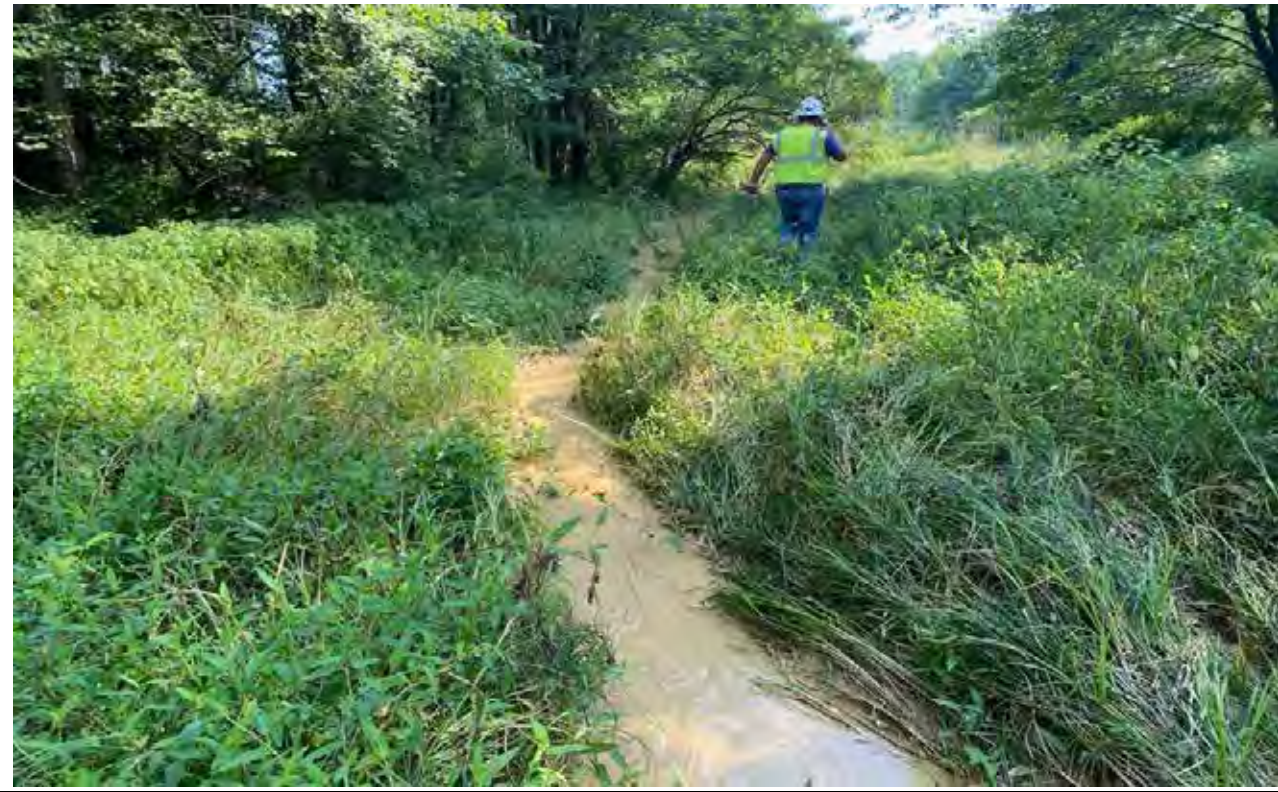
8/10/2020

View of drilling fluid flowing downstream within stream S-H10 (UNT to Marsh Creek).

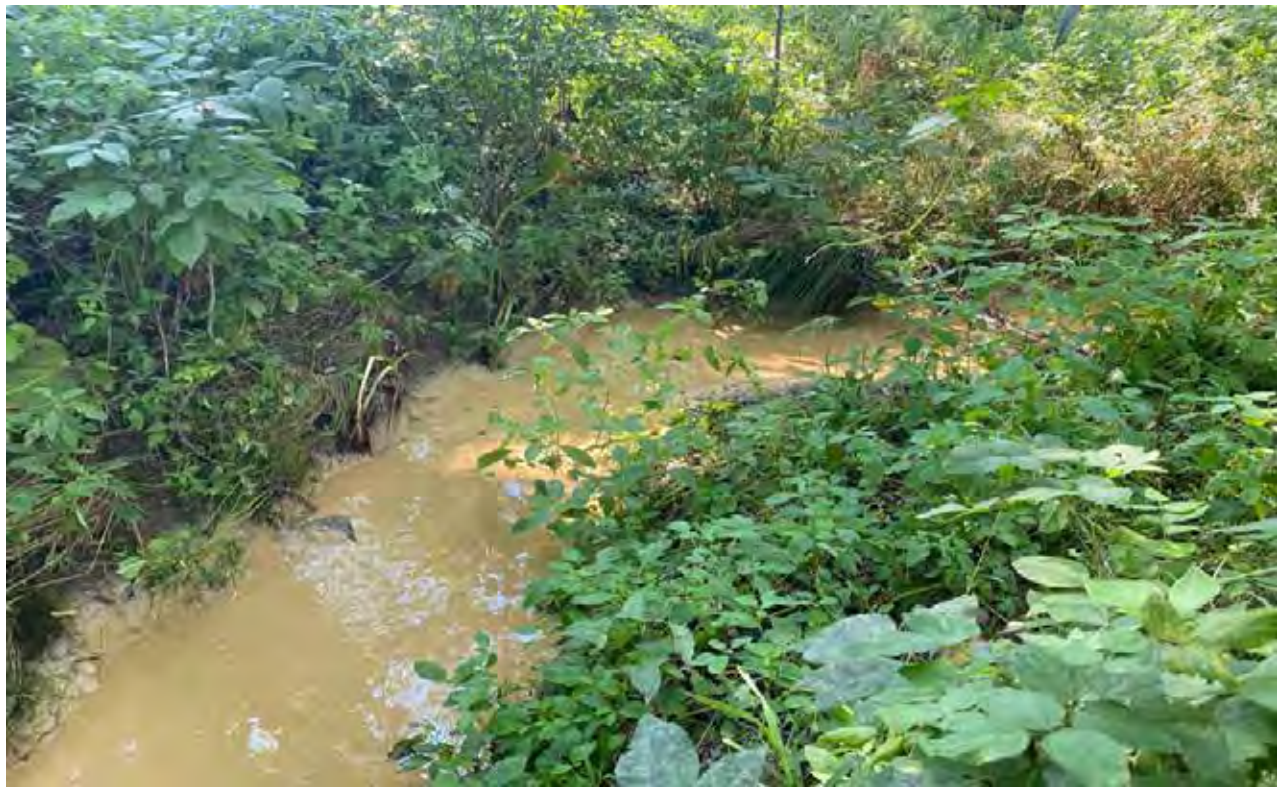
8/10/2020

View of drilling fluid within stream S-H10 (UNT to Marsh Creek).

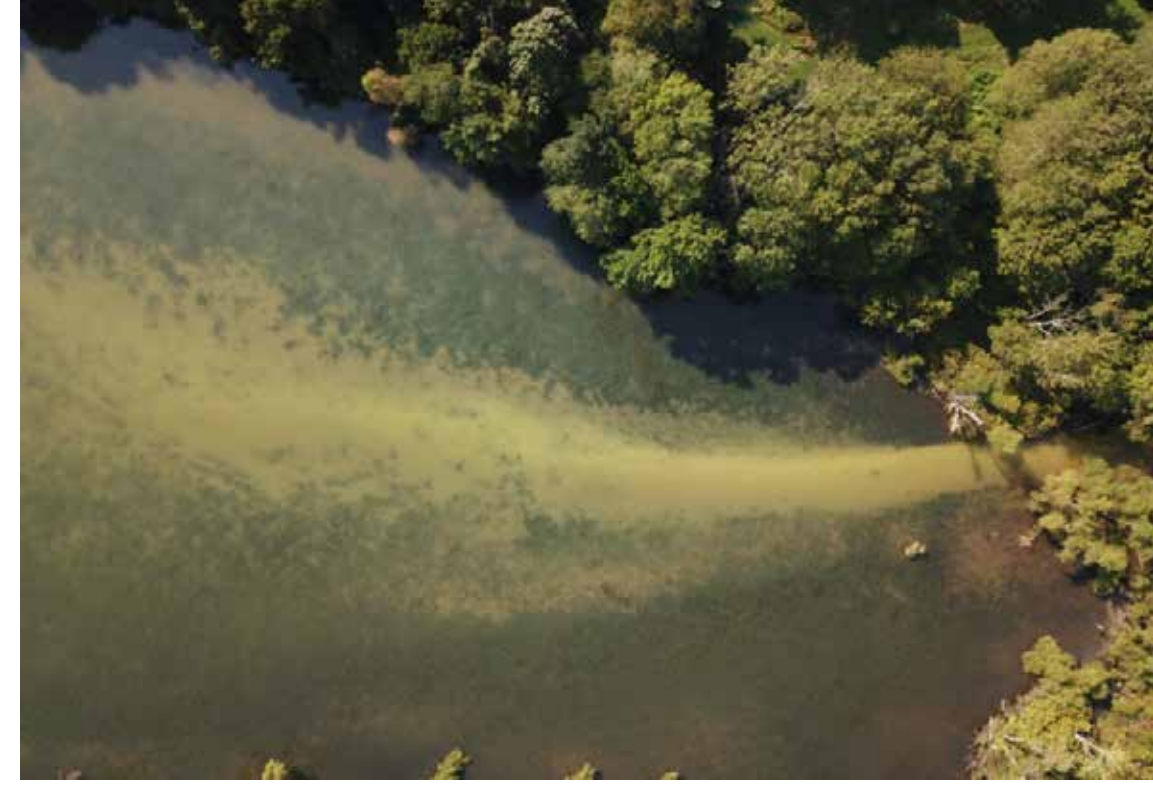
8/10/2020

View of drilling fluid entering pond H3 (Marsh Creek Reservoir).

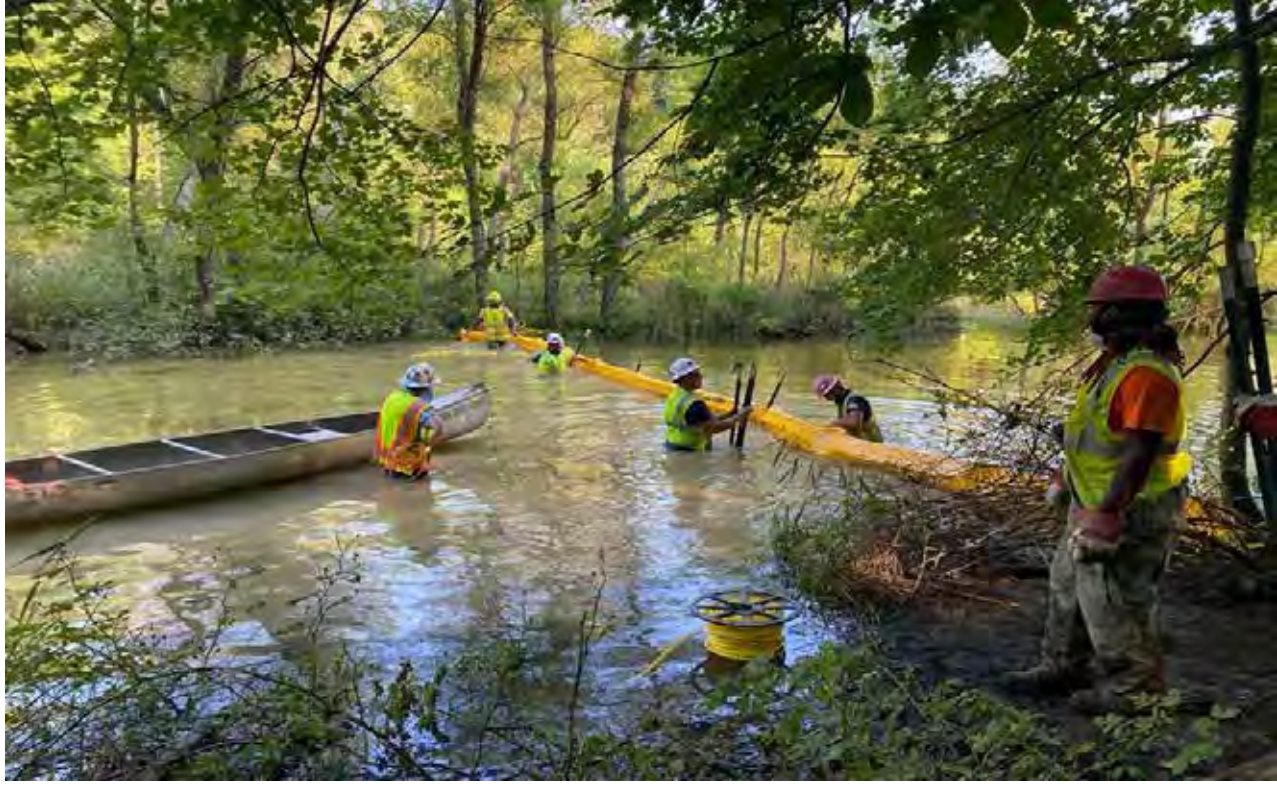
8/10/2020

View of contractor crew members installing two turbidity curtains at the confluence of stream S-H10 (UNT to Marsh Creek) and pond H3 (Marsh Creek Reservoir).

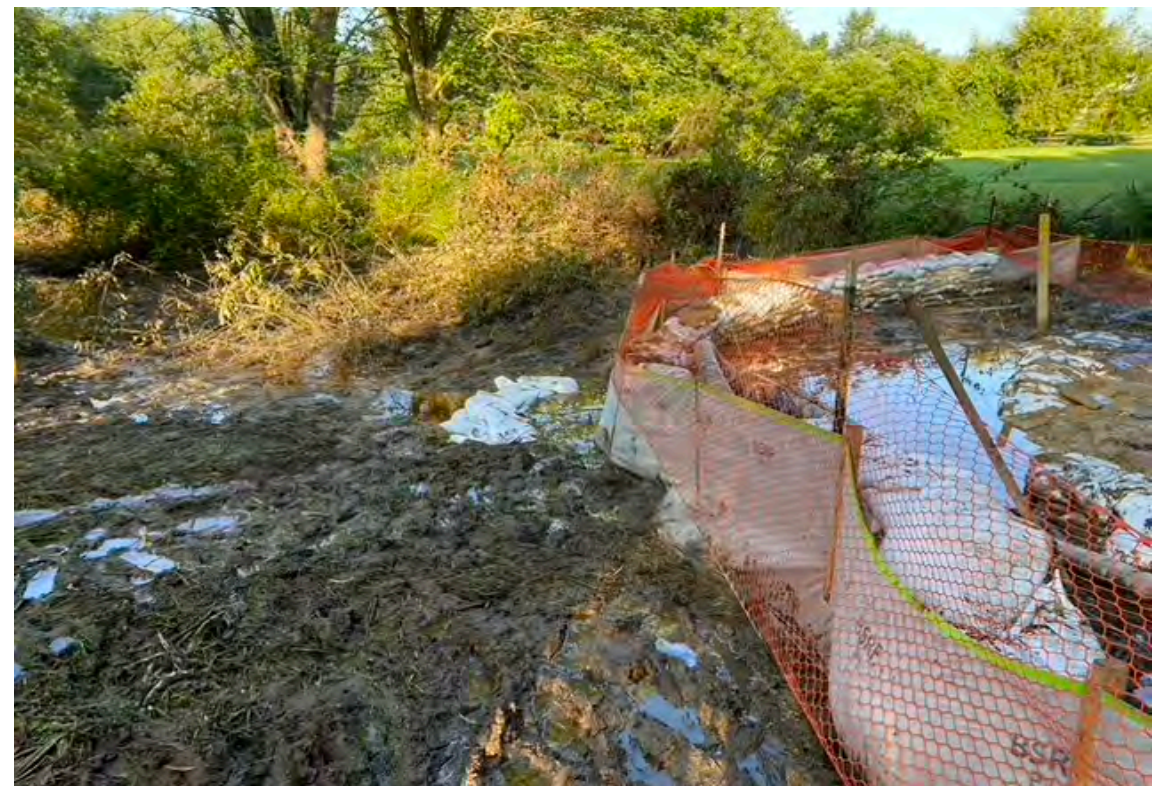
8/17/2020

View of IR release location within WL-H17.

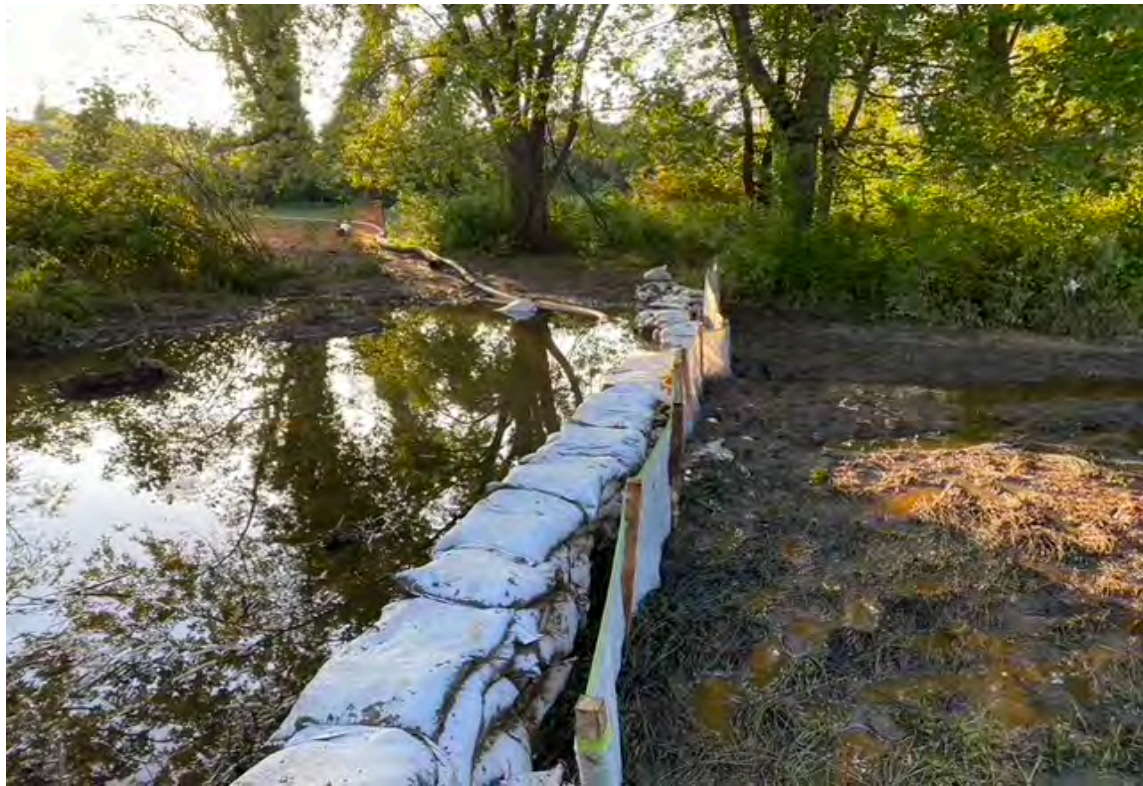
8/17/2020

View of sandbag containment within S-H10 (UNT to Marsh Creek).

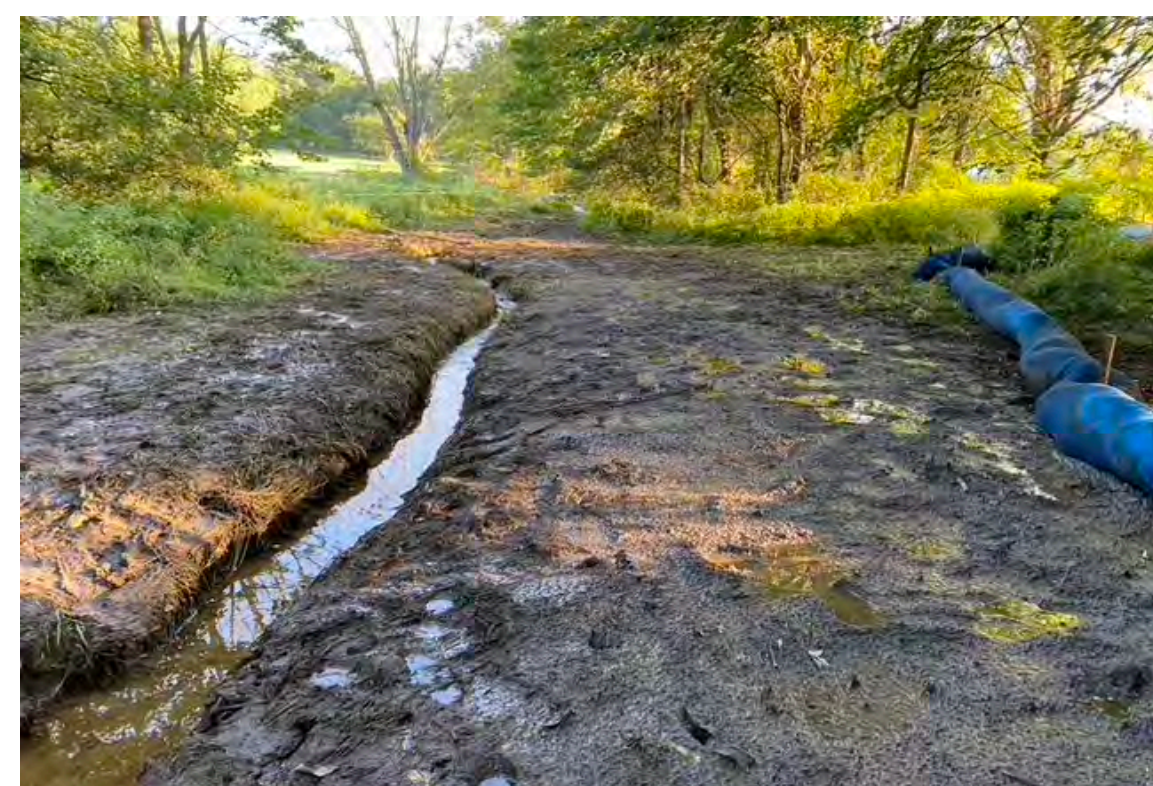
8/17/2020

View of stream S-H10 (UNT to Marsh Creek) following cleanup.

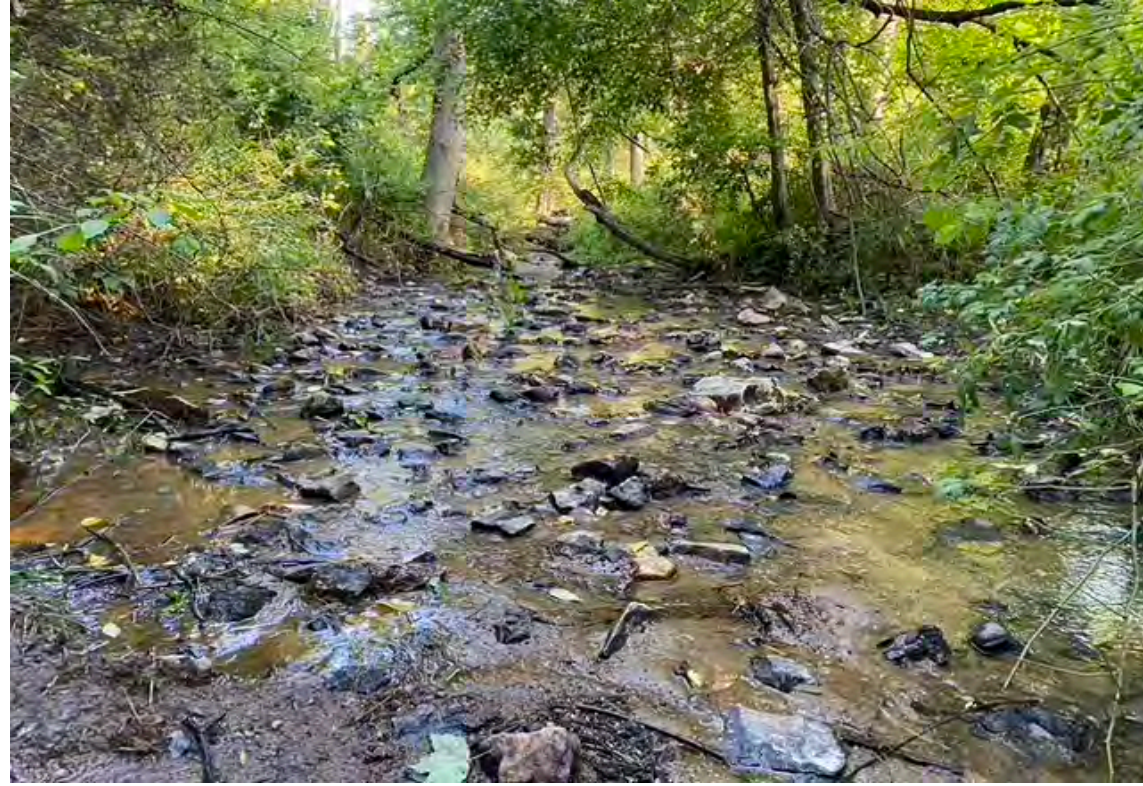
8/17/2020

View of stream S-H10 (UNT to Marsh Creek) following cleanup.

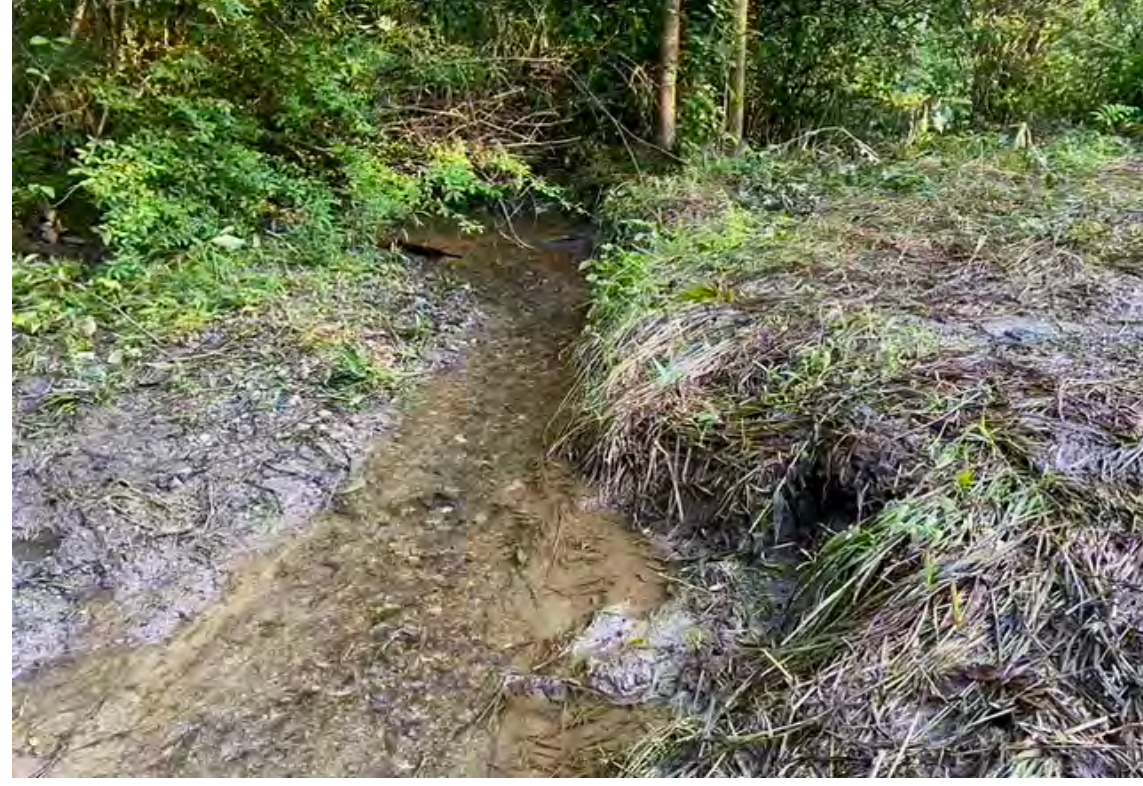
8/17/2020

View of stream S-H10 (UNT to Marsh Creek) following cleanup.

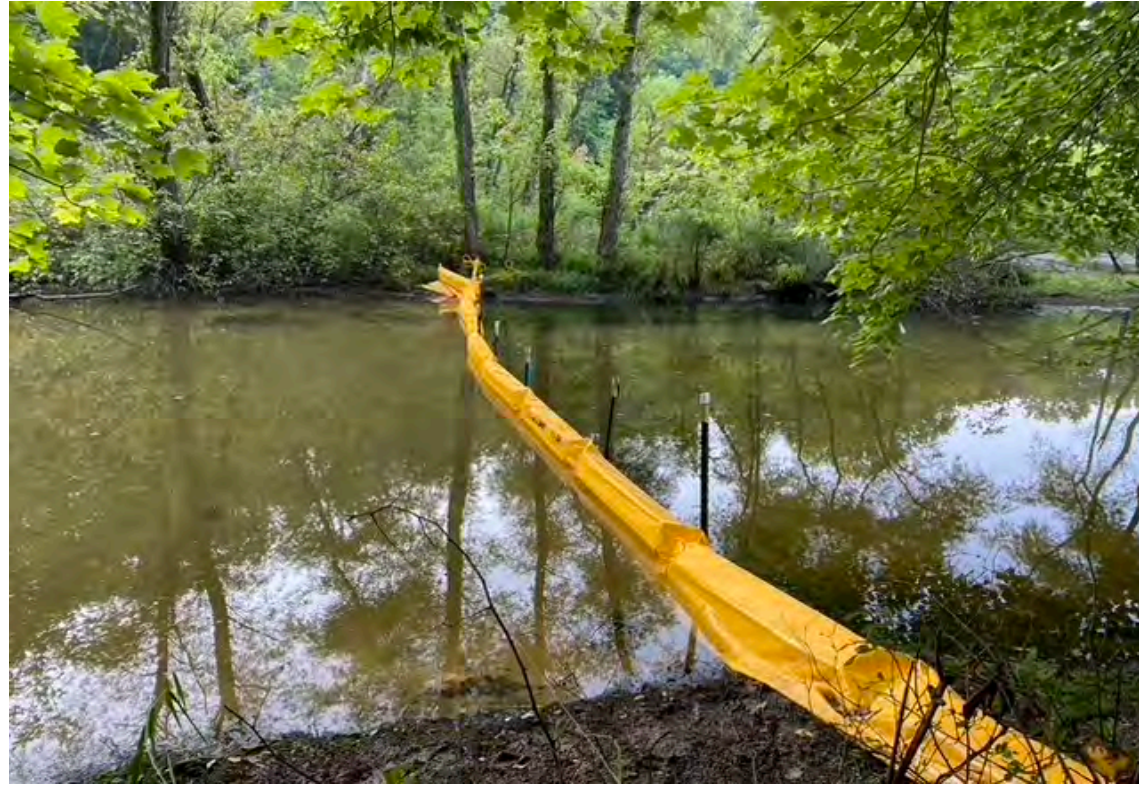
8/17/2020

View of turbidity curtain at the confluence of stream S-H10 (UNT to Marsh Creek) and pond H3 (Marsh Creek Reservoir).

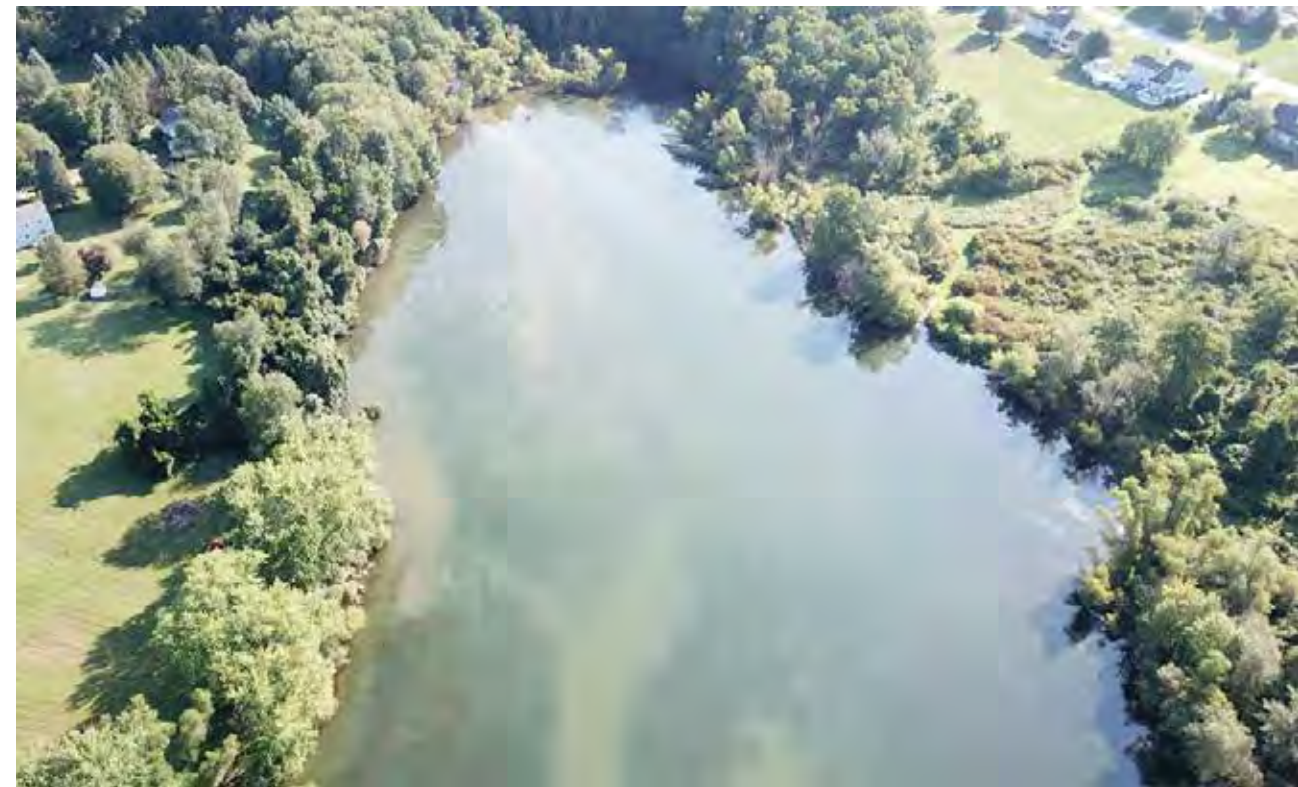
8/17/2020

View of pond H3 (Marsh Creek Reservoir).

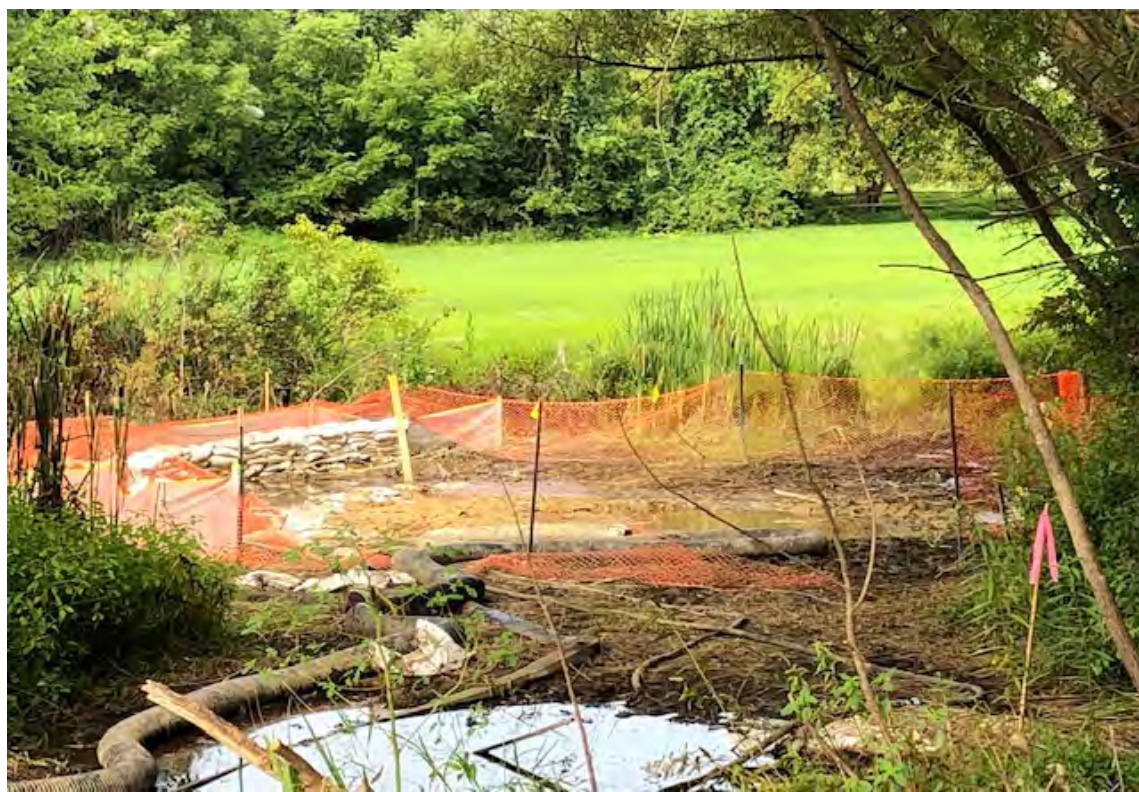
8/22/2020

View of IR release location within WL-H17.

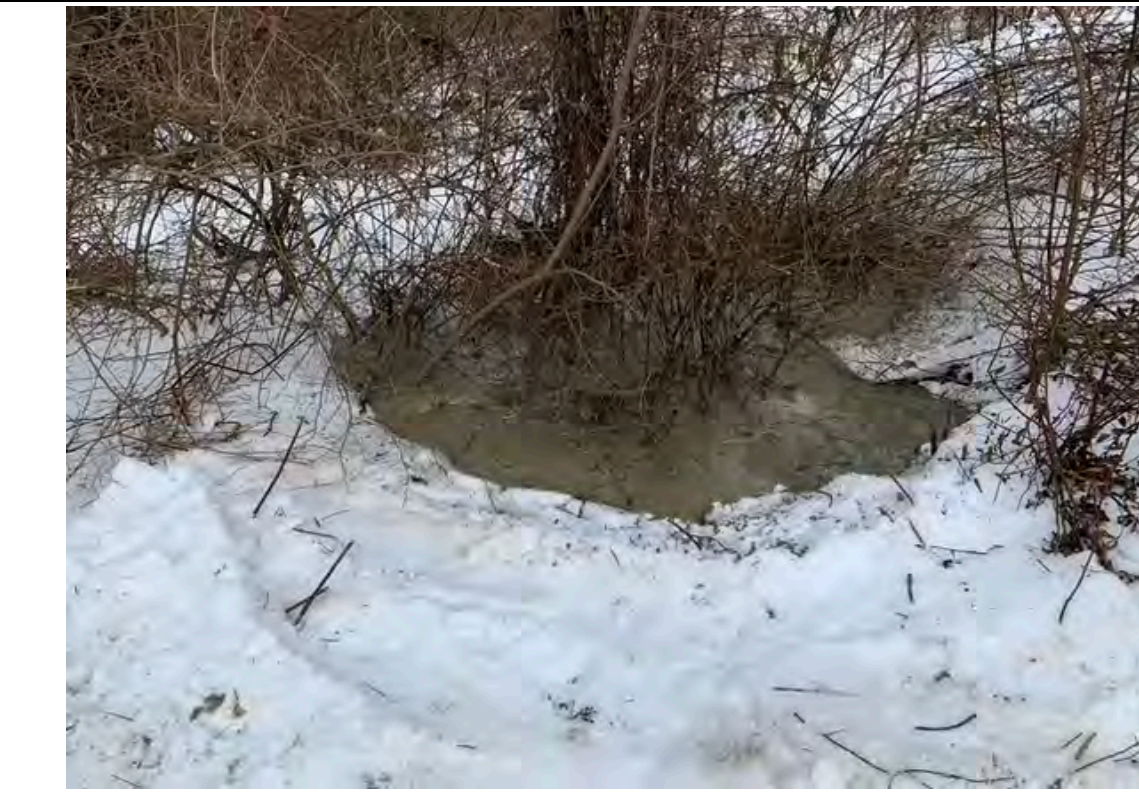
12/19/2020

View of earth feature one filled with 13 cubic yards of flowable fill.

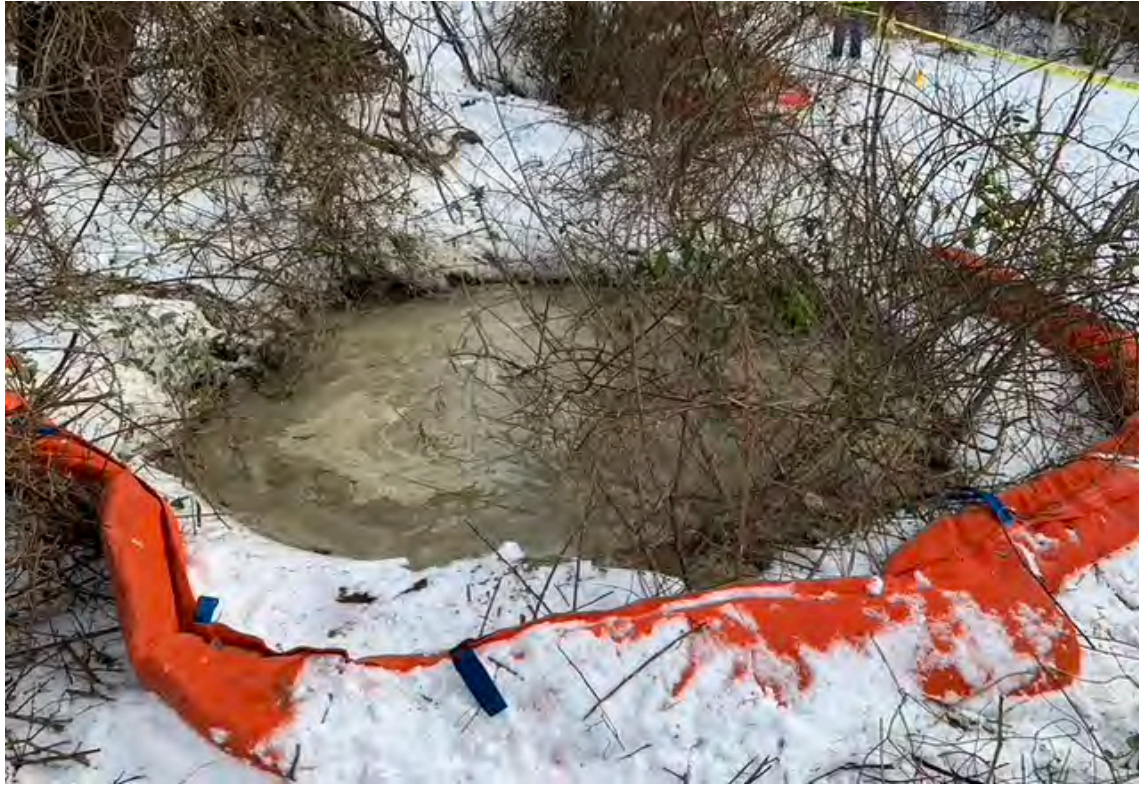
12/19/2020

View of earth feature two filled with 28 cubic yards of flowable fill.

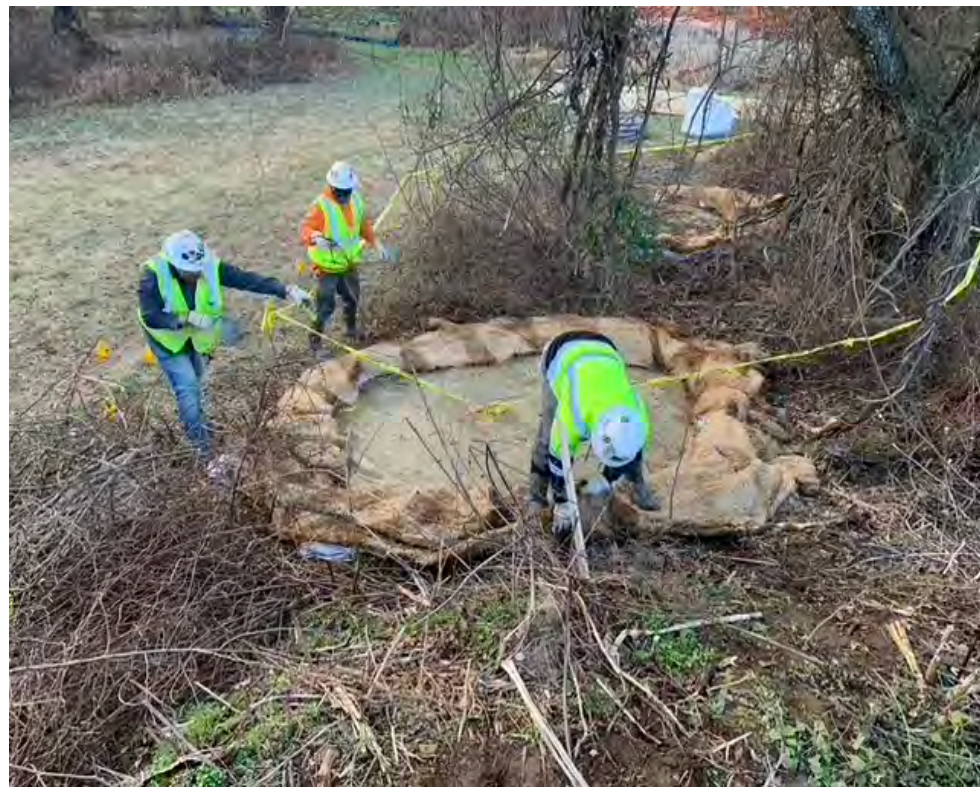
12/28/2020

View of contractor crew members installing erosion control blanket to stabilize earth feature locations.
