If Interim report, Subject to Change as Additional Information Becomes Available
If Interim Report, this Report is cumulative, containing information from previous reports in addition to new information and may change
SPLP PENNSYLVANIA PIPELINE PROJECT
HORIZONTAL DIRECTIONAL DRILLING – INADVERTENT RETURN REPORT FORM

REPORT DATE:	Current as of 6/1/2021	HDD ALIGNMENT #	PA-CH-100.0000-RD				
PROJECT SITE:	PPP 6 - S3-0290 - Milford Rd./Little Conestoga Rd		HDD COMPANY:	Michels Directional Crossing			
DATE AND TIME WHEN IR WAS INITIALLY DISCOVERED			DATE:	8/10/2020	TIME:	1530	
LOCATION: STREET	427-423 Green Valley Rd, Downingtown, PA 19335		MUNICIPALITY:	Upper Uwchlan	COUNTY:	Chester	
LATITUDE:	40.0794	LONGITUDE:	-75.7104	FROM STATION:	14824+00	TO STATION	14824+00
STREAM NAME:	S-H10 (UNT to Marsh Creek), S-H11 (UNT to Marsh Creek)		POND / LAKE NAME:	Pond H3 (Marsh Creek Reservoir)	WETLAND NAME:	WL-H17 (PEM, PFO)	
DEP PERMIT Nos. (102 AND 105)	E&S Permit # ESG0100015001, Water Obstruction Permit E15-862						
CORPS PERMIT NO.	PASPGP-5 (issued April 12, 2017)						
IR TRACKING ID:	PPP6_PA-CH-0100.0000-RD_MilfordRd_IRInterim_42_060221						
IS AUGUST 8, 2017 ORDER APPLICABLE?	YES	LISTED I

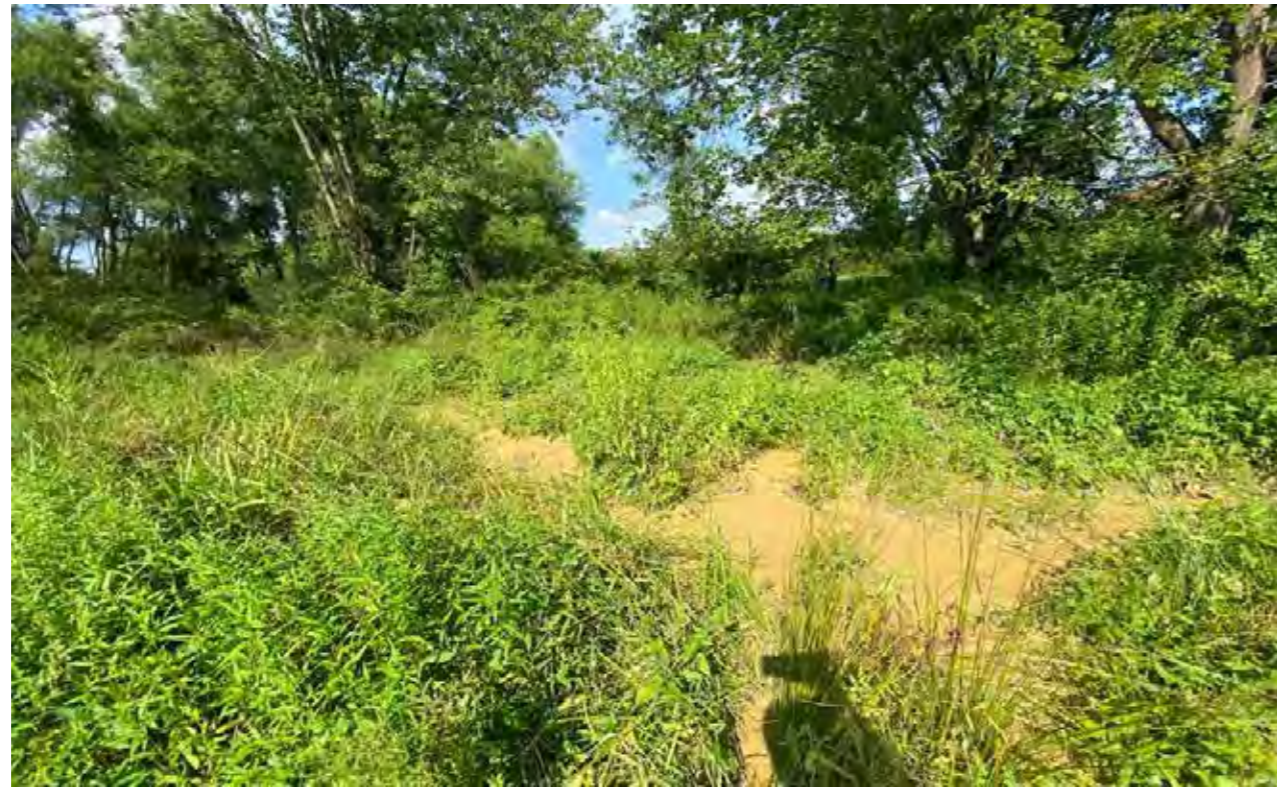
COMPLETE THE FOLLOWING QUESTIONS IF APPLICABLE:							
1. IS THE IR ON-GOING? Provide dates, times, and duration of all IRs.	NO	NOTE:	On 8/10/20 at approximately 1530 hours, approximately 7,712 gallons of drilling fluid emerged within WL-H17, and entered streams S-H11 and S-H10. The drilling fluid continued to flow down S-H10 and entered pond H3 (Marsh Creek Reservoir). The IR ceased emerging after drilling was stopped.

View of drilling fluid within WL-H17 at location of IR release point.

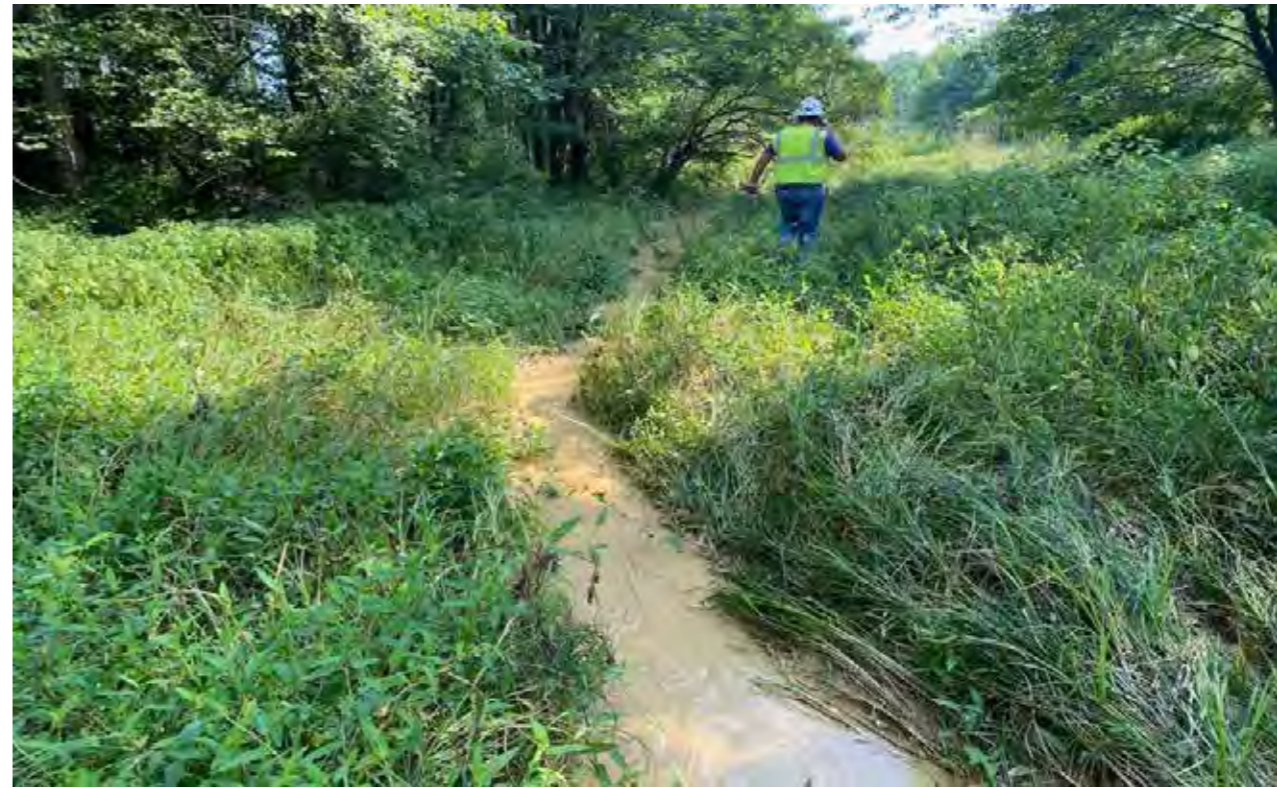
View of drilling fluid flowing downstream within stream S-H10 (UNT to Marsh Creek).

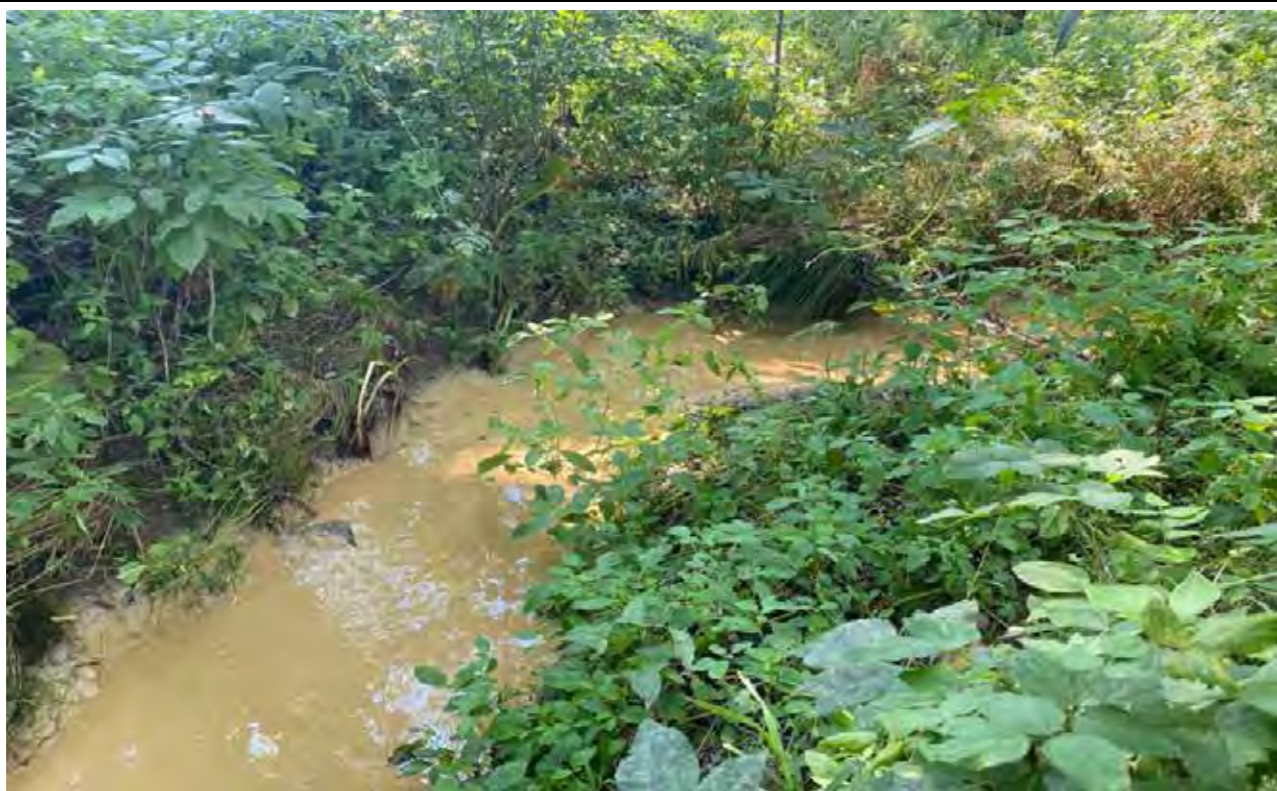
View of drilling fluid within stream S-H10 (UNT to Marsh Creek).

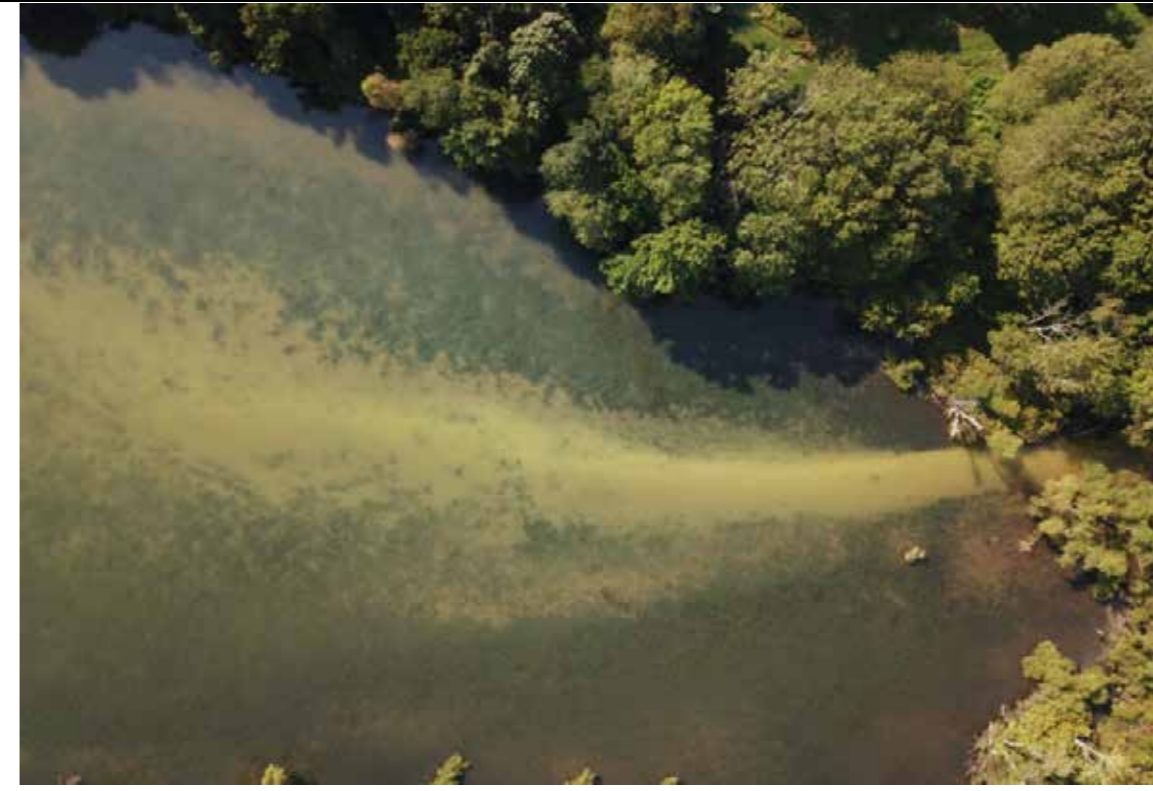
View of drilling fluid entering pond H3 (Marsh Creek Reservoir).

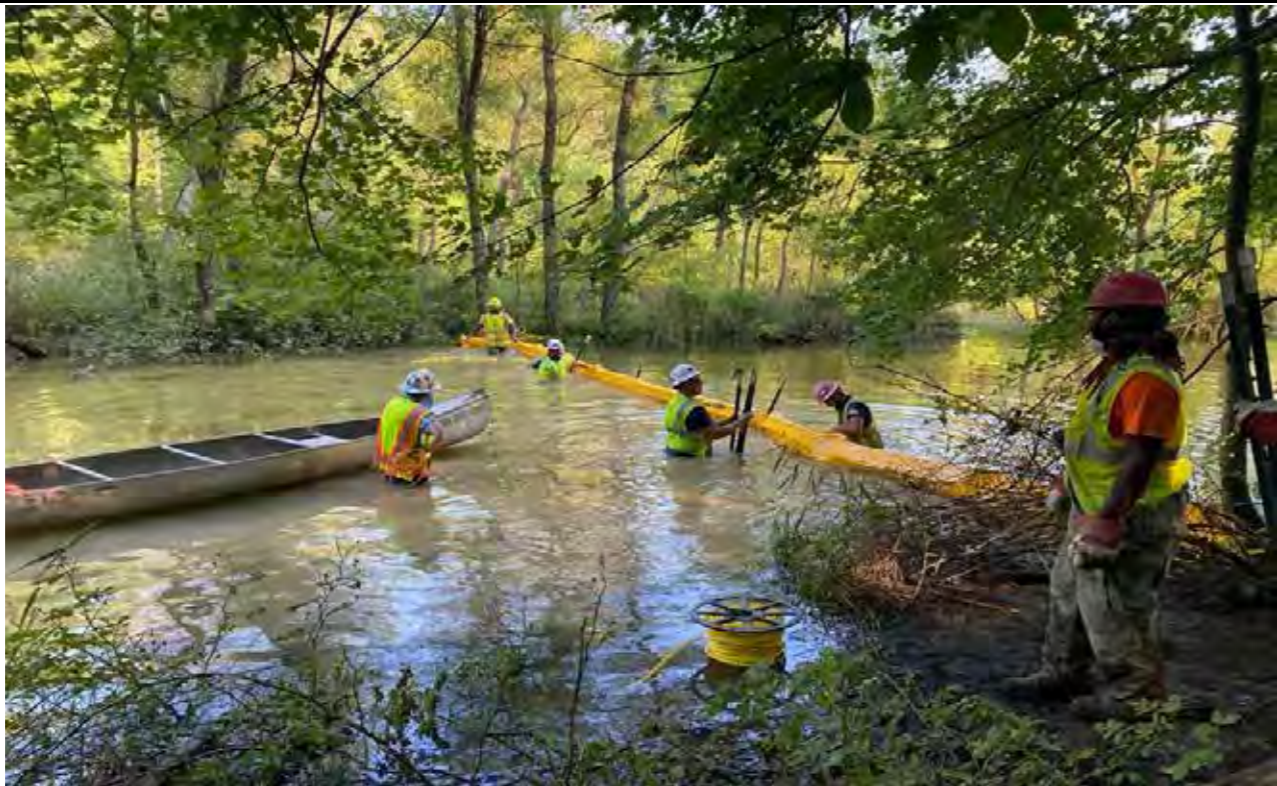
View of contractor crew members installing two turbidity curtains at the confluence of stream S-H10 (UNT to Marsh Creek) and pond H3 (Marsh Creek Reservoir).

10. HAS IR BEEN CONTAINED? If YES, Provide dates, times, and measures for each IR.	YES	NOTE:	Two turbidity curtains were installed at the confluence of S-H10 (UNT to Marsh Creek) and pond H3 (Marsh Creek Reservoir). Ten sand bag and silt fence dams were constructed within S-H10 (UNT to Marsh Creek) on 8/10/2020.

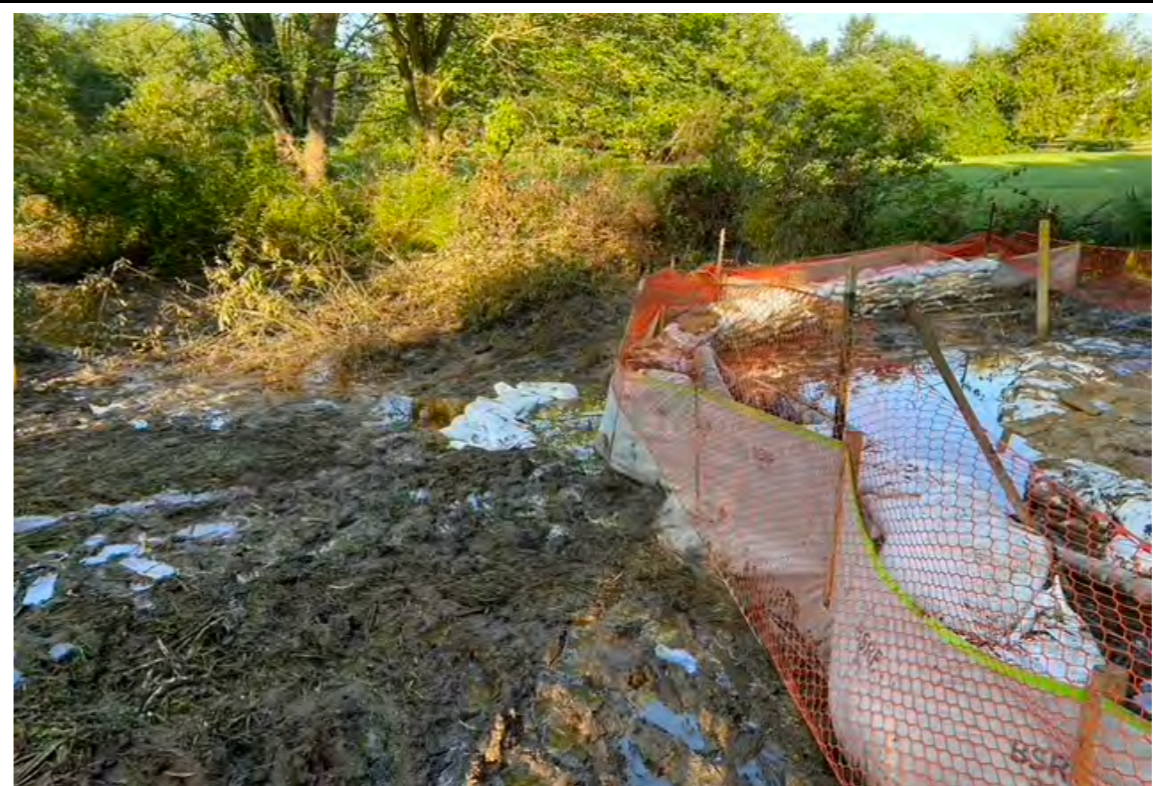
View of IR release location within WL-H17.

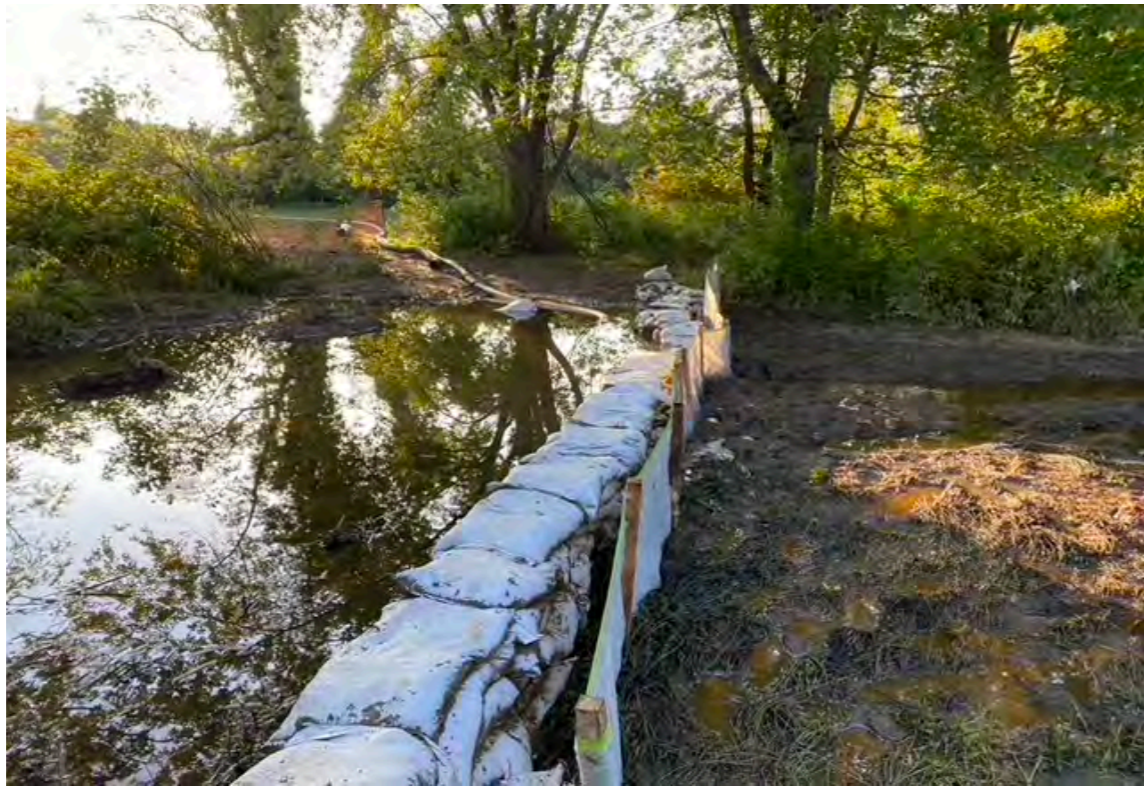
View of sandbag containment within S-H10 (UNT to Marsh Creek).

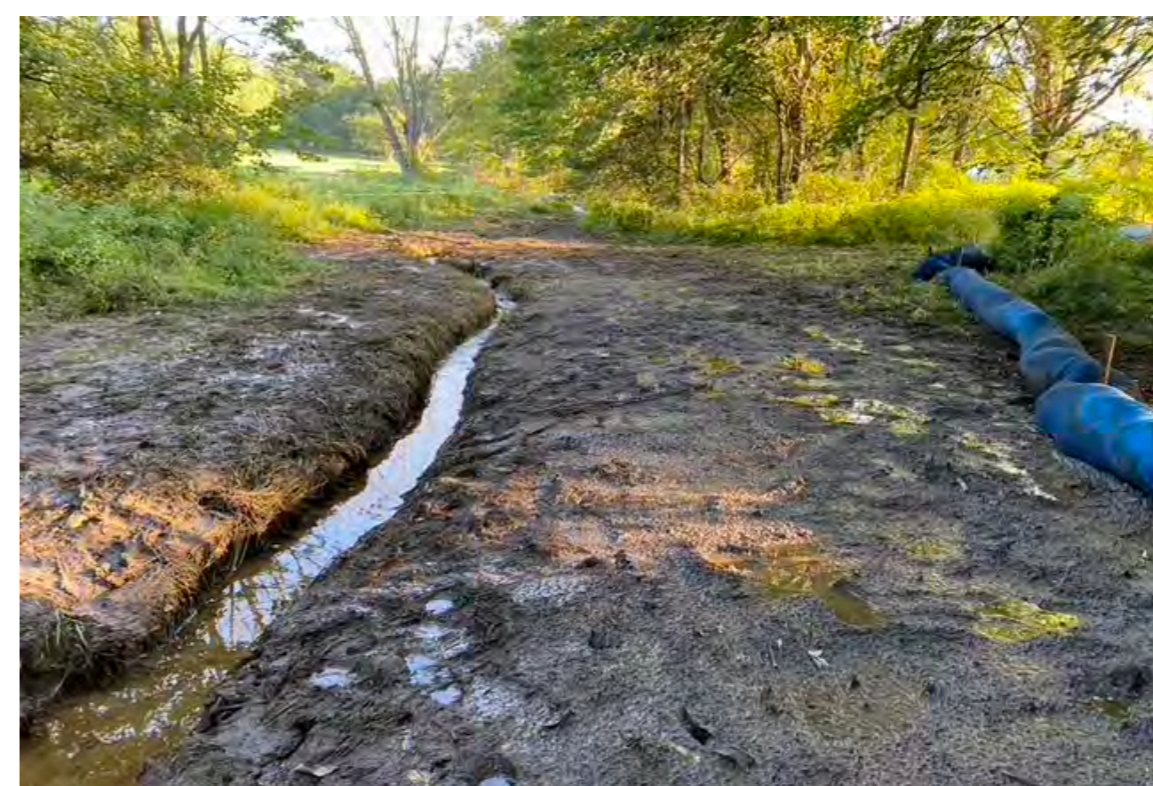
View of stream S-H10 (UNT to Marsh Creek) following cleanup.

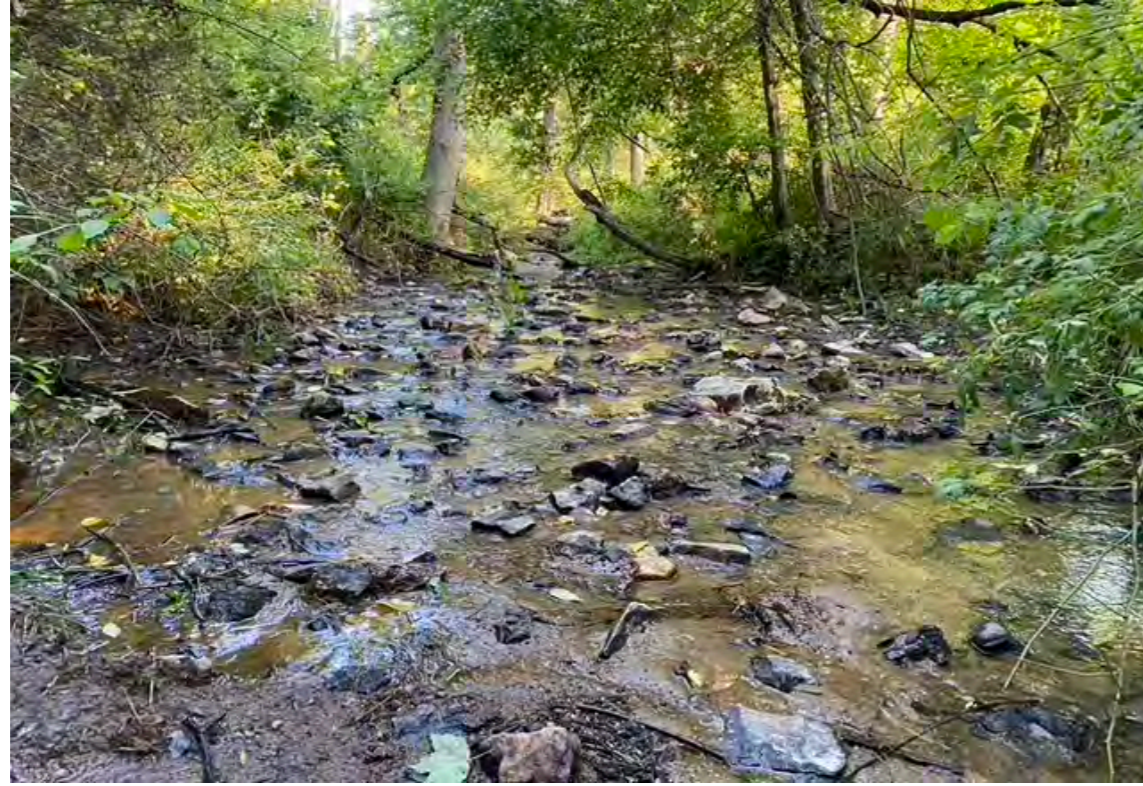
View of stream S-H10 (UNT to Marsh Creek) following cleanup.

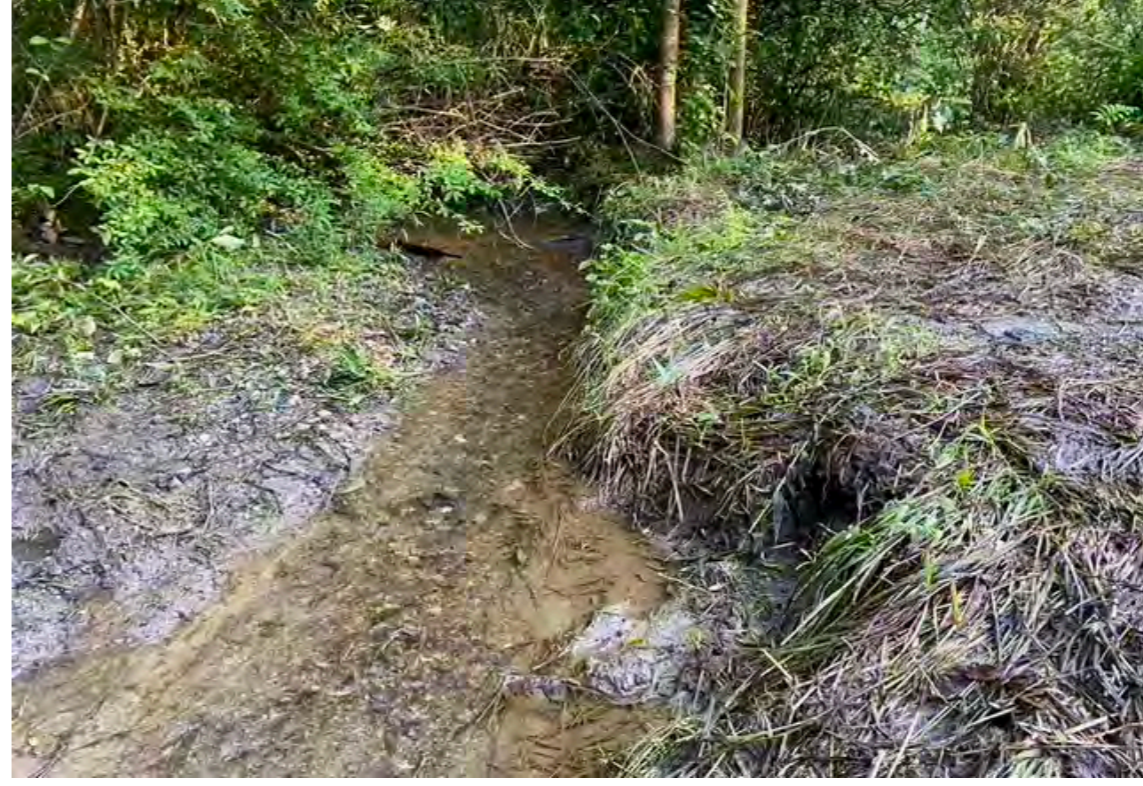
View of stream S-H10 (UNT to Marsh Creek) following cleanup.

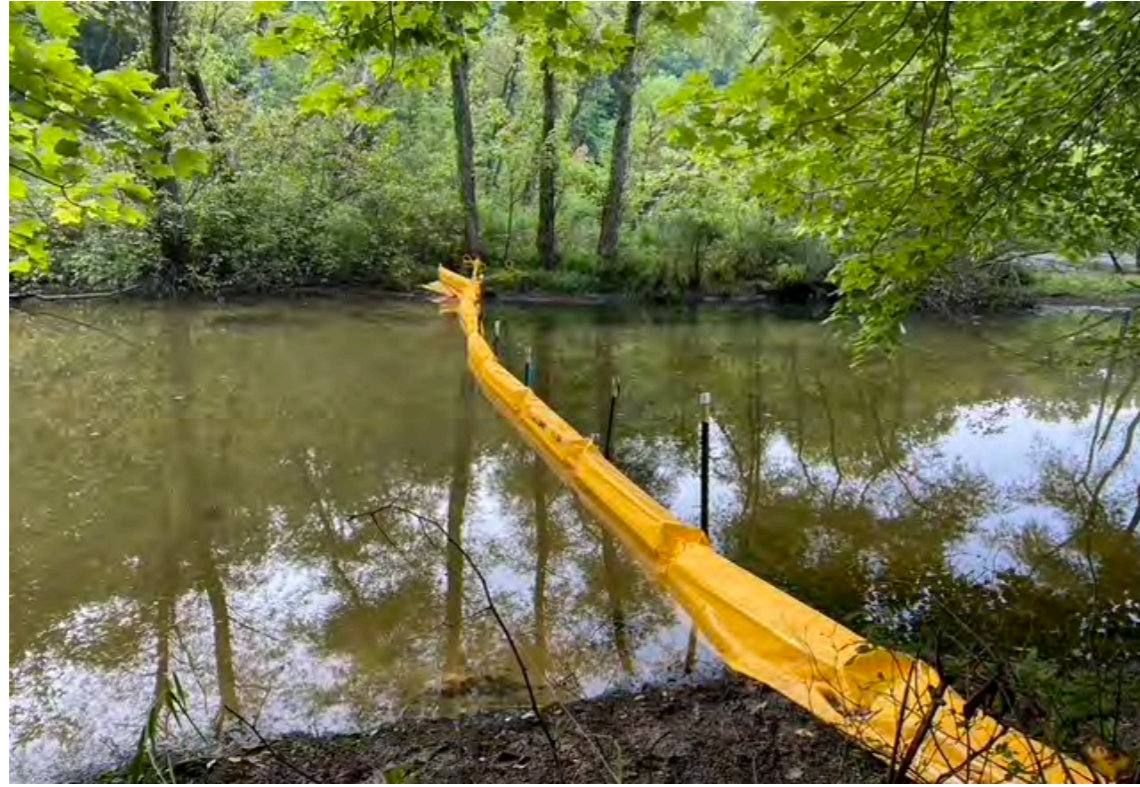
View of turbidity curtain at the confluence of stream S-H10 (UNT to Marsh Creek) and pond H3 (Marsh Creek Reservoir).

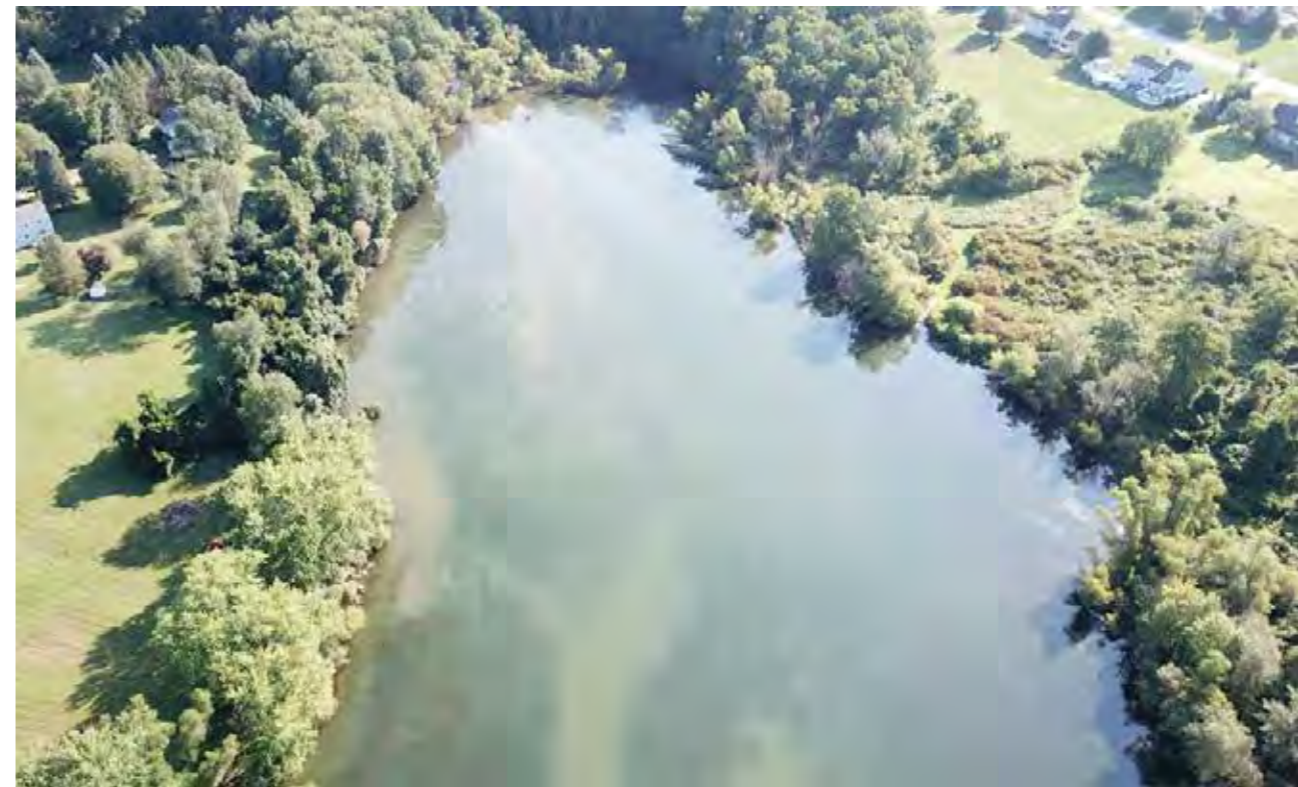
View of pond H3 (Marsh Creek Reservoir).

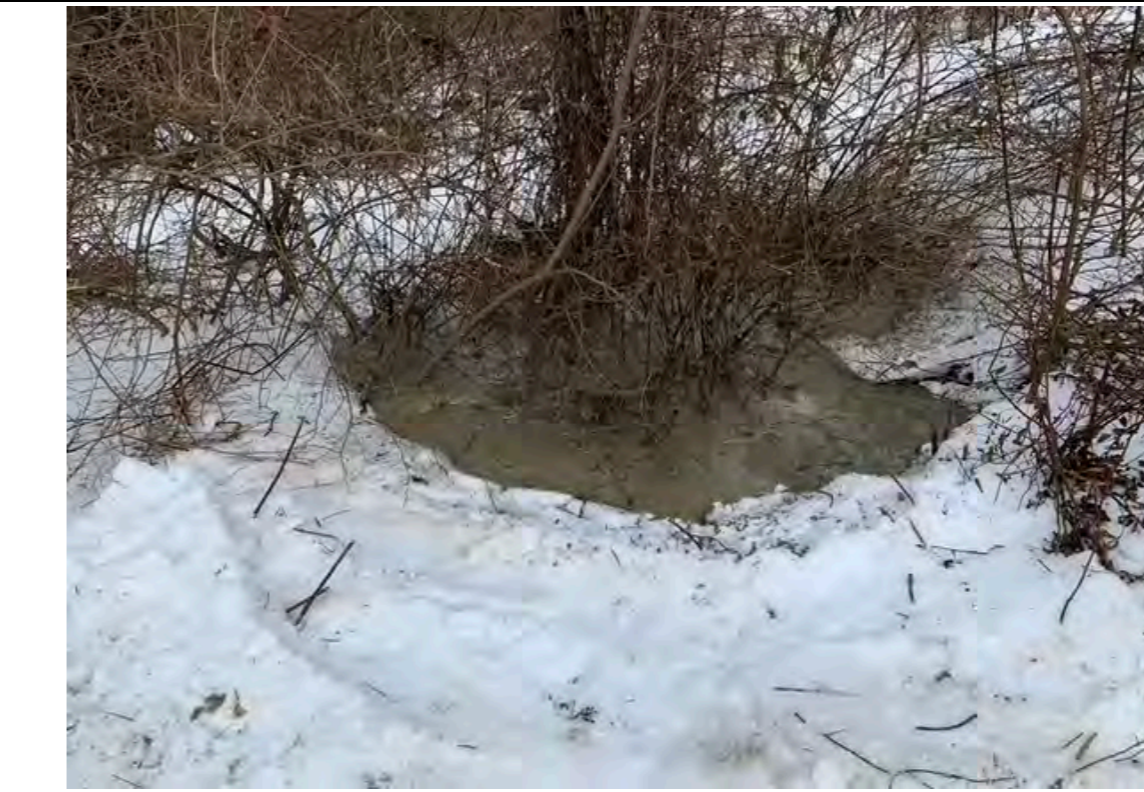
View of earth feature one filled with 13 cubic yards of flowable fill.

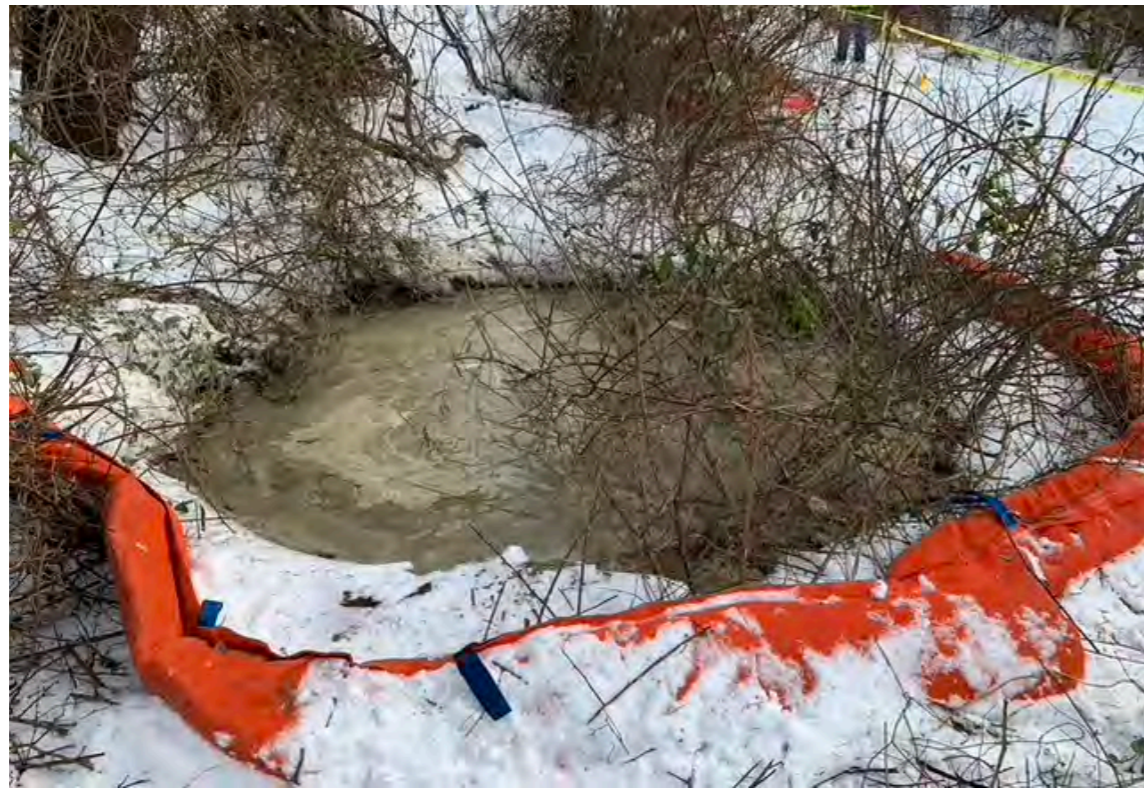
View of earth feature two filled with 28 cubic yards of flowable fill.

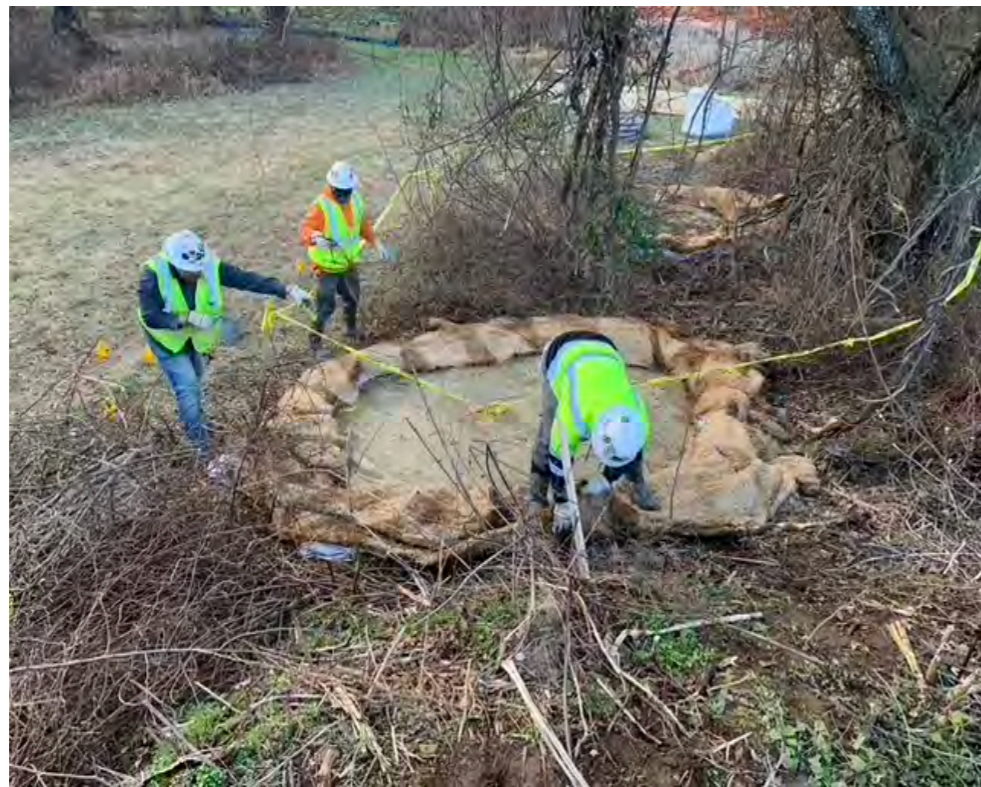
View of contractor crew members installing erosion control blanket to stabilize earth feature locations.
