**If Interim report, Subject to Change as Additional Information Becomes Available**  
**If Interim Report, this Report is cumulative, containing information from previous reports in addition to new information and may change**  
**SPLP PENNSYLVANIA PIPELINE PROJECT**  
**HORIZONTAL DIRECTIONAL DRILLING – INADVERTENT RETURN REPORT FORM**

<b>REPORT DATE:</b>	Current as of 9/21/2020	<b>HDD ALIGNMENT #</b>	PA-CH-100.0000-RD				
<b>PROJECT SITE:</b>	PPP 6 - S3-0290 - Milford Rd./Little Conestoga Rd		<b>HDD COMPANY:</b>	Michels Directional Crossing			
<b>DATE AND TIME WHEN IR WAS INITIALLY DISCOVERED</b>			<b>DATE:</b>	8/10/2020	<b>TIME:</b>	1530	
<b>LOCATION: STREET</b>	427-423 Green Valley Rd, Downingtown, PA 19335		<b>MUNICIPALITY:</b>	Upper Uwchlan	<b>COUNTY:</b>	Chester	
<b>LATITUDE:</b>	40.0794	<b>LONGITUDE:</b>	-75.7104	<b>FROM STATION:</b>	14824+00	<b>TO STATION</b>	14824+00
<b>STREAM NAME:</b>	S-H10 (UNT to Marsh Creek), S-H11 (UNT to Marsh Creek)		<b>POND / LAKE NAME:</b>	Pond H3 (Marsh Creek Reservoir)	<b>WETLAND NAME:</b>	WL-H17 (PEM, PFO)	
<b>DEP PERMIT Nos. (102 AND 105)</b>	E&S Permit # ESG0100015001, Water Obstruction Permit E15-862						
<b>CORPS PERMIT NO.</b>	PASPGP-

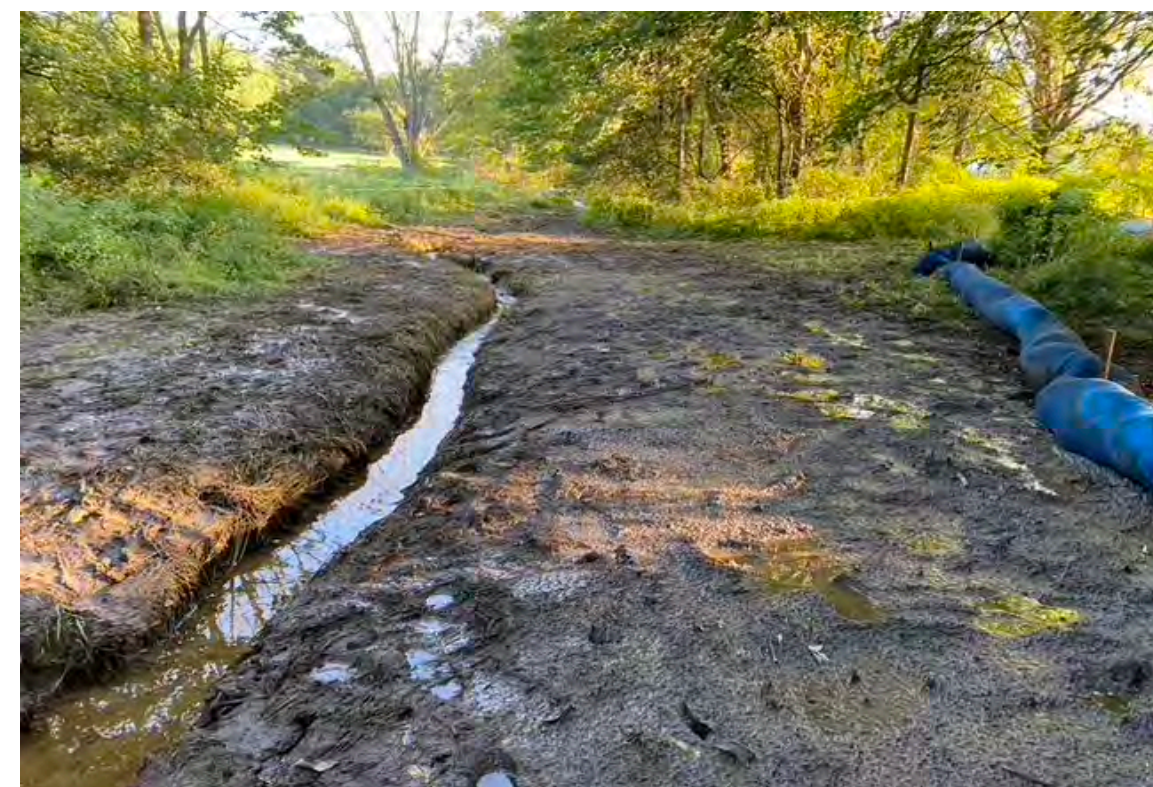
8/17/2020

View of stream S-H10 (UNT to Marsh Creek) following cleanup.

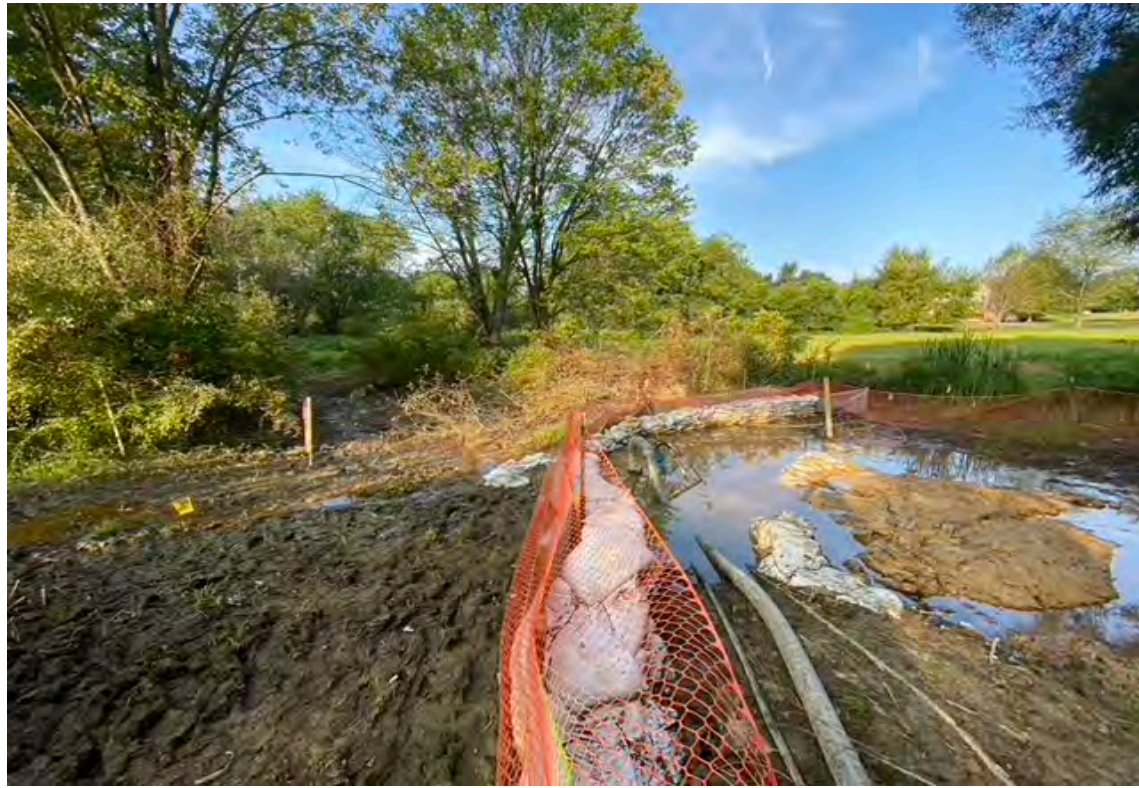
8/28/2020

View of IR release location and containment within WL-H17.

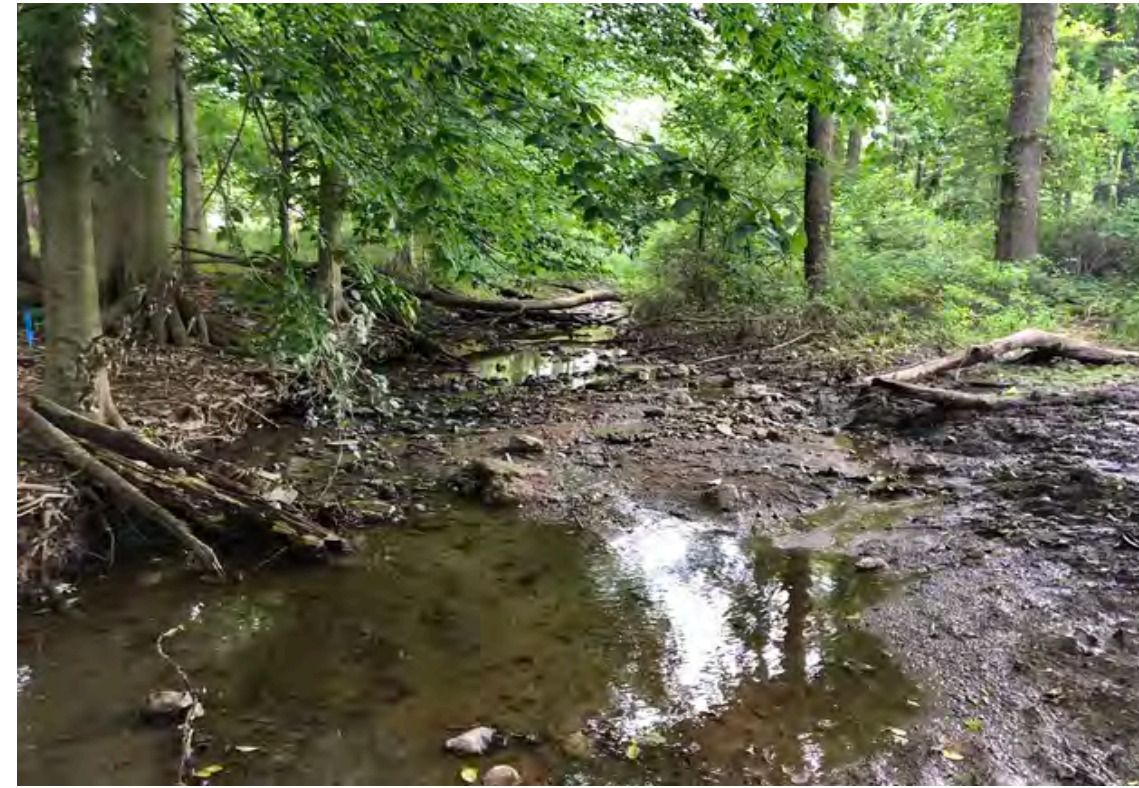
8/31/2020

View of stream S-H10 (UNT to Marsh Creek)

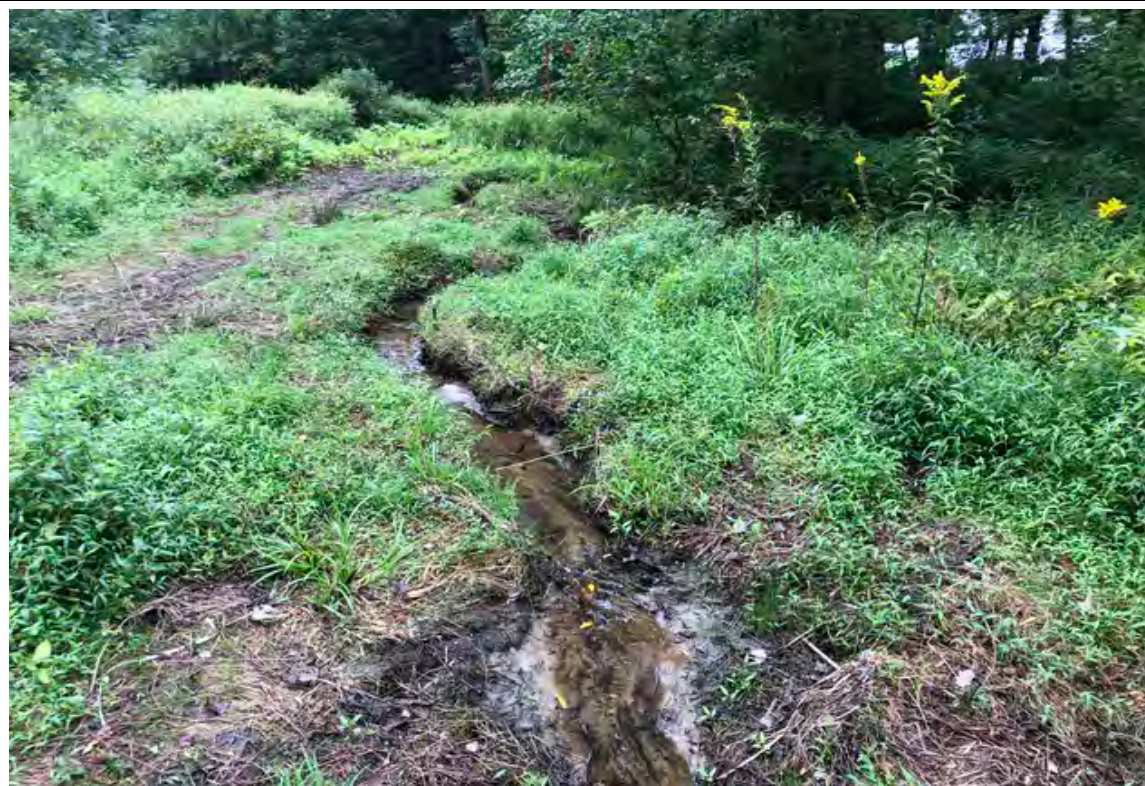
8/31/2020

View of stream S-H10 (UNT to Marsh Creek)

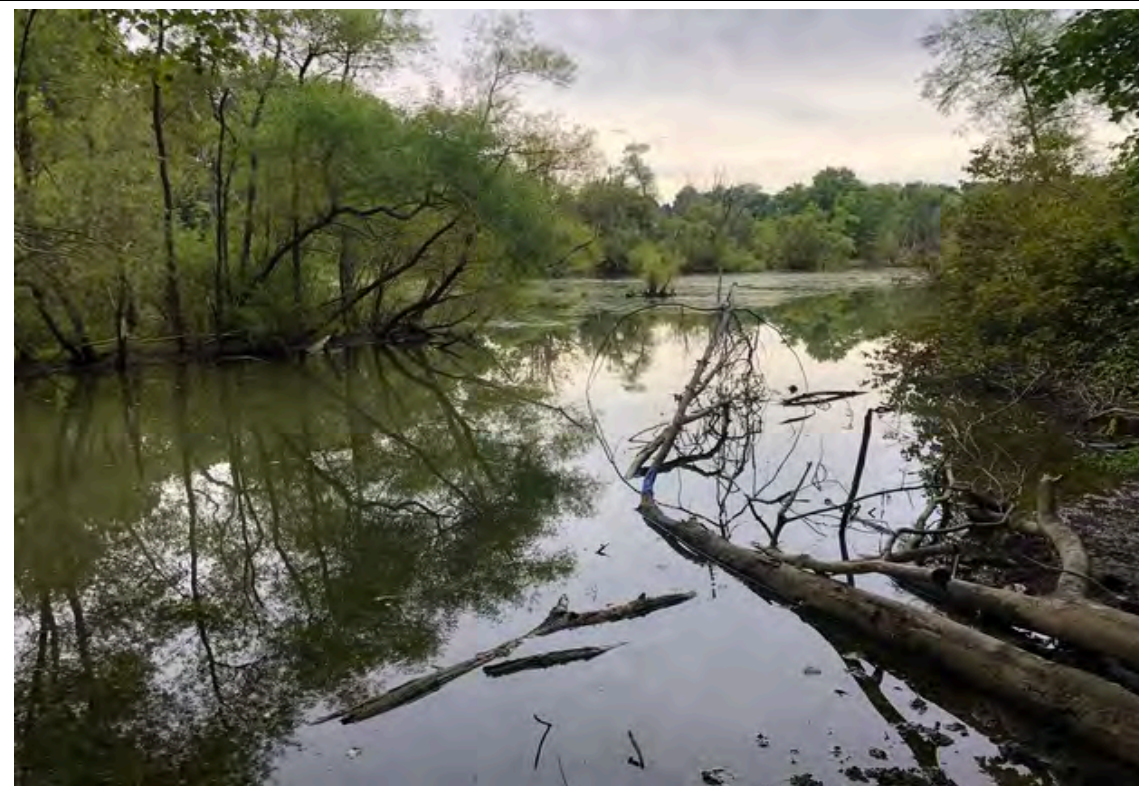
8/31/2020

View of pond H3 (Marsh Creek Reservoir).

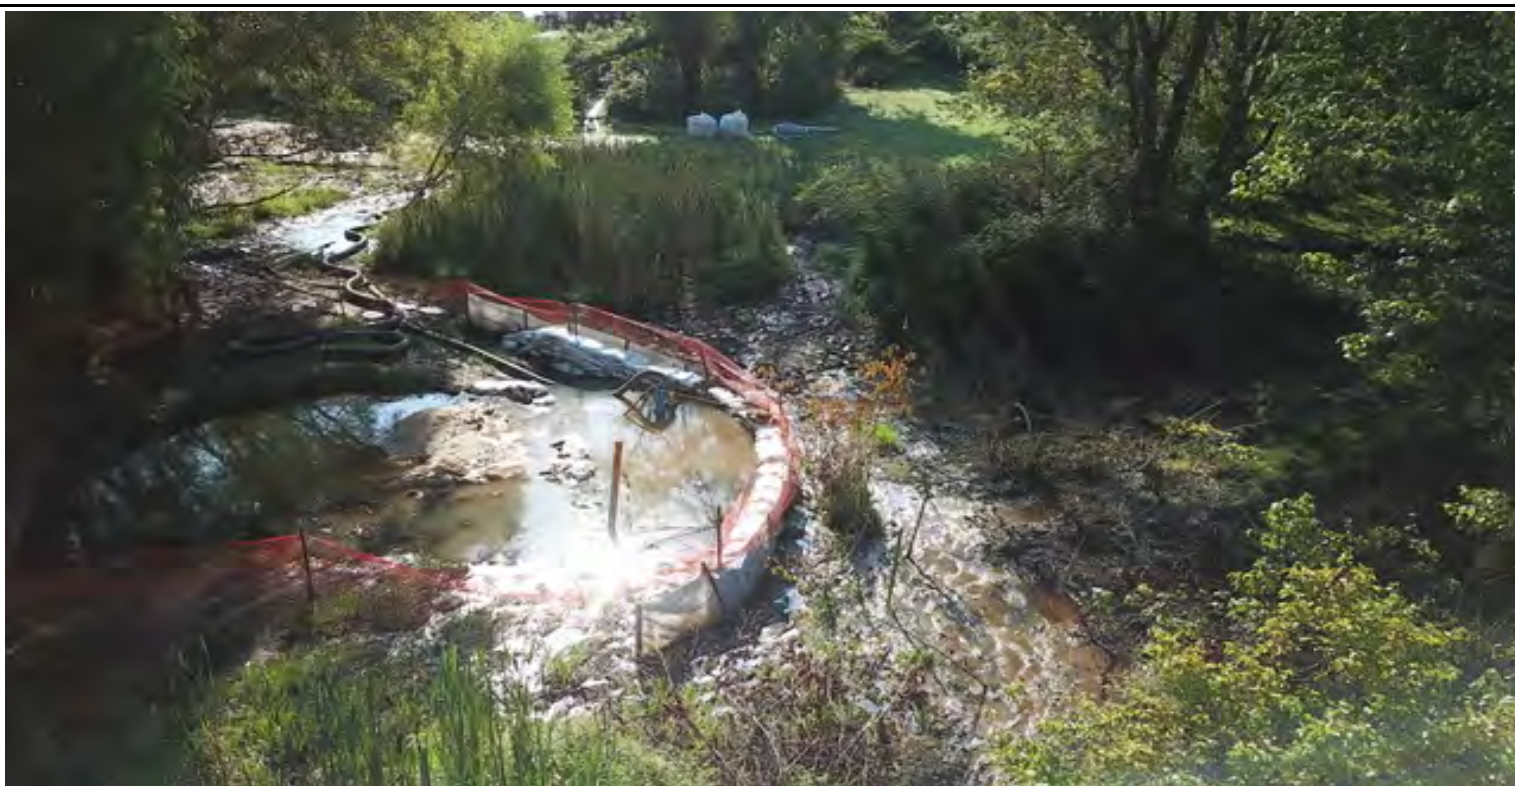
9/4/2020

View of IR release location and containment within WL-H17.

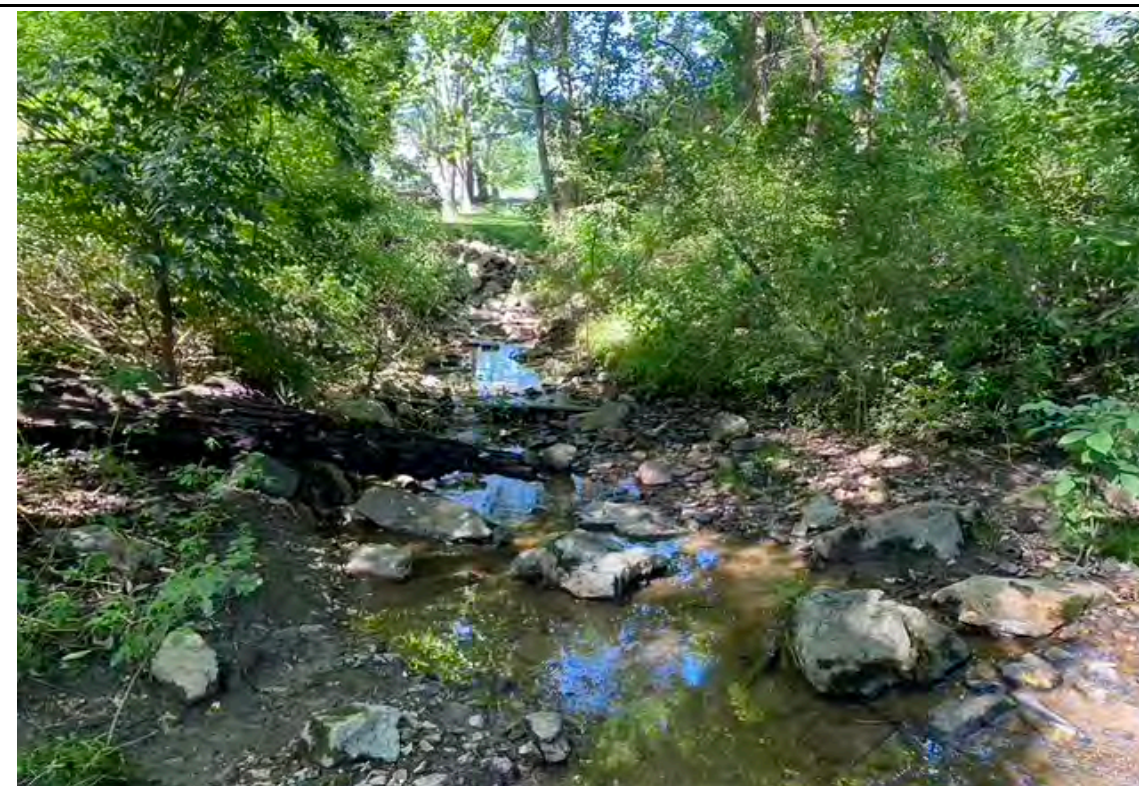
9/5/2020

View of stream S-H10 (UNT to Marsh Creek)

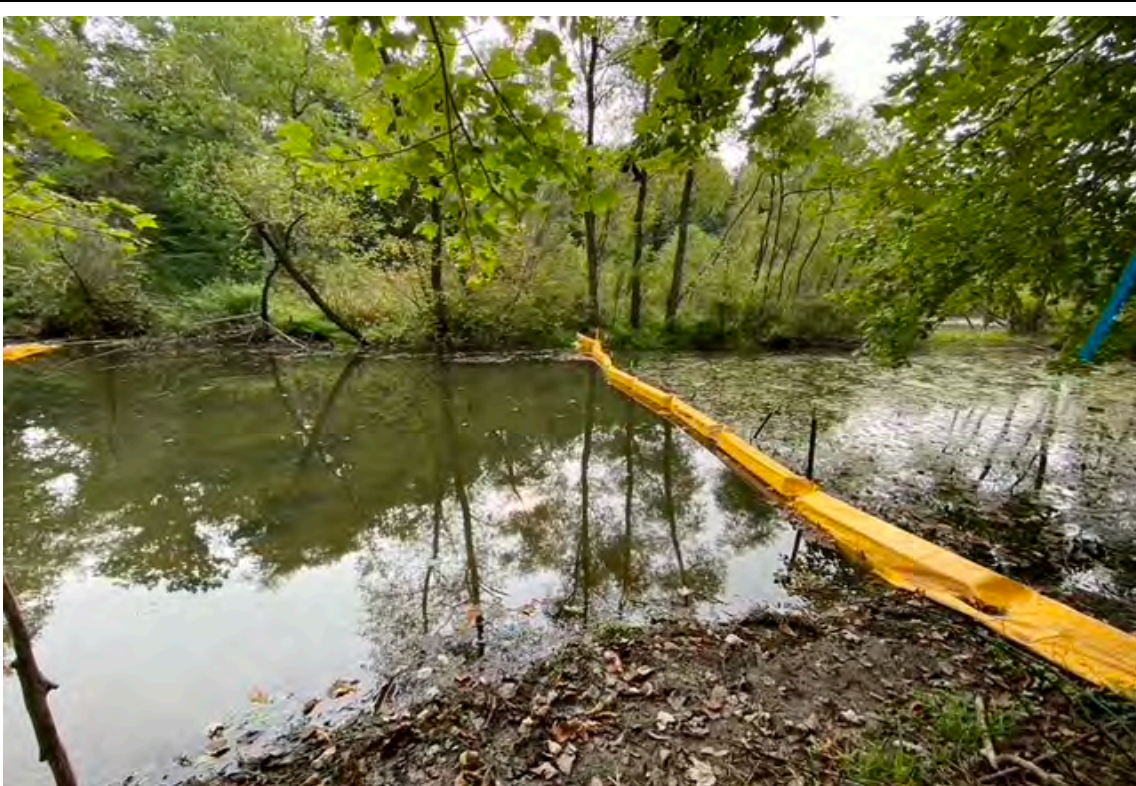
9/14/2020

View of turbidity curtain at the confluence of stream S-H10 (UNT to Marsh Creek) and pond H3 (Marsh Creek Reservoir).

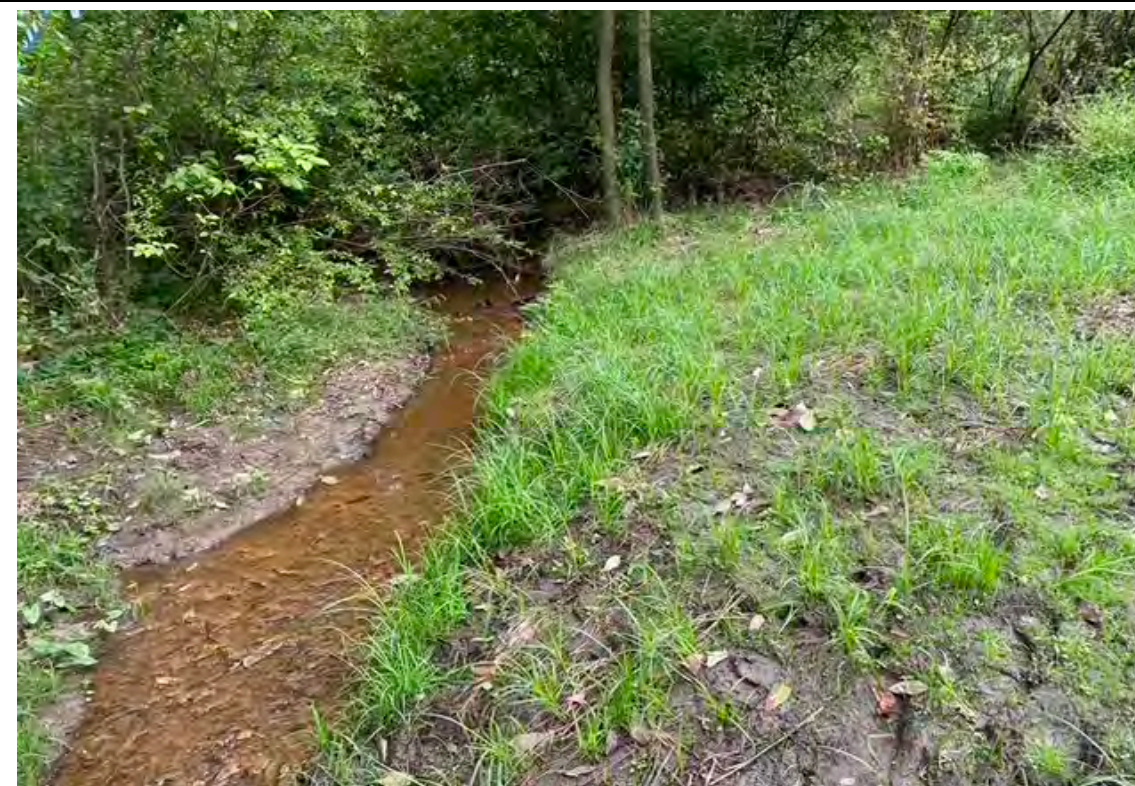
9/14/2020

View of stream S-H10 (UNT to Marsh Creek)
