**Re: Rock Hill Quarry NOA Monitoring Plan  
SMP No. 7974SM1  
East Rockhill Township  
Bucks County, Pennsylvania**

**EarthRes January 18, 2018  
Asbestos Investigation Results Report**

**SUBJECT: Asbestos Investigation Results  
Rock Hill Quarry Operation  
SMP No. 7974SM1  
East Rockhill Township, Bucks County  
EarthRes Project No. 061003.051**

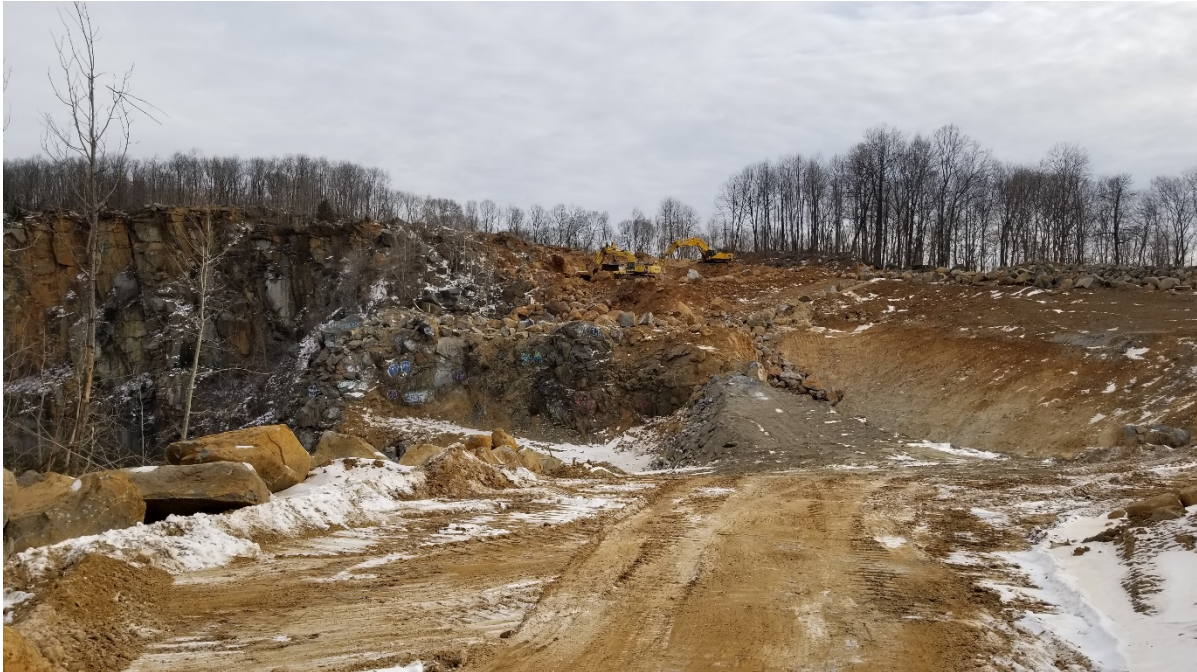
Southern Quarry Working Area

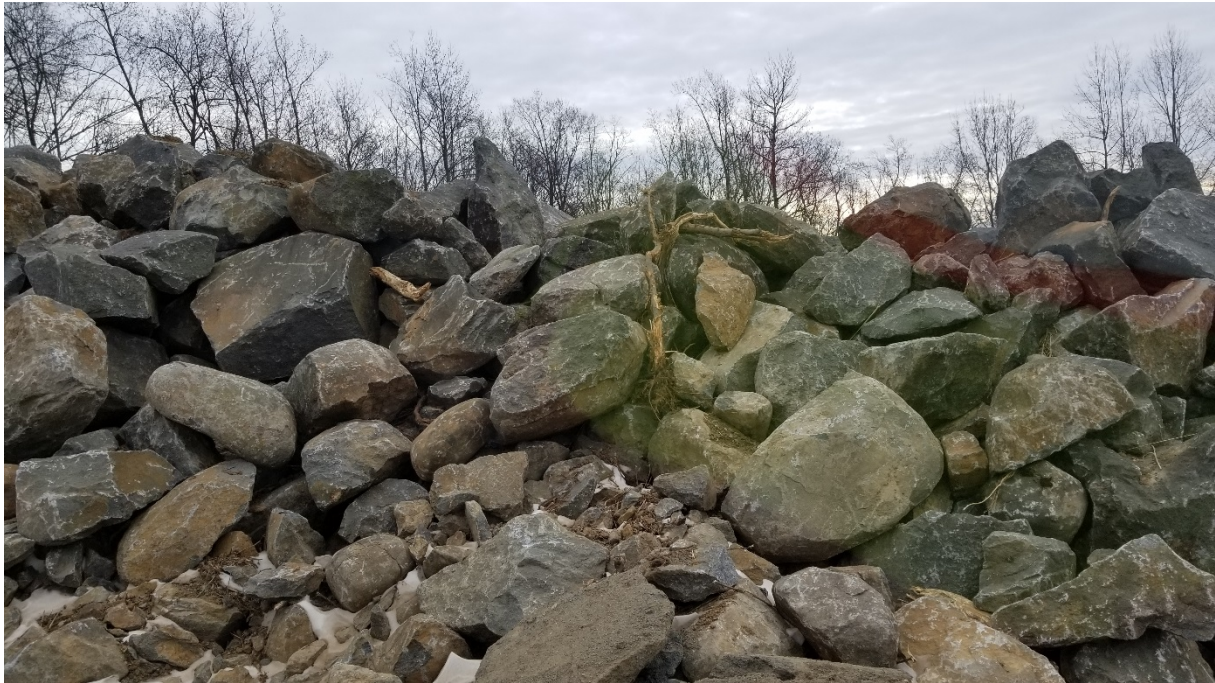
Diabase Boulder Field, south side of southern access road

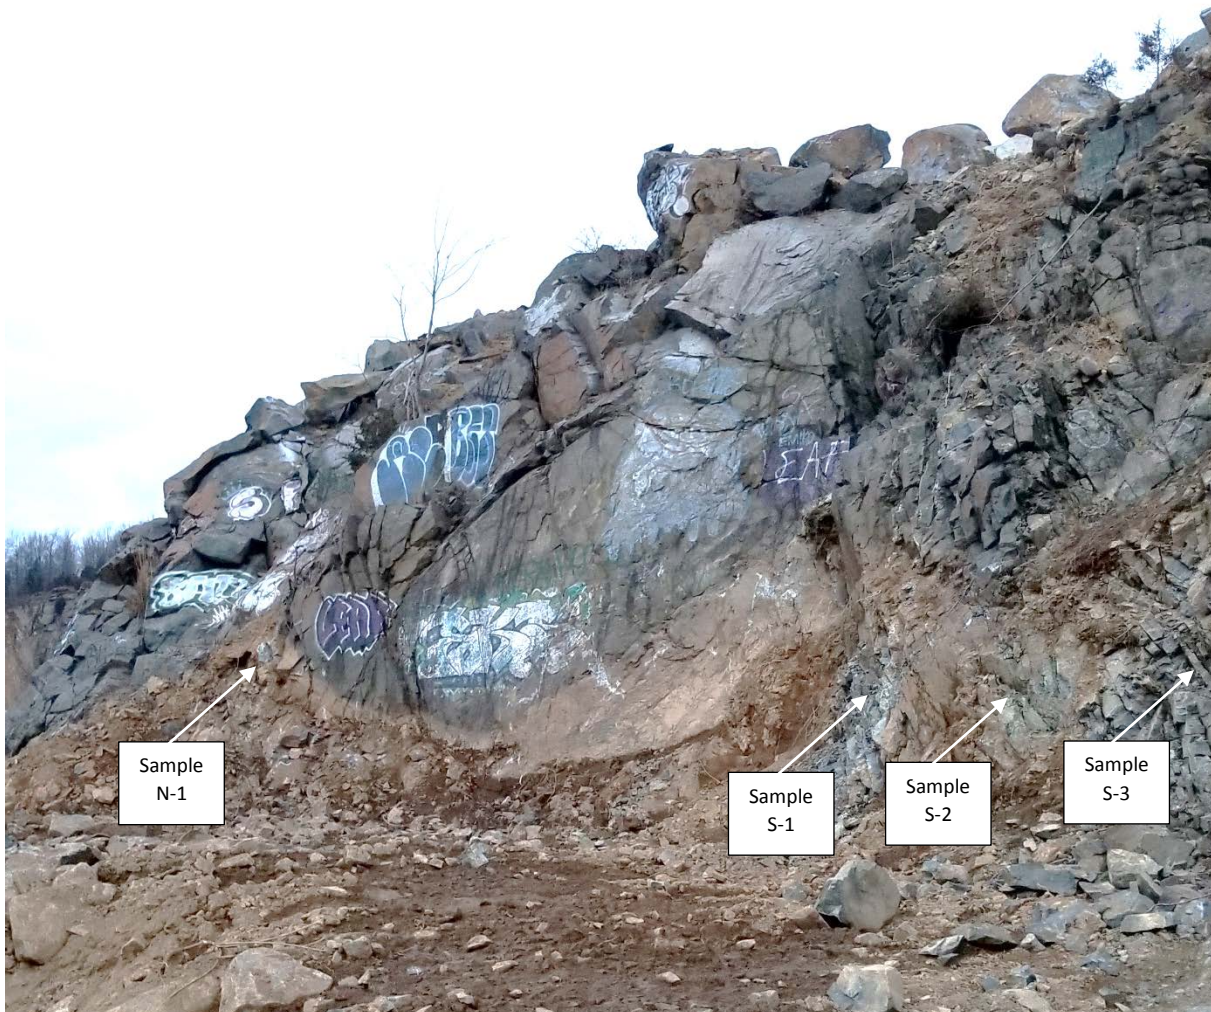
## LOCATION OF SAMPLING

Outcrop hand samples of observed mineral veining from the southern highwall were collected and numbered (from north to south): N-1, S-1, S-2 and S-3, as the highwall in the area of the sampling trends approximately north-south. The general sampling location is shown on the attached Figure in Appendix A. Pictures of the highwall, specific sampling locations and the collected samples are provided in the photographs in Appendix C.

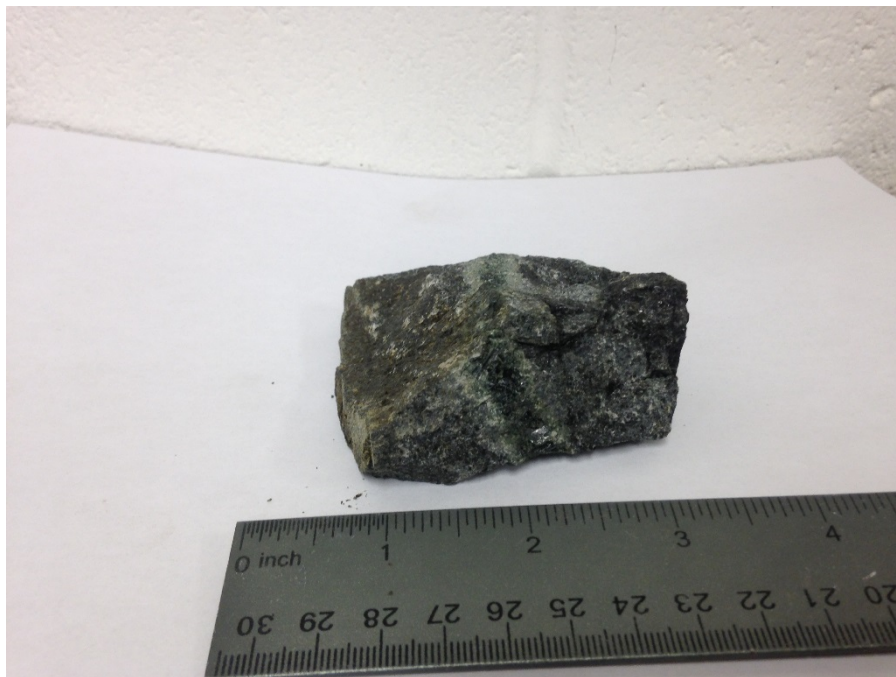
SAMPLE S-2

| Sample | Description | Appearance | Non-Asbestos | | Asbestos |
|---|---|---|---|---|---|
| S-2<br>041800978-0003 | Rock Sample | Gray<br>Non-Fibrous<br>Homogeneous | | 100% Non-fibrous (Other) | None Detected |

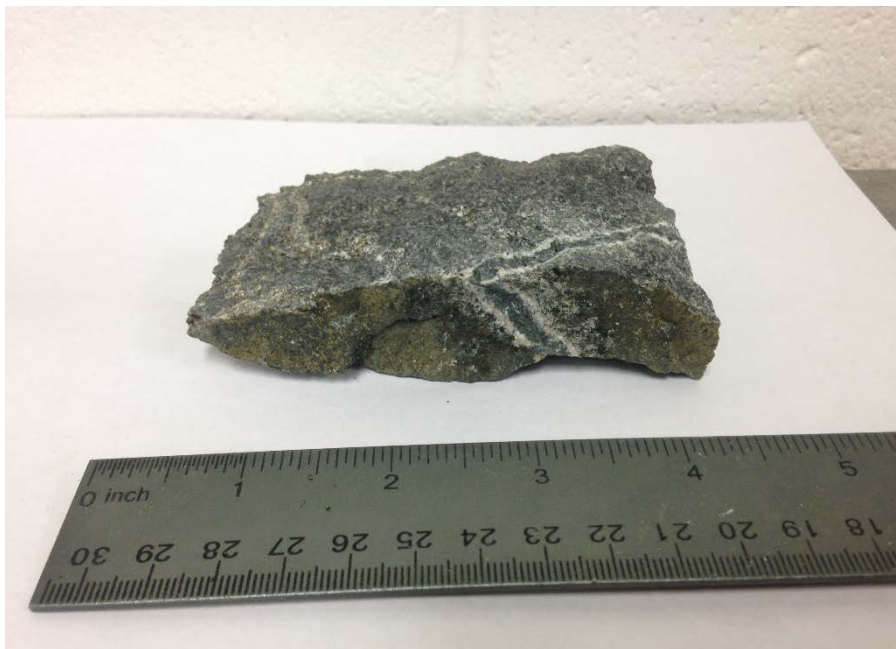
SAMPLE S-3

| Sample | Description | Appearance | Non-Asbestos | | Asbestos |
|---|---|---|---|---|---|
| S-3<br>041800978-0004 | Rock Sample | Gray<br>Non-Fibrous<br>Homogeneous | | 100% Non-fibrous (Other) | None Detected |
