## NARRATIVE REPORT FORM

**Facility Name:** Upper Makefield Twp Pipeline Release
**Primary Facility ID:** 881609

| <b>Narrative:</b><br><p>The intent of this Pennsylvania Department of Environmental Protection (PADEP) inspection was to oversee recovery well installation activities at the property located at 108 Spencer Road, Washington Crossing, PA 18977 (the Site, Photo #1). Drilling began on Wednesday, March 19, 2025, when 5-inch steel casing was advanced in the recovery well borehole to a depth of 25 feet (ft) below ground surface (bgs) and grouted into place. Please see PADEP's field narrative dated March 19, 2025, for additional details of the first day of drilling activities.</p> <p>Dustin Lipik (DL), Caroline Spengler (CS), and Riley Paul-Cook (RPC) of the Pennsylvania Department of Environmental Protection (PADEP) left the Southeast Regional Office (SERO) at 08:40.</p> <p>PADEP arrived at the Site at 09:25. Matthew Sabetta, P.G. (MS), also of PADEP, met DL, CS, and RPC on Site at 09:30. Multiple entities were already present on Site upon DEP's arrival, including many staff from Energy Transfer LP (ET) and Sunoco L.P. (Sunoco), an air monitoring team from CTEH, a drilling

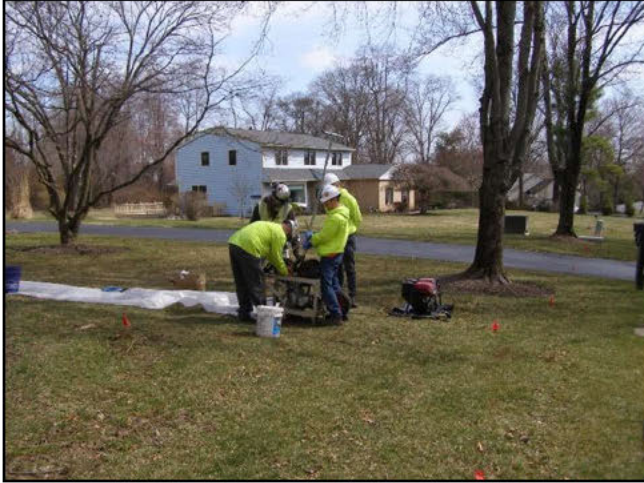
**Photo #4**

ET/GES staff began pump removal activities (Photo #4) at 12:00. By 12:30, the bailer had been retrieved and the well pump was reinstalled. In total, ~20 ft of hosing/wiring were lifted from the well to remove the bailer. No LNAPL was observed in the bailer sample (Photo #5). I again spoke with [REDACTED], who indicated that the pump had been reinstalled and was operational.

ET/GES staff removing pump from potable well at [REDACTED] Road.  
3/20/2025 @ 12:07

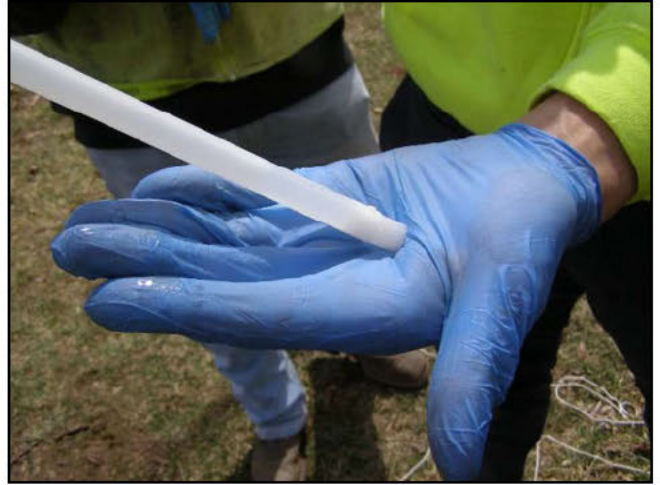
**Photo #5**

Water sample from potable well at [REDACTED].  
No LNAPL observed.  
3/20/2025 @ 12:33.

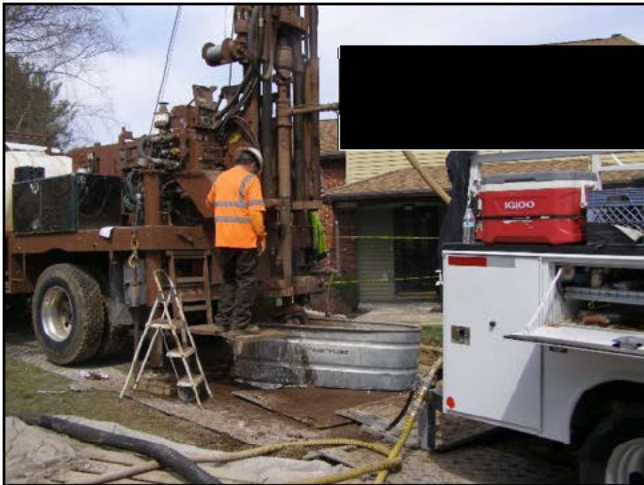
**Photo #6**

Parratt-Wolff continued drilling activities at 13:00 after setting up secondary containment (Photo #6). Between 13:00 and 13:43, the borehole was advanced from 34.5 ft bgs to ~45 ft bgs. At 13:43, drilling was stopped so Parratt-Wolff could fix the diverter shroud that redirects cuttings into the containment pad. Strong odors were briefly noted by PADEP and staff in the vicinity of the drilling area at ~40 ft bgs and ~42 ft bgs. DL and DS concurred that the source of the strong odors was the borehole. Though odors were detected, no visual evidence of petroleum impacts were observed, and DS indicated that PID readings increased slightly above 1.0 ppm, but remained less than 5.0 ppm. MS left Site ~13:40.

Parratt-Wolff drilling recovery well.  
3/20/2025 @ 13:11
