## NARRATIVE REPORT FORM

**Facility Name:** Glenwood Drive & Walker Road

**Primary Facility ID:** 881609

| <b>Inspection Date:</b> 8/1/25 | | <b>Inspection Time:</b> 9:50 – 11:20 | | <b>Lat/Long:</b> | |

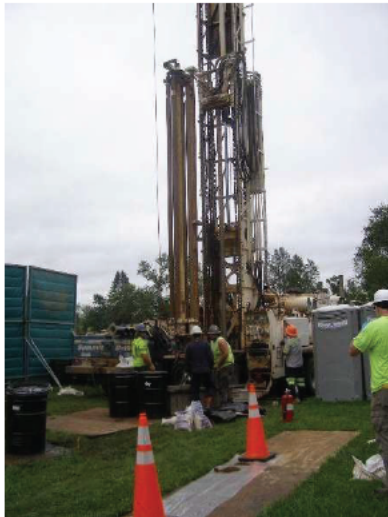
Photo 1: Drilling in progress

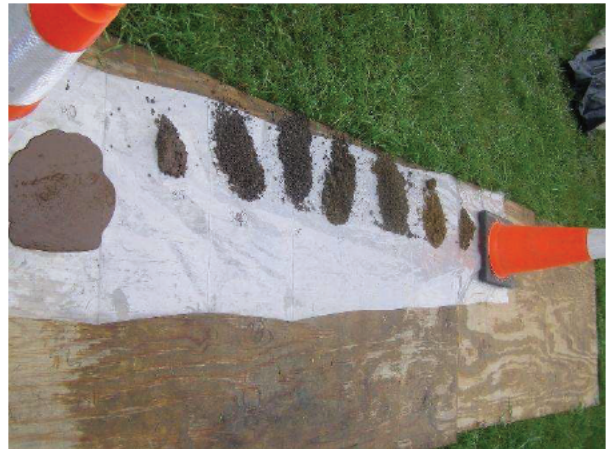
The monitoring well was drilled to a total depth of 40 feet below ground surface (bgs). Saprolite was encountered at about 15 feet bgs and competent argillite bedrock was at about 17 feet bgs. Groundwater was encountered at about 34 feet bgs which is also shown in the soil collected for characterization (photo 2). The well was constructed with the same materials as all other monitoring wells.

Photo 2: Staging of soil cuttings from 5-foot intervals

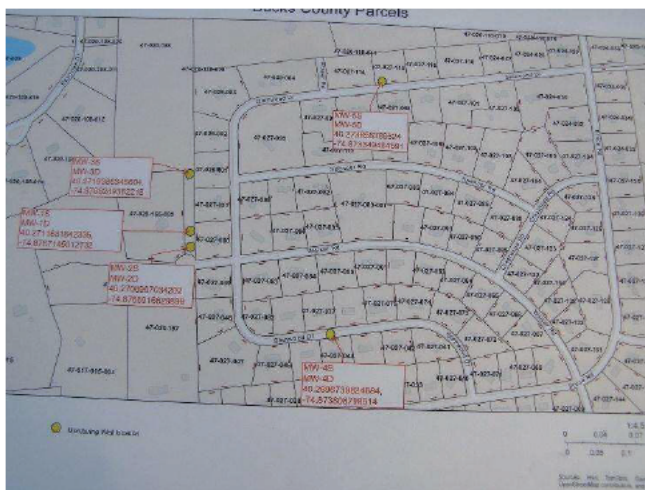
The purpose of today's site visit was to observe installation of monitoring well MW-2S. This well completed the set of one shallow and one deep well located in the township green space that runs parallel to Glenwood Drive. There are six total wells installed in this space. See Photo 3 for reference of completed wells to date.

Photo 3: Map of proposed and completed wells to date

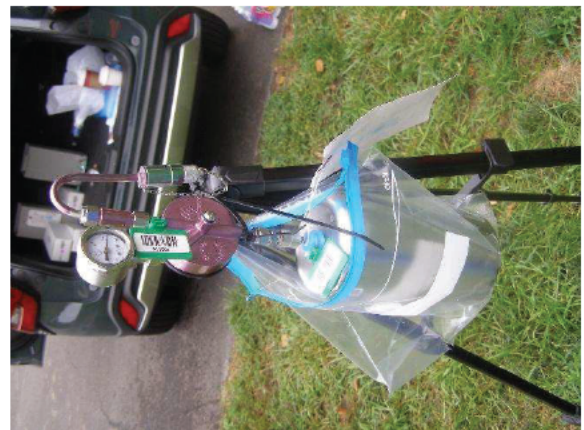
During drilling CTEH was onsite monitoring noise quality with handheld devices. They also set up Summa canisters (Photo 4) around the drilling area perimeter to collect air samples. Sound barriers shown in photo 5 were set up around drilling to help mitigate noise.

Photo 4: Summa canister for air monitoring

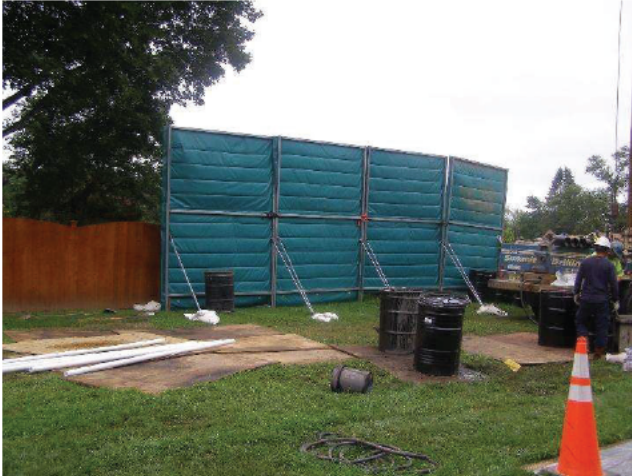
Photo 5: Sound barrier staging

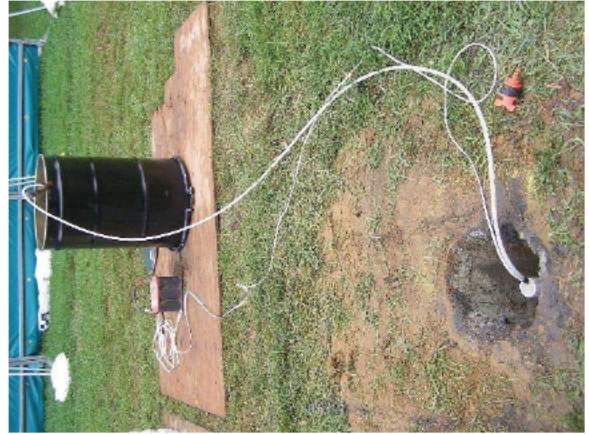
I arrived at the drilling area at 9:50. The drill rig was set up and ready for drilling upon my arrival. The Summit crew informed me that hand digging was completed earlier in the week. Monitoring wells MW-1S, MW-1D, MW-3S, and MW-3D were being developed and flush mounted when I arrived, and these activities continued after my departure.

Photo 6: Well Development of MW-15

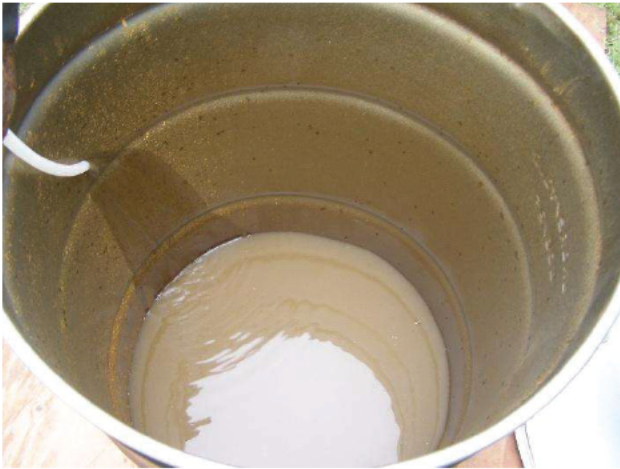
Photo 7: Well development water
