## NARRATIVE REPORT FORM

Facility Name: Glenwood Drive & Walker Road

Primary Facility ID: 881609

| Inspection Date: 9/9/2025 | | Inspection Time: 09:45 – 13:45 | | Lat/Long: | |

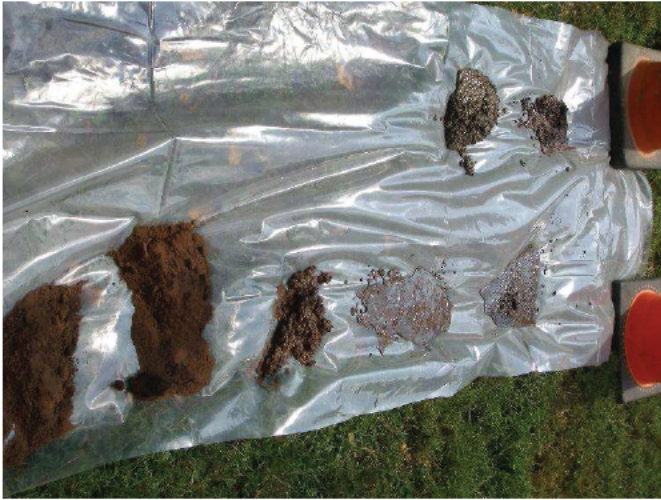
Photo 1: Soil characterization

During drilling soil was collected from five-foot intervals and placed on poly sheet for screening and characterization (shown in photo 1). Competent bedrock was encountered at 25 feet below ground surface (bgs) and soft zones were encountered at 27-28 feet bgs. There were slightly elevated PID readings of 8.3 ppm and 0.5 ppm at 16 feet bgs and 22 feet bgs, respectively. The well was advanced to 40 feet bgs and constructed with 20 feet of screen.

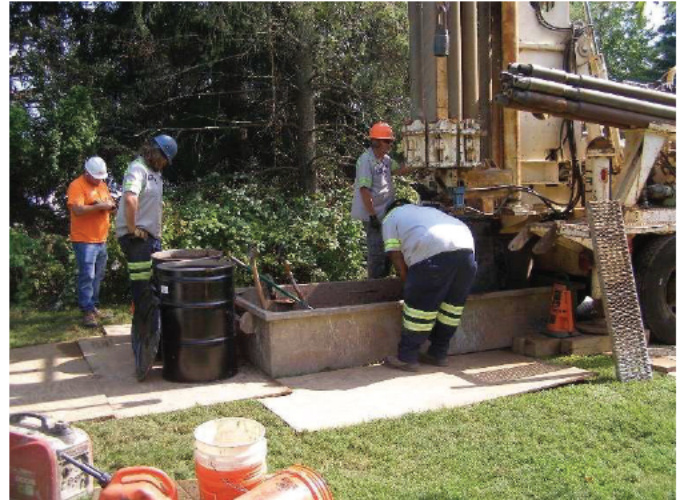
Photo 2: Drill rig placement and set up

Drilling equipment was being staged upon my arrival. Drilling began at 10:50. The homeowner was outside to observe drilling activities, and we spoke briefly at the start.

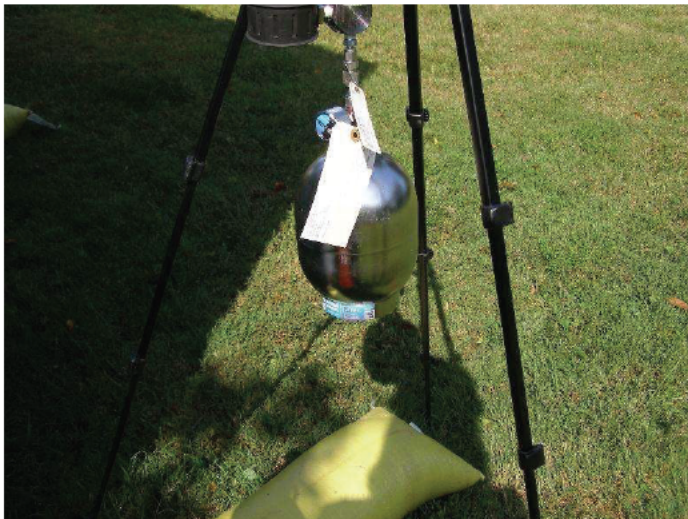
Photo 3: Summa Canister for air monitoring

I arrived onsite at 9:45 and equipment was still being set up upon my arrival. Sound barriers were placed along the side of the residence, along the opposite side of the driveway, and along the front of the backyard. Plastic mats were placed over the driveway and heavily traveled grass in the drilling area. Stantec was onsite performing air monitoring with four summa canisters placed around the property (see photo 3). Personnel from SPLP was performing noise monitoring with a handheld device.
