## NARRATIVE REPORT FORM

Facility Name: Glenwood Drive & Walker Road

| Inspection Purpose: Inspection of residential potable well at [REDACTED] Washington Crossing, PA 18977 following [REDACTED] complaint filed with DEP on September 16, 2026. | | | | | |

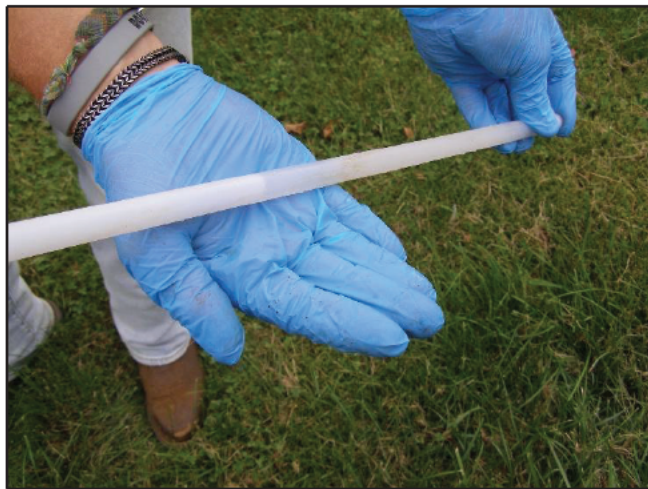
Photo #2

■ gives permission to GES staff to open the residential potable supply well to collect a PID reading, collect a depth to water measurement, and to conduct a bailer check to evaluate for the presence of LNAPL at the top of the water column. GES measures a PID reading 0.0 ppm from the well headspace. GES measures a depth to water of 52.17 ft below top of casing (bTOC). GES collects an aliquot of water from the top of the water column using a small diameter bailer. No LNAPL is observed on the surface of the aliquot of water within the bailer (Photo #2) and a PID measurement of the water within the bailer reads 0.0 ppm (Photo #3).

Aliquot of Water from Top of Water Column  
9/17/2026 @ 13:20

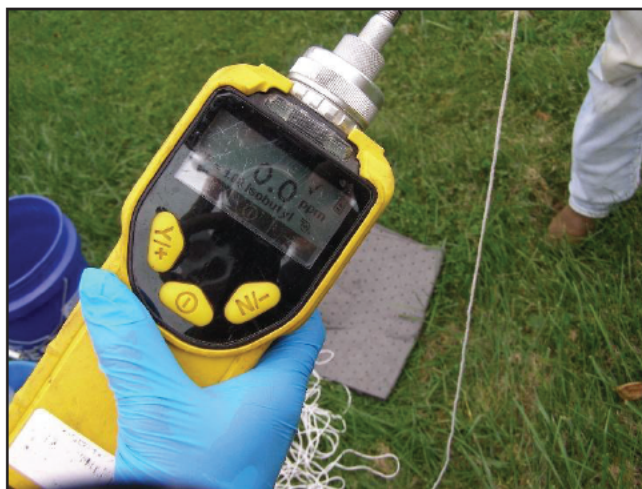
Photo #3

PID Reading from Bailer  
9/17/2026 @ 13:20

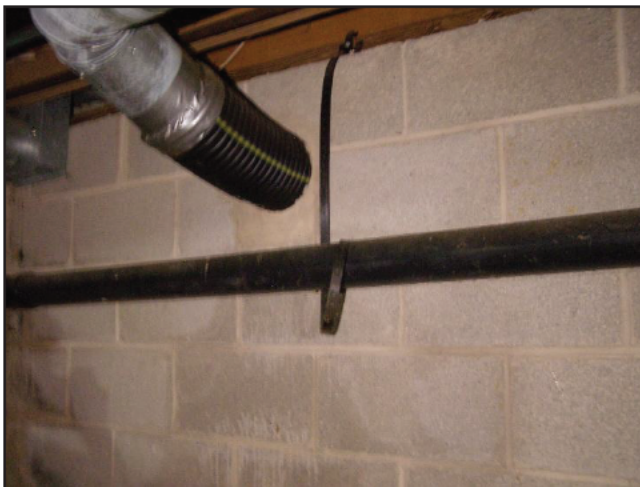
Upon arriving in the basement, BB notes to the group that several pipe hangers supporting the septic system piping conveying septic waste to the septic field are broken and that the piping is hanging at an angle that may be inhibiting the flow of septic waste to the septic field (Photo #4). BB recommends that ■ hire a septic company to evaluate the issue and make repairs, if needed. GES collects a PID reading from the basement of 0.0 ppm.

**Photo #4**  
Broken Septic Pipe Hangars in Basement of Residence  
9/17/2026 @ 13:45
