Final Report

Goodwill Industries Material Recovery Facility Evaluation

PA Department of Environmental Protection

December 2004

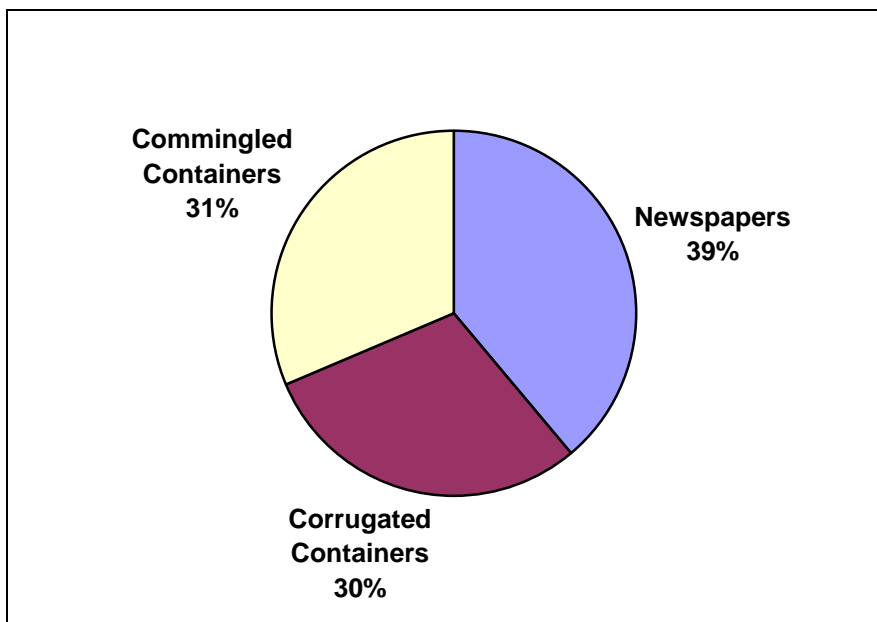
Figure 1
Breakout of Incoming Materials
Tons Received, 2003

In 2003 the facility processed 1,166 tons of newspaper, 892 tons of corrugated containers, and 942 tons of commingled containers, for a total of 3,000 tons of material. Figure 1 shows the breakout of incoming materials.

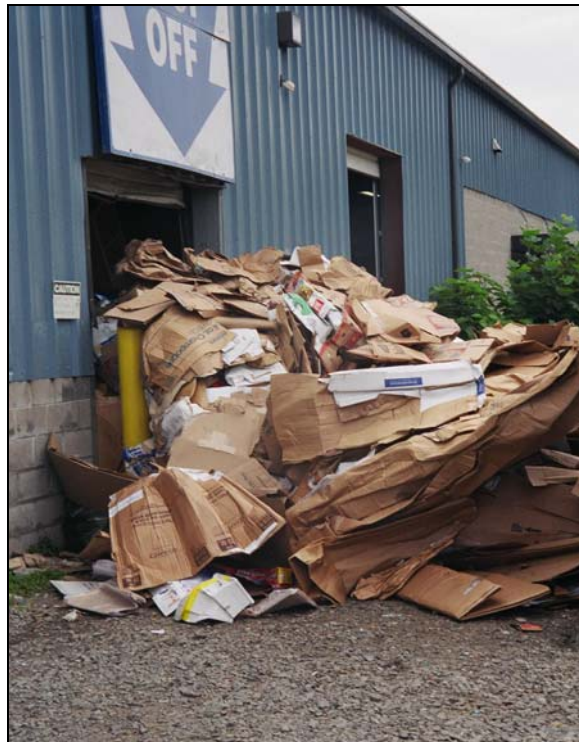
Figure 2
West Tip Area for ONP, OCC, and Drop-Off Materials

Old Newspaper (ONP) is typically collected bundled or bagged and arrives source-separated. On arrival, ONP is tipped inside the incoming materials bay located on the west side of the building, which is the same area used for OCC processing. After it is tipped, newspaper is normally manually loaded directly onto the ONP incline feed conveyor that leads to the ONP baler. Contaminants are removed during this manual handling process. If the tip floor is needed for OCC processing, a skid steer scoops up the newspaper and deposits it in wire bins for processing at a later time.

In addition to receiving OCC and newspapers, the west tip area is also where individuals go to drop off any materials they might have. Self-delivered materials are handed to an employee as there are no drop-off bins. Facility management indicates that they receive from 20 to 25 drop-offs by residents each day. Figure 2 shows the west tip area entrance. As Figure 2 shows, the west tip area is not conducive as a drop-off area, particularly when truck traffic is considered.

The OCC/ONP floor sort area inside of the bay entrance is approximately 100 square feet, and there is an additional 300 square feet or so outside the building where OCC is initially tipped. Generally, OCC is processed by the end of the day, and therefore does not stay outside over night. Upon occasion the OCC does remain outside, however moisture has not been problematic.

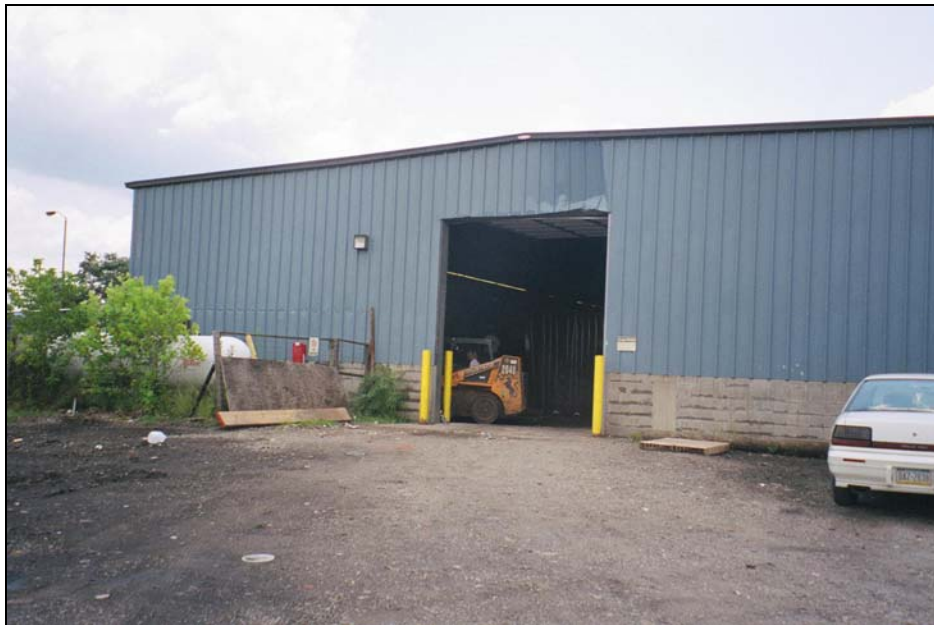
Figure 3
North Entrance to Commingled Container Tip Area

Commingled materials and any other types of containers that arrive (such as “bar run” glass bottles) are tipped in the incoming materials bay located on the north side of the building. A front-end loader then pushes the containers into a commingled materials pit area that is 12 feet long by 10 feet wide by 5 feet deep. The entire tip area including the pit is approximately 25 feet by 15 feet. This is enough to store one to three days’ worth of incoming materials. The facility manager indicates that this is not sufficient, and that there have been times in the past when the facility had been unable to operate due to equipment malfunction, or in the case of holidays, that incoming materials had to be tipped outside of the facility. Figure 3 shows the north entrance leading to the commingled containers tip area.

Goodwill Industries plans to expand the Recycling Center by 5,000 square feet. The addition will be on the north side (commingled tip floor) of the building, which will eliminate tip floor and processed material storage space deficiencies. After the addition is complete, delivery vehicles will be able to drive into the facility, close the door, then tip their materials. Currently there is only enough space for vehicles to back partially into the facility, one at a time, to tip their loads, which makes it uncomfortably cold inside the facility during the winter months and costly to heat the space. The area outside the expansion will also be paved to reduce dust levels and graded to make maneuvering easier for trucks.

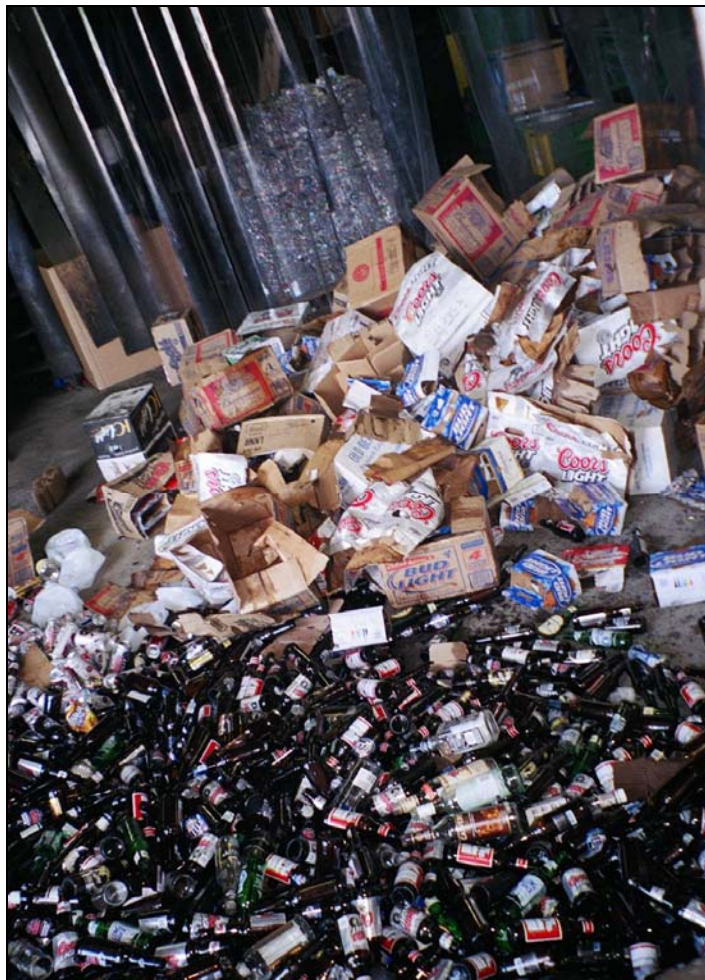
Figure 4
De-Cased Bar Glass

Glass that arrives in cases from "bar runs" is processed as time allows. The bottles that are in cases and are already color sorted are supposed to be manually dumped into the appropriate roll-off container of processed clear, brown, or green glass. This does not happen routinely because of inclement weather, the fact that some cases have mixed colors of glass in them, the inefficiency of de-casing next to the roll-offs (which are tall), and the fact that the empty cases need to be carried inside the facility for baling. Instead bottles are often de-cased indoors where they are dropped into a pile, contributing to mixed color cullet that is disposed, and presenting spurts of glass for the sorting line to deal with. Instead a de-casing area should be set aside inside the facility with self-dumping hoppers for each color of glass. Space has been too limited in the past for this to occur indoors; however, with the facility addition there should be sufficient indoor space to implement this recommendation in the future. Figure 4 shows de-cased bar glass being tipped on the commingled container tip floor.

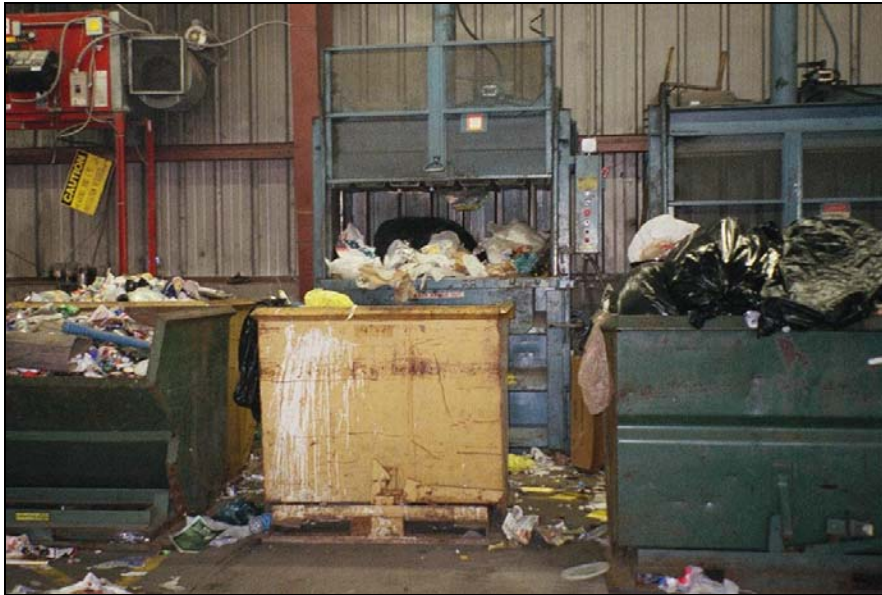
Figure 5
Trash Baler

Residue from the containers sort line is negatively sorted at the Recycling Center, falling off the end of the sort line into a two cubic yard hopper. Contaminants from the paper side of the facility are positively sorted off the tip floor into similar dumpsters. Approximately three to four dumpsters are filled in a day. The hoppers are brought to the southeast side of the building, where the loose trash is manually loaded into an old vertical downstroke baler using a shovel. The facility decided to bale residue so that it would not blow away and become litter. The resulting bales of trash are moved outside, using a forklift, and stored there until a landfill run is made. Figure 5 shows the trash baler.

- During the process of conducting this study, R. W. Beck recommended that the facility replace baling and self-haul of residue with roll-off container service by a local waste hauler. The facility subsequently investigated that option and decided to implement the recommendation. A local waste hauler agreed to service a 30 cubic yard roll-off for \$75 per pull, which will cost \$3,900 per year assuming a once per week pull. The waste hauler is also able to offer a reduced tip fee of \$32.00 per ton compared to the self-haul tip fee of \$43.30 that Goodwill was charged at the landfill. The \$11.30 per ton tip fee reduction will save the facility \$4,100 per year in tip fees at current residue levels. The net cost savings, therefore, is estimated at \$200 per year. Additional savings of approximately \$7,800 are projected from eliminating:

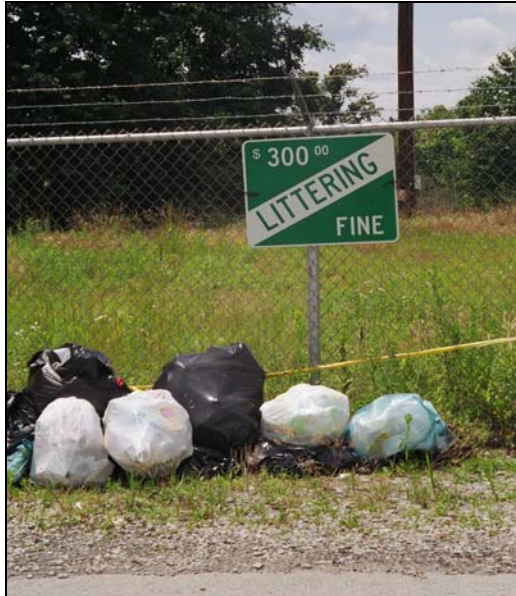
Figure 6
Trash Disposed Illegally Outside of the Recycling Center

Some of the facility's "residue" is waste that is illegally dumped outside the gates of the facility. Despite posting signs, waste is still illegally dumped as shown in Figure 6, and law enforcement assistance should be pursued.

- The facility receives a considerable amount of trash in plastic bags. The Recycling Center management and/or the County Recycling Coordinator should work with municipalities to ensure that a small trash can is located at each drop-off site for plastic bags and other contaminants. Trash dumpsters are not recommended, as they can attract illegal dumping. Furthermore, the location of recycling sites should be in visible high-traffic areas to discourage illegal dumping.
- The Recycling Center management should request more frequent patrols by County or Municipal law enforcement to reduce illegal dumping that occurs

outside of the Recycling Center. Some communities have also found that searching through the dumped material for envelopes with names and addresses, installing lighting, and installing real or fake video surveillance cameras can reduce illegal dumping.

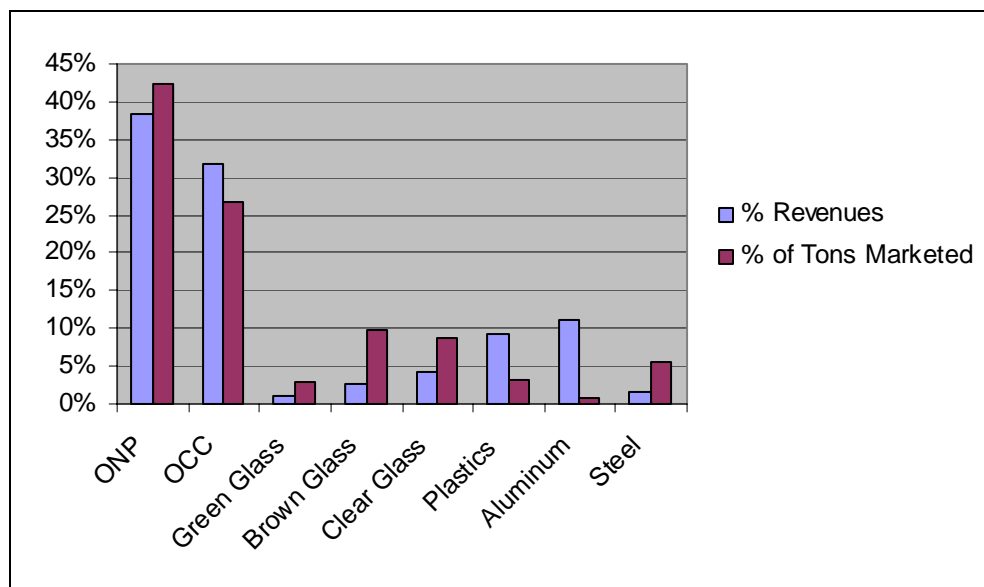
Figure 8
Materials Processed at Goodwill Industries Recycling Center in 2003

Figure 8 provides a summary by material indicating portion of incoming materials each material comprises, and the portion of revenue associated with each material.

As Figure 8 shows, the majority of tons and revenues for the Recycling Center comes from newspaper and corrugated containers.

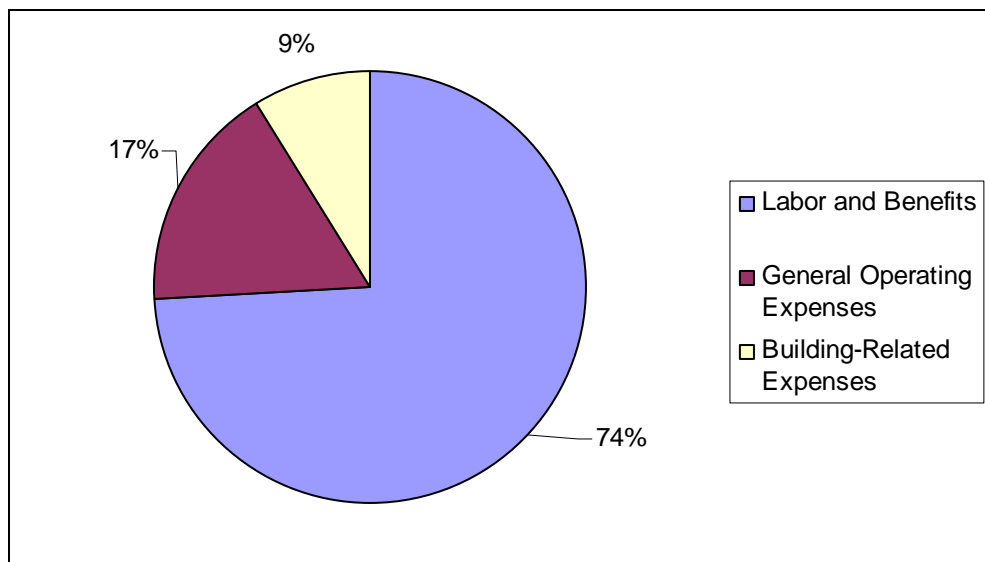
Figure 9
Goodwill Industries' Primary Operating Cost Areas

With annual total operating costs of \$301,051 and 3,000 annual tons, the facility's operating cost is \$100.35 per ton of incoming materials. Figure 9 compares the primary operating cost areas for the Recycling Center.
