SPRING CREEK AREA OF INTEREST WATERSHED IMPLEMENTATION PLAN

December 2025

Prepared for The Doc Fritchey Chapter of Trout Unlimited

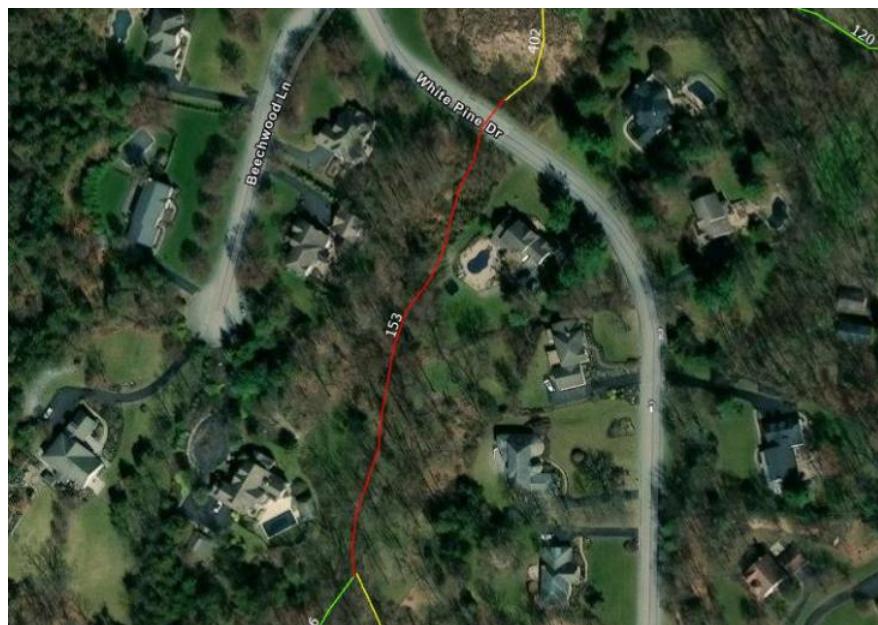
Figure 1. Example Non-Priority Reach with Poor Condition Scoring

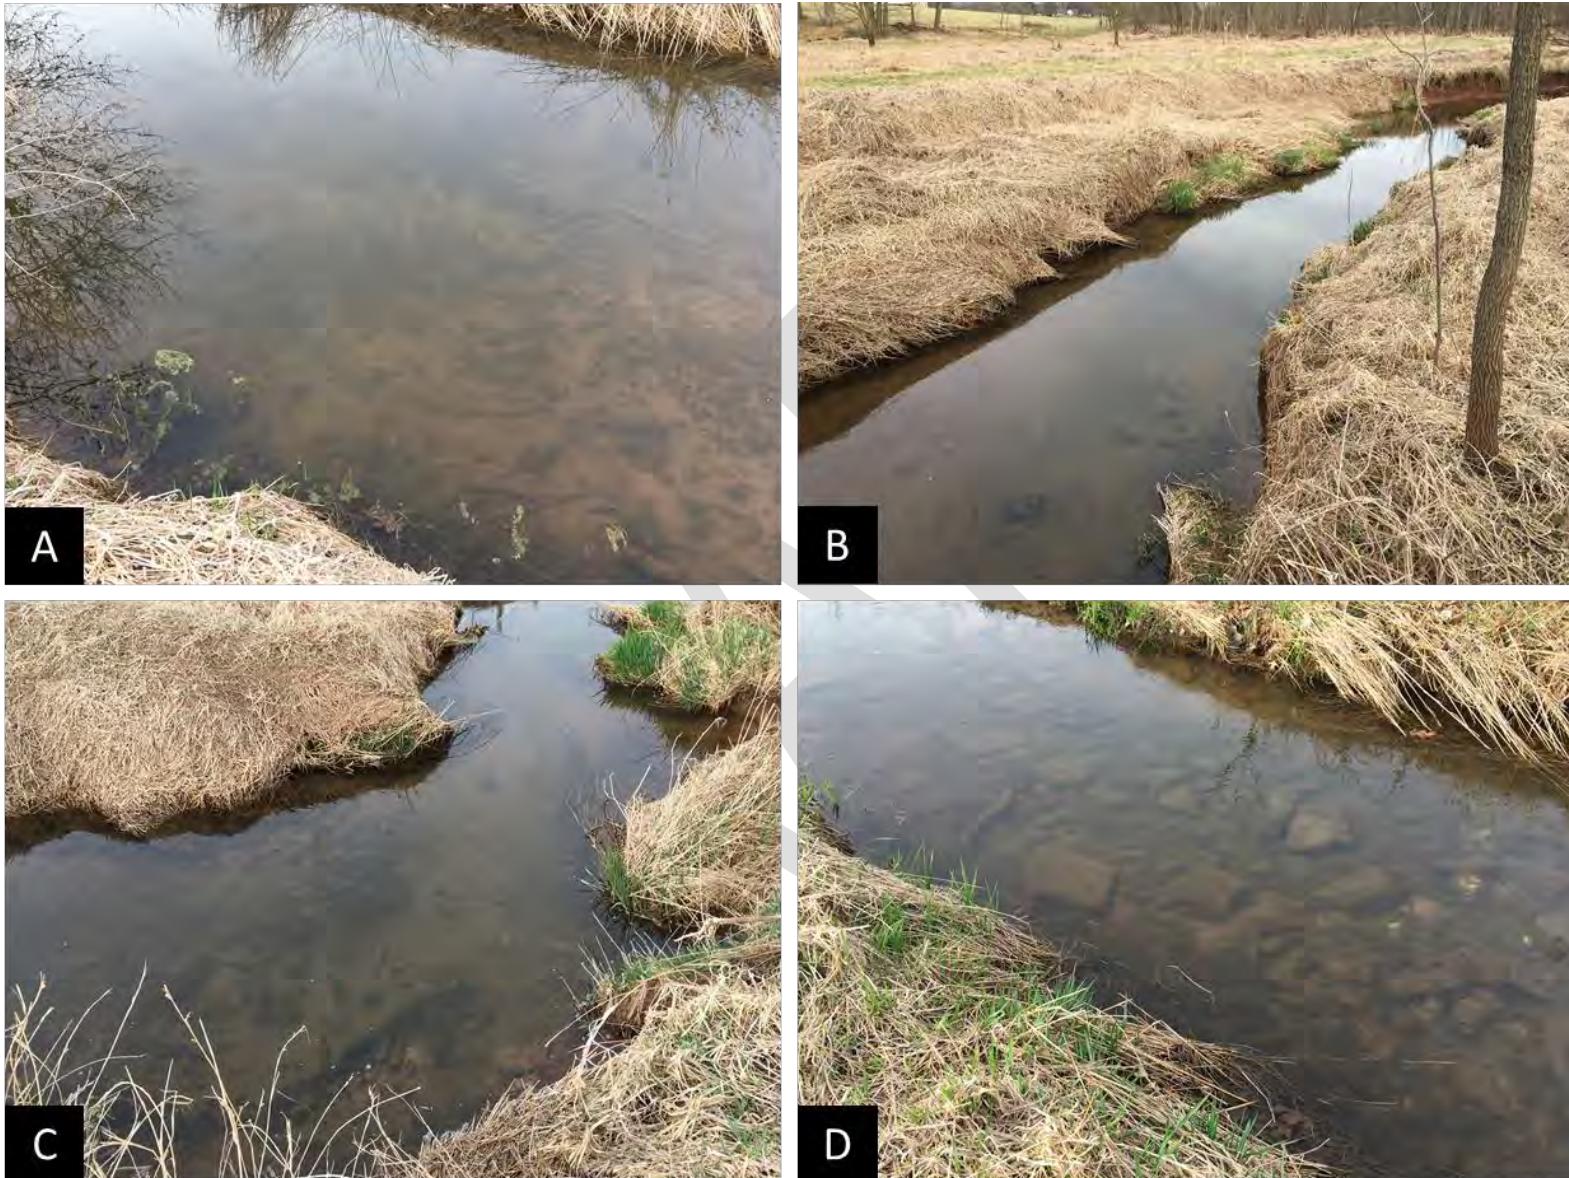
Figure 8. Stream conditions within the downstream mainstem of the eastern branch of the Spring Creek 319 study area watershed. Heavy siltation was obvious in many areas, although some rockier conditions could also occur.

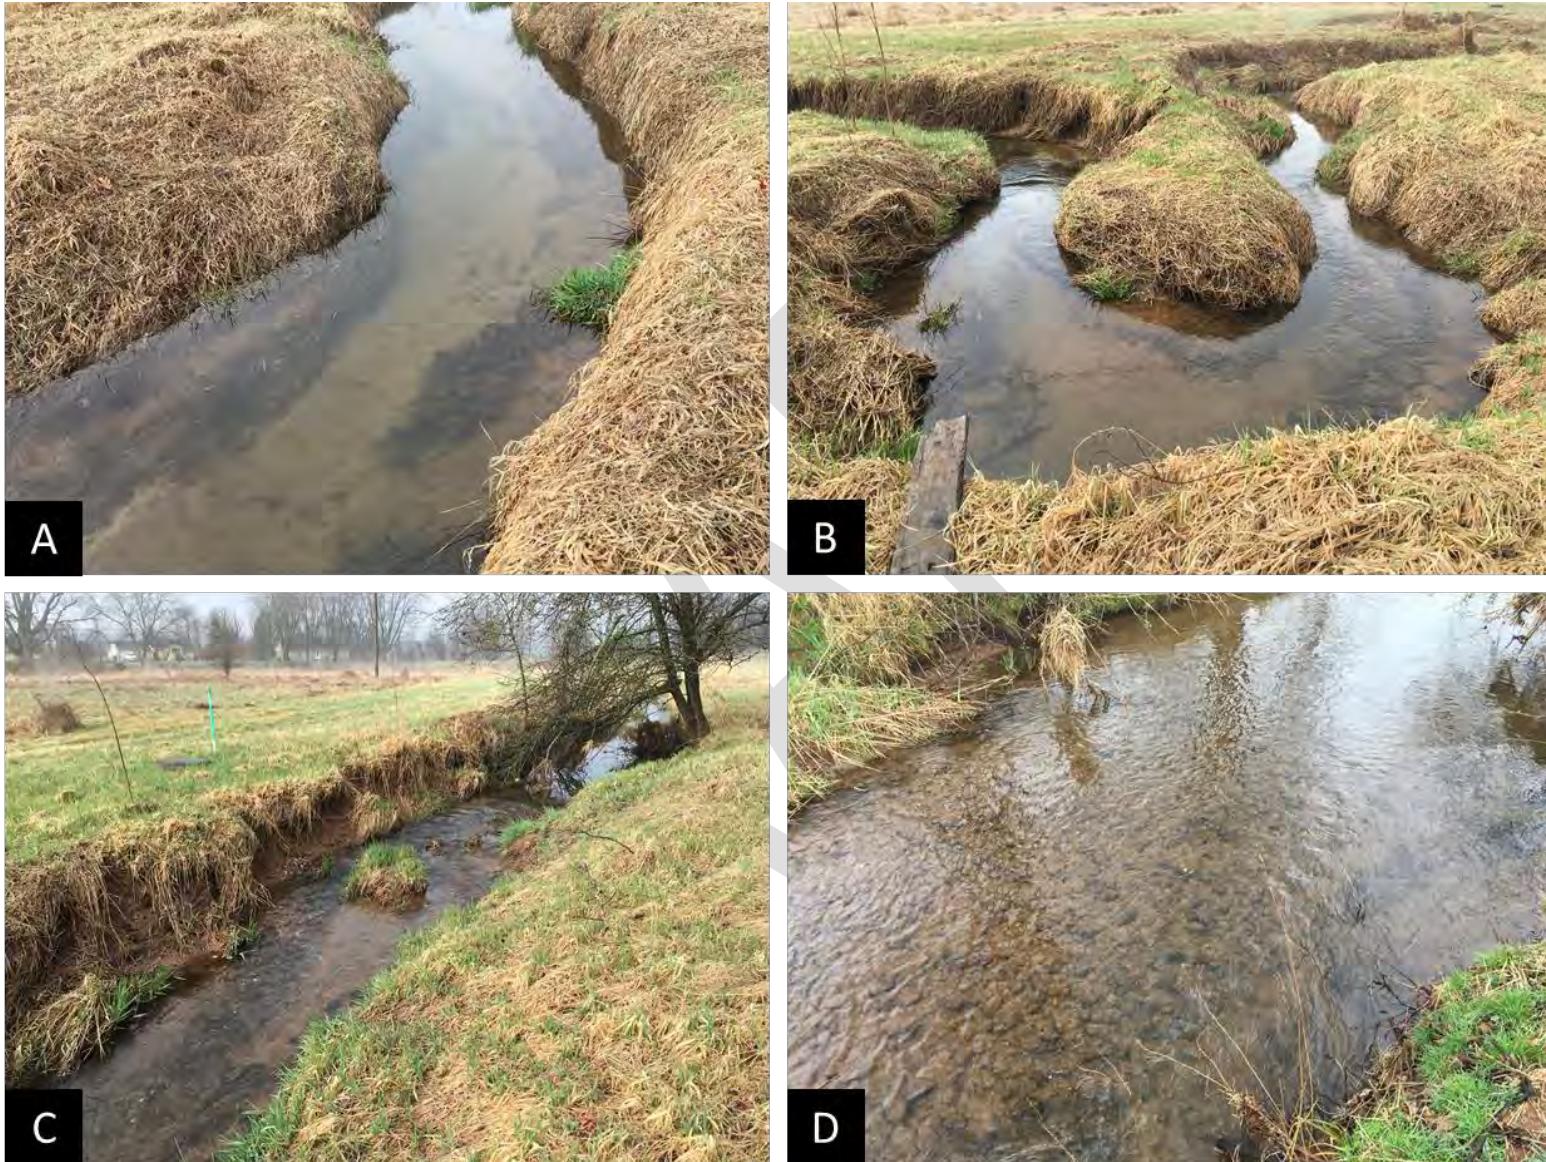
Figure 9. Stream conditions within the downstream mainstem of the western branch of the Spring Creek 319 study area watershed. Heavy siltation was obvious in many areas, although rockier conditions could also occur.

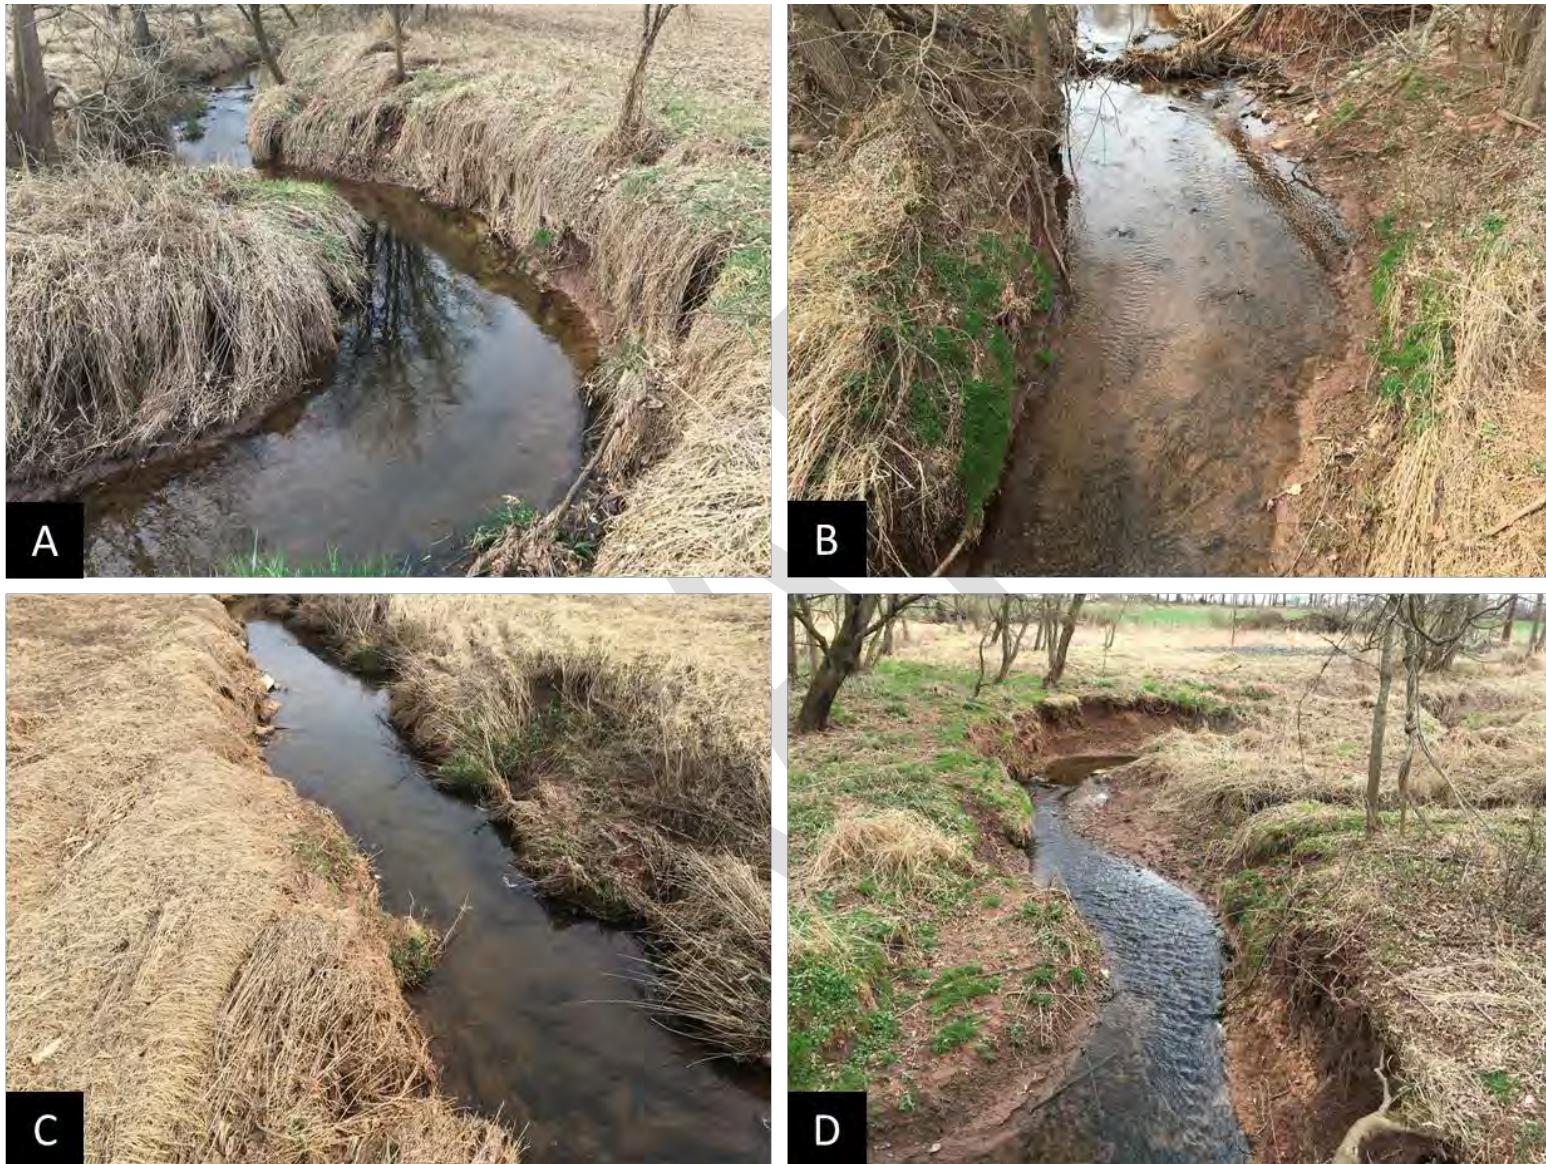
Figure 10. Stream conditions within lowland tributary areas of the Spring Creek 319 study area watershed. Heavy siltation was obvious in many areas.

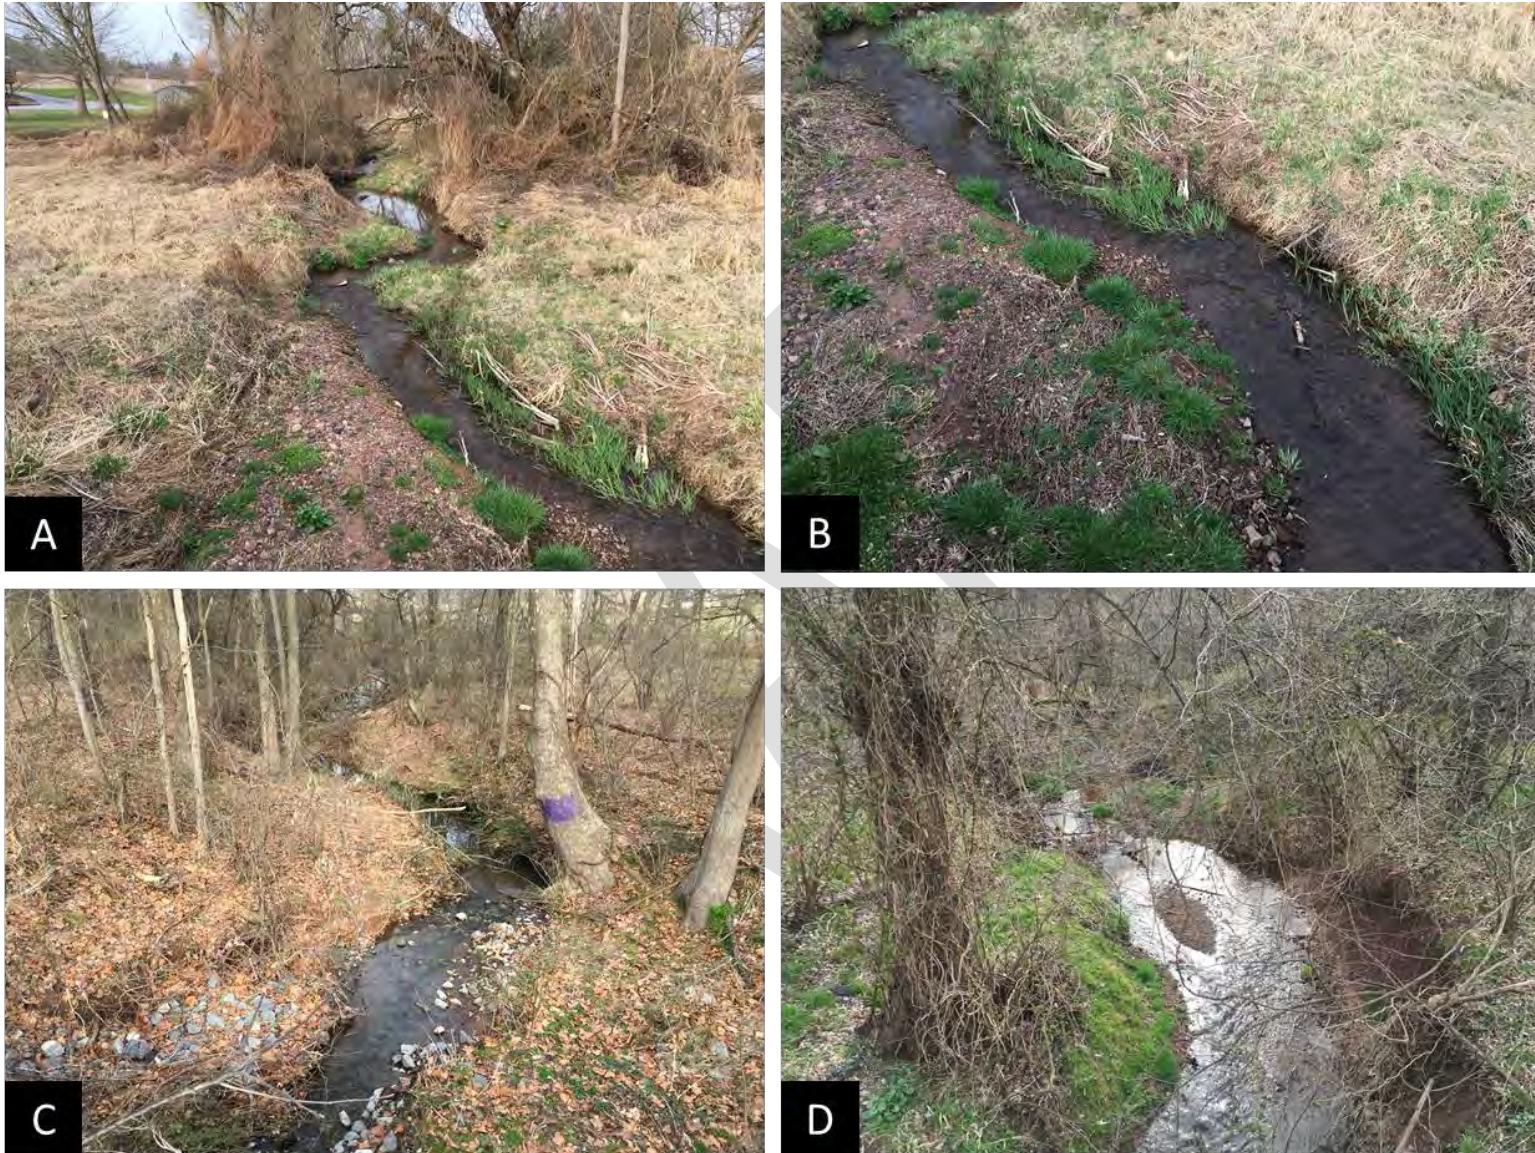
Figure 11. Stream conditions within the upland tributary areas of the Spring Creek 319 study area watershed. These stream segments often appeared far healthier than their lowland counterparts.

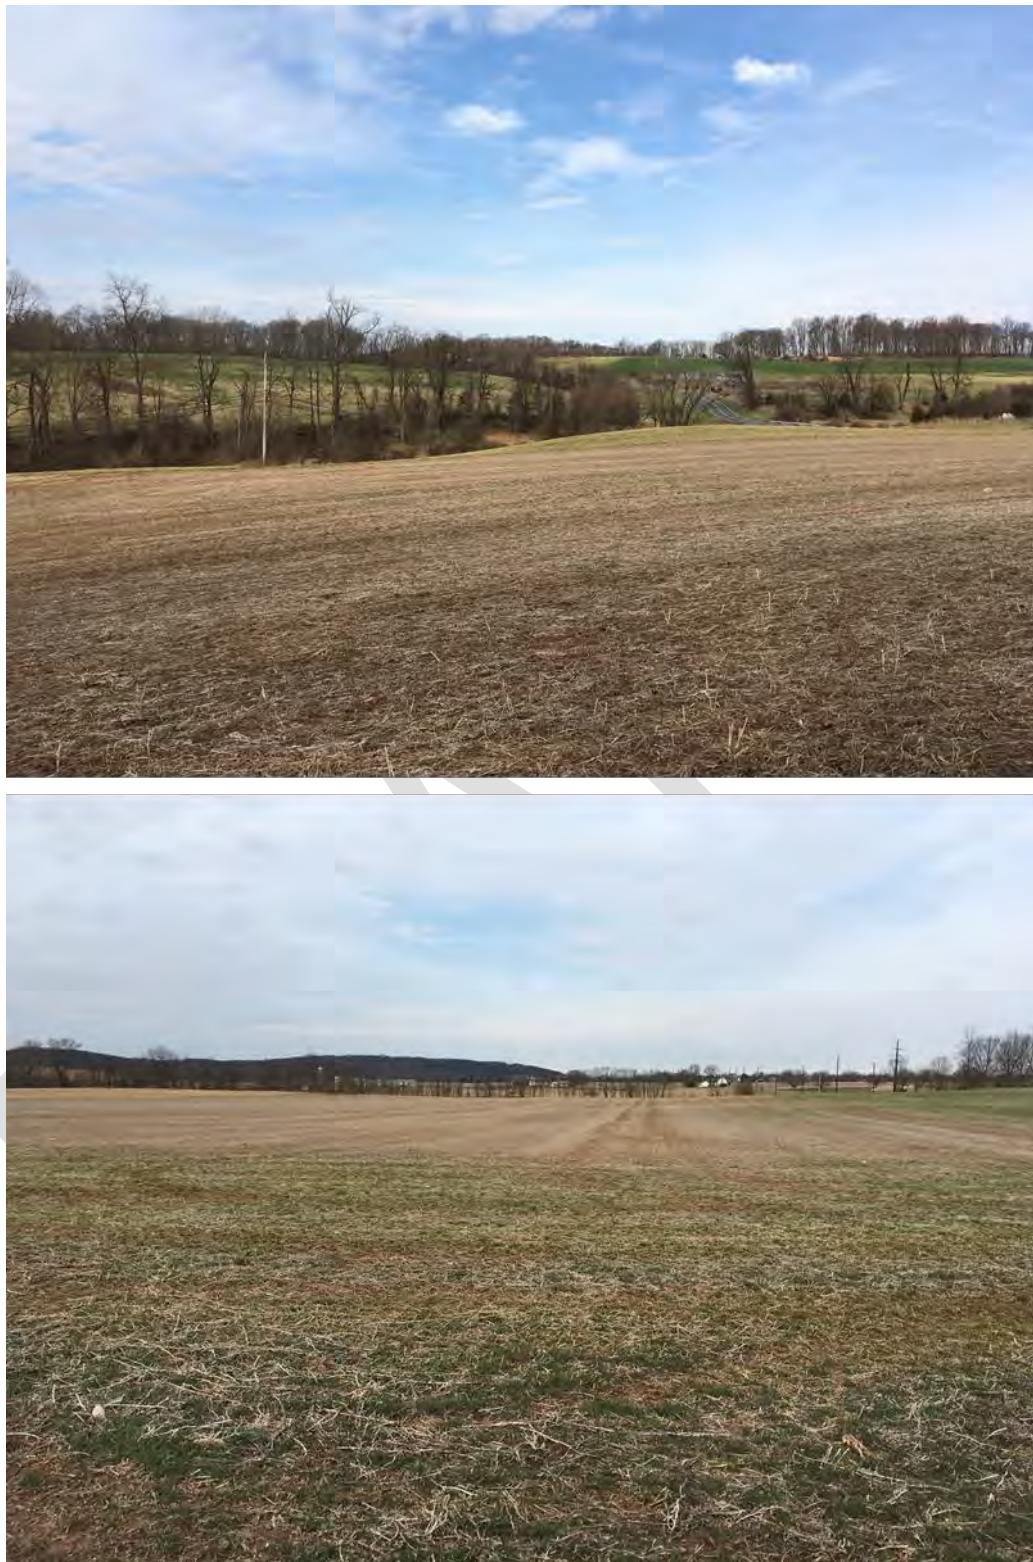
Figure 12. Landscapes within the Spring Creek 319 study area watershed. Upland areas (above photo) had large amounts of agriculture, though with patchy areas of forest especially along headwater streams. Downstream areas (below photo) often existed as broad areas of agriculture. The downstream area also had much development, though this is not visible in these photographs.

Practices that may be protective against sediment pollution were observed in the Spring Creek watershed as well, including both historic and recently planted buffers in some areas, and the protection of drainageways. And, practices such as no-till or conservation tillage were common (Figures 12 and 14). The overall impression from these observations was, that aside from the very high amount of agricultural land cover, practices within the watershed did not appear to be especially problematic. For instance, obvious highly degraded conditions, such as widespread use of conventional tillage, bare pasture areas, large numbers of livestock in the stream, etc. were not typically observed during the site visit. Thus, current practices alone did not appear to be sufficient to fully explain the severity of the observed siltation.

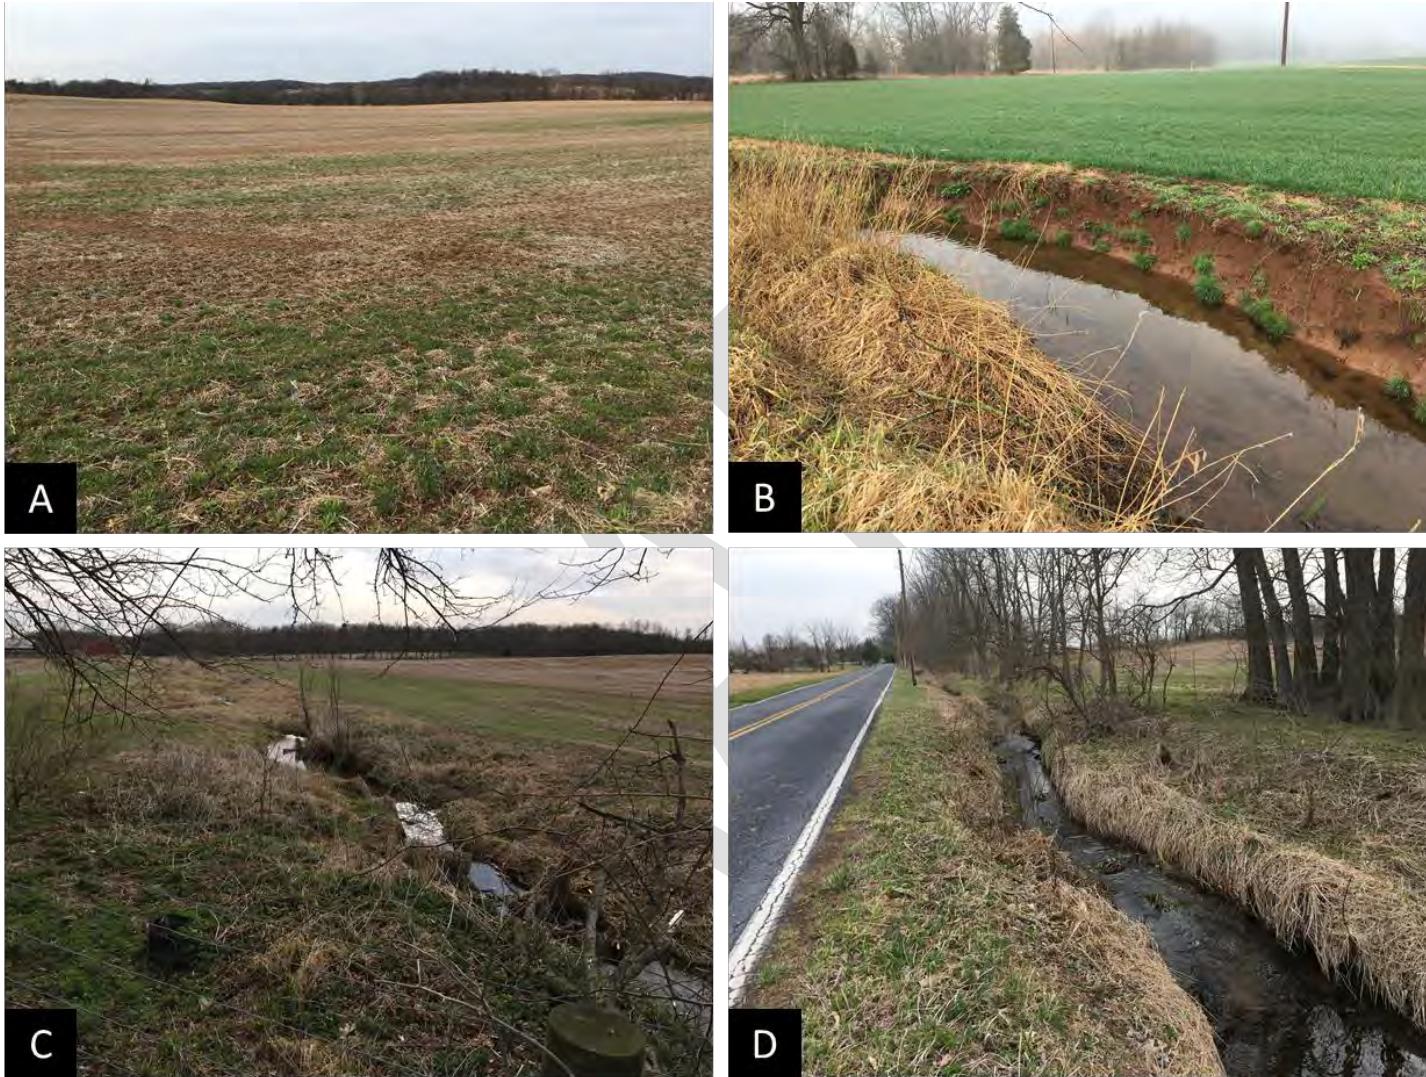
Figure 13. Factors promoting siltation within the Spring Creek 319 study area watershed. Photograph A shows an expanse of agricultural fields, while photograph B shows croplands draining to a stream segment. Also note the severe streambank erosion. Photograph C shows an area where it appears that livestock had direct access to the stream. Photograph D shows a stream running along a road amongst unbuffered croplands.

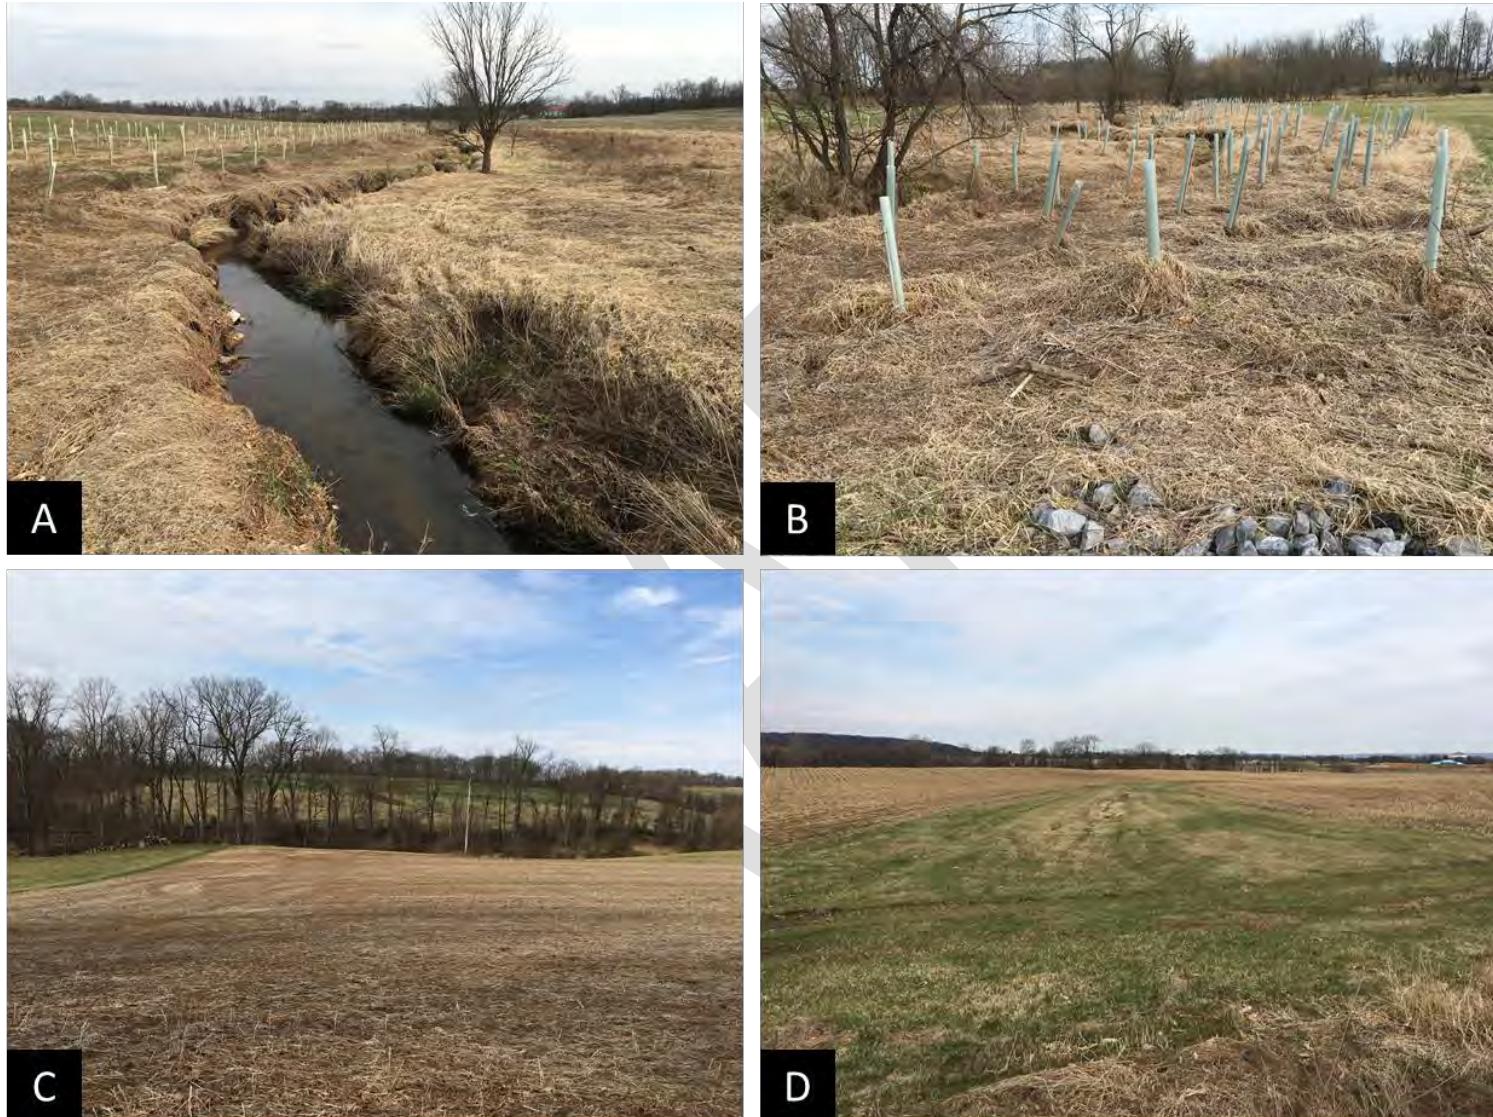
Figure 14. Factors that may protect against sediment pollution in the Spring Creek 319 study area watershed. Photographs A and B show large areas of new buffer plantings. Photograph C shows existing mature buffers. Photograph D shows a drainageway with a grass buffer. Note however, this could be improved by allowing for the growth of tall grass.

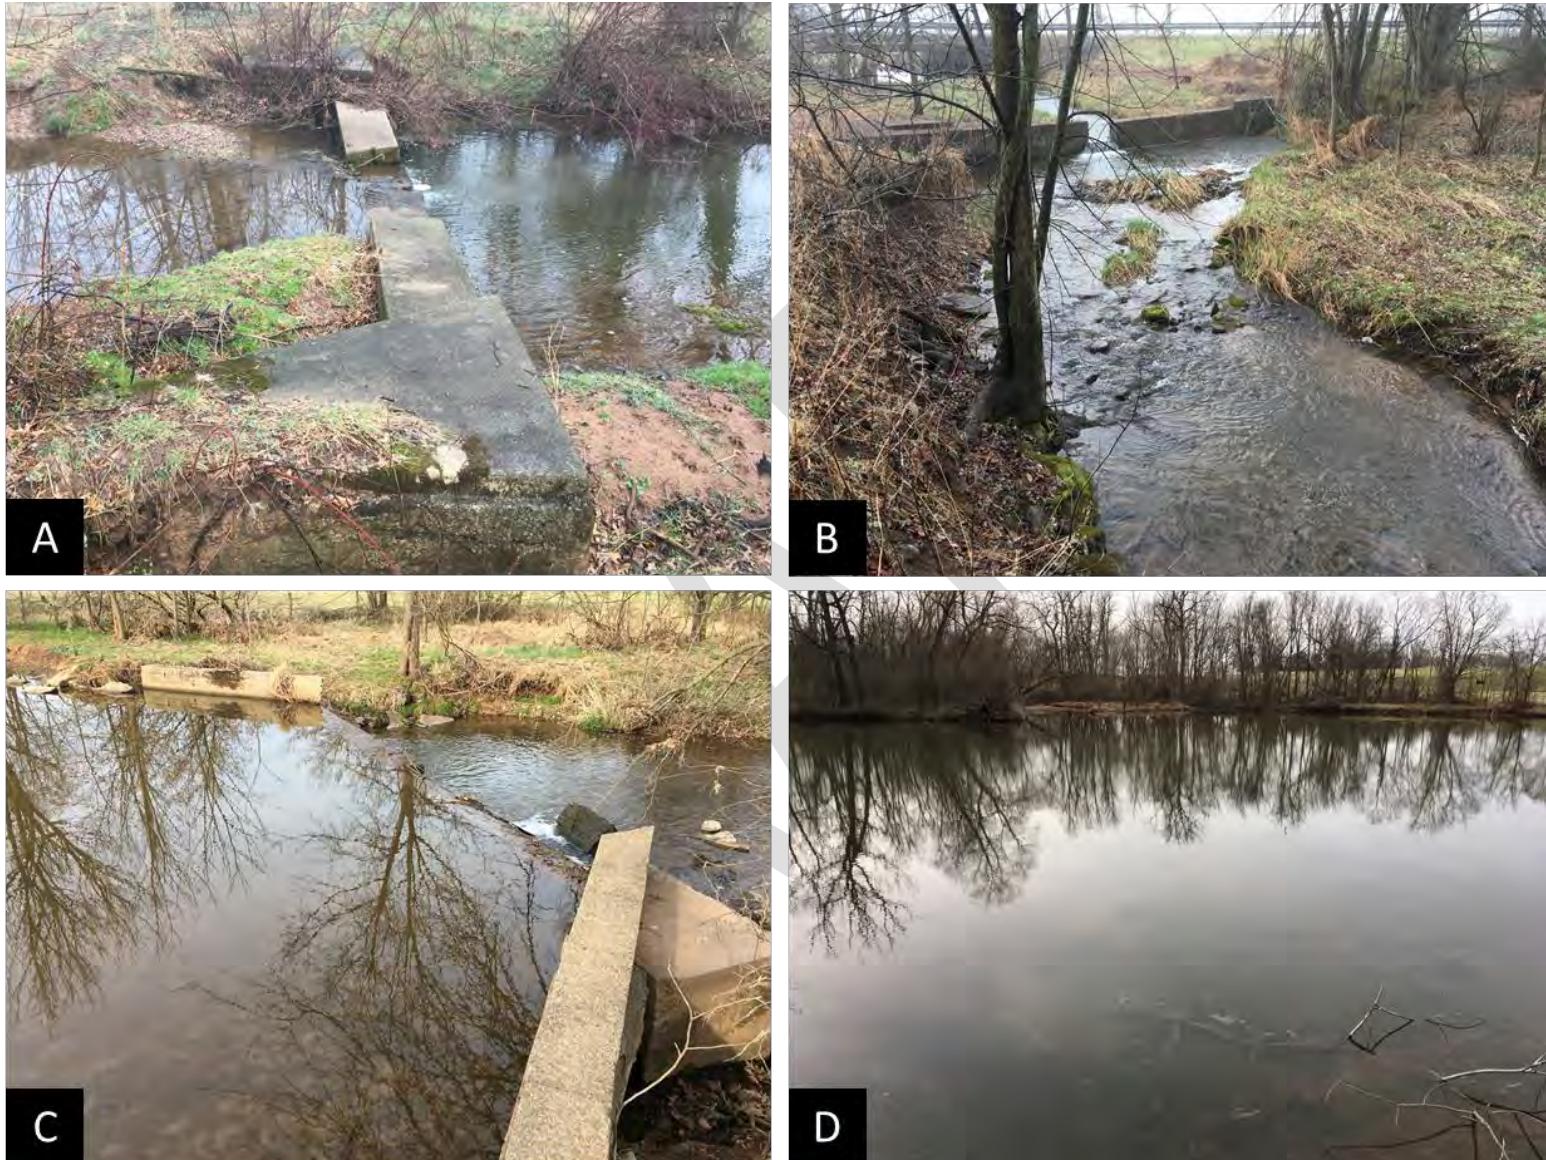
Figure 15. Examples of existing dams within the Spring Creek 319 study area watershed. These photographs show just a few of the numerous such dams that exist within this watershed.

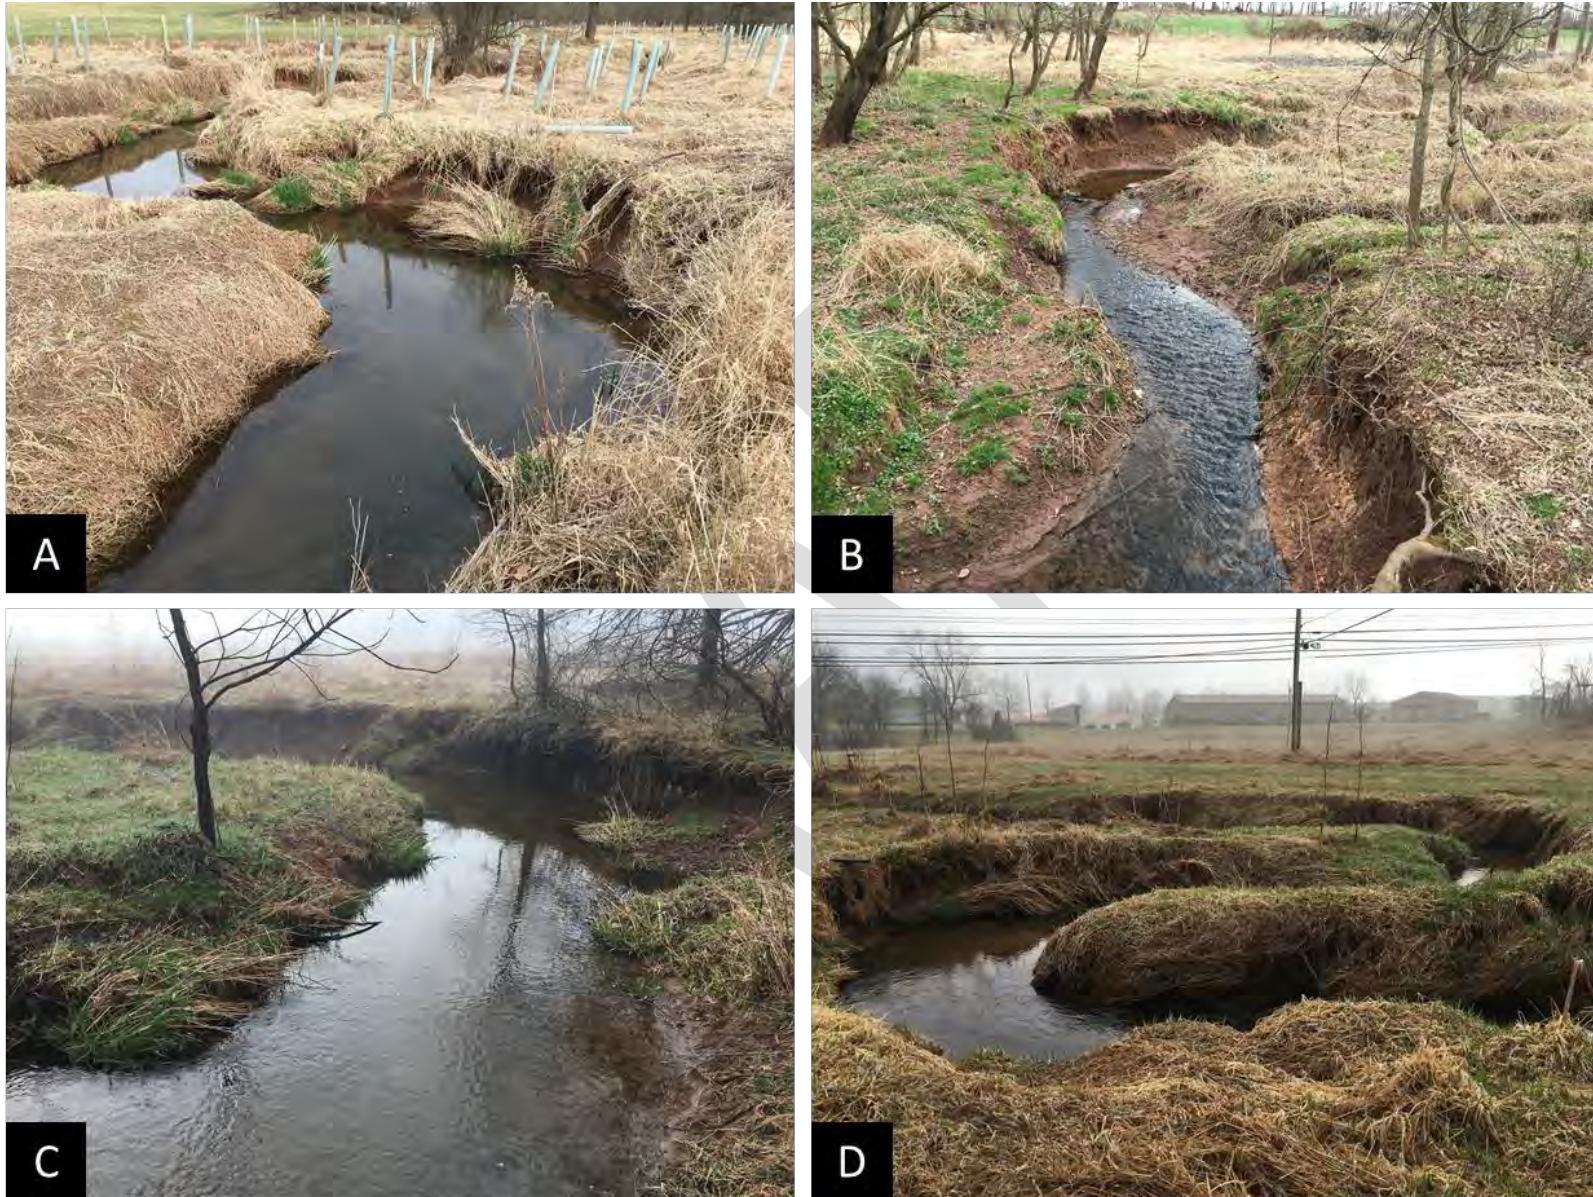
Figure 16. Apparent legacy sediments and resultant bank erosion within the Spring Creek 319 study area watershed.

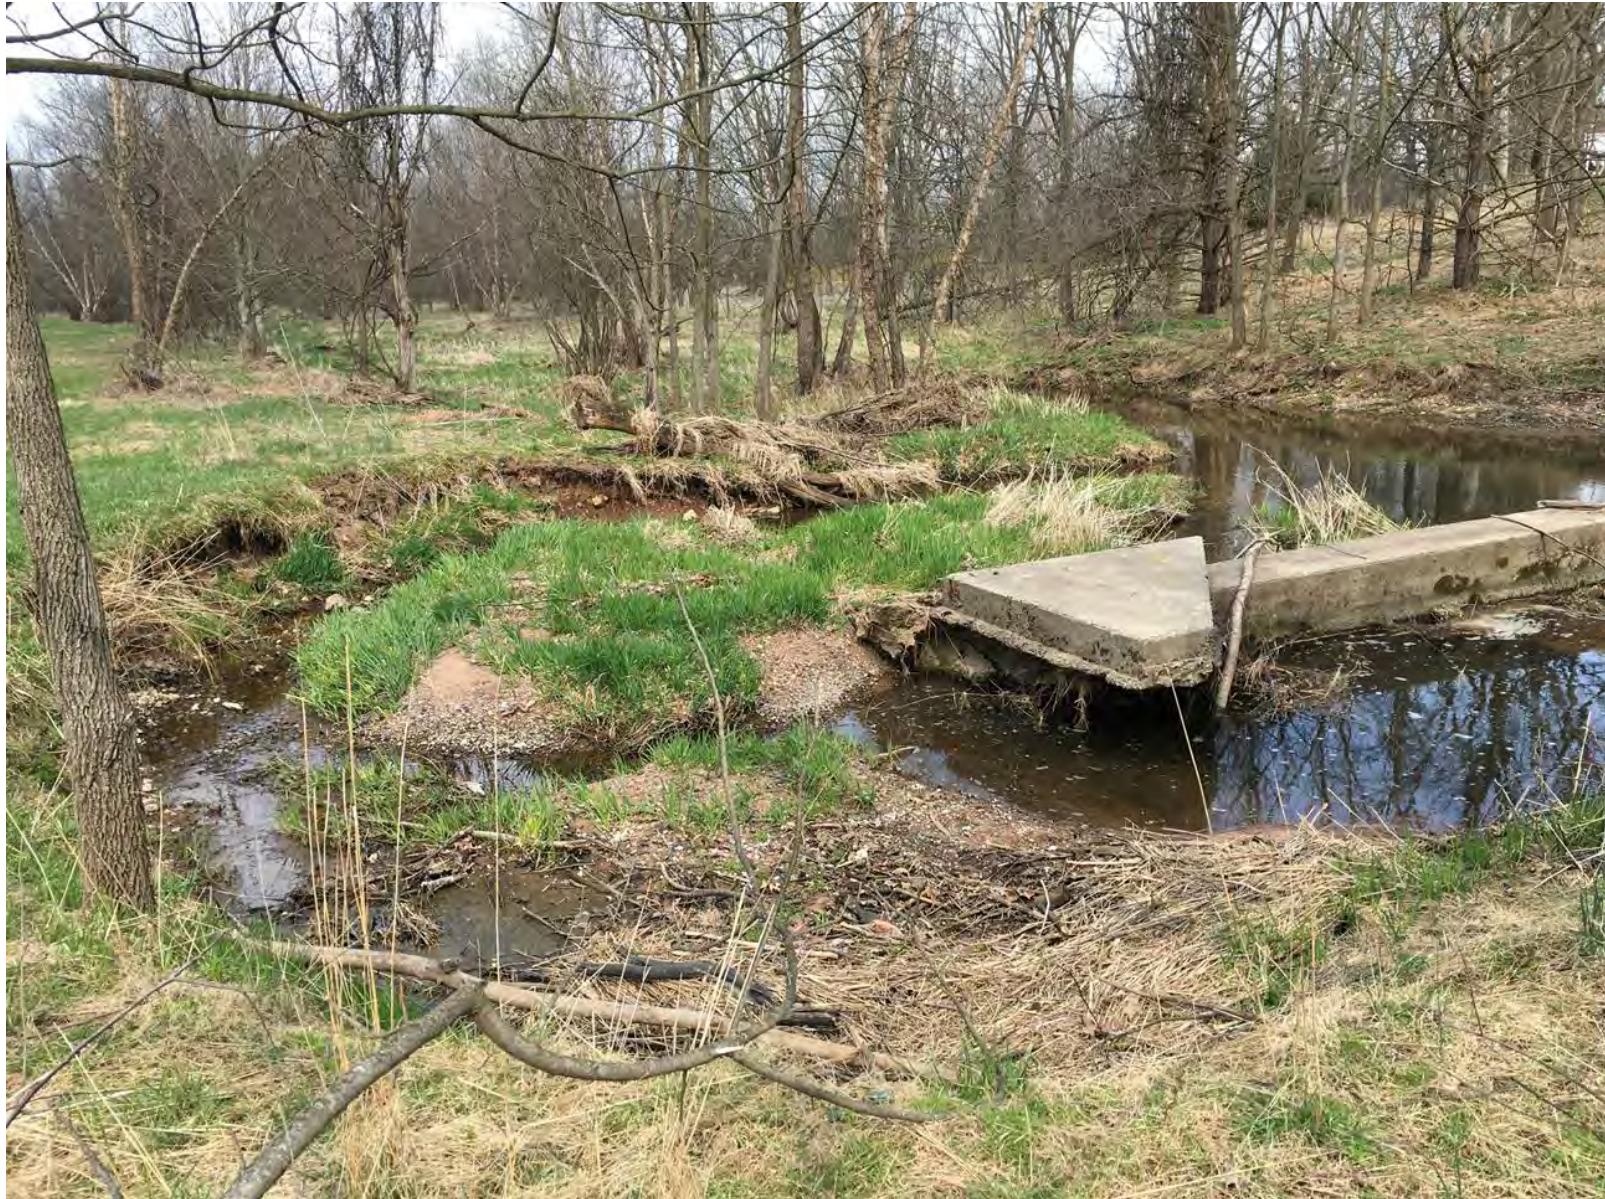
Figure 17. Erosive circumvention of an existing dam in the Spring Creek 319 study area watershed.

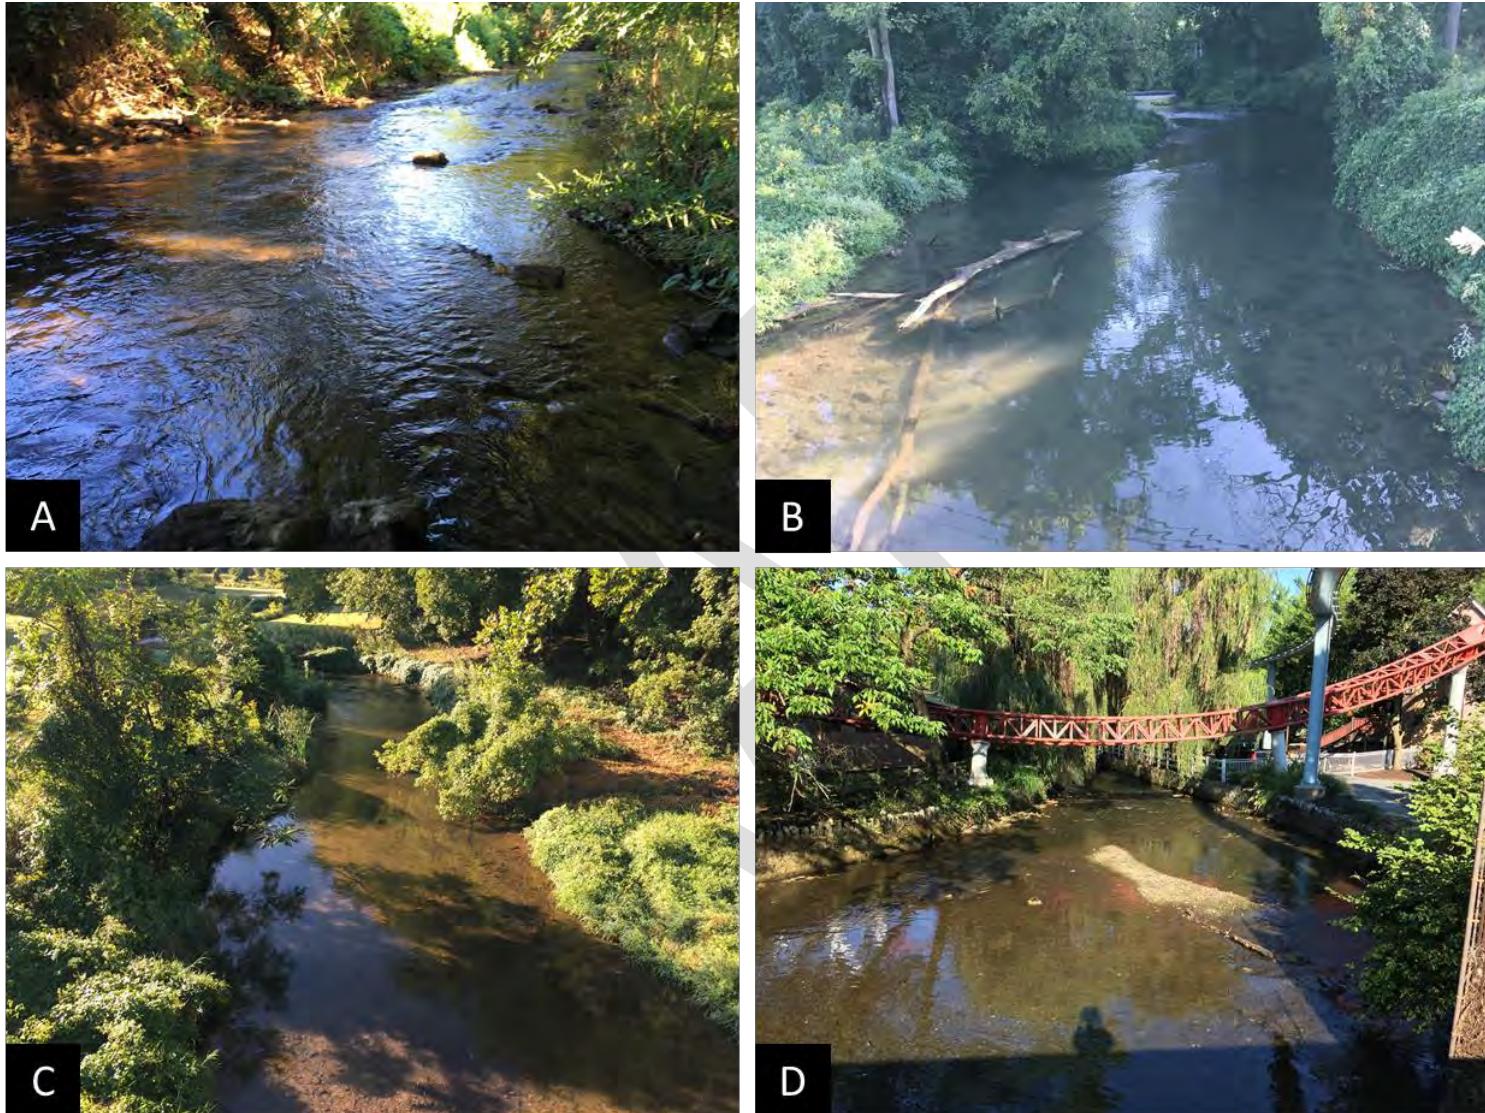
Figure 18. Lower mainstem reaches of Spring Creek downstream of the 319 study area. Photograph A shows the creek near its outlet to Swatara Creek. This area tended to be rocky, perhaps in part due to its higher gradient. While significant fines were apparent further upstream in the sluggish reach shown in B, much of the lower mainstem appeared to be dominated by gravel substrate (C and D).

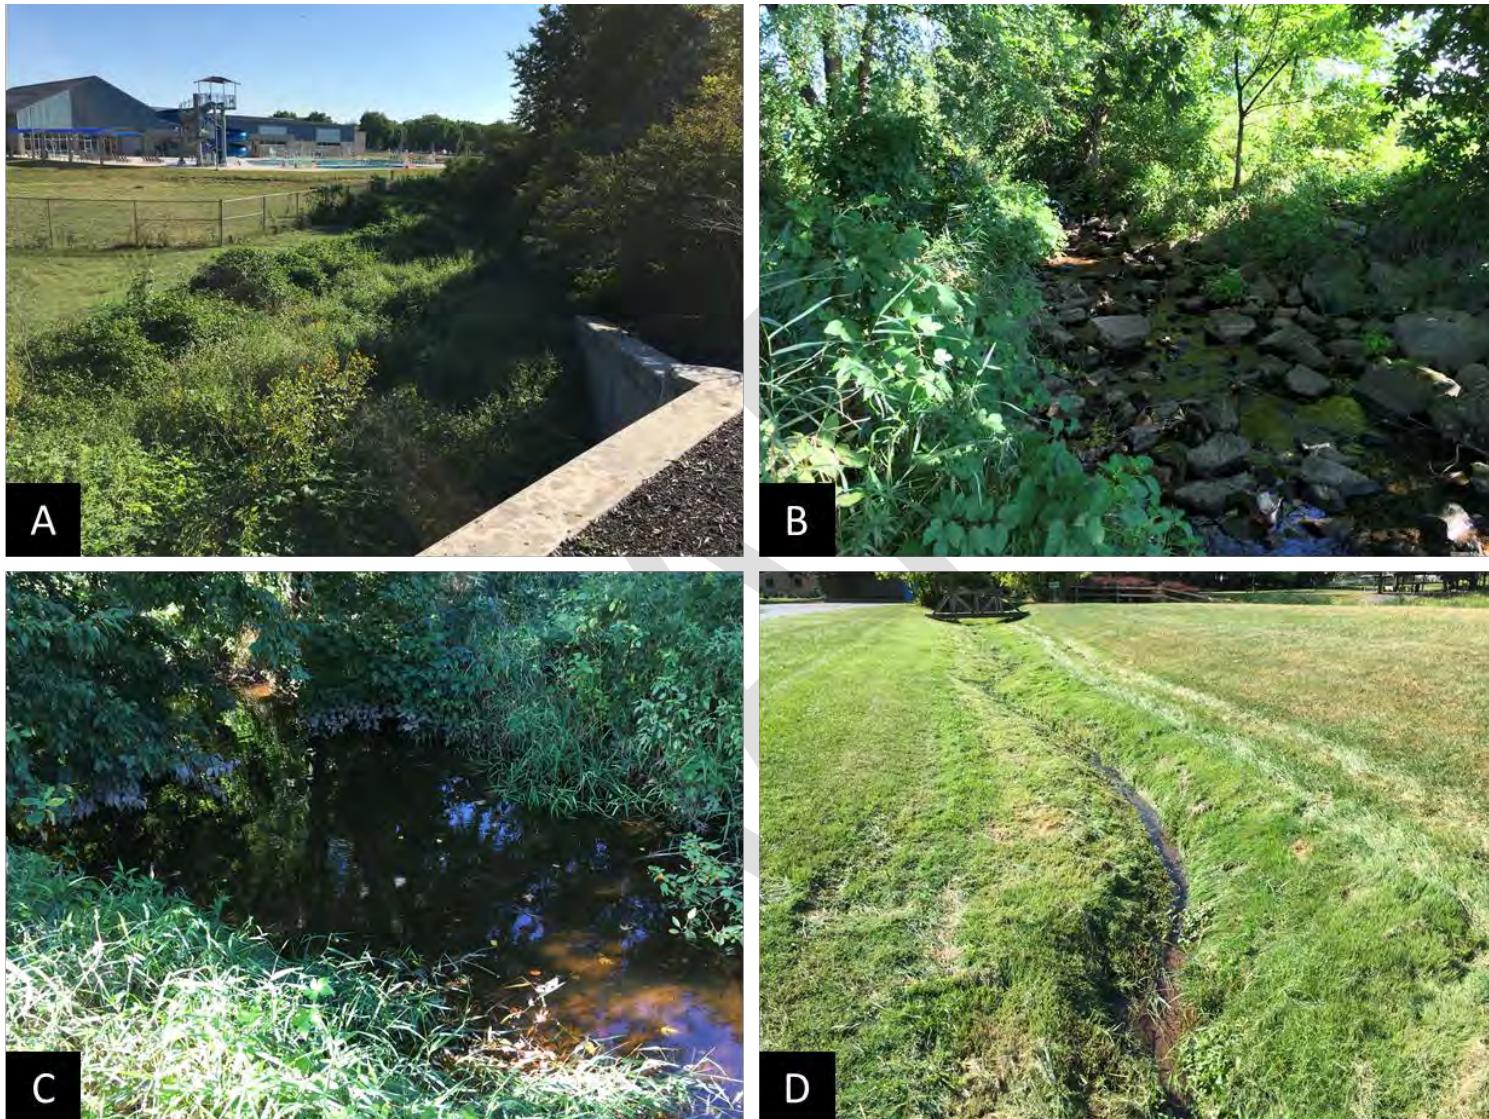
Figure 19. Main tributary west of the 319 study area (near Hockersville). During the summer visit, the lower portion of this tributary (in the Hershey Area) had no surface flow. Areas further upstream could be rocky and clear, while other areas appeared sluggish and suffered significant fine sediment deposition.
