SPRING CREEK AREA OF INTEREST WATERSHED IMPLEMENTATION PLAN

December 2025

Prepared for The Doc Fritchey Chapter of Trout Unlimited

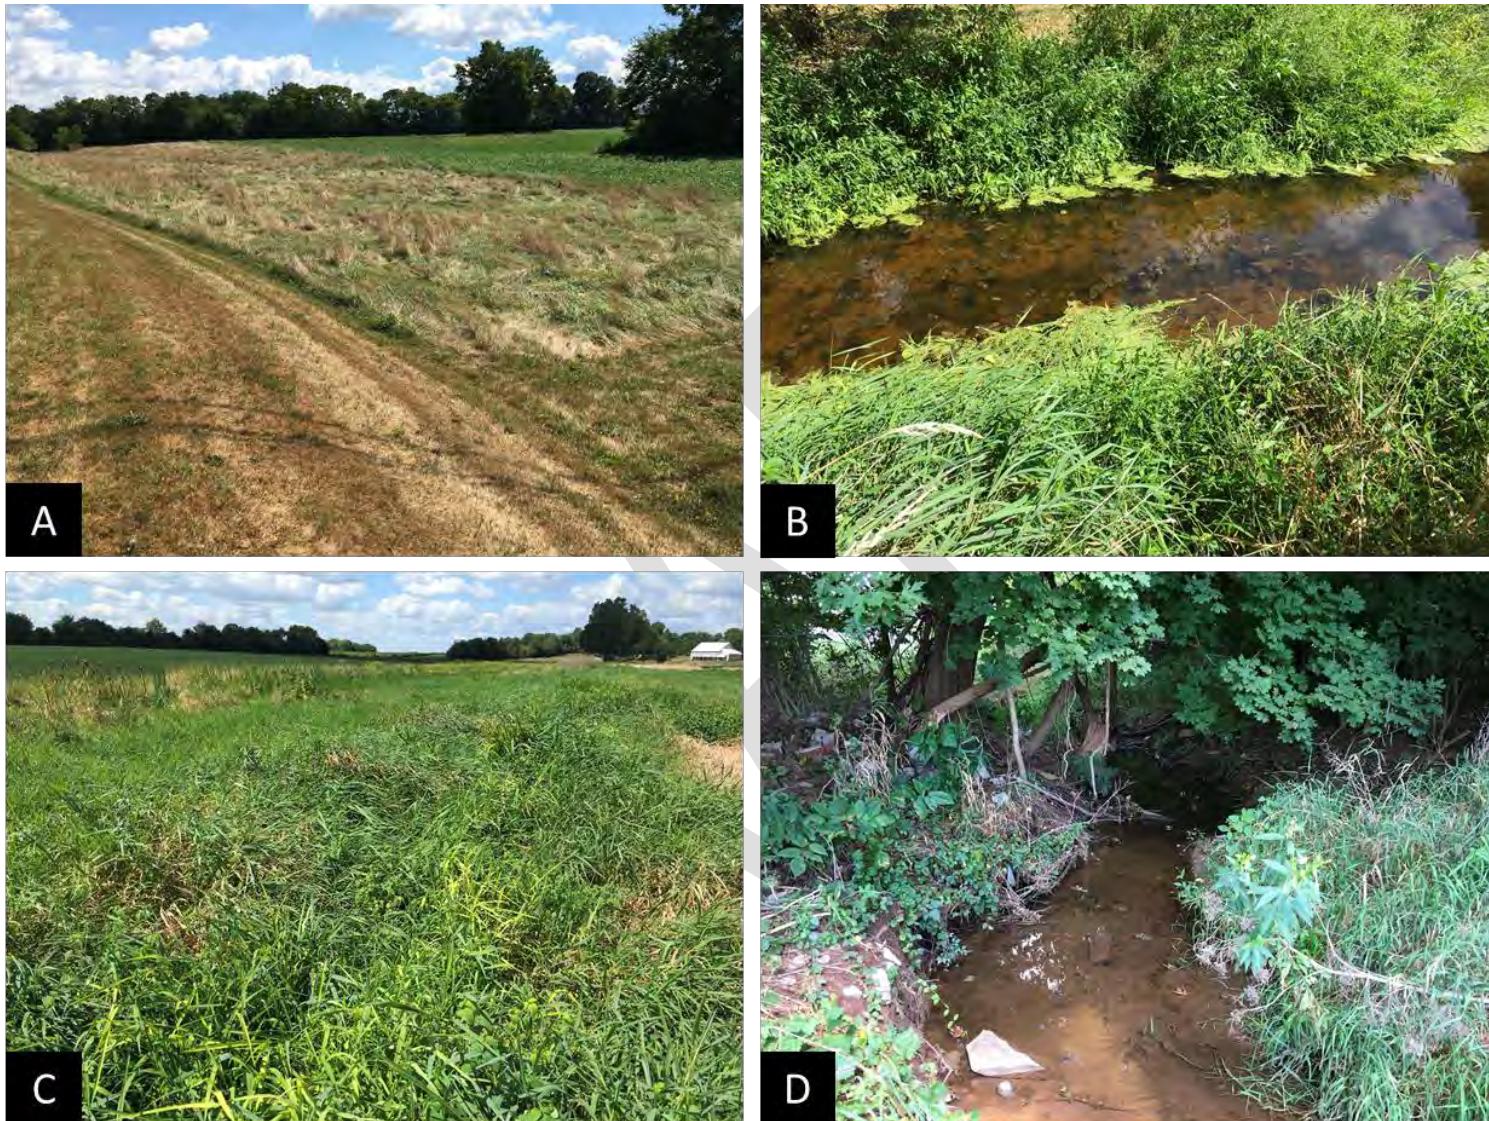
Figure 20. Main tributary east of the 319 study area (Campbelltown and Palmdale areas). As can be seen in photograph A, this tributary also lacked surface flow, at least from the Palmdale area to the Hershey Country Club Area (see Figure 2). Flow existed further upstream (photos B-D) and these areas tended to be sluggish and with silty substrate.

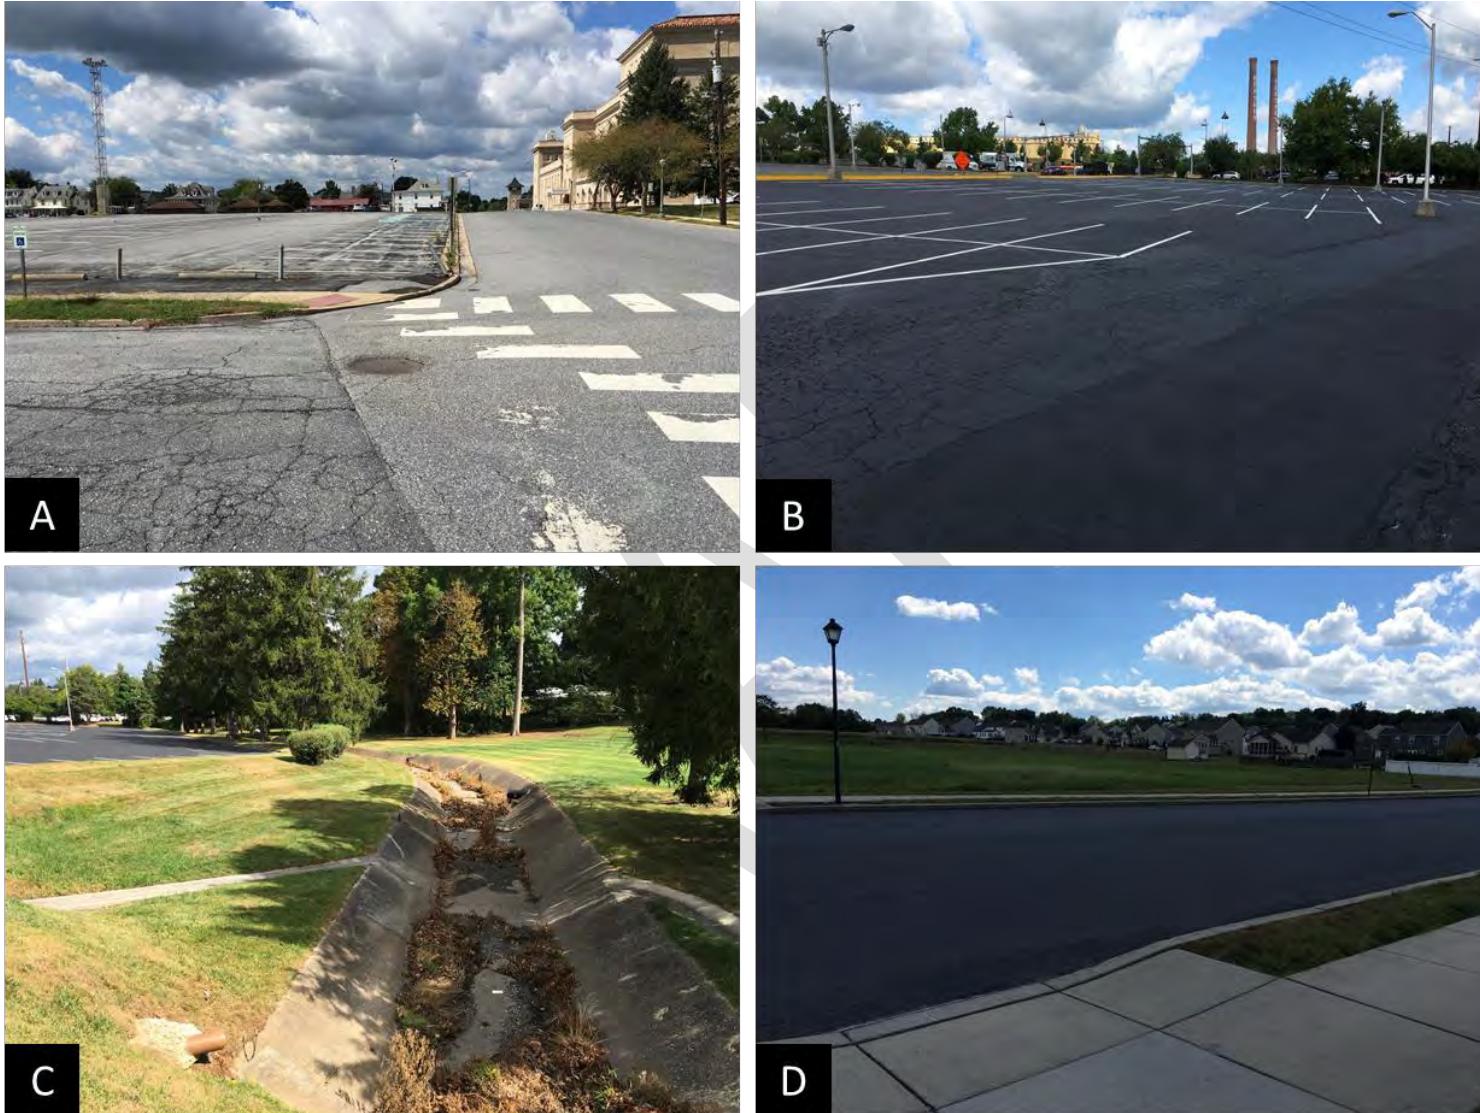
Figure 21. Developed lands outside of the 319 study area within the Spring Creek watershed. The Hershey area in particular had large amounts of high-density development and impervious area (A-C). Lower intensity development, as in D, occurred throughout the watershed.

As can be seen in Figures 2 and 21, both of these tributaries and the lower mainstem of Spring Creek are heavily influenced by development, which was especially intensive in the Hershey and Palmyra areas. In addition to being a direct source of siltation, the impervious nature of such development may increase surface runoff rates and bank erosion. Some areas outside of the 319 study area also had significant agriculture, but again, agricultural practices were not observed to be especially problematic, though tillage practices could not be evaluated during the summer visit (Figure 22). BMPs such as historic and new riparian buffer plantings, as well as drainageway protection and urban runoff BMPs (Figure 23), were likely helping to improve water quality, though more work needs to be done (Figure 22).

Figure 22. Examples conditions outside the 319 study area that may result in excessive siltation. In addition to the development shown in Figure 21, there was also areas of substantial agriculture, as in A and B. Photograph C shows a reach within a golf course suffering from severe bank erosion. Photograph D shows an unbuffered drainageway through a developed area that outlets to a stream.

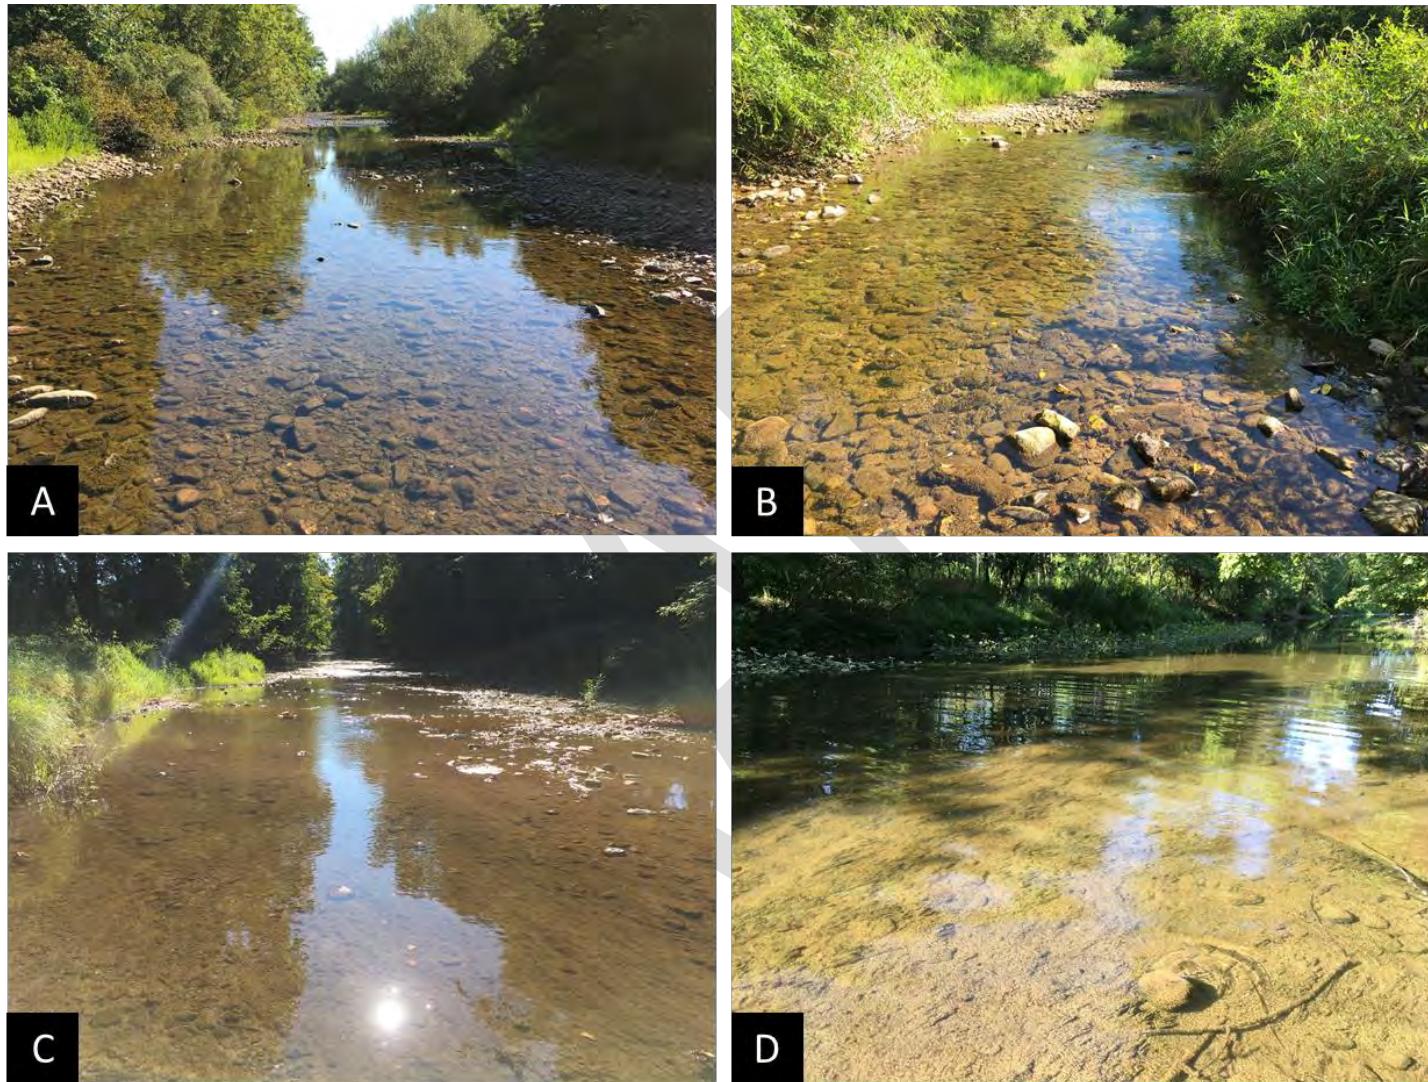
Figure 24. Stream conditions within the middle and lower mainstem of the Ontelaunee Creek watershed. Stream conditions were often clear and rocky as in A and B. While some fines deposition was apparent in C and D, wading through such areas revealed that this was typically a light dusting of fines on otherwise rocky substrate. This may be in part due to very low flows during the midsummer site visit that may have promoted settling.

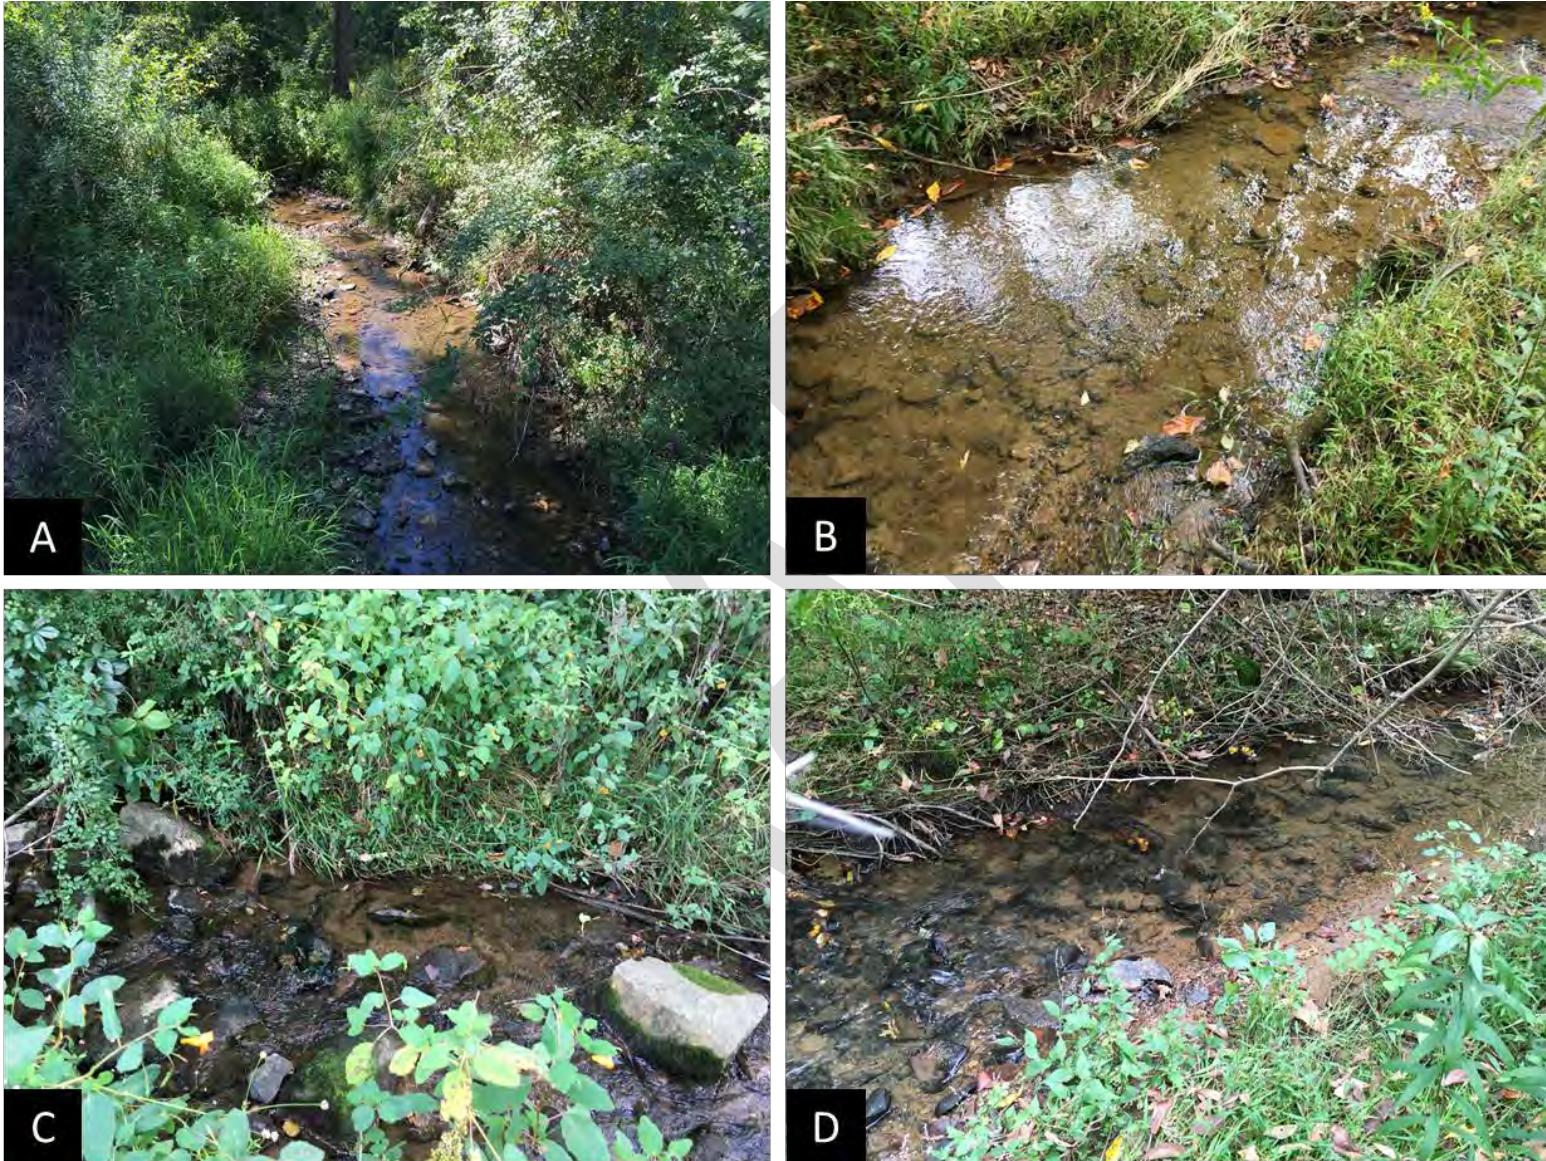
Figure 26. Stream conditions within smaller tributaries of the Ontelaunee Creek watershed. While such streams were typically rocky, significant fines deposition was present in some cases.

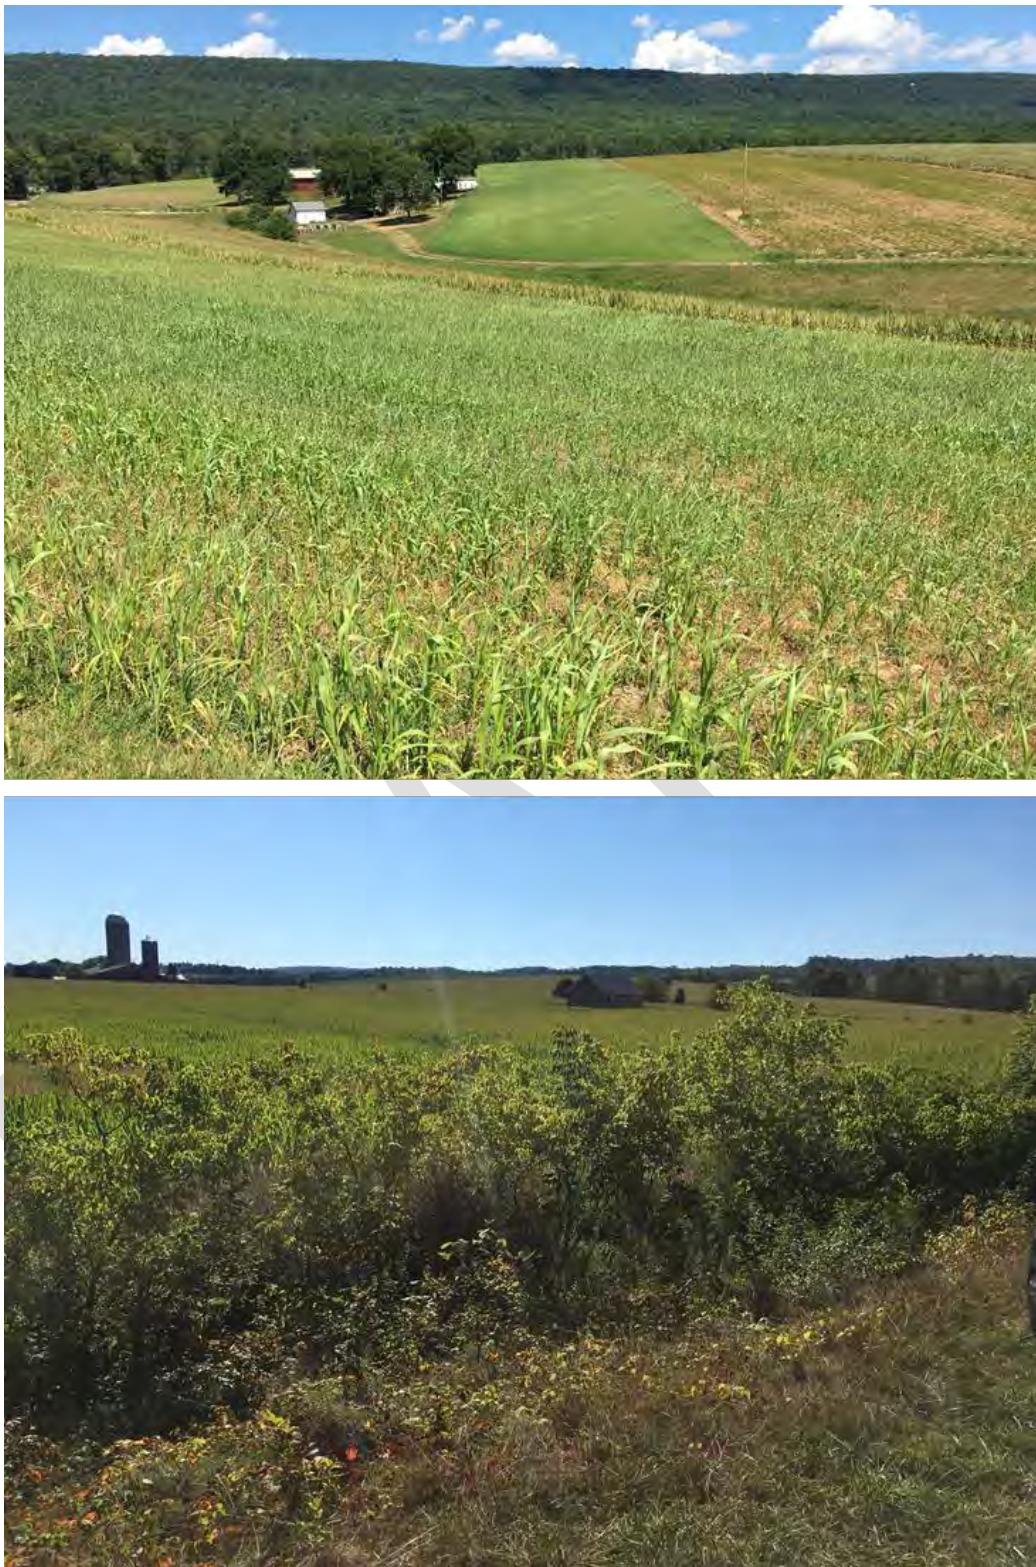
Figure 27. Typical landscapes within the Ontelaunee Creek watershed. Much of the watershed was dominated by agriculture, though some large forested tracts existed in uplands of the northern and southern margins of the watershed. While not shown above, streamside areas often had expansive forested buffers.

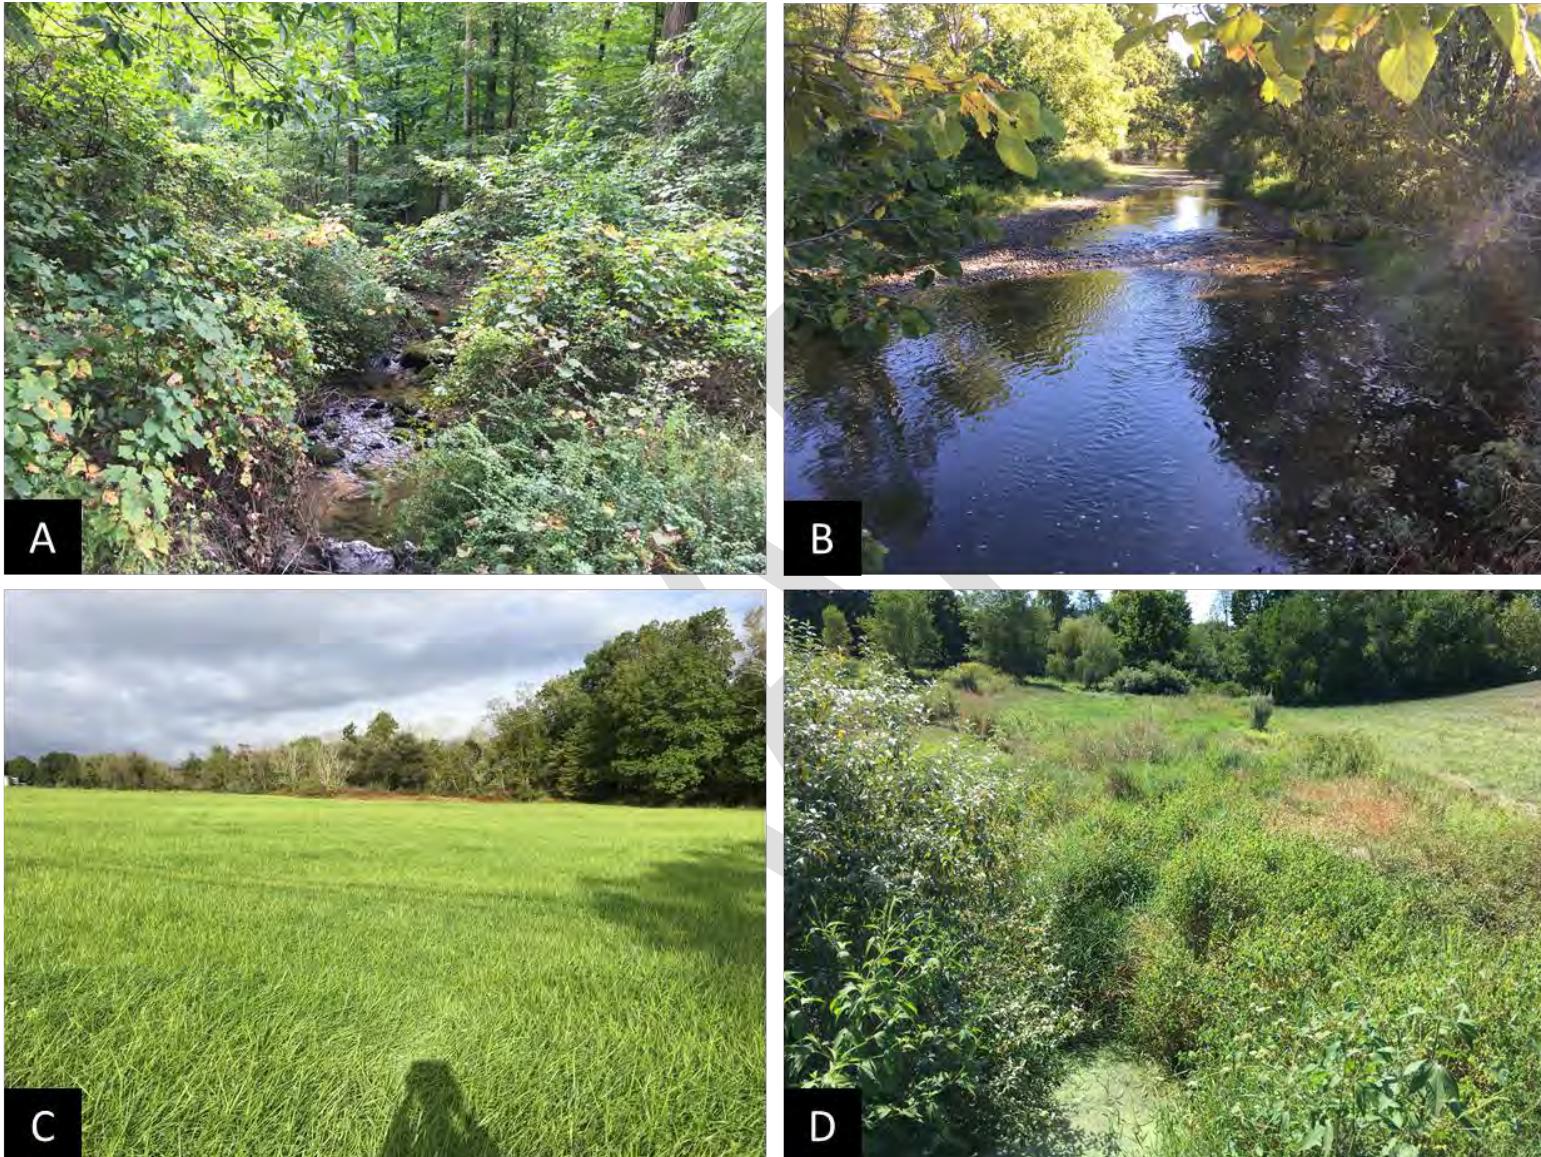
Figure 28. Factors that may be protective of water quality within the Ontelaunee Creek Watershed. Stream segments tended to be exceptionally well buffered.

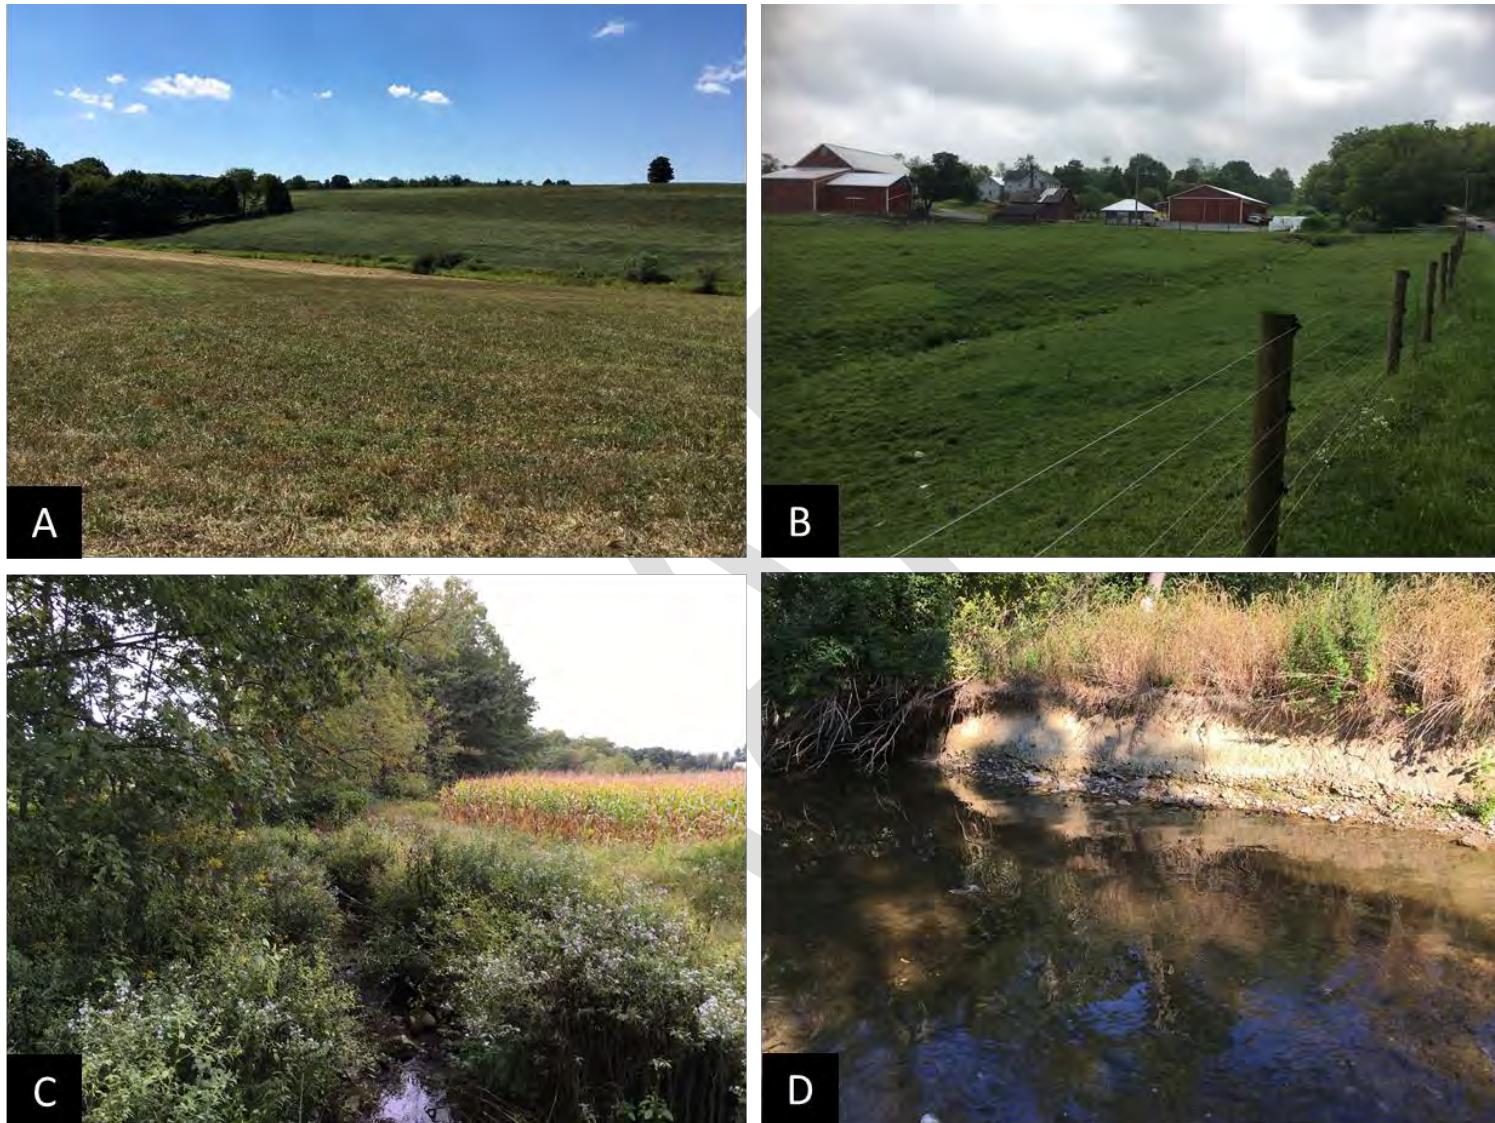
Figure 29. Factors that may promote siltation pollution within the Ontelaunee Creek watershed. In addition to the overall high amount of agriculture, areas where buffering could be implemented or improved were also observed (A through C). Photograph D shows an area of substantial bank erosion.
