# UPPER BIG COVE CREEK WATERSHED IMPLEMENTATION PLAN

June 2024

Prepared by Center for Watershed Protection, Inc. (CWP)  
&  
Ecosystem Planning & Restoration (EPR)

Prepared for the Fulton County Conservation District

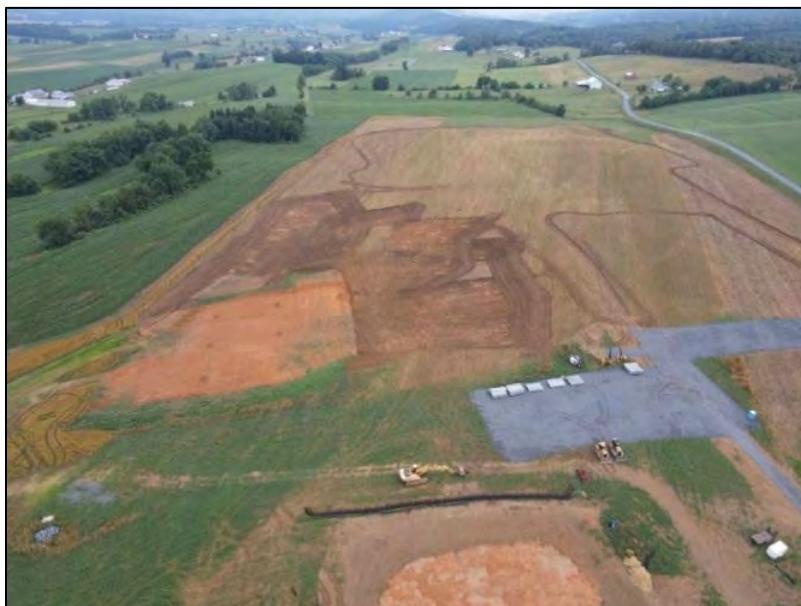
Figure 14. Solar farm site Big Cove Creek watershed (Source: Fulton County Conservation District)

A potential issue of concern in the Big Cove Creek watershed is the increasing use of agricultural land for the placement of solar farms (Figure 14). The construction associated with solar farms is subject to the same NPDES permit coverage requirements for earth disturbance of one acre or greater as outlined in 25 Pa. Code § 102.5(a). This includes erosion and sediment control practices as well as post construction stormwater controls to mitigate runoff. The primary goal to address stormwater runoff is mitigation through the preservation or restoration of perennial vegetative cover to infiltrate runoff and avoid concentrated flows beneath the installed panels. PA DEP has a frequently asked questions (FAQ) document that details the criteria to meet post construction requirements for solar farms (PA DEP, 2021).

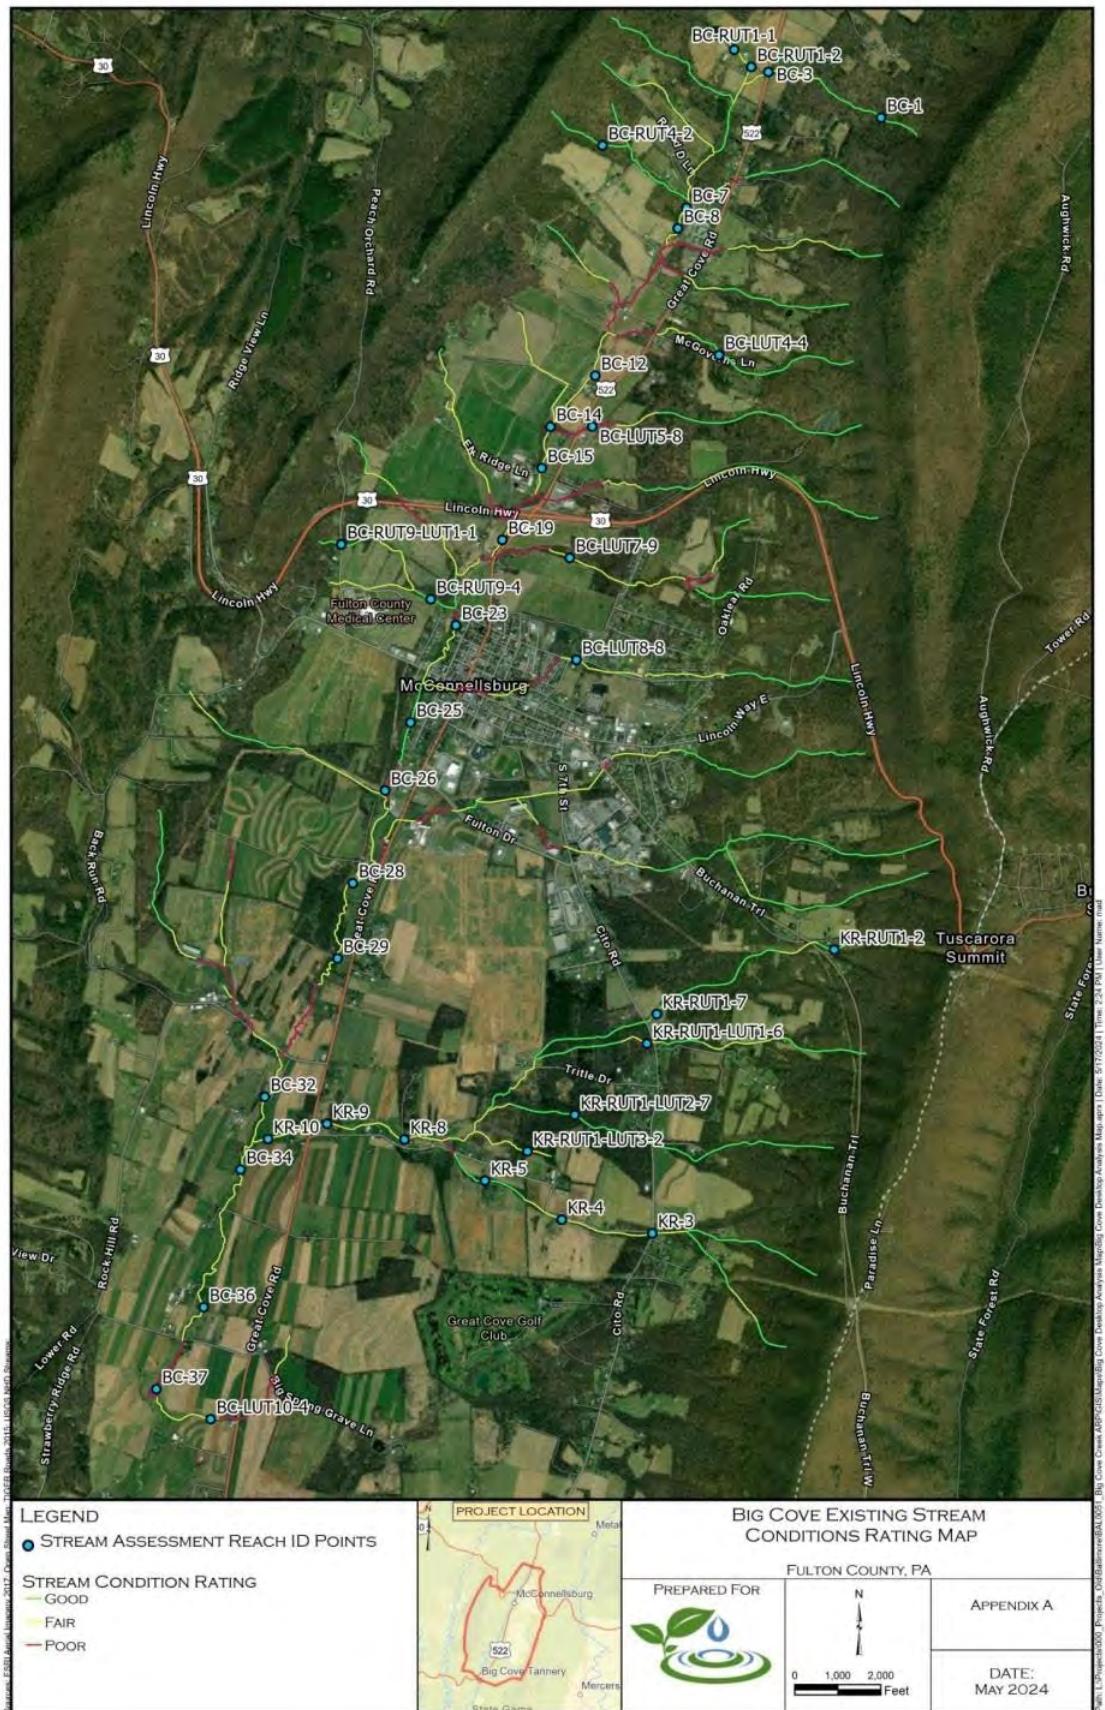
Figure 24. Map of existing stream condition ratings from Appendix B to EPR's Upper Big Cove Creek Alternative Restoration Plan Stream Assessment Report (Appendix C)

The scores for each reach were summed to yield the overall stream segment condition score. The worst overall score possible is theoretically a 16, but no reach scored worse than a rating of 14. Given this distribution, scores were then sorted into three equal sub-ranges for stream stability: 6 – 8 is good condition, 9 – 11 is fair condition, and 12 – 14 is poor condition.

The FBRSA used the assessment ratings of Functioning, Functioning-at-Risk, and Not-Functioning to parallel the overall rating conditions of good, fair, and poor.

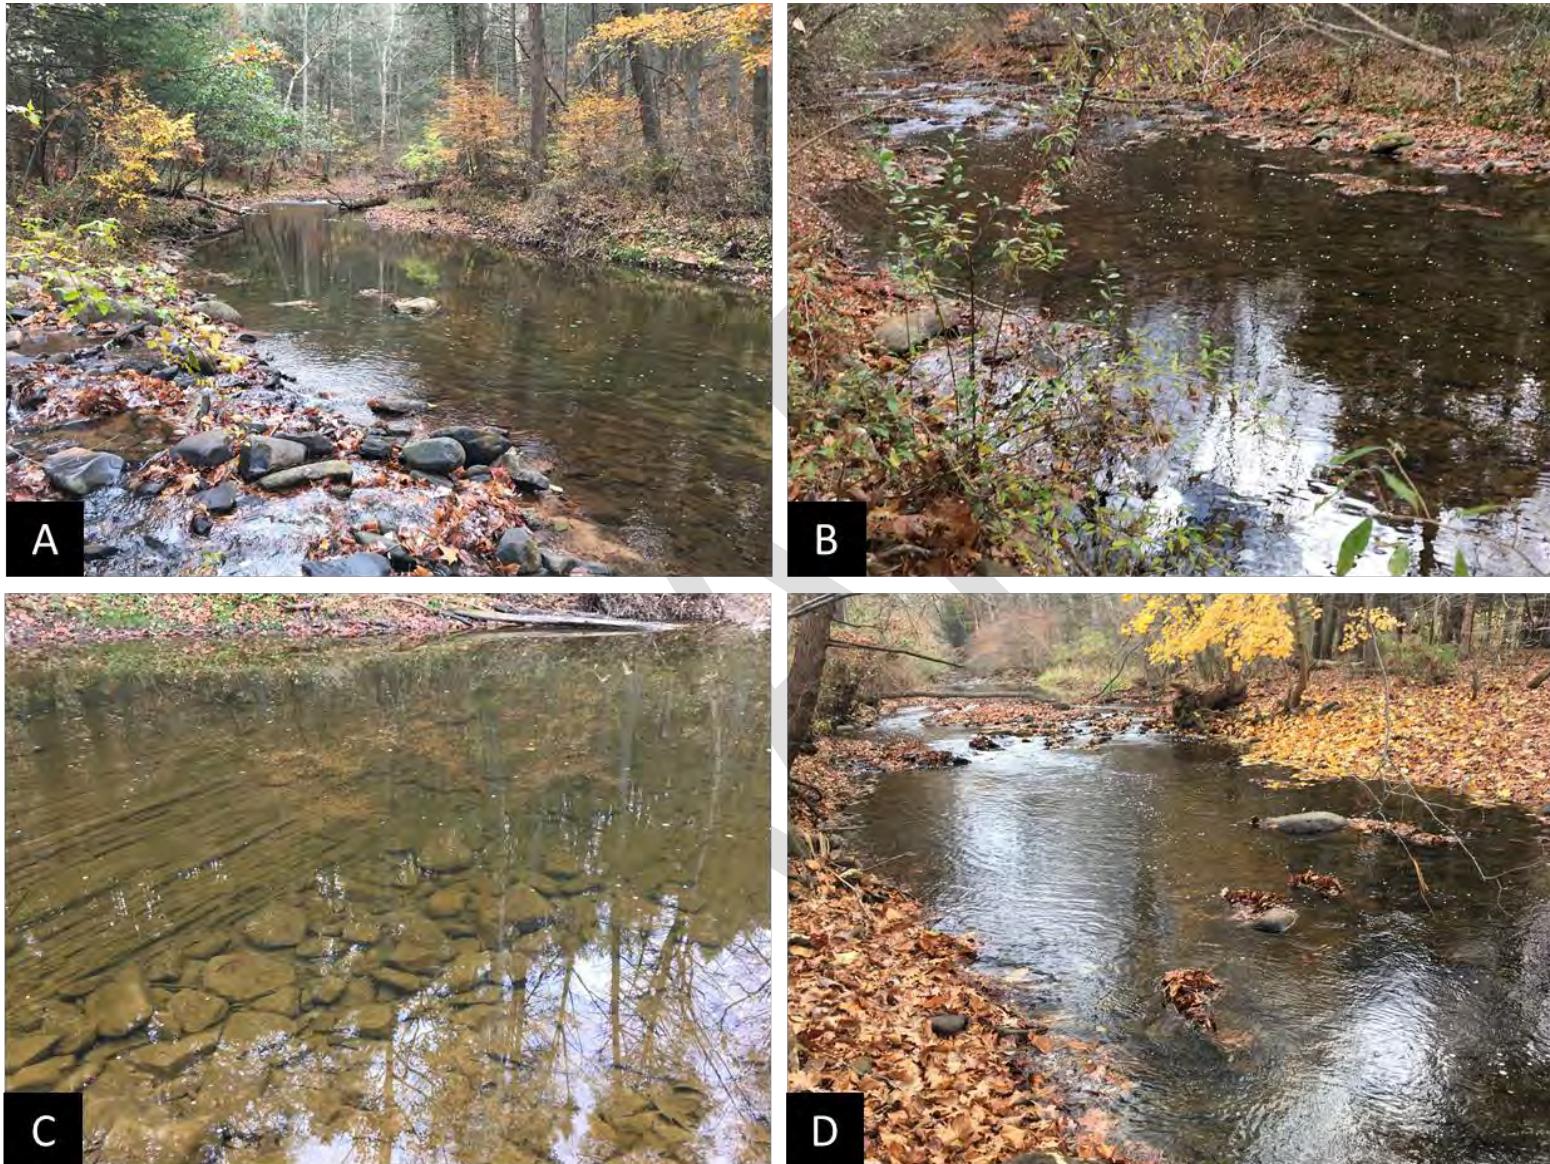
**Figure 9.** Big Cove Creek approximately three miles downstream of the impaired area. Note the clear water and largely rocky substrate.

Observations of the Big Cove Creek watershed were consistent with a significant siltation problem within the study area but improved conditions further downstream. At approximately three miles downstream from the outlet of the present study area, the mainstem appeared to be clear and rocky (Figure 9). The lack of obvious impairments in this area may be in large part due to: more forested land cover, increased topographic relief resulting in a higher gradient stream channel, and increased flow volumes especially from two largely forested tributary systems. Higher stream gradient and greater flow volume may make the stream better able to flush rather than accumulate its fine sediment load. Further upstream within the study subwatershed the mainchannel passes through a broader and flatter valley resulting in a more sluggish stream channel surrounded by intensive agriculture (Figures 10 and 11). Signs of degradation, including silt deposits and increased turbidity, were apparent in the mainstem of the study subwatershed (Figures 10 and 11). Conditions within smaller tributaries were variable and dependent on the conditions of their surrounding landscape (Figure 12). While mapping indicated a high density of first order streams (Figure 1), many were dry during the site visit (Figure 12) likely due to both recent dry weather and infiltration into karst geology.

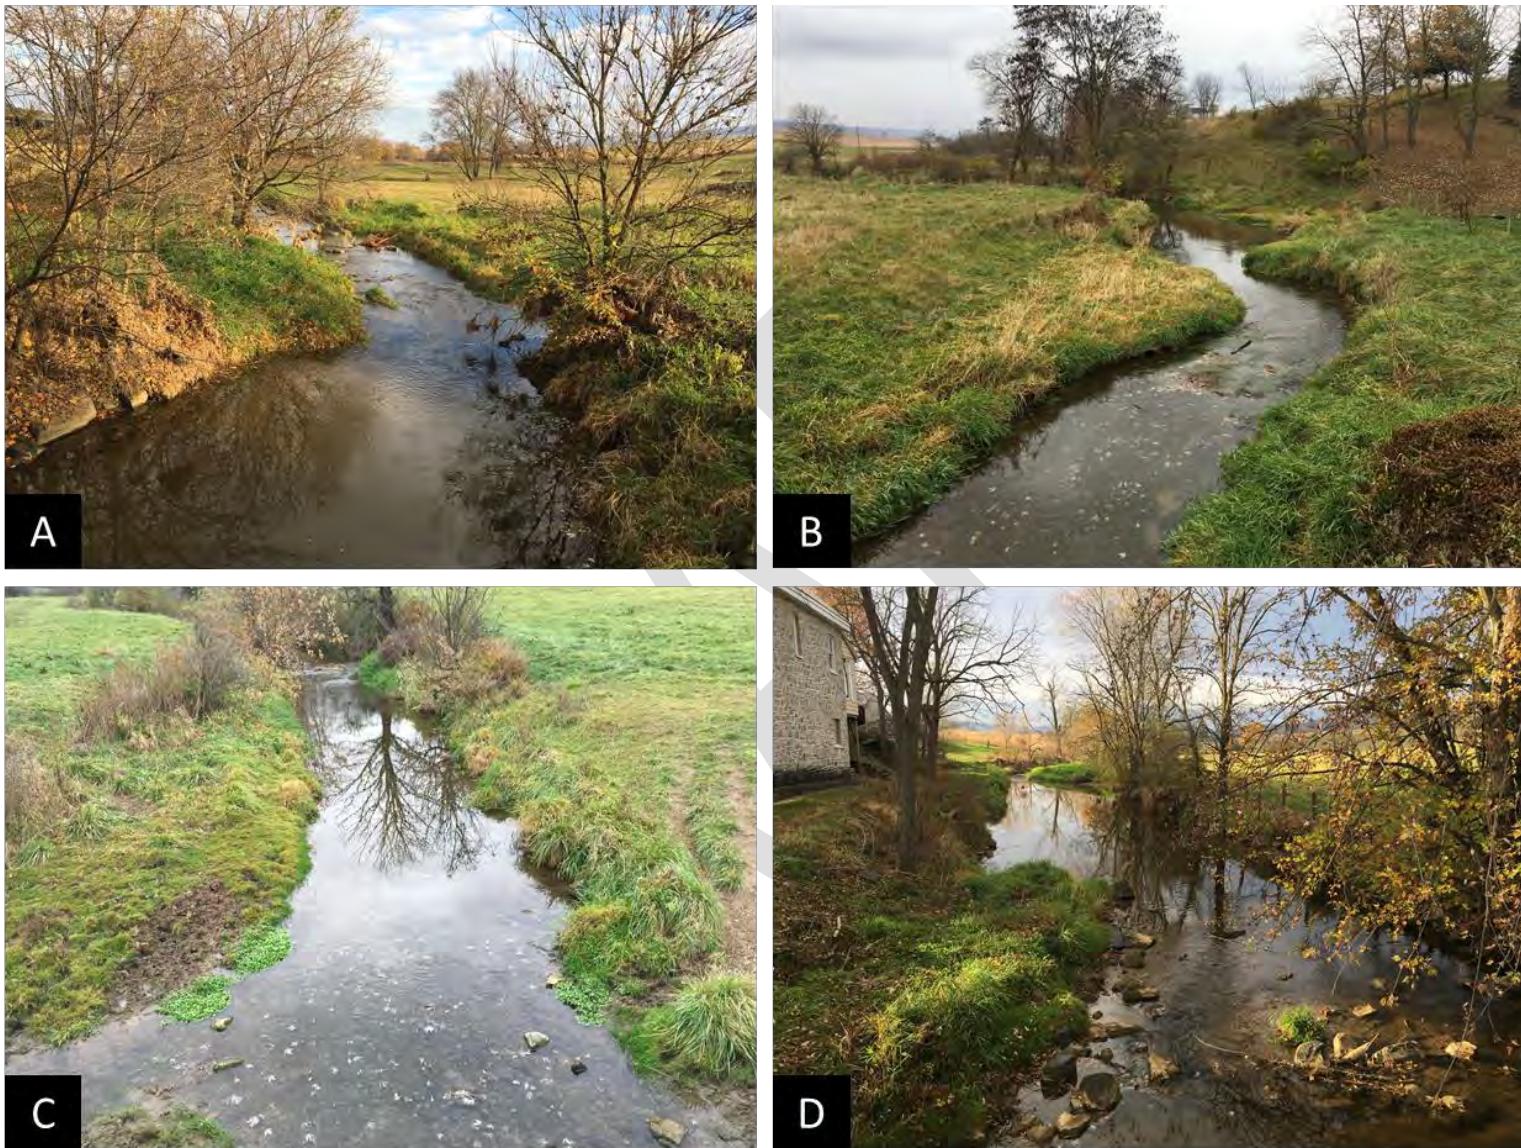
**Figure 10.** Stream conditions within the lower mainstem of the impaired area within the Big Cove Creek subwatershed. Note the obvious turbidity and signs of siltation pollution.

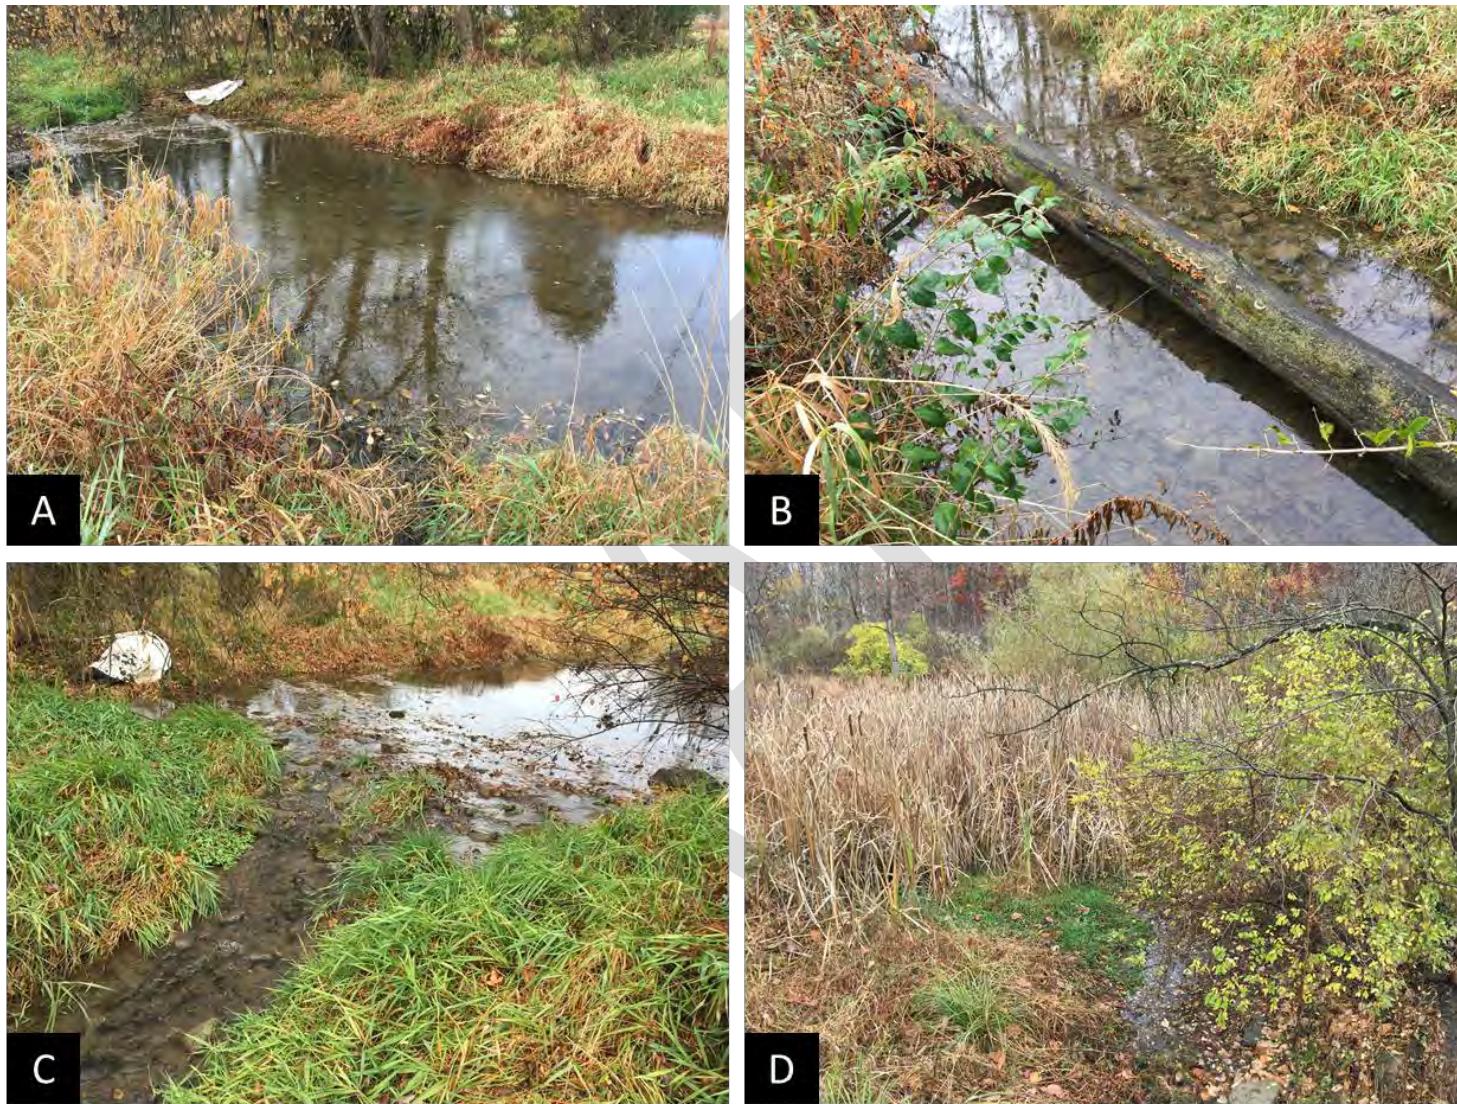
**Figure 11.** Mainstem conditions upstream of McConnellsburg within the Big Cove Creek subwatershed. Siltation was obvious, likely due in part to agricultural landuses but also low gradient wetland conditions. Photograph D shows obvious wetlands near the mainstem's origins.

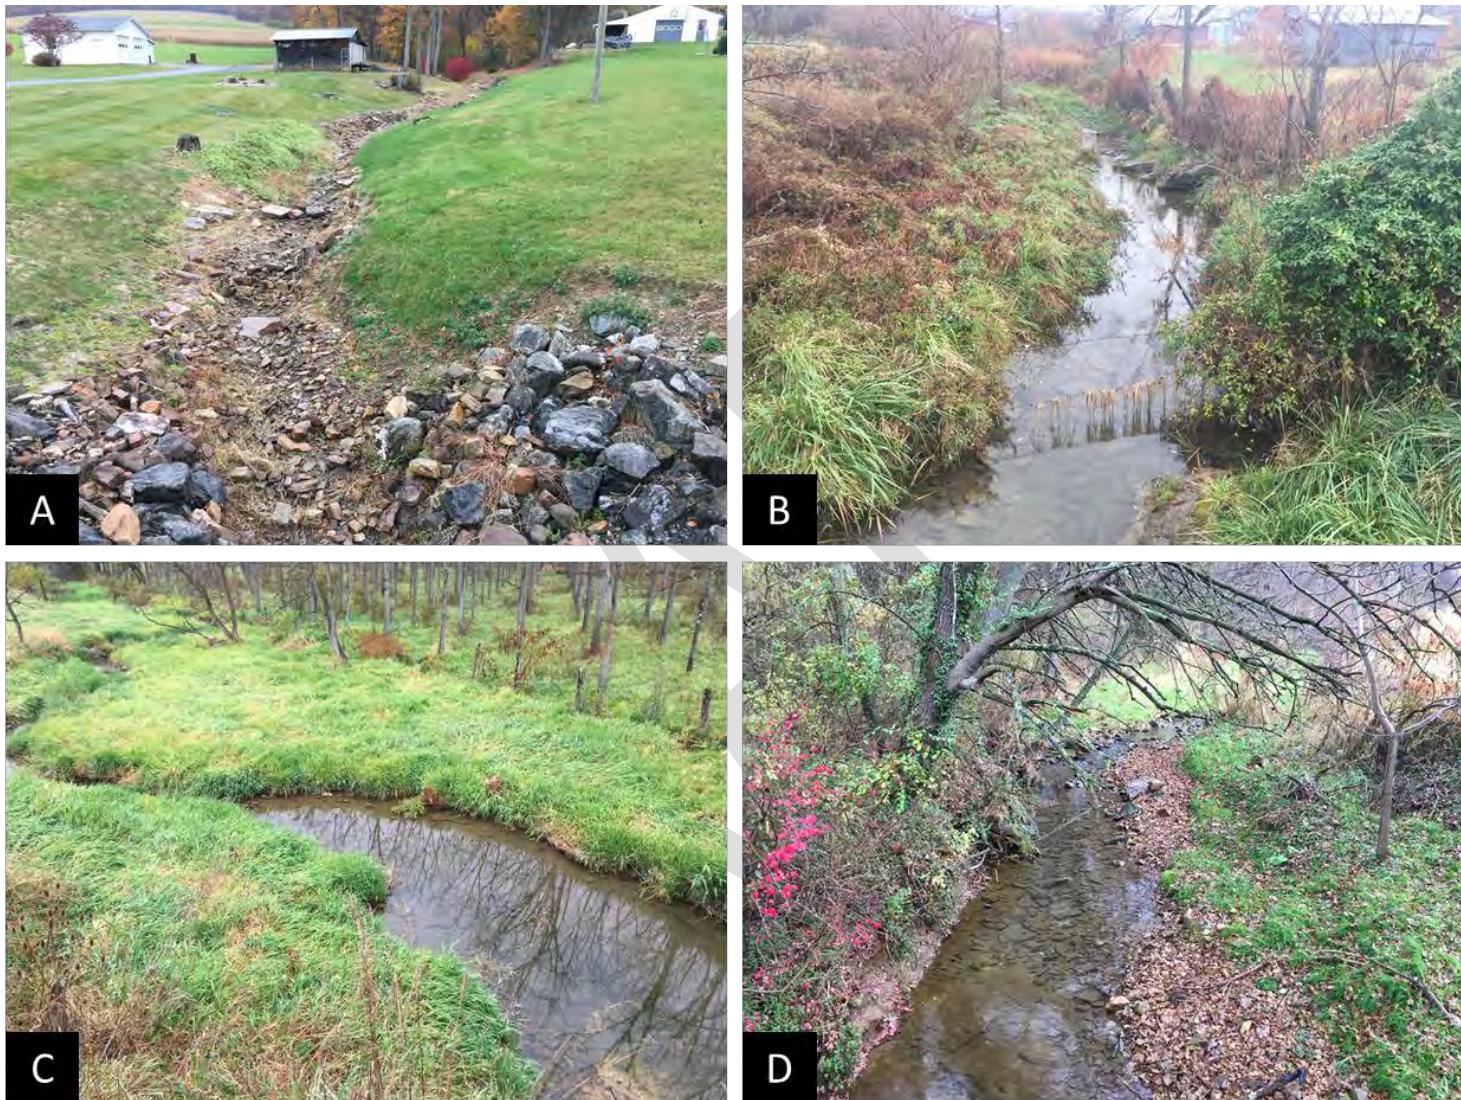
**Figure 12.** Condition within small tributaries of the Big Cove Creek subwatershed. Many tributaries were dry as in A during the October 2022 site visit, likely in part due to karst geology as well as recent dry weather. Photographs B through D show that tributary conditions ranged from murky and with obvious siltation to clear and rocky.

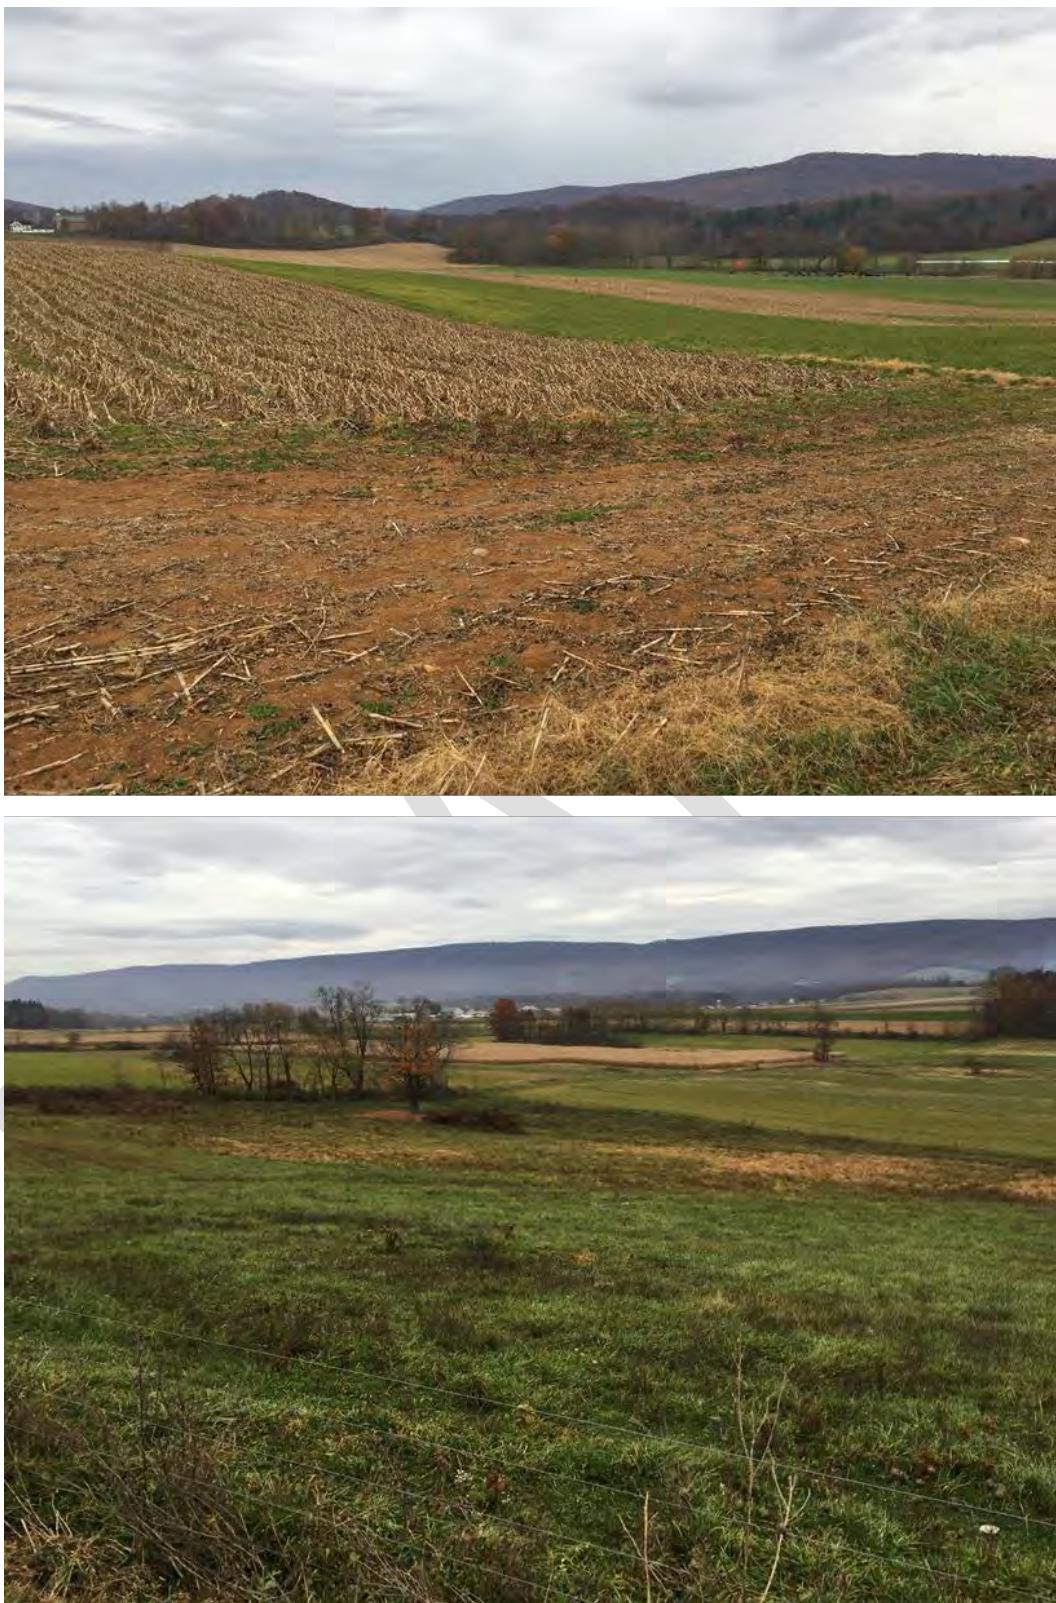
**Figure 13.** Landscapes within the Big Cove Creek subwatershed. The eastern and western watershed margins consisted largely of forested mountain ridges while the valley lowlands were dominated by agriculture.

Figure 13 illustrates typical landscapes within the Big Cove Run study subwatershed. As is also evident in mapping (Figure 1), there was a broad central valley with very intensive agriculture, while the eastern and western margins of the subwatershed were bounded by forested ridges. Given the intensity of agriculture in the central valley, impairments within the mainstem would be expected. Furthermore, much of this land was large expanses of croplands, which tend to have the highest sediment loading rates among the land covers typically found in Pennsylvania. Some croplands with bare soils were observed during the late October site visit. Also, livestock had direct access to some stream segments which may result in the lack of riparian buffers, bank trampling, and direct animal waste inputs.

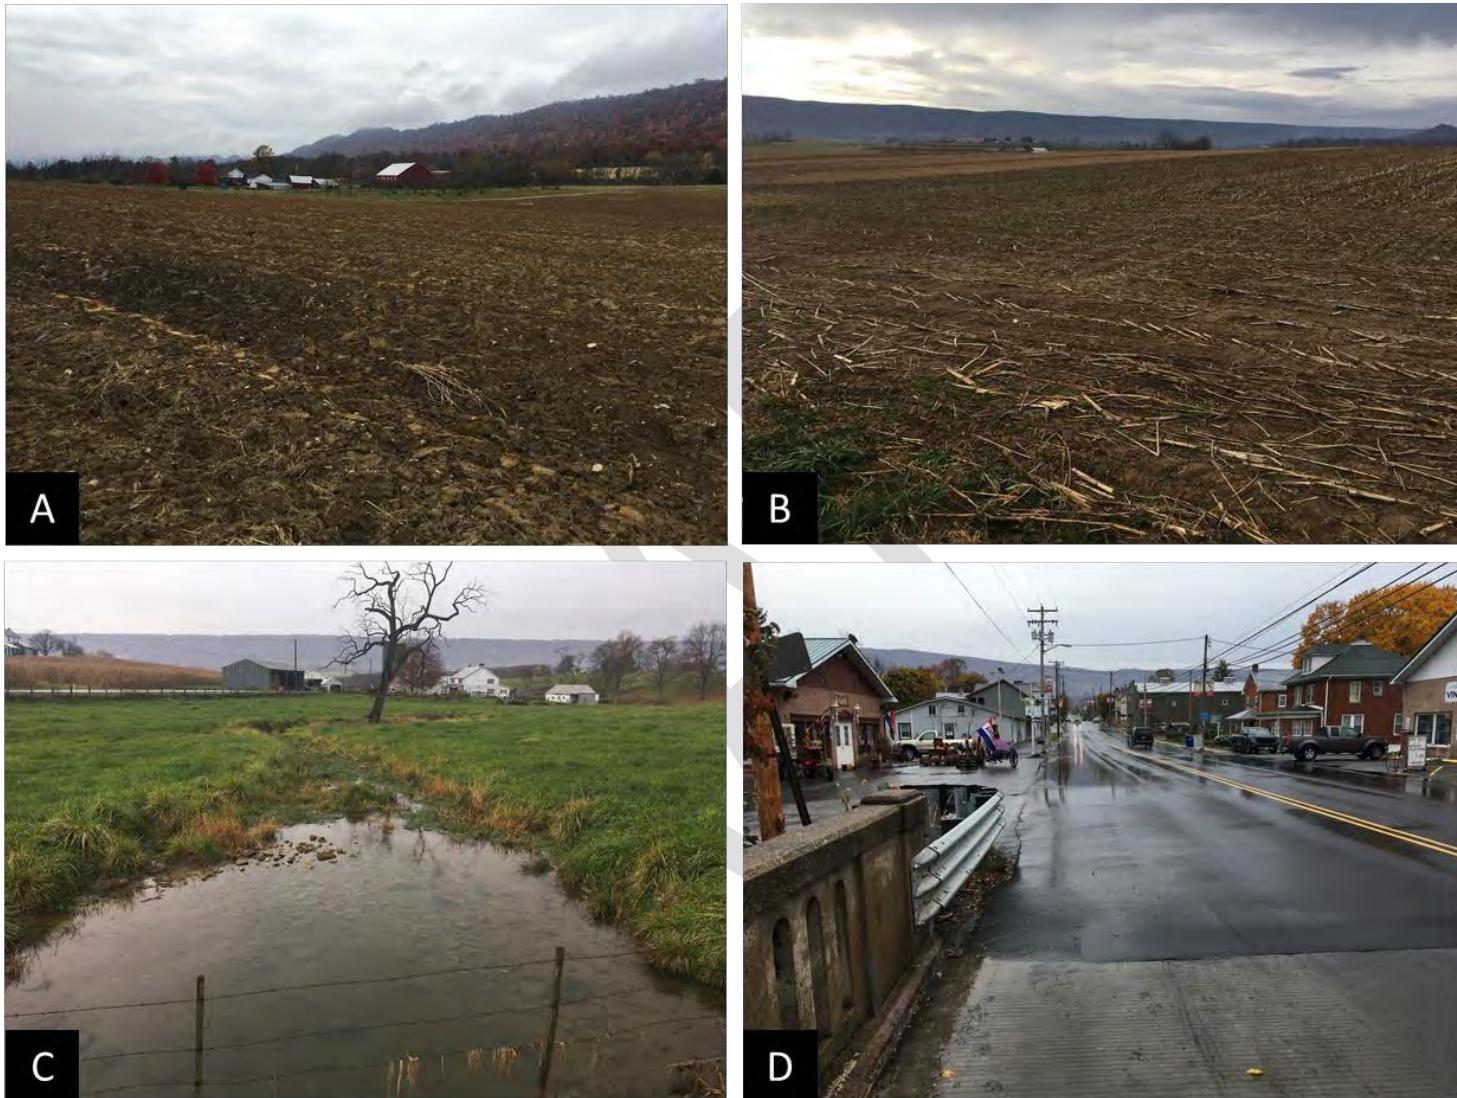
**Figure 14.** Factors promoting siltation within the Big Cove Creek subwatershed. Photographs A and B show large expanses of crop fields with seasonally bare soils. Photograph C shows a pasture where livestock had direct access to the stream. Photograph D shows urbanized lands within McConnellsburg.

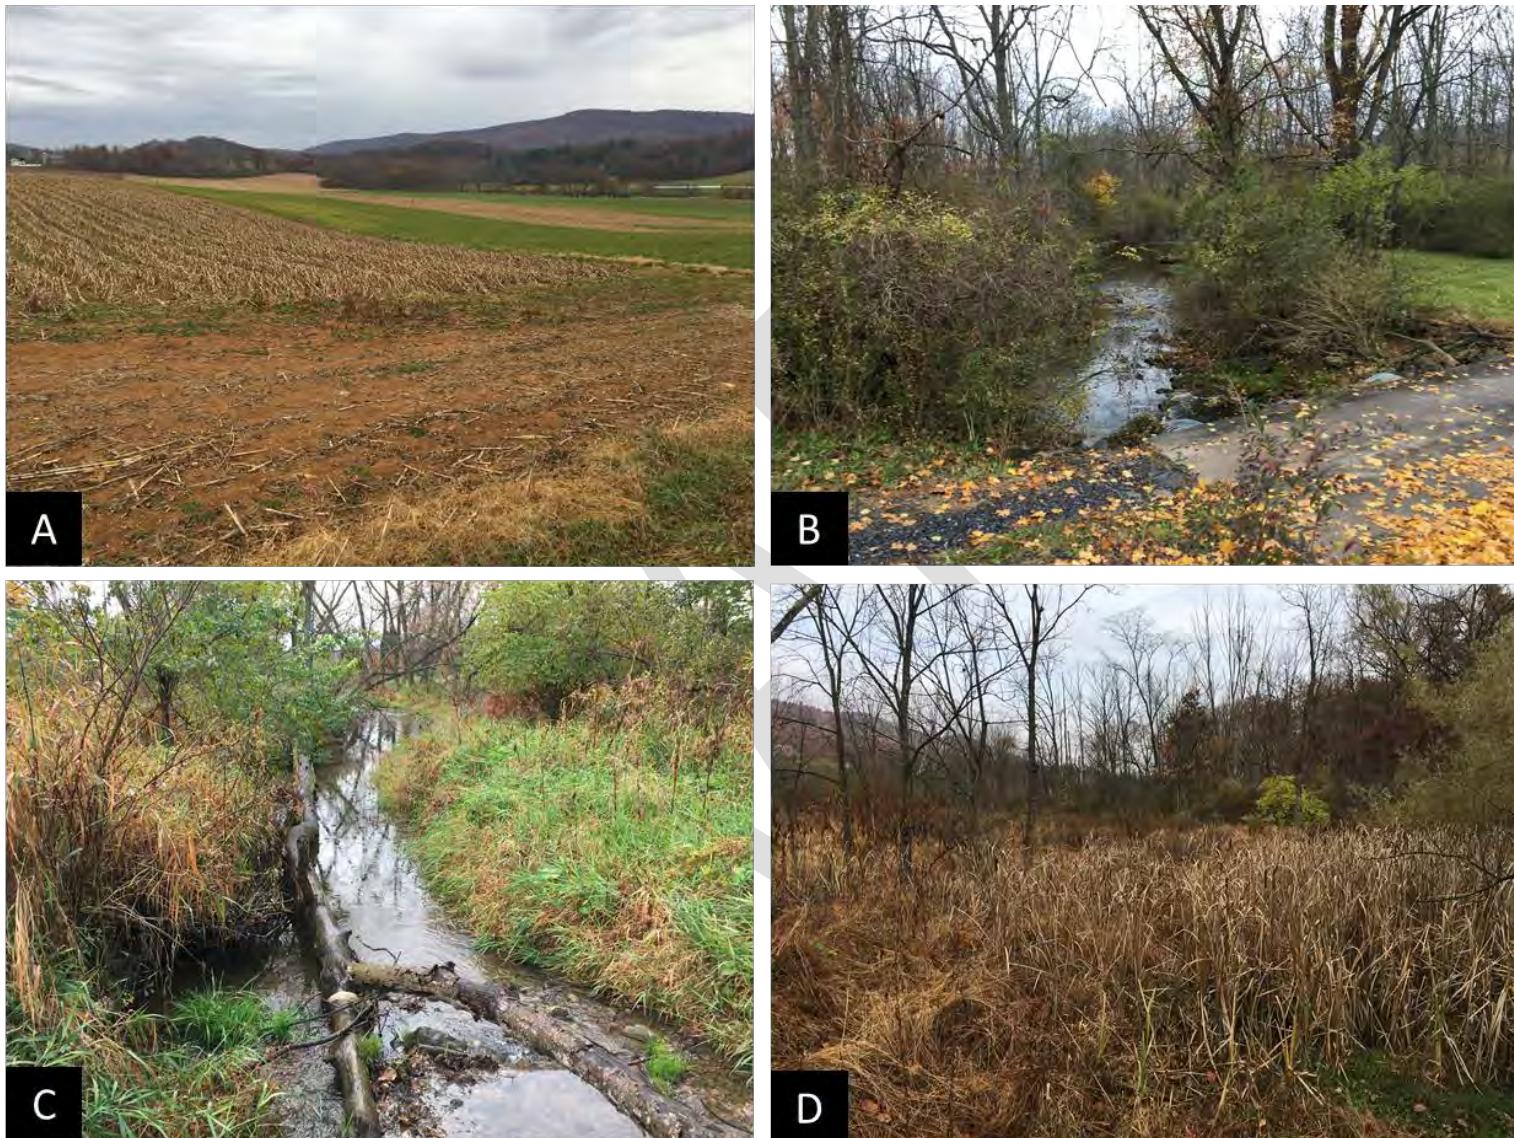
**Figure 15.** Factors that may protect against sediment pollution in the Big Cove Creek subwatershed. Note the high levels of crop residues and use of contour tillage in A. Photographs B through D show the use of forested riparian and wetland buffers.

On the other hand, positive factors that may be protective against siltation pollution were observed in some cases as well, including the use of contour tillage, the allowance for crop residues following harvest, and the presence of forested and wetland riparian buffers (Figure 15).

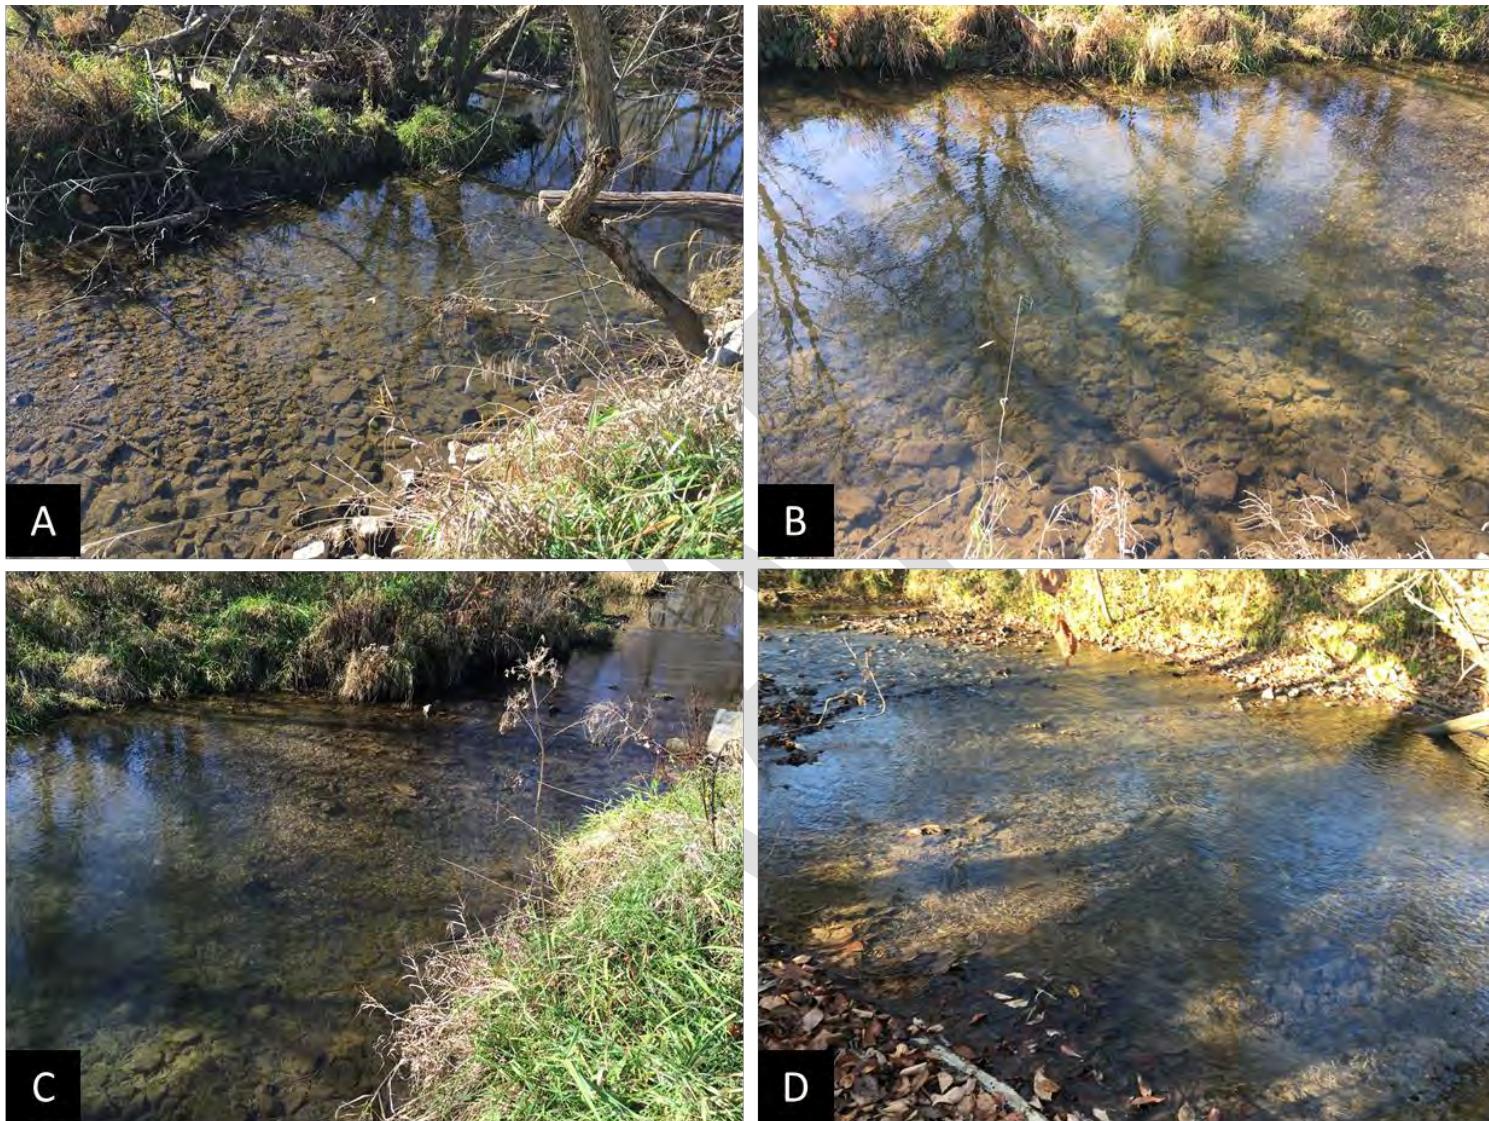
**Figure 18.** Condition of the mainstem near the outlet of the Cove Creek reference subwatershed. While the water was largely clear and the substrate was gravelly, there was some obvious siltation coating the substrate of slower reaches. This fine sediment deposition is likely attributable to both the high amounts of agriculture within the watershed and the sluggish flows of the low gradient mainstem.

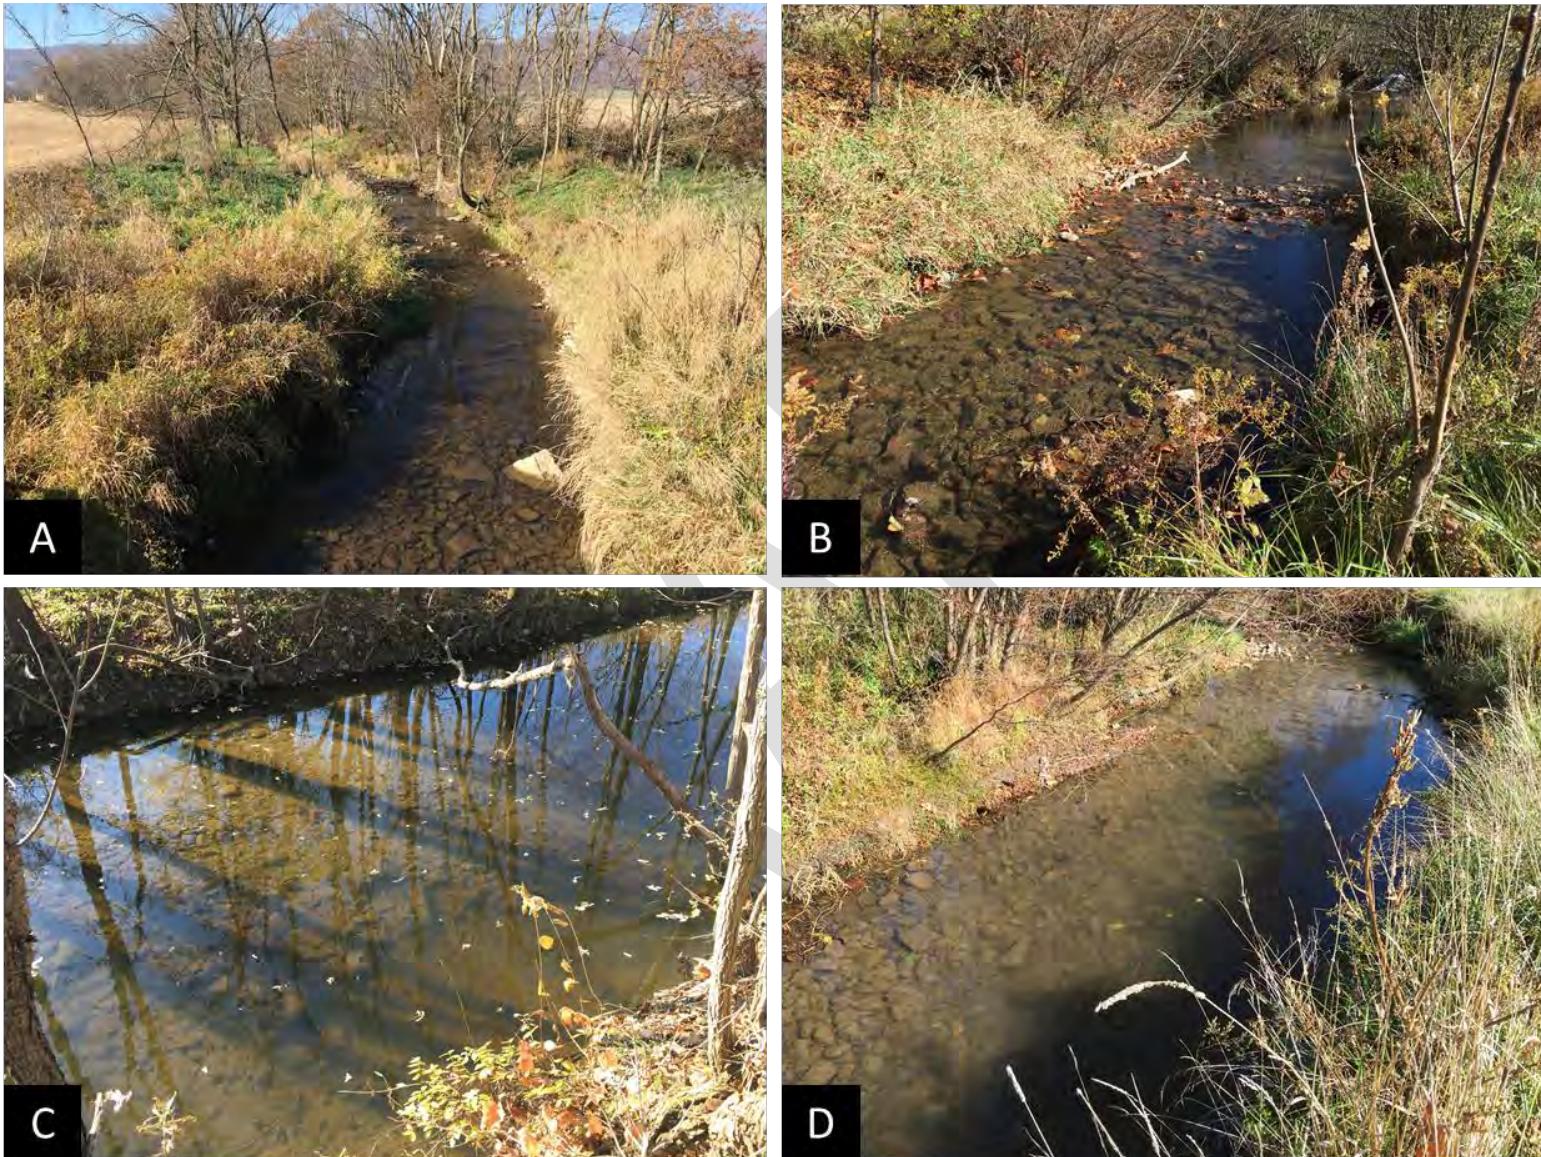
**Figure 19.** Upper mainstem within the Big Cove Creek subwatershed. The substrate was largely clear and rocky, though some turbidity and siltation can be seen in the pools shown in C and D.

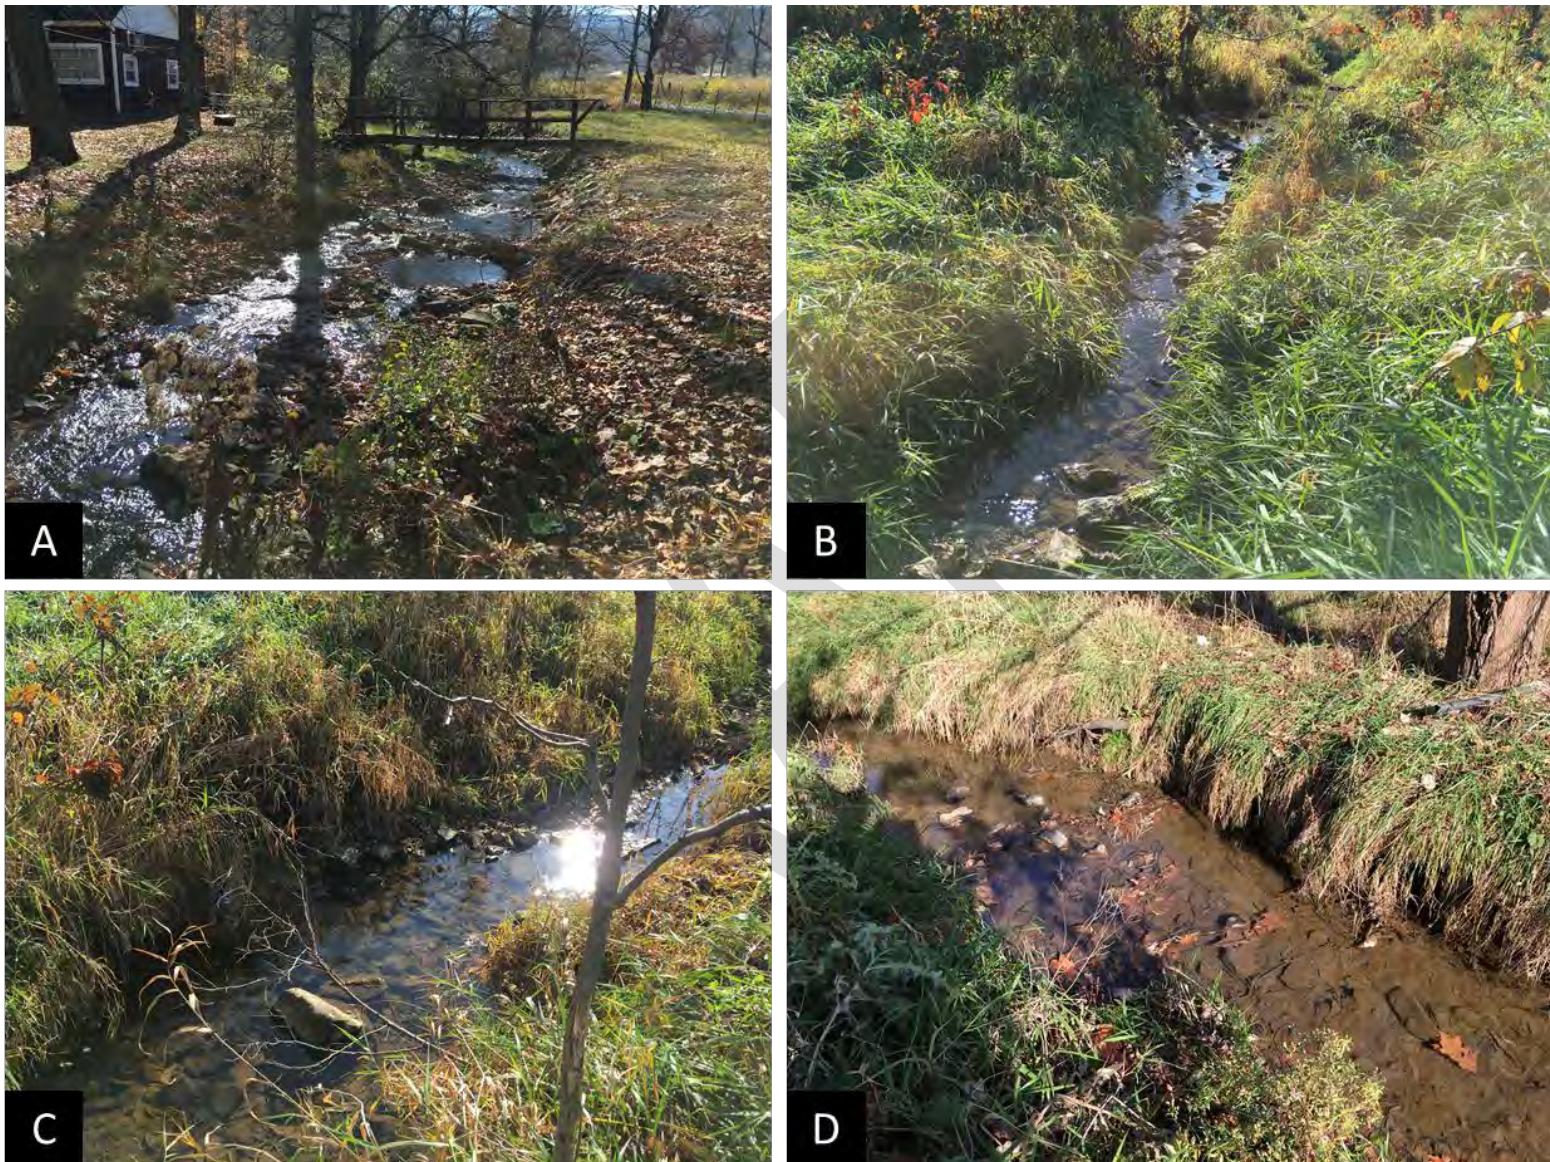
**Figure 21.** Small flowing channels within the Cove Creek subwatershed. Such streams tended to be rocky and clear, though siltation was obvious in some areas.

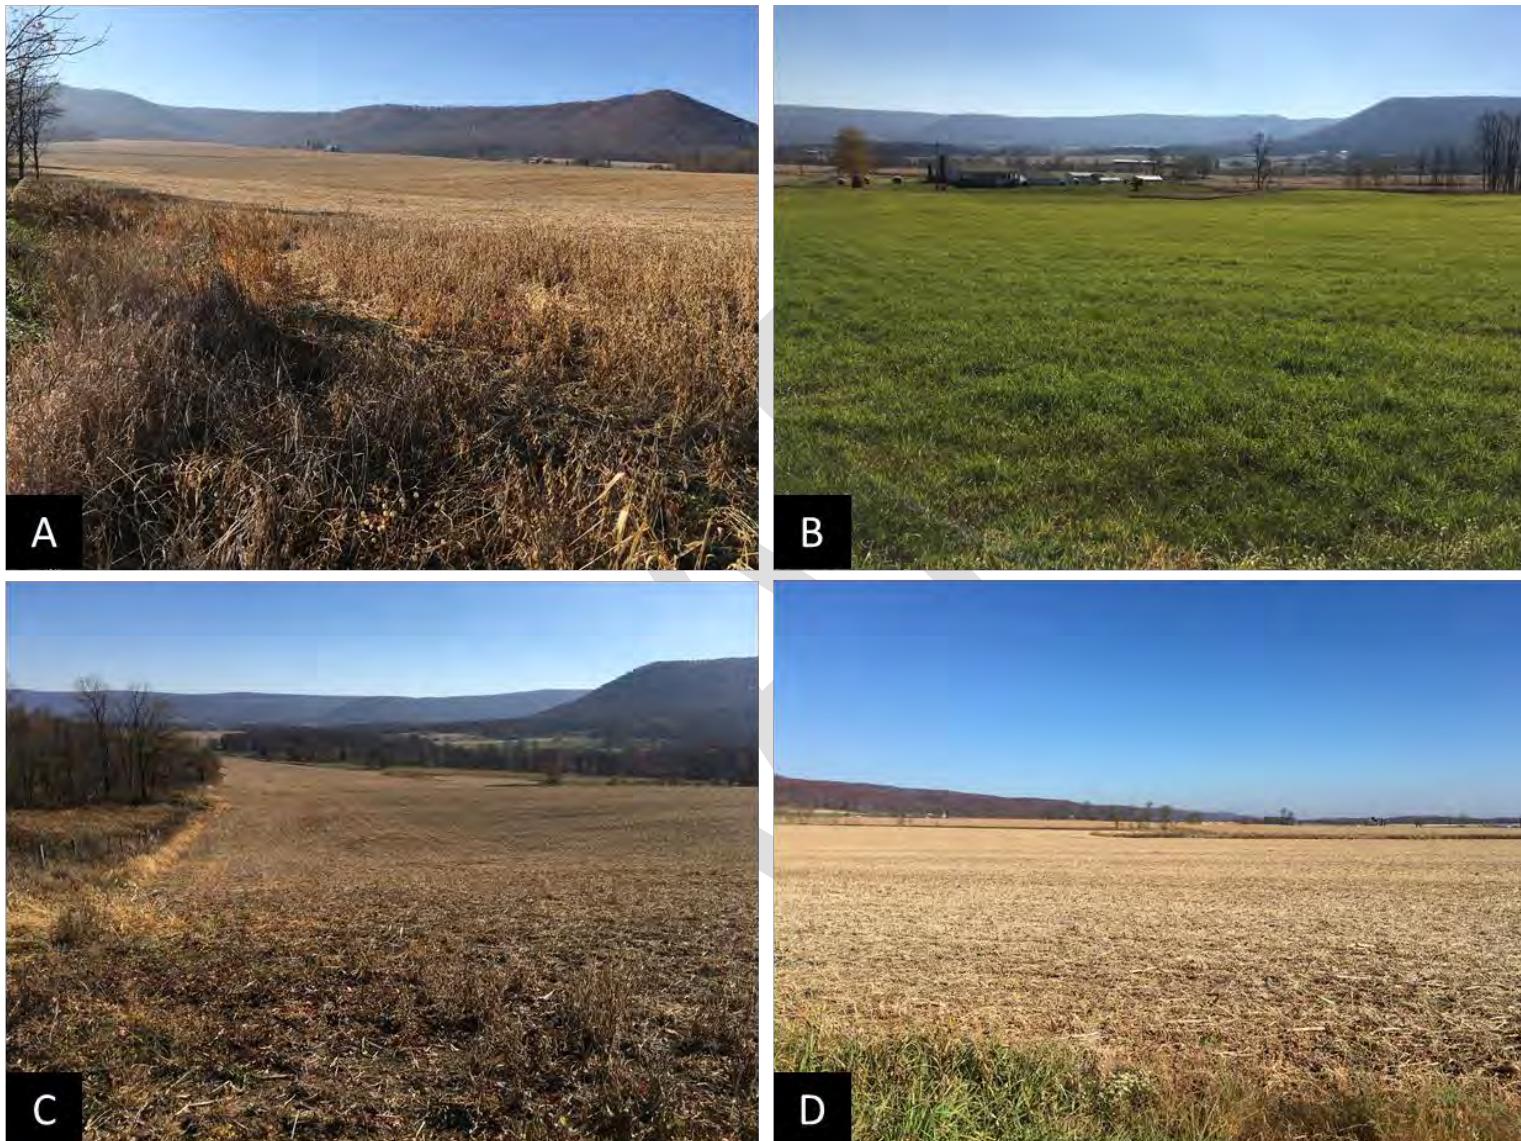
**Figure 22.** Landscapes within the Cove Creek reference subwatershed. The watershed was bounded by forested mountain ridges in its southern, western and eastern margins, while the central valley area was dominated by agriculture.
